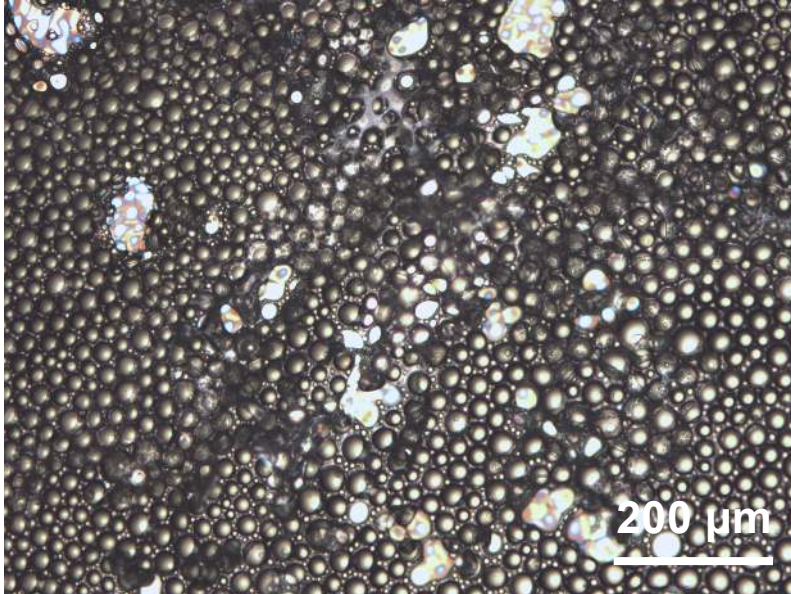
**Figure S1.** Optical microscope image of PDMS dielectric film in sensor from Figure 4(c) at lower magnification (100x).

A lower magnification image of the PDMS dielectric in the sensor from Figure 4(c) reveals some defects in the film, in particular unpatterned patches. Such patches could either contain unpatterned PDMS or exposed electrode with no PDMS. Unpatterned PDMS would contribute to greater hysteresis, as it would cause the film to behave slightly more like a completely unpatterned PDMS film dielectric, and likely results from PDMS not fully filling the pores in those areas. Exposed electrode, on the other hand, would reduce hysteresis due to the removal of compressible material and the compression of air instead of PDMS in those regions. Such empty patches can be due to poor transfer of the PDMS to the electrode.

The presence of some structures in the patches in Figure S1 and their iridescent appearance indicates that the patches likely contain unmolded PDMS, which would justify its having greater hysteresis than the sensor in Figure 4(b) despite its having domes with seemingly high aspect ratios (10.45 kPa compared to 7.85 kPa).
