Failure and Collapse of Building Structures in the Cities of Yaoundé and Douala, Cameroon from 2010 to 2014

The aim of this article is to elaborate various cases that occurred in Yaoundé and Douala, Cameroon between 2010 and 2014 leading to losses of lives and properties. It also mentions the possible causes which could have caused such incidents, along with various suggestions and recommendations to mitigate or ameliorate future buildings collapse in these cities.

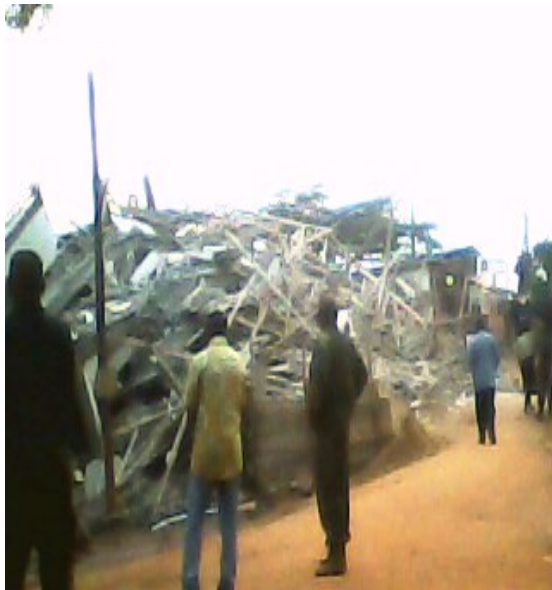
Figure 1. Building collapse at Elig-essono Suburb, Yaoundé

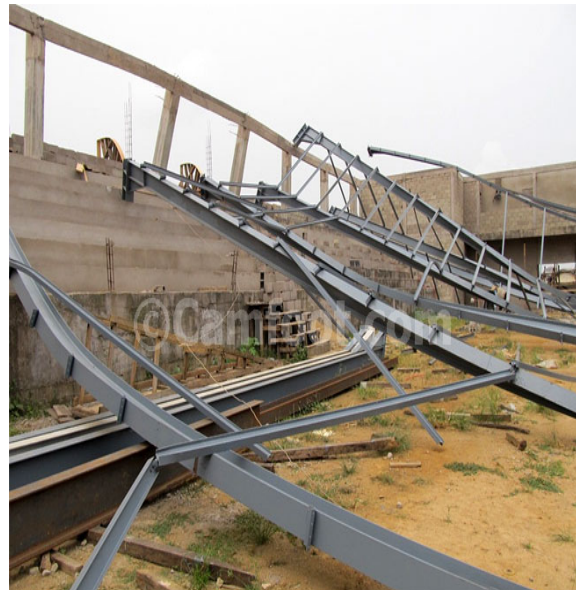
Figure 2. Multi-Sport Complex Steel Truss Roof collapse at Bépanda Suburb, Douala

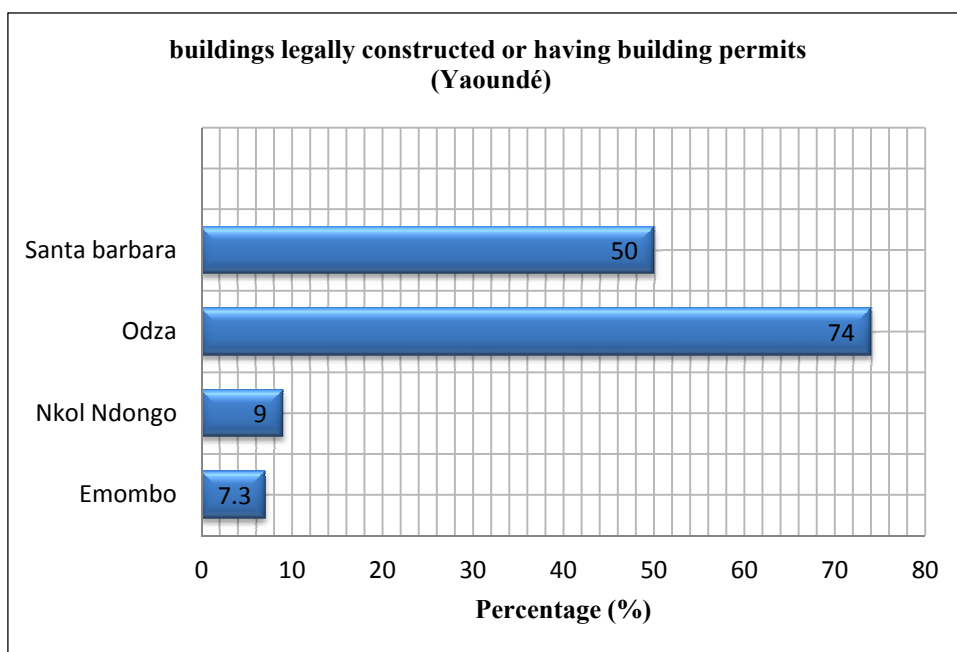
The percentages of buildings legally constructed or having building permits in certain suburbs in the city of Yaoundé are shown in figure 3 below. We observe that the suburb Odza has the highest number of buildings legally constructed or having building permits representing 74% of the buildings and the suburb Emombo and Nkolndongo the smallest representing 7.3% and 9% respectively.

Figure 3. Percentages of buildings legally constructed or having building permits in certain suburbs in the city of Yaoundé

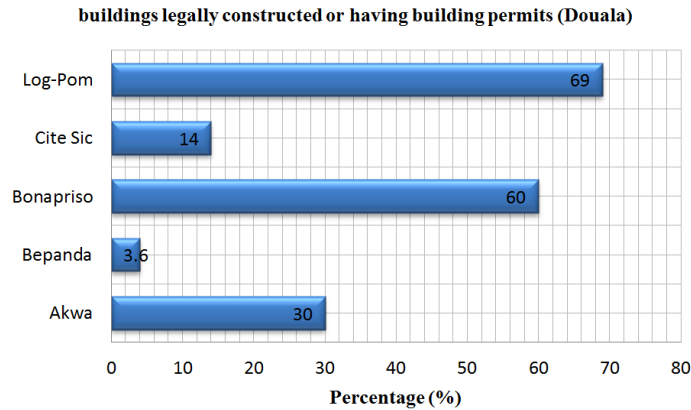
Figure 4 shows the percentages of buildings legally constructed or having building permits in the city of Douala. From this figure, it can be observed that the suburb Log-pom has the highest number of buildings legally constructed or having building permits representing 69% of the buildings and the suburb Bépanda the smallest representing 4%.

Figure 4. Percentages of buildings legally constructed or having building permits in certain suburbs in the city of Douala

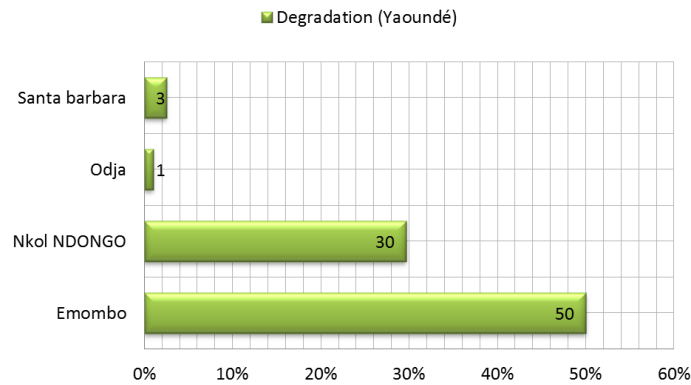
The percentages of buildings in certain suburbs in the city of Yaoundé showing signs of degradations /defects (cracks in walls, roof defects, etc.) can be seen in figure 5 below. We observe that the Emombo suburb has the highest number of buildings with signs of degradations/defects with 50% of the buildings and the suburb Odza and Santa Barbara the smallest with 1% and 3% respectively.

Figure 5. Percentages of buildings in certain suburbs in the city of Yaoundé with signs of degradations/defects

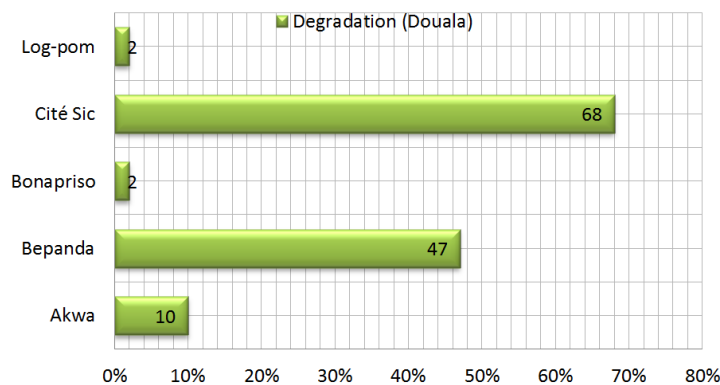
Figure 6 represents the percentages of buildings in certain suburbs in the city of Douala showing signs of degradations/defects (cracks in walls, roof defects, etc.). From this figure, it can be observed that the suburb Cité SIC has the highest number of buildings showing signs of degradations/defects with 68% of the buildings and the suburb Bonapriso and Log-pom the smallest with 2% each.

Figure 6. Percentages of buildings in certain suburbs in the city of Douala with signs of degradations/defects

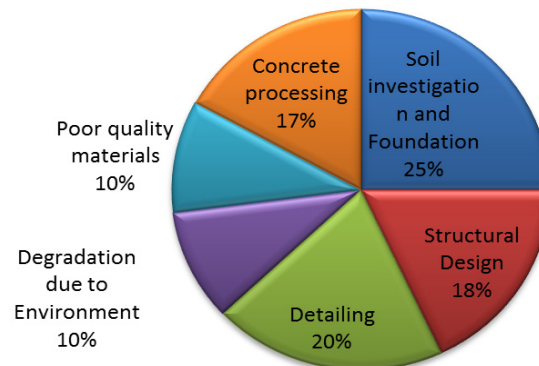
The percentages of causes of buildings collapse in the cities of Yaoundé and Douala are shown in figure 7 below. Soil investigation and foundation, structural design and detailing form major causes of buildings collapse in the cities of Yaoundé and Douala. The trio had 25%, 18% and 20% occurrence respectively. It can be observed also that 17% of the building collapses in these cities are due to concrete processing.

Figure 7. Causes of building collapse in the cities of Yaoundé and Douala

1. A preliminary geotechnical investigation should be carried out before design. Prohibiting the use of quacks or of non-professionals in building construction.

4. Construction materials quality control check should be made before commencement of using.
5. Getting approval before commencing construction on site.

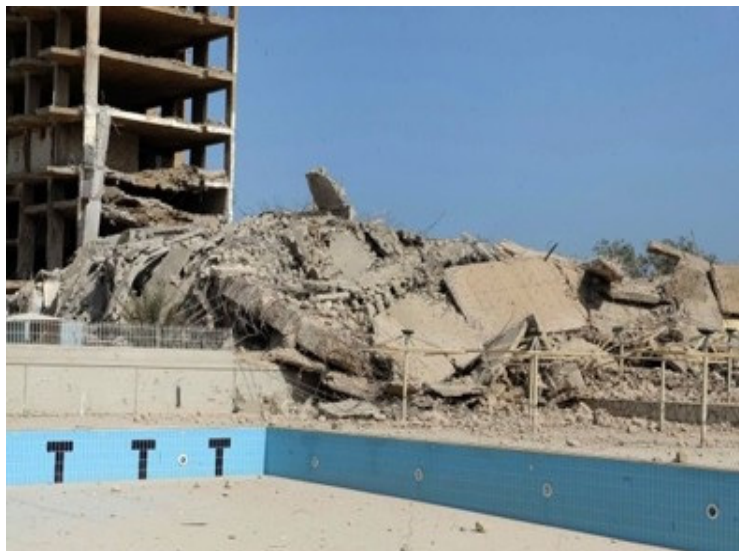
A four-storey building under use though under construction after ten years collapsed (see Figure 8) in Akwa Nord, Douala, on May 18, 2014.

Figure 8. Collapse site of a 4-storey building at Akwa Nord, Douala (Source: Journal le messenger, 2014)

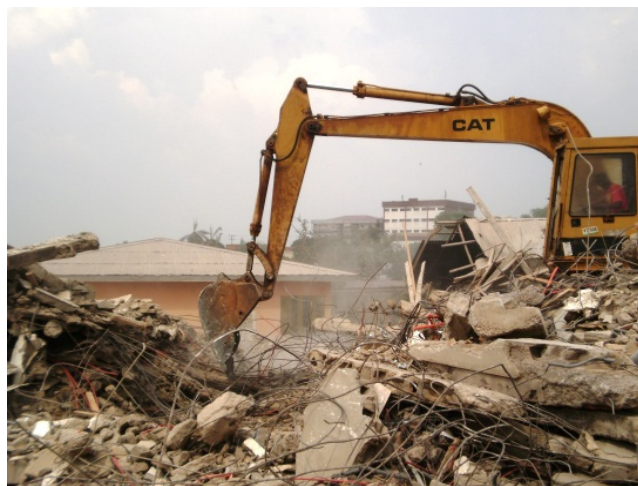
On February 26, 2010, the structure of the building in Nkolndongo, Yaoundé catastrophically collapsed (Figure 10), bringing down the entire five-storey reinforced concrete structure. The building was originally designed for five-storey building for residential use, but out of greediness, the owner decided to add extra one floor. This additional weight on the structure without due consideration of the foundation, column and slab led to the collapse of the building (Amadi et al., 2012; Oke, Amadi, Abalaka, & Akerele, 2009a) as a result of structural inefficiency due to excessive loading of area after remodelling, improper binding of units and unequal distribution of load (Ayuba et al., 2012).

Figure 10. Collapse site of a 5-storey building at Nkoldongo, Yaoundé (Source: Journal du Cameroun, 2010)

In the Nkolndongo building case, the investigation found that the design approval process was simply not undertaken. Moreover for a 5-storey reinforced concrete building, there were no structural drawings and no bills of quantities prepared. These strong signs of non-conformity with approval procedures would have been reason enough for the municipal authorities to query the construction at its early stages and interrogate their lack of approved documents. Interestingly, the municipal authorities did not undertake any such action to inspect and monitor the site construction, and by so doing the authorities too passively contributed to the tragic collapse (Alinaitwe & Ekolu, 2014).

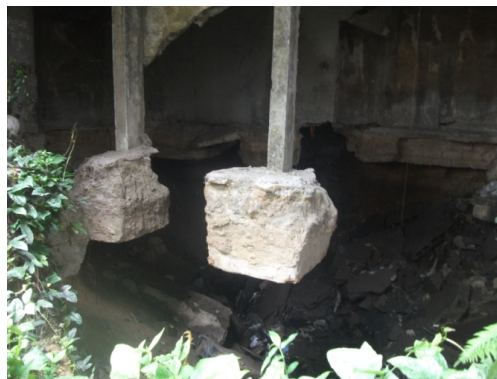
- Poor materials and workmanship
- Lack of equipment in the construction industry
- Absence of professional supervision of site works
- Inadequate design
- Faulty construction methodology
- Illegal conversion of building
- Change of use of buildings
- Financial pressures
- The use of quacks or of non-professionals in building construction
- Lack of quality control check
- Fire disaster
- Poor management and maintenance in buildings
- Reinforcement steel corrosion
- Erosion (Figure 12)

Figure 12. Foundation failure due to Erosion (Source: Author, 2014)
