# Failure Mechanism Analysis and Support Design for Deep Composite Soft Rock Roadway: A Case Study of the Yangcheng Coal Mine in China

This paper presented a case study of the failure mechanisms and support design for deep composite soft rock roadway in the Yangcheng Coal Mine of China. Many experiments and field tests were performed to reveal the failure mechanisms of the roadway. It was found that the surrounding rock of the roadway was HJS complex soft rock that was characterized by poor rock quality, widespread development of joint fissures, and an unstable creep property. The major horizontal stress, which was almost perpendicular to the roadway, was 1.59 times larger than the vertical stress. The weak surrounding rock and high tectonic stress were the main internal causes of roadway instabilities, and the inadequate support was the external cause. Based on the failure mechanism, a new support design was proposed that consisted of bolting, cable, metal mesh, shotcrete, and grouting. A field experiment using the new design was performed in a roadway section approximately 100 m long. Detailed deformation monitoring was conducted in the experimental roadway sections and sections

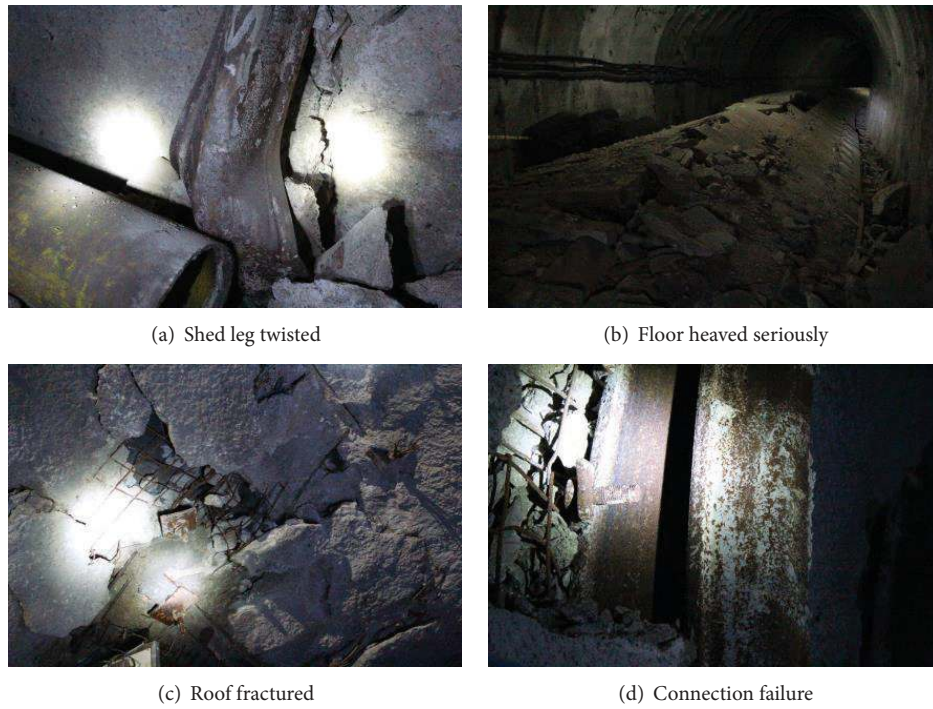
FIGURE 4: Deformation and failure of the roadway after repairing.

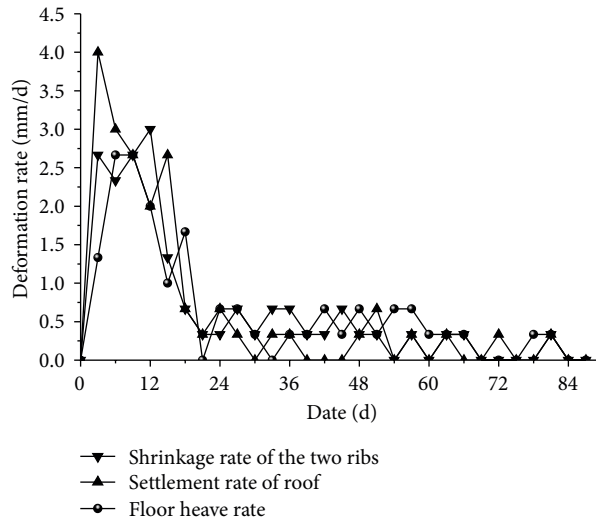
The monitoring results are shown in Figures 13, 14, 15, and 16. The monitoring results of sections 1 to 3 showed that there was an obvious increase in the deformation during the first 12 days after supporting the roadway. However, after approximately 12 days, the deformation rates started to decrease, and the deformations appeared to be stable after approximately 30 to 60 days. For the comparable sections 4 and 5 with the old support design, the deformation continued to increase over the whole monitoring period, and no obvious decline in the deformation rates was observed during the monitoring period.

FIGURE 14: The rate of deformation of the roadway with the new support design.

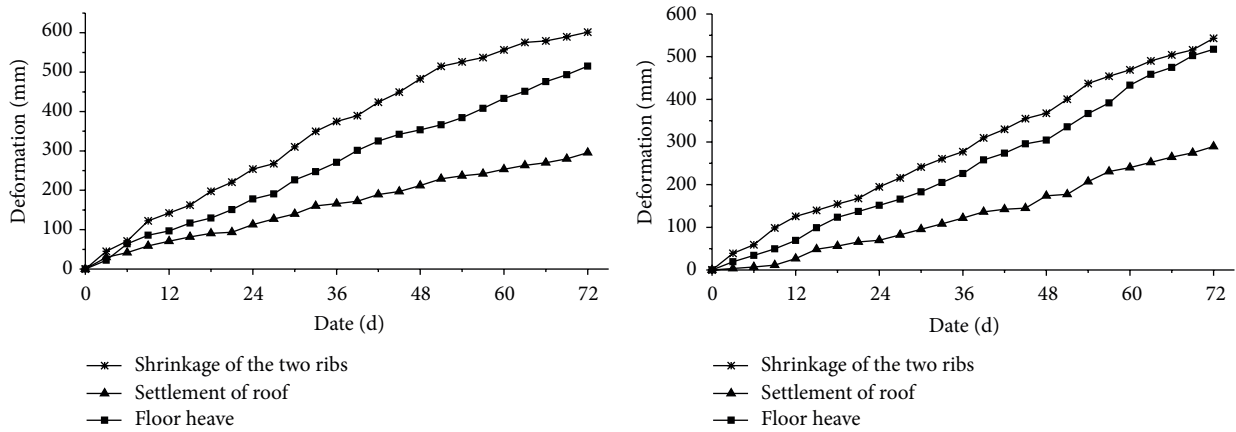
FIGURE 15: The cumulative deformation of the roadway with the old support design.

After monitoring, the maximum monitored ribs convergence, roof settlement, and floor heave in the roadway with the new support design were 56 mm (section 3), 44 mm (section 1), and 44 mm (section 3), respectively. In sections 4 and 5 with the old support design, these results were 601 mm (section 4), 295.6 mm (section 4), and 517.2 mm (section 5), respectively. It is clear that the roadway deformation with the new support design is much smaller than that with the old design. A similar conclusion is drawn by comparing the deformation rates of the ribs convergence, roof settlement, and floor heave in the roadway with the new support design and the old design. The highest deformation rates of the two ribs, roof, and floor of the roadway with the new support design were 3 mm/d, 4 mm/d, and 2.7 mm/d, respectively, compared to 17 mm/d, 10 mm/d, and 14 mm/d in the roadway with the old design.

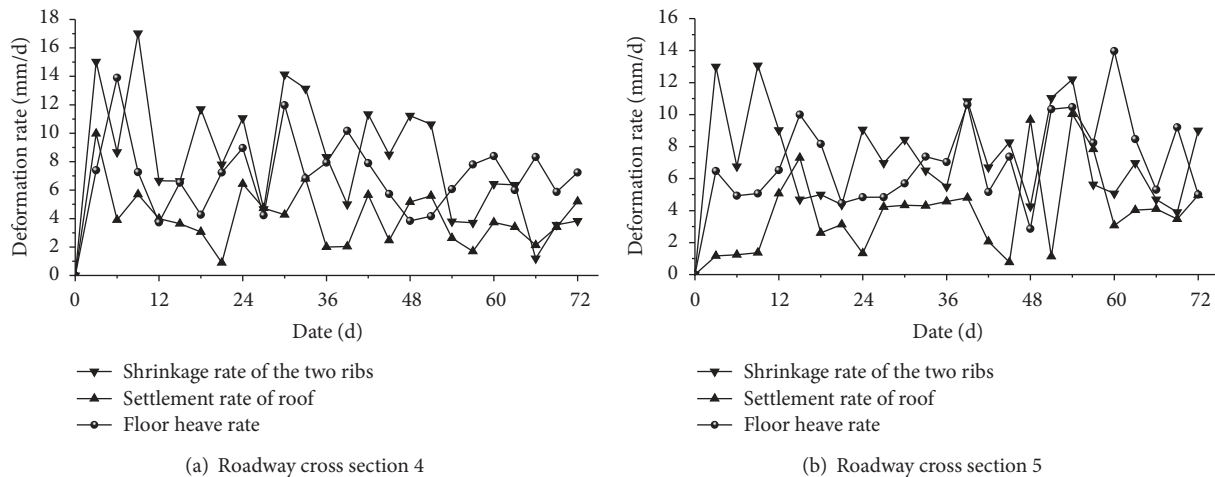
FIGURE 16: The rate of deformation of the roadway with the old support design.

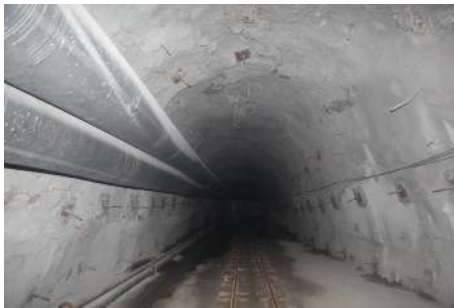
FIGURE 17: The roadway with new supporting design.

In general, compared with the old support design, the new support design can reduce the roadway deformation by at least 85–90%. During the monitoring period, the roadway roof, ribs, and floor with the new support design were intact and no obvious failure was visible. In contrast, the roadway with the old design experienced large deformations and severe failure. This indicates that the new support design can effectively control the deformation of the roadway and maintain stability of the roadway. The effectiveness of the new support design can be visually observed in Figure 17.
