Article

Fatigue Behavior of Ultrafine-Grained Medium Carbon Steel with Different Carbide Morphologies Processed by High Pressure Torsion

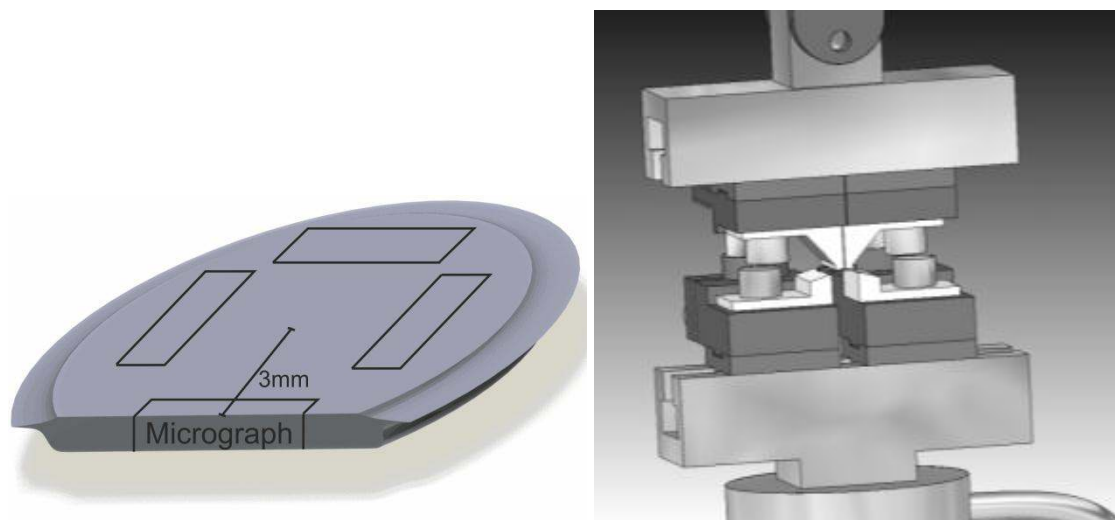
Figure 1. (a) HPT disc with indicated specimen extraction areas. (b) cyclic four-point-bending test fixture.

Four rectangular fatigue samples with dimensions of 4 mm \times 1 mm (w) \times 0.6 mm (h) were cut with their center at a distance of 3 mm from the center of every 10 mm \times 0.6 mm cylindrical HPT disk as illustrated in Figure 1a. The fatigue samples were ground into the final shape and polished to 1 μ m grid size. Hardness measurements were carried out with an ASMEC UNAT 2 Nanoindenter (ASMEC GmbH, Radeberg, Germany) and a proof force of 200 mN on a surface polished with colloidal SiO₂.

Cyclic four-point-bending tests were performed on a BOSE ELECTROFORCE 3230 electrodynamic testing machine at a frequency of 40 Hz under stress control. They were conducted with a load ratio of $R = 0.1$ at room temperature. The mountings are shown in Figure 1b with a lower mounting distance of 3.2 mm and an upper one of 1.6 mm. To determine the endurance limits, the staircase method [20] was used with different step sizes, depending on the fatigue limit to be expected by a linear correlation with the hardness. Stress calculations were carried out for the controlled force F considering the specimen geometry, using Equation (2):

In this case, $d = 0.8$ mm is the distance between the upper and lower mounting rollers. The parameter σ_{edge} specifies the edge stress as real stress in longitudinal direction in the lowest tension fiber when linear-elastic material behavior is assumed.

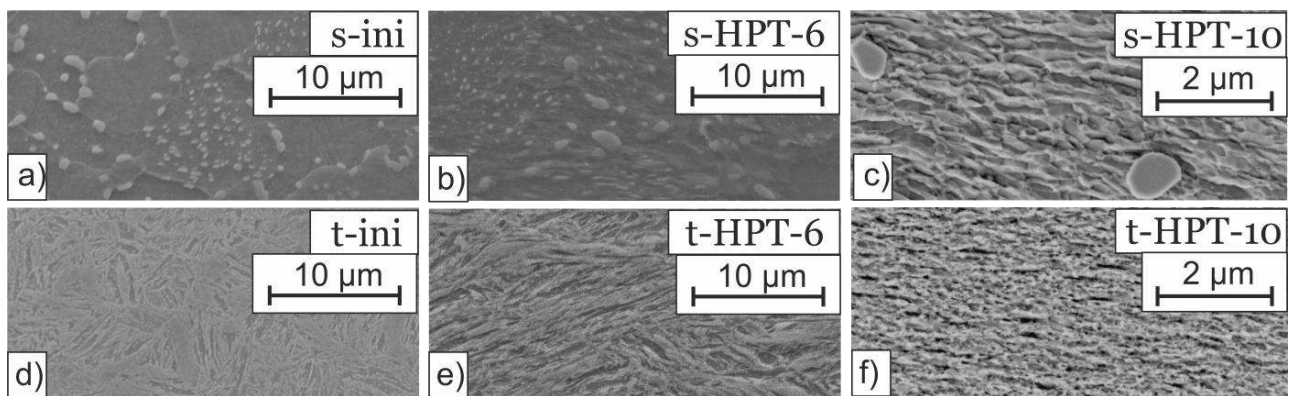
Figure 2. Etched surface microstructures prior to the fatigue tests (a) initial state after soft annealing containing spheroidal carbides (b) after 6 HPT rotations (c) after 10 HPT rotations (d) initial state with tempered microstructure (e) after 6 rotations (f) after 10 rotations.

The microstructure of C45 steel after spheroidizing annealing (S state) is shown in Figures 2a and 3a,b.

The soft annealed state contains spheroidal carbides distributed in a uniform coarse grained microstructure with well-defined grain boundaries (Figures 2a and 3b). The grains are micrometer sized ($\sim 15 \mu\text{m}$) and initial hardness is 169 HV. This state will be referred to as s-ini. Typical images of the S state after warm HPT for six and ten rotations (these states will be referred to as s-HPT-6 and s-HPT-10) are shown in Figures 2b,c and 3c–f. After six rotations, the microstructure is refined and new grain boundaries appear (Figures 2b and 3c). The grain size shrinks to approximately $0.8 \mu\text{m}$ and the grains show a slight elongation along the HPT shear direction (Figure 3c) with a hardness of 289 HV. After ten rotations, the ferrite grain size decreases further to approximately $0.2 \mu\text{m}$ and the elongation is more pronounced (Figure 3e,f). Hardness rises to 511 HV. The continuous grain refinement is best visible in Figure 3a,c,e.

Needle-shaped microstructures are visible in Figures 2d and 4a,b for C45 steel after tempering (T state). Carbides are finely dispersed between the needles (Figure 4b). The samples have an initial hardness of 388 HV before HPT. This state will be referred to as t-ini. After six HPT rotations (t-HPT-6), the needles become slightly refined (Figures 2e and 4c), their long axis is oriented along the shear direction and the formation of new low and high angle grain boundaries is visible. The hardness increases to 457 HV in t-HPT-6. After ten rotations (t-HPT-10), the microstructure shows strong refinement by SEM (Figure 2f) with no visible needles anymore. ACOM-TEM reveals an ultrafine grained structure with elongated grains and the cementite is finely dispersed in the ferrite matrix. The final hardness at the fatigue samples extraction point is 758 HV. However, the microstructure and hardness show variations along the radius of the HPT disk due to the shear strain variation (compare Equation (1)). The cementite distribution is most homogeneous after 10 rotations.

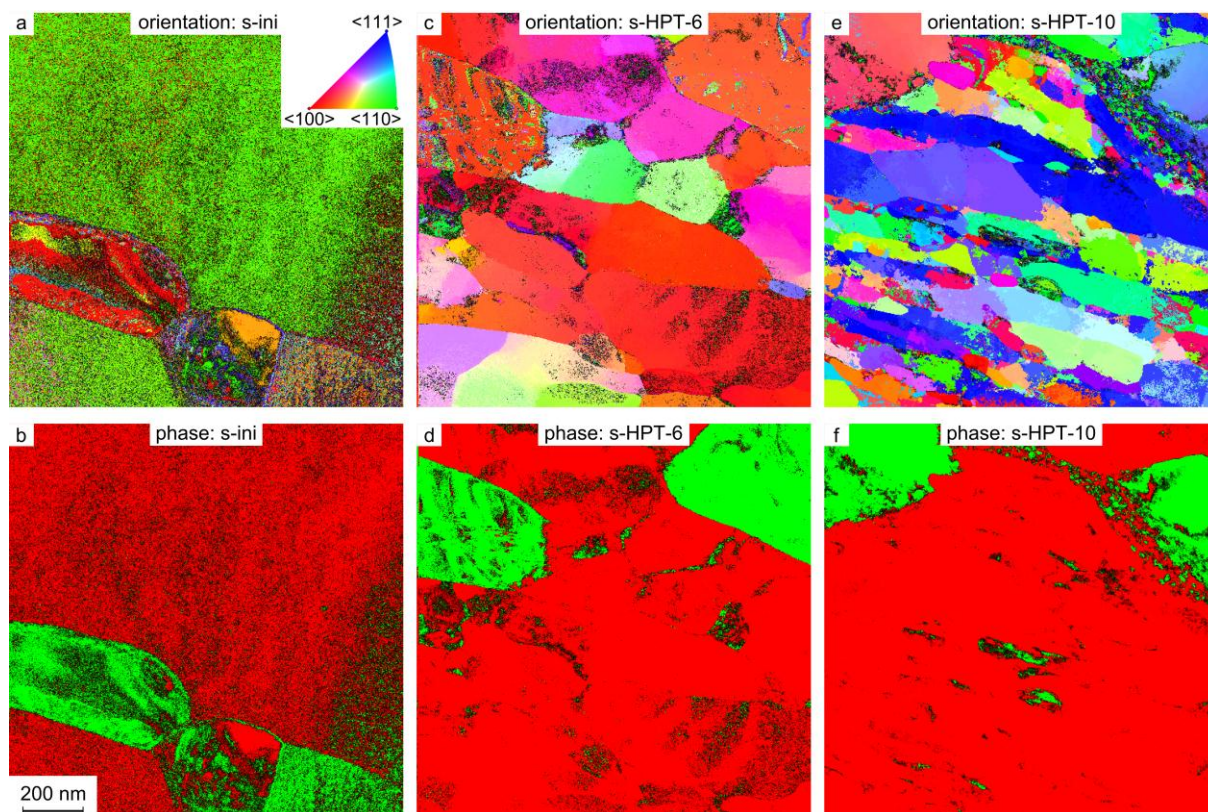
Figure 3. Orientation (a,c,e) and phase (b,d,f) maps (ACOM-TEM) overlaid with the reliability of the spheroidized microstructures (a,b), after 6 (c,d) and 10 HPT rotations (e,f) all prior to the fatigue tests. The color code of the orientation maps is given in (a). The projection direction is normal to the paper plane. The Fe phase is given in red and green represents the carbide phase. The reliability is given in black for both types of maps.

The spheroidal carbides are still clearly visible in s-HPT-10, but the larger ones in Figure 3e are partially fragmented and appear blurred. In addition, an increasing number of small carbides are distributed between the ferrite grains.

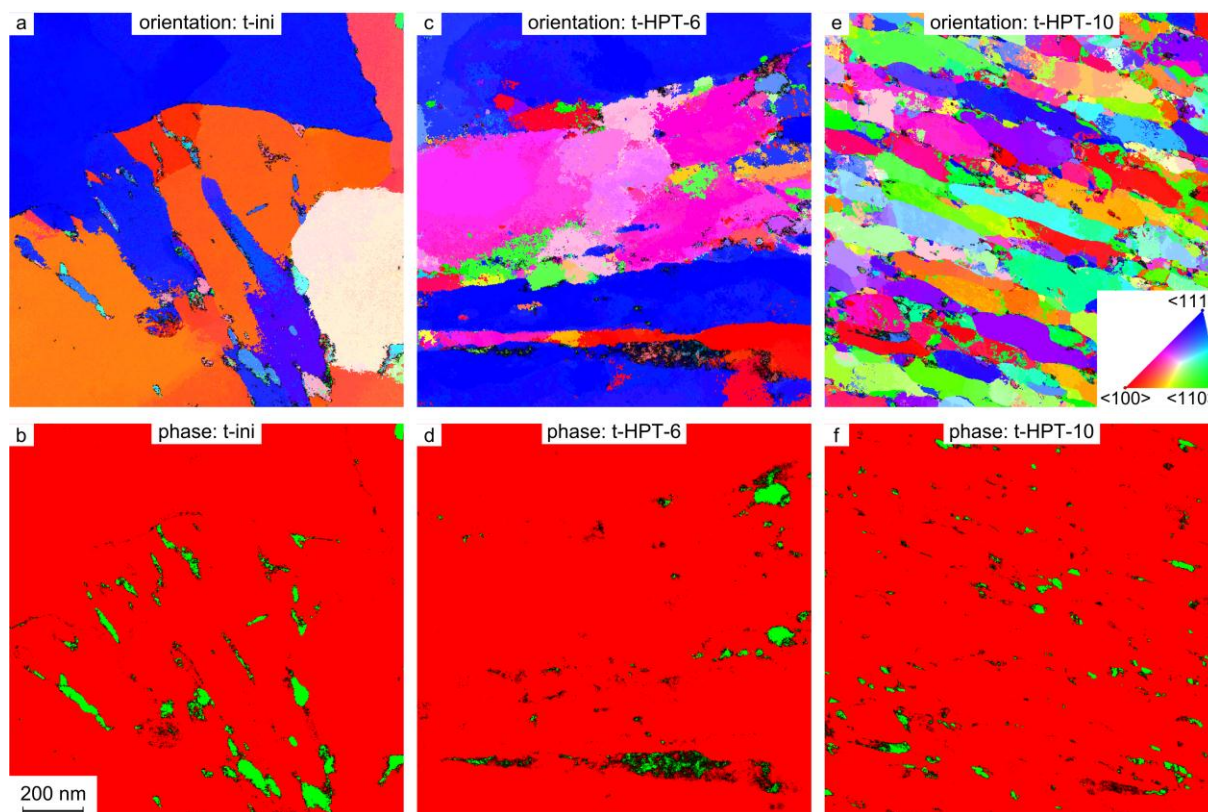
Figure 4. Orientation (a,c,e) and phase (b,d,f) maps (ACOM-TEM) overlaid with the reliability of the tempered microstructures (a,b), after 6 (c,d) and 10 HPT rotations (e,f) all prior to the fatigue tests. The color code of the orientation maps is given in (e). The projection direction is normal to the paper plane. The Fe phase is given in red and green represents the carbide phase. The reliability is given in black for both types of maps.

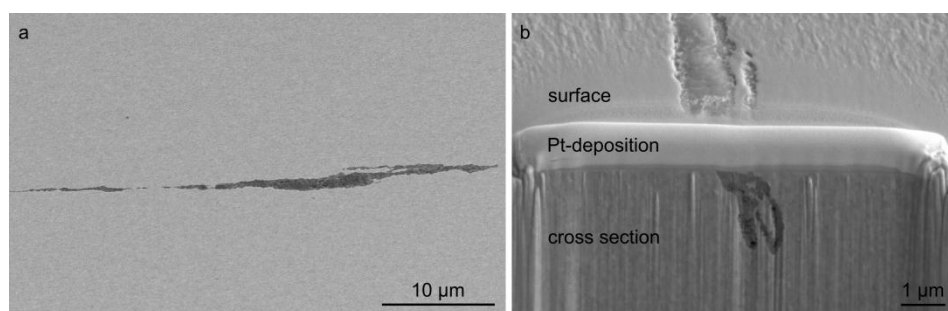
Figure 5. SEM images of a sheared non-metallic inclusion on the (non-etched) surface of t-HPT-10: (a) top view; (b) FIB cut through the inclusion.

After HPT, shear bands are visible by optical microscopy on the surface, fracture surface, and cross section of all specimens. Such shear bands have been reported earlier for HPT processed nanocrystalline metals such as palladium [25]. Interesting to notice is that, in the present case of the C45 steel, non-metallic inclusion were sometimes sheared by the shear bands as seen in the FIB cross-section in Figure 5.

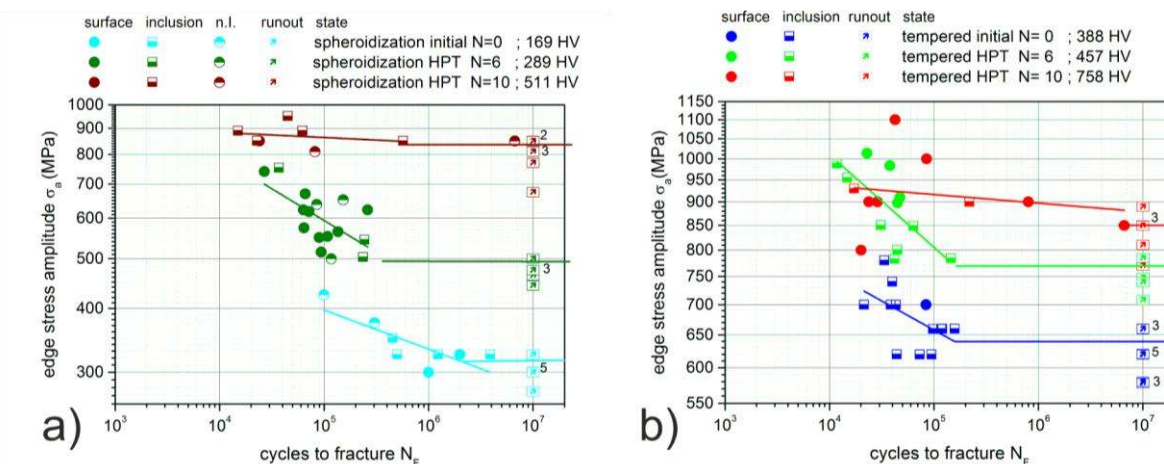
Figure 6. S-N curves of (a) CG and UFG spheroidized SAE 1045 revealing endurance limits of 316 MPa, 493 MPa and 837 MPa and of (b) UFG and CG tempered SAE 1045 showing endurance limits of 640 MPa, 769 MPa and 850 MPa.

Four-point-bending fatigue tests were carried out with both carbide morphologies in the initial coarse grained (CG) and the HPT deformed states (Figure 6). The edge stress amplitude was plotted against the number of cycles to fracture for both initial carbide morphologies. The arrows in the squares indicate runouts after 10^7 cycles. The small numbers beside the arrows show the number of overlapping runout-points. The crack initiation site type is indicated on top of the diagrams. A few specimens could not be investigated (n.I.) after fatigue, e.g., because they did not break completely.

Figure 6a shows the values for the spheroidizing annealed state in the CG (s-ini) and the UFG (s-HPT-6 and s-HPT-10) condition. For the s-ini state, a fatigue limit of 316 MPa was determined by the staircase method. Fractured specimens were observed after more than 10,000,000 cycles at stress amplitude of 325 MPa, while at stress amplitude of 300 MPa only one specimen fractured. In contrast, s-HPT-6 with a hardness of 289 HV showed fatigue fracture at lifetimes below about 400,000 cycles. The endurance limit (494 MPa) was significantly higher compared to s-ini. Crack initiation was mainly at the surface as indicated in the diagram. After 10 HPT rotations, resulting in a hardness of 511 HV, the fatigue limit further increased to 837 MPa. One specimen failed at 800,000 cycles, all other either failed within the first 80,000 cycles or ran out. Below 800 MPa, no fatigue failure was observed for s-HPT-10. The crack initiation site changed with an increasing number of HPT-rotations from the surface without non-metallic inclusions for s-HPT-6 to crack initiation at non-metallic inclusions at the surface in s-HPT-10 (see also Figure 7).

Figure 6b shows the S-N-curves for t-ini, t-HPT-6 and t-HPT-10. A fatigue limit of 640 MPa was determined for t-ini, corresponding to a hardness of 388 HV. In this case, crack initiation mostly occurred at non-metallic inclusions at the surface. With an increased hardness of 457 HV, the fatigue limit of t-HPT-6 rose to 769 MPa. For higher fatigue loads, a specific crack initiation location could not be identified. The exceptions are cyclic edge stresses between 780 MPa and 900 MPa, where all cracks initiated at non-metallic inclusions. For the t-HPT-10 specimens, offering the highest shear strain and hardness, the S-N curves and the crack behavior seem to be completely different. In contrast to the initial state and t-HPT-6, where specimens either failed before 200,000 cycles or ran out, many t-HPT-10 samples failed at a higher number of cycles. In addition, this state also revealed a number of very early cracks, which reduced the fatigue limit to a value of 850 MPa, lower than expected for a hardness of 758 HV, when considering a linear correlation between hardness and fatigue limit. Cracks were mostly initiated at the surface of the t-HPT-10 specimens.

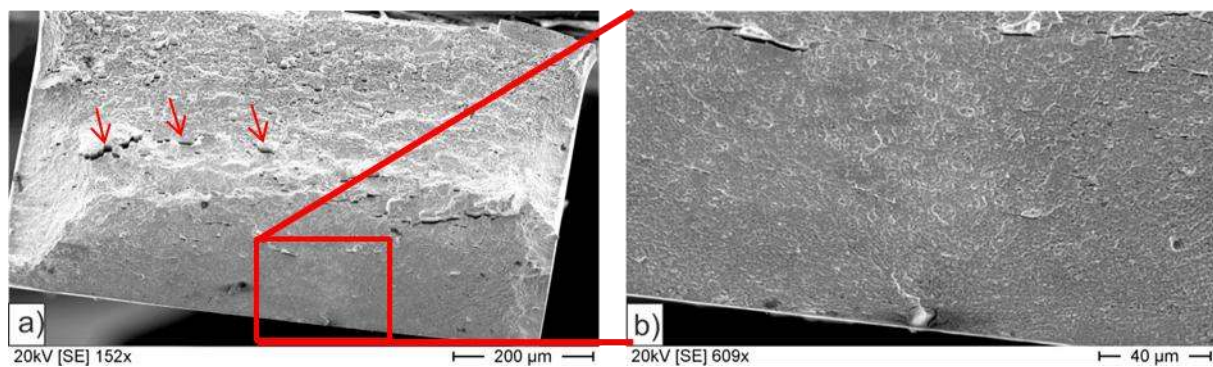
Figure 7. Fracture surface of s-HPT-10 (a) whole fracture surface (b) fatigue fracture surface; some shear bands resulting from HPT are shown with arrows.

Figure 7a shows the fracture surface of one of the s-HPT-10 specimens after a fatigue load of 850 MPa. A large fatigue fracture surface (Figure 7b) is visible, which is larger than typically found in conventional high strength materials. The fatigue fracture surface shown in Figure 7b is very homogeneous and appears smooth. The crack initiation occurred at a non-metallic inclusion. In the transition area between fatigue and residual fracture surface, some short cave-like shear bands are visible. Such shear bands are observed in fracture surfaces of HPT processed materials, for example in nanocrystalline palladium after HPT [25]. In this specimen, shear bands seem not to have influenced the crack initiation or early fatigue crack growth because they are observed only in the late fatigue crack growth areas well as in the residual fracture area.

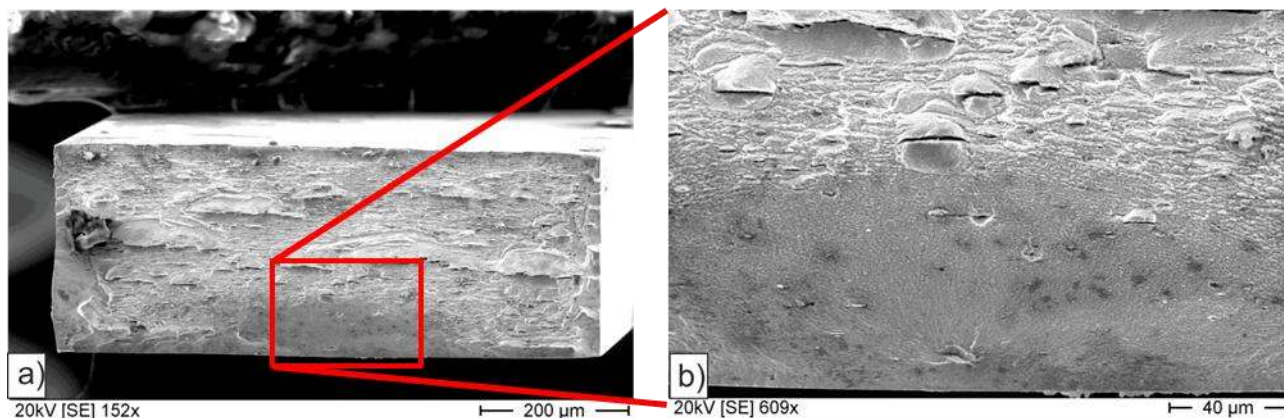
Figure 8. Fracture surface of t-HPT-10 (a) whole fracture surface (b) crack initiation area at the surface without nonmetallic inclusion and fatigue fracture surface.

Figure 8 illustrates the fracture surface of a t-HPT-10 sample loaded at a stress of 900 MPa. SEM investigations reveal shear bands in the fracture surface. The cave-like characteristics appear over the whole residual fracture surface. With a length of up to 200 μm , they seem to be larger than those in the spheroidizing annealed state, which are only up to 40 μm long. The fatigue fracture surface in Figure 8b is smaller than in the s-HPT-10 state although the sample was loaded at nearly the same stress level. We also observe crack initiation at a non-metallic inclusion. The fracture appearance is rather homogenous with a flat fatigue fracture surface. In addition, some shear bands are visible in the fatigue fracture surface but similar to the spheroidizing annealed state, they do not influence the crack initiation or propagation.

Comparing Figures 8 and 11, the fracture surfaces of t-HPT-10 do not appear as uniform as those of s-HPT-10. The main difference is that while the fatigue fracture surface in Figure 8 is not affected by

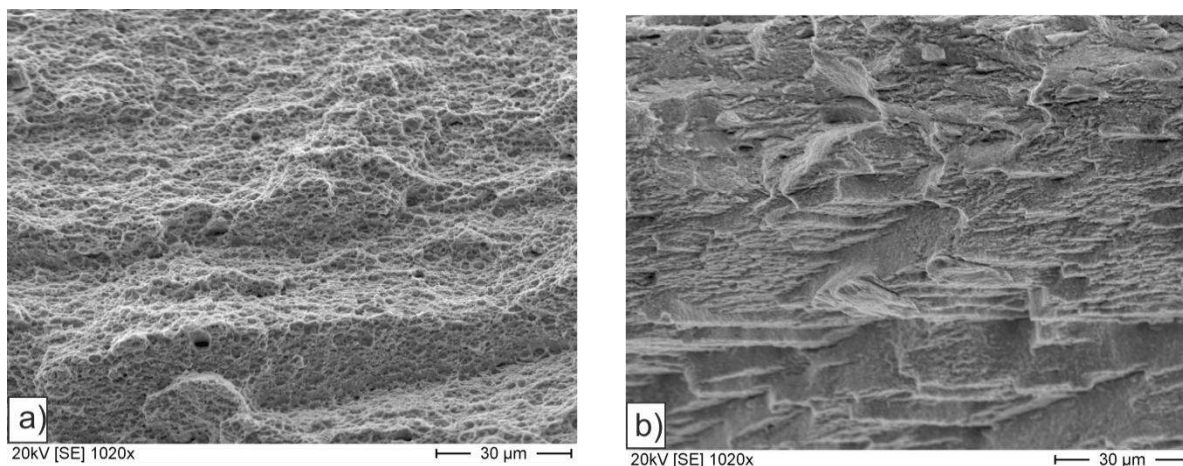
Figure 9. Residual fracture surface of (a) s-HPT-10 and (b) t-HPT-10.

Figure 9 shows a comparison of the residual fracture surfaces of the two states with tempered and spheroidizing annealed microstructure after HPT. There are significant differences in the morphology. In Figure 9a, s-HPT-10 shows well-defined dimples, which indicate a homogeneous ductile fracture behavior.

In contrast, Figure 9b reveals a rather rough residual fracture surface with sharp edges, which are common for this material state and indicate a brittle material behavior. Most likely, these sharp edges are shear steps from shear banding. Figure 10a,b show an FIB cross-section of the t-HPT-residual fracture surface at a characteristic cave, which was formed by a shear band. This indicates a correlation between shear bands observed at the fracture surface and the microstructure underneath. The shear band at the fracture surface is connected to a line-shaped inhomogeneity inside the microstructure. A similar line pattern is also visible in a polished and Nital-etched cross section of the HPT specimen in Figure 10c prior to fatigue loading. These lines are extended along the shear direction during HPT and become visible after etching in SEM in this case in the t-HPT-10 state. However, similar shear bands can also be seen in the micrographs of the s-HPT-10 states.

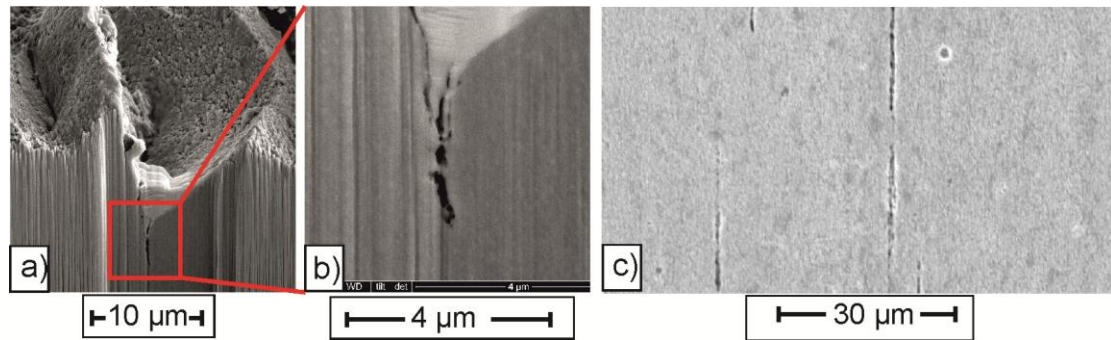
Figure 10. SEM images of shear bands in t-HPT-10 samples (a,b) inside the residual fracture surface and (c) on the polished and etched cross section.

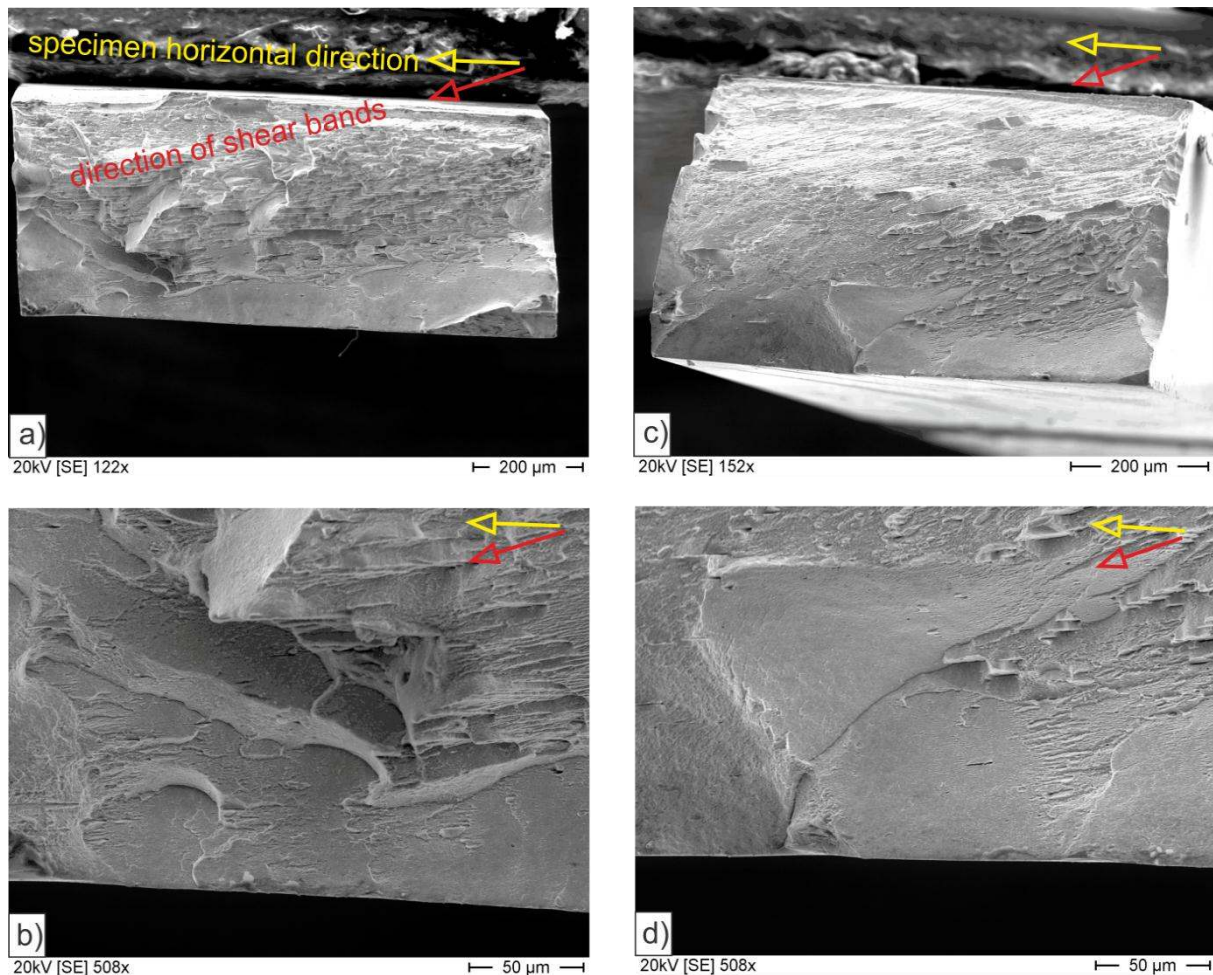
Figure 11. Fracture surface of t-HPT-10 state which shows shear bands (a,b) loaded at 900 MPa and (c,d) loaded at 850 MPa (red open arrows at the top indicate the direction of shear bands in correlation to the specimens surface indicated by the yellow open arrows. The crack initiation site is always at the bottom of the pictures).

The fracture surface of a tempered specimen after HPT, which failed very early at 900 MPa, is shown in Figure 11a,b. The picture shows a cliff-like fracture surface with a high topology in the residual and also in the fatigue fracture surface. The fatigue crack seems to change direction and jump between different levels. Usually, fatigue cracks grow mostly perpendicular to the tensile stress in one

A similar behavior is presented in Figure 11c,d, showing the fracture surface of a t-HPT-10 state sample, which cracked after 6,000,000 cycles. It is obvious that shear bands are present in the area of fatigue crack growth, especially at the crack initiation site, where an extension of a shear bands are points of multiple crack initiation. These shear bands have been produced during HPT and seem to have promoted the crack initiation during fatigue load. Further crack growth in the fatigue fracture surface is similar to that shown in Figure 11a,b, exhibiting a high topology. The fatigue crack growth is dominated by the shear bands (marked with red arrows in all pictures). The two arrows in each part of Figure 11 indicate that there is an angle of misorientation between the expected shear plane at HPT (yellow arrows) and the shear band plane in the respective specimen (red arrows). This is the case for both specimens, which both exhibited early failure during fatigue testing, and it establishes a significant difference in contrast to samples in the spheroidization annealed or tempered state, which offer a homogeneous fracture behavior in the S-N curve without early cracks (t-HPT-6). For both specimens shown in Figure 11, a complex structure of different fracture planes is visible in the fatigue fracture surface. The surface of each single plane itself seems to be very flat, as expected for fatigue failure in ultrafine grained materials, resulting in a strong topology with clustering in different spatial directions.

inhomogeneities, Figure 11 reveals a strong topology with fracture planes of different directions covering the whole surface, including the fatigue fracture surface. In both cases shown in Figure 11, the residual fracture surface has shear steps and no dimples indicating a brittle fracture behavior. In this context, Figure 10 provides an opportunity to understand the morphology of the shear bands prior to fatigue testing. Figure 10a shows an FIB cross-section of one of these cavities, which exhibits the typical fracture appearance of the shear bands [25]. There is a narrow plane-shaped inhomogeneity beneath the surface inside the microstructure. This could be a link to shear bands generated during HPT as similar stripes are present throughout the microstructure before fatigue loading, as visible in the optical micrograph in Figure 10c. This observation can be made not only in the brittle tempered state but similarly also in the ductile spheroidizing annealed microstructure with excellent fatigue properties. It follows that s-HPT-10 and t-HPT-10 do contain shear bands prior to fatigue testing but only in the tempered state they affect the fatigue properties. Therefore, the brittle behavior is the main reason for fatigue limits which are lower than expected in consideration of the hardness, because the brittle material has a more limited ability to reduce stress around process flaws owing to plastic flow. In this context, the s-HPT-10 state is an ideal material in respect of fatigue because it exhibits a high hardness and also a high ductility resulting in excellent fatigue performance with higher tolerance against crack initiation at inhomogeneities.

However, an open question is: why do early cracks or cracks at low stress amplitudes occur in some specimens of t-HPT-10? This can be explained comparing Figures 8 and 11, which both show shear bands in the fracture surface. Shear bands represent inhomogeneities, which, in combination with a brittle material, are detrimental to the fatigue performance, as shown in Figure 14. However, when comparing fracture surfaces of late and early failure, it is visible that the specimens with the worst fatigue properties exhibit a rotation of the shear bands, which is not parallel to the nominal HPT-shear planes. Unusually turbulent flows, manifesting themselves in the appearance of whirls observed at the macroscopic [30] and microscopic [31] scale in severely deformed materials, are most likely the reason for this rotation. This effect seems to increase the influence of the shear bands on fatigue failure.

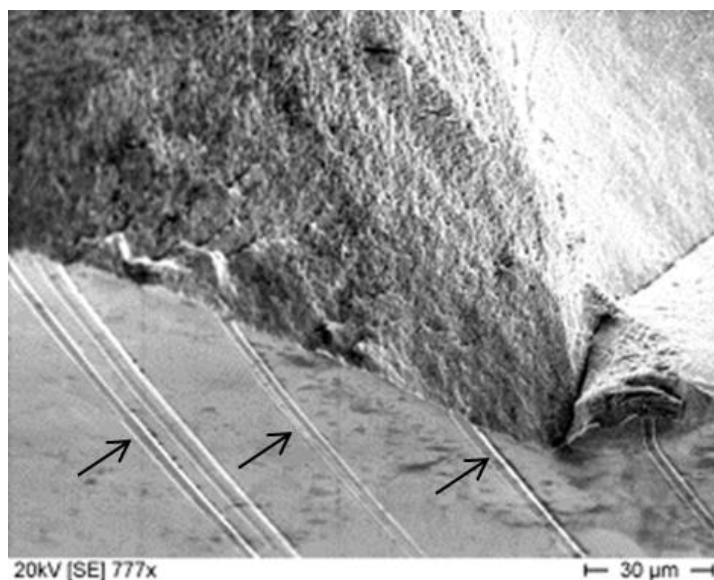
Figure 12. Shear bands visible at the sample's surface in the area of the crack initiation site.

Figure 12 shows the crack initiation site marked in Figure 11c,d in higher magnification after rotating the specimen by 20° out of plane. Some penetration lines are visible at the specimen surface where shear bands from HPT deformation seem to have been re-activated during fatigue loading. The assumed path of the shear bands inside the specimen is indicated by parallel lines, which fits the direction estimated from the overall fracture surface in Figure 11.

propagation is lower for favorably oriented shear bands [34]. Evidence for this explanation and for the crack initiation being affected by the shear bands and their orientation is presented in Figure 12, where the shear bands are visible on the fracture surface and also at the lower side of the specimen with the highest fatigue stresses. This characteristic appearance has already been reported in literature [35] and seems to be beneficial for crack initiation.

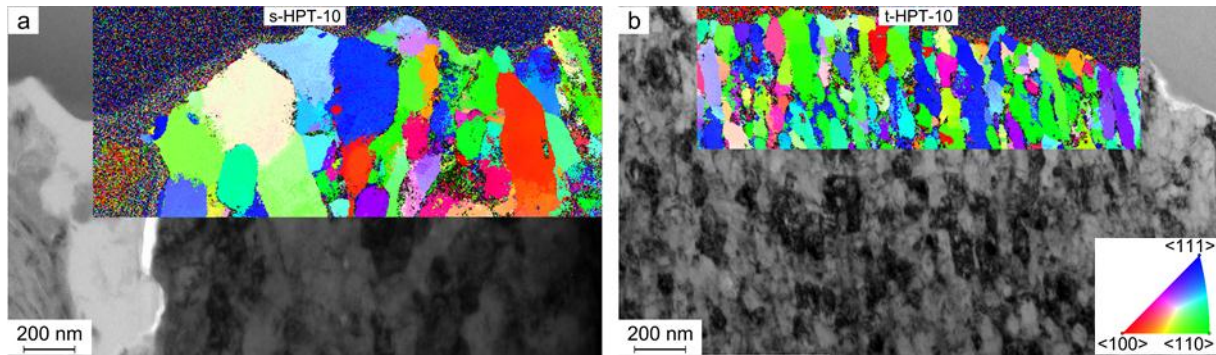
Figure 13. Cross section of the crack initiation (a) non-metallic inclusion for s-HPT-10 and (b) crack path near crack initiation from the surface for t-HPT-10. The overlays are orientation maps in projection direction normal to the paper plane with the reliability in black. The color code of the orientation maps is given in (Figure 3a).

Figure 13 shows cross sections of typical crack initiation sites for the HPT states after ten HPT rotations. BF-TEM and ACOM-TEM images were obtained to correlate the crack path, which is in both cases horizontal in the upper part of the images, with the microstructure underneath. In Figure 13a, a non-metallic inclusion, located on the left side of the shown area, was responsible for crack initiation in the s-HPT-10 state. Grain size and morphology close to the crack do not differ significantly from the pre-fatigue s-HPT-10 state.

Similarly, no significant grain coarsening or grain refinement has been observed for the t-HPT-10 state in Figure 12b. Nevertheless, in both cases, the crack path is influenced by the microstructure as it (partly) deviates from a straight crack front when crossing grain boundaries.

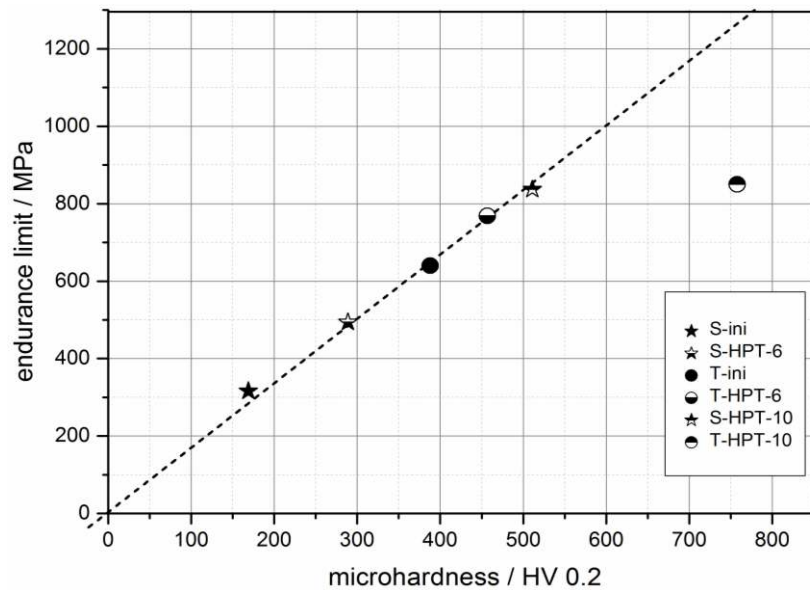
Figure 14. Relationship between hardness and endurance limit revealing a linear correspondence.

Figure 14 indicates the relationship between hardness and endurance limit in our investigations. It was created on the basis of the endurance limits presented in Figure 6. A linear correlation can be seen for the hardness range up to about 500 HV. The fatigue limit primarily correlates with the hardness which itself is strongly affected by the microstructure such as the carbide and grain morphologies. The initial and HPT-6 states fit this correlation very well. Following the investigation by Murakami [26], there must be a decrease of the fatigue limit with increasing hardness values over

Responsible for a deviation from the linear relationship are inherent material flaws such as non-metallic inclusions, which become more and more dominant at higher hardness. The subsequent decrease of the endurance limit, as suggested in Figure 14, depends on the material state and processing route. In high strength steels, the so-called process flaws resulting from the respective treatment are responsible for such behavior. For conventional steels, it is mostly the heat treatment which leads to process flaws. In our case, the HPT treatment replaces heat treatment for reaching a high strength. Thus, instead of the traditional process, flaws known from the literature, such as micro-cracks or weakened former austenite grain boundaries in carburized steels [28], here we are confronted with shear bands or cracks created during HPT, which act as process flaws. Other possible process flaws could not be clearly identified in the metallographic sections after the fatigue testing. Nevertheless, one result of the present investigation is that, in contrast to a material that only exhibits inherent or intrinsic flaws, here the process flaws in the material state with the highest hardness (t-HPT-10) lower the fatigue limit. The S-N curves already provide evidence for this, as contrary to our expectation, no non-metallic inclusions were responsible for crack initiation in the t-HPT-10 state, but the cracks mostly initiated from the surface. This is untypical for high strength steels and indicates that there must be something inside the microstructure that is more inhomogeneous or detrimental than the non-metallic inclusions.
