RESEARCH ARTICLE

Fatigue Performance of Medical Ti6Al4V Alloy after Mechanical Surface Treatments

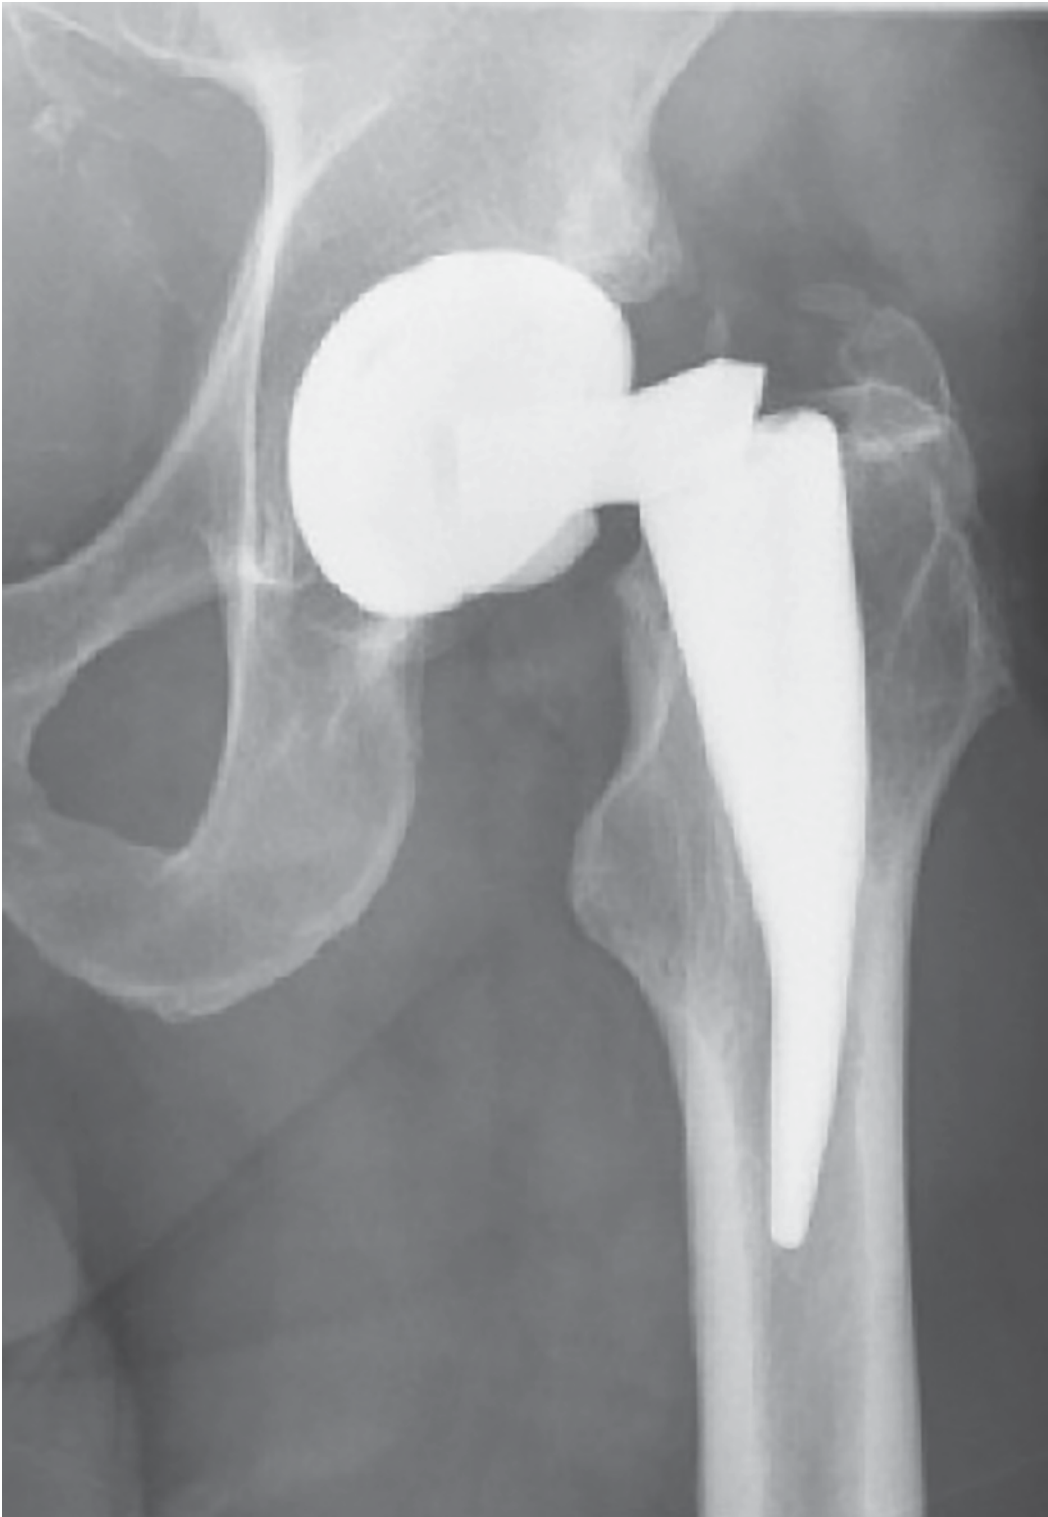
Fig 1. Example of Ti6Al4V implant failure in cementless total hip prosthesis [4].

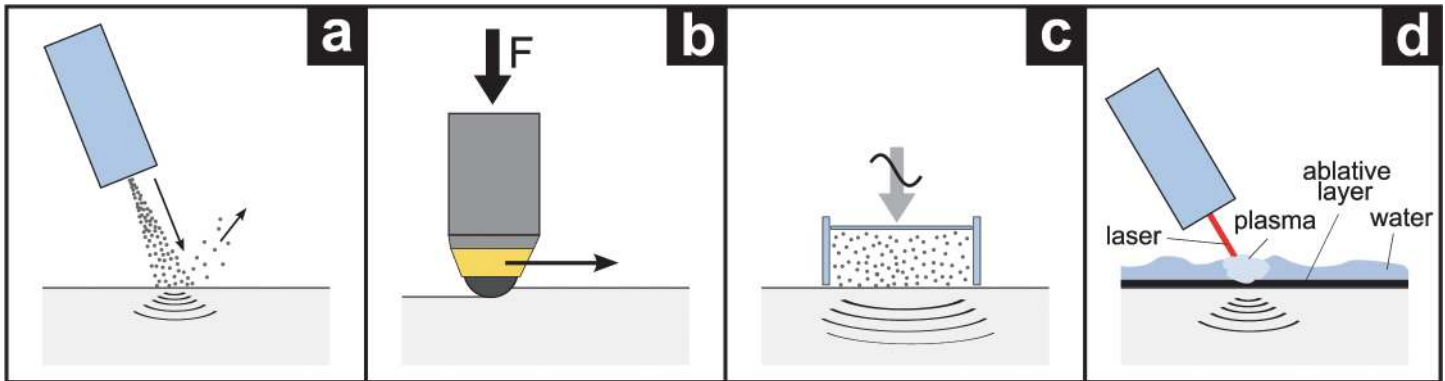
Fig 2. Investigated surface treatments: (a) shot peening (SP); (b) deep rolling (DR); (c) ultrasonic shot peening (US-SP); (d) laser shock peening (LSP).

Four different typical mechanical surface treatments were applied to introduce high compressive residual stresses at the surface ([Fig 2](#)). They were chosen from available processes as a result of their applicability to orthopedic implants. The parameters were chosen according to the manufacturers’ expertise in that field and with respect to the Ti6Al4V material’s state. The results of all treatments were compared to the ‘as annealed’ condition after annealing and bating.

- a. **Shot peening (SP)** ([Fig 2A](#)): A directed beam of the blasting material is fired on the specimen’s surface which is slowly rotated. The impacting beads locally deform the substrate at the surface introducing compressive residual stresses. Here, a combined two-step peening process is used which is identical to the application on hip revision systems and serves as a peening reference regarding fatigue performance of the other treatments.

- b. **Deep rolling (DR)** ([Fig 2B](#)): A tool consisting of a ball or roller at the end is moved across the work piece’s surface while applying an axial force in a conventional turning machine. Under the high contact stresses, the material starts to flow and smoothens the surface while introducing residual compressive stresses. The specimens were treated with an HG6 tool

(hard material sphere, $d = 6 \text{ mm}$) (Ecoroll AG, Celle, Germany) in a conventional turning machine (speed = 530 rpm, feed rate = 0.1 mm/rev) at a pressure of 300 bar.

- c. **Ultrasonic shot peening (US-SP) (Fig 2C):** The principle of impacting beads and deformation of the substrate's surface follows the classical shot peening process. The difference lies in how the ceramic beads ($d = 1.0\text{--}1.2 \text{ mm}$, hardness = 1200 HV) are applied. This is carried out by a closed acoustic block where the beads are placed under an ultrasonic frequency (amplitude = 80 μm , peening intensity = F20.12A) for 120 seconds, forming a 'bead gas'. During application, the treated specimen is slowly rotated (speed = 3 rpm, coverage > 125%).

- d. **Laser shock peening (LSP) (Fig 2D):** Generally, the substrate to be treated is covered with an opaque ablative layer (black paint) prior to the treatment. Here, no ablative layer is used to decrease and adapt the process' impact to the small cross-section of the specimens. A high-energy laser (spot size = 3x3 mm, performance = 10 GW/cm², pulse length = 8 ns, coverage = 100%) is fired to generate an expanding plasma which applies pressure pulses of about one million pounds per square inch, sending shock waves through the specimen. In a final step, a shot peening cleaning process using glass beads (same as for the combined shot peening process (a.)) is applied to remove burnt residuals from the laser application.

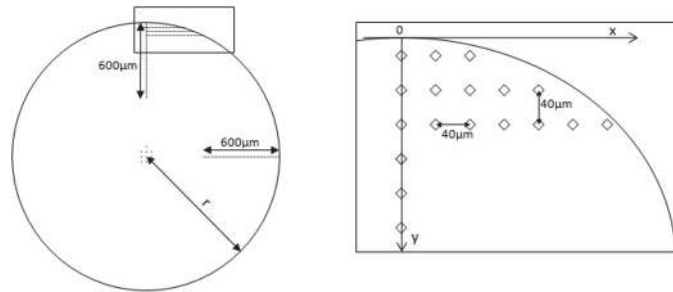
Fig 3. Microhardness measurement distributions in the cross-section.

To determine the effect of the mechanical surface treatments, the microstructure of the cross-section's near-surface region was analyzed using a light microscope (Axiovert 200 MAT, Zeiss, Jena, Germany) at magnifications of up to 1000x. Etching was carried out according to Kroll and Weck [36]. On the same cross-sections, Vickers hardness measurements (test load = 25 g, dwell time = 15 s) were performed at different depths according to DIN EN ISO 6507-1 (Shimadzu HV-2000, Columbia, USA). The hardness tests were carried out on the cross-section using a distance between adjacent indentations of 40 μm to determine a hardness depth distribution with sufficient statistics (Fig 3).

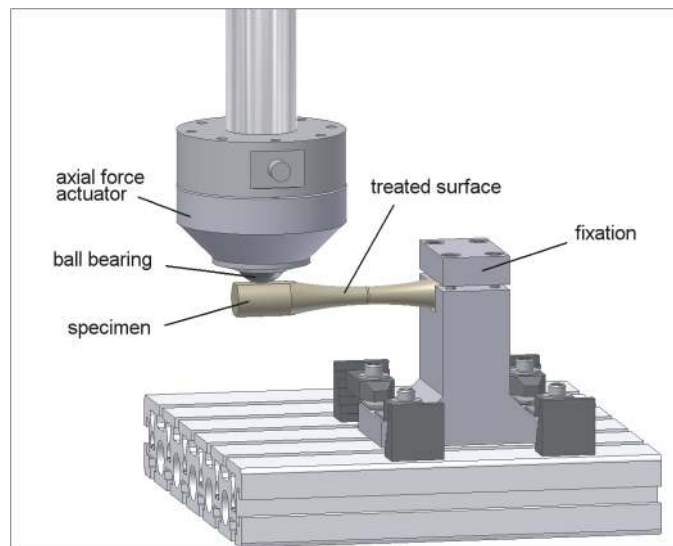
Fig 4. Setup for fatigue testing up to 10^7 cycles.

Finally, specimens were subjected to a destructive fatigue testing at different load levels using a single-station servo-hydraulic uniaxial test machine (Bosch Rexroth, Germany) with lateral force compensation (Fig 4). A constant axial load ratio $R = F_{\max}/F_{\min}$ of 0.1 was used while tests were run under pulsating conditions (pure bending) at 10 Hz for a maximum of 10^7

cycles (high-cycle fatigue testing) or until fracture occurred (as annealed: $n = 16$; SP: $n = 12$; DR: $n = 10$; US-SP: $n = 10$; LSP: $n = 11$).

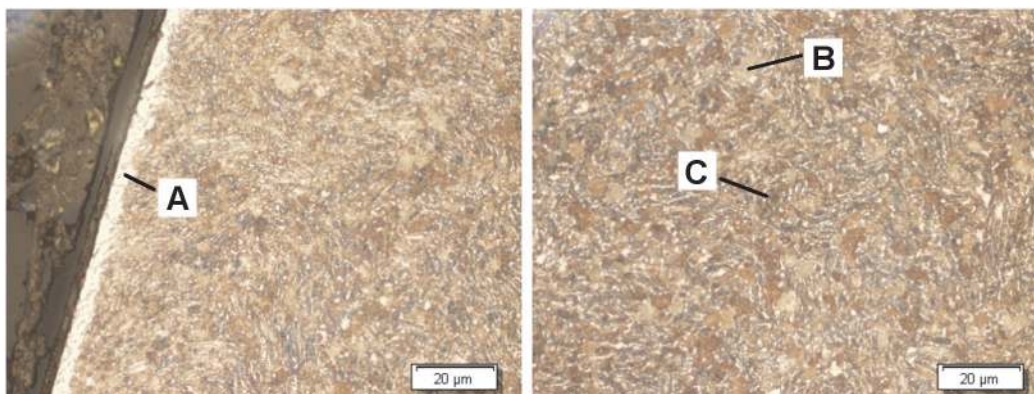
Fig 5. Micrograph of the cross section of the ultrasonic shot peened sample, Kroll &Weck etchant. Left: surface near region with indication of a thin α -case at the very surface (A), right: core of the sample with α -phase (B) and α + β -phase (C).

The microstructure analyses indicate that after the stress relief heat treatment, the material shows a bimodal structure consisting of α + β -phases (Fig 5). The white-brownish regions indicate a pure α -phase while the gray-bluish regions indicate the α + β two-phase regions. A change of the microstructure due to the subsequent mechanical surface treatments was not observed for any of the samples.

However, the Kroll &Weck etchant revealed that a 5 μm thick layer appears directly at the surface. This can be assigned to a so called α -case (hard and brittle surface layer) which might be built during the annealing treatment. Obviously, the bating process was not sufficient enough to remove the layer completely. The α -case is sensitive to crack initiation and might reduce the lifetime endurance. Due to the fact that this is the initial condition for all applied mechanical surface treatments and that the benefit of the treatment and their relative divergences are of further relevance, the thin α -case layer has no significant impact on the results. As expected, the X-ray stress analysis results show no residual stresses after annealing and bating, representing the initial condition prior to the various mechanical treatments (Fig 6). However, the residual stress values at the utmost surface reflects the values for the α -case layer. Residual stresses due to mechanical treatment are introduced as a superposition of plastic deformation and Hertzian stresses. The residual stress depth profiles show clear differences between the various mechanical surface treatments regarding the maximum residual stresses and the penetration depth. While the deep rolling process introduces very high compressive residual stresses ($> 1,200$ MPa) in the axial direction near the surface, other treatments show comparable maximal residual stresses around 800 MPa. As expected, the deep rolling results in a residual stress state that strongly depends on the rolling direction, meaning that much higher compressive residual stresses are induced in axial direction compared to the tangential direction. Shot peening and laser shot peening result in slightly higher compressive residual stresses in the axial direction for near-surface regions. Only for ultrasonic shot peening was an orientation-independent residual stress state determined. Based on the coverage of the compressively stressed region for laser shock peening of Ti6Al4V using the process parameters chosen by the executing company, the highest range exceeding depth of 1.6 mm was determined. In case of the deep rolling process, depths of about 600 μm are observed. However, shot peening and

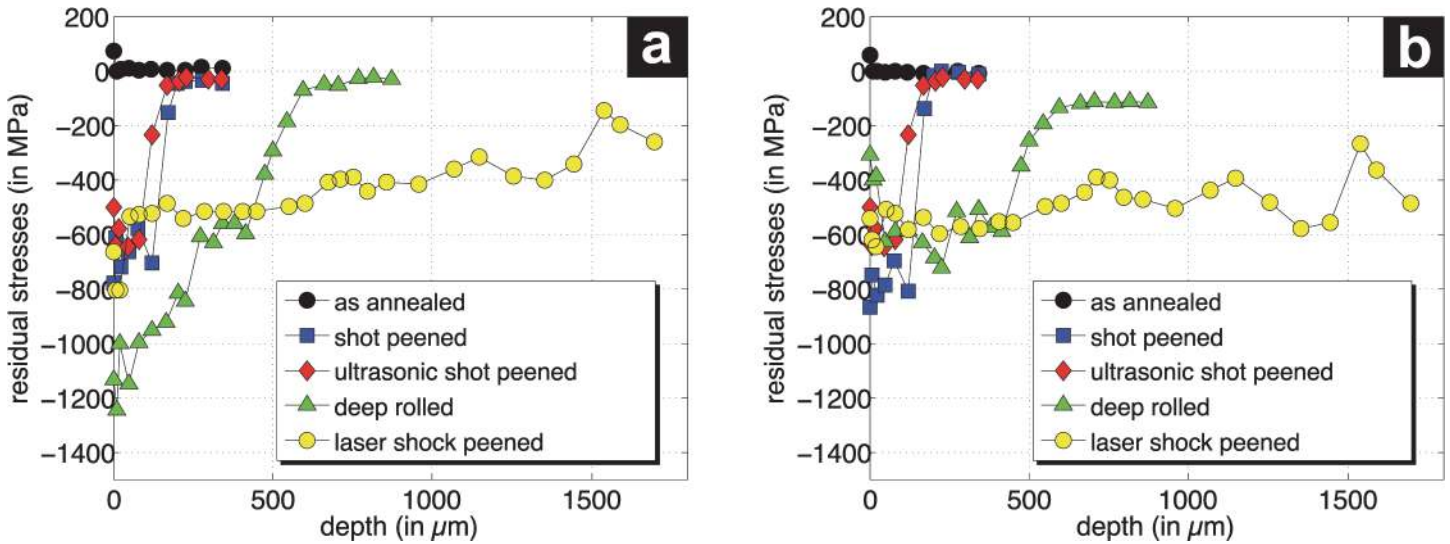
Fig 6. Residual stress depths profiles (a) axial direction (b) tangential (hoop) direction.

ultrasonic shot peening result in the lowest coverages of the compressive residual stresses of about 200 μm for both treatments.

The range of compressive residual stresses corresponds well to the region where much higher FWHM values were determined due to the mechanical treatment. For higher depths, i.e. for shot peening and ultrasonic shot peening for depths larger than 200 μm and for deep rolling for depths larger than 600 μm, the FWHM values reach the level of the initial state after annealing and bating. In contrast, the FWHM determined for the laser shot peening process is clearly higher than those of the initial material state even for large depths. This indicates that the impact of the laser shot peening might exceed the depth of 1700 μm covered by the X-ray stress analysis.

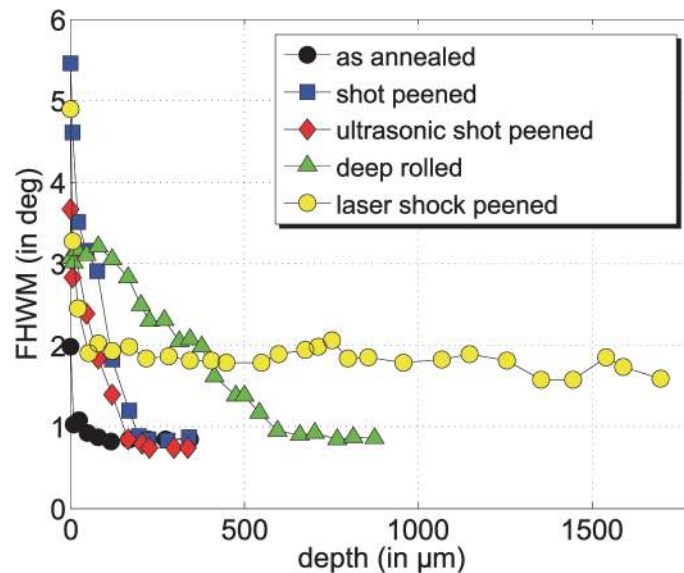
Fig 7. Full width at half maximum (FWHM) depth profiles (arithmetic average).

The statements made for the coverage of the compressive residual stresses are underlined by the course of the average full width at half maximum values (FWHM) of the X-ray diffraction profiles (Fig 7). Using the identical measurement set-up for the comparative X-ray analysis, the change of the average FWHM values of the analyzed X-ray interference profiles can be used as a measure of the cold forming induced by the mechanical surface treatment. Apart from the instrument effect, the peak broadening reflects the average size of the coherent scattering regions. Here the change in the peak width is, in most cases, due to changes in the dislocation density. Due to the fact that the FWHM values were much more sensitive to the induced work

hardening than the microhardness measurements, which showed a relative large scatter of the data (Fig 8), only the FWHM can be used for interpretation.

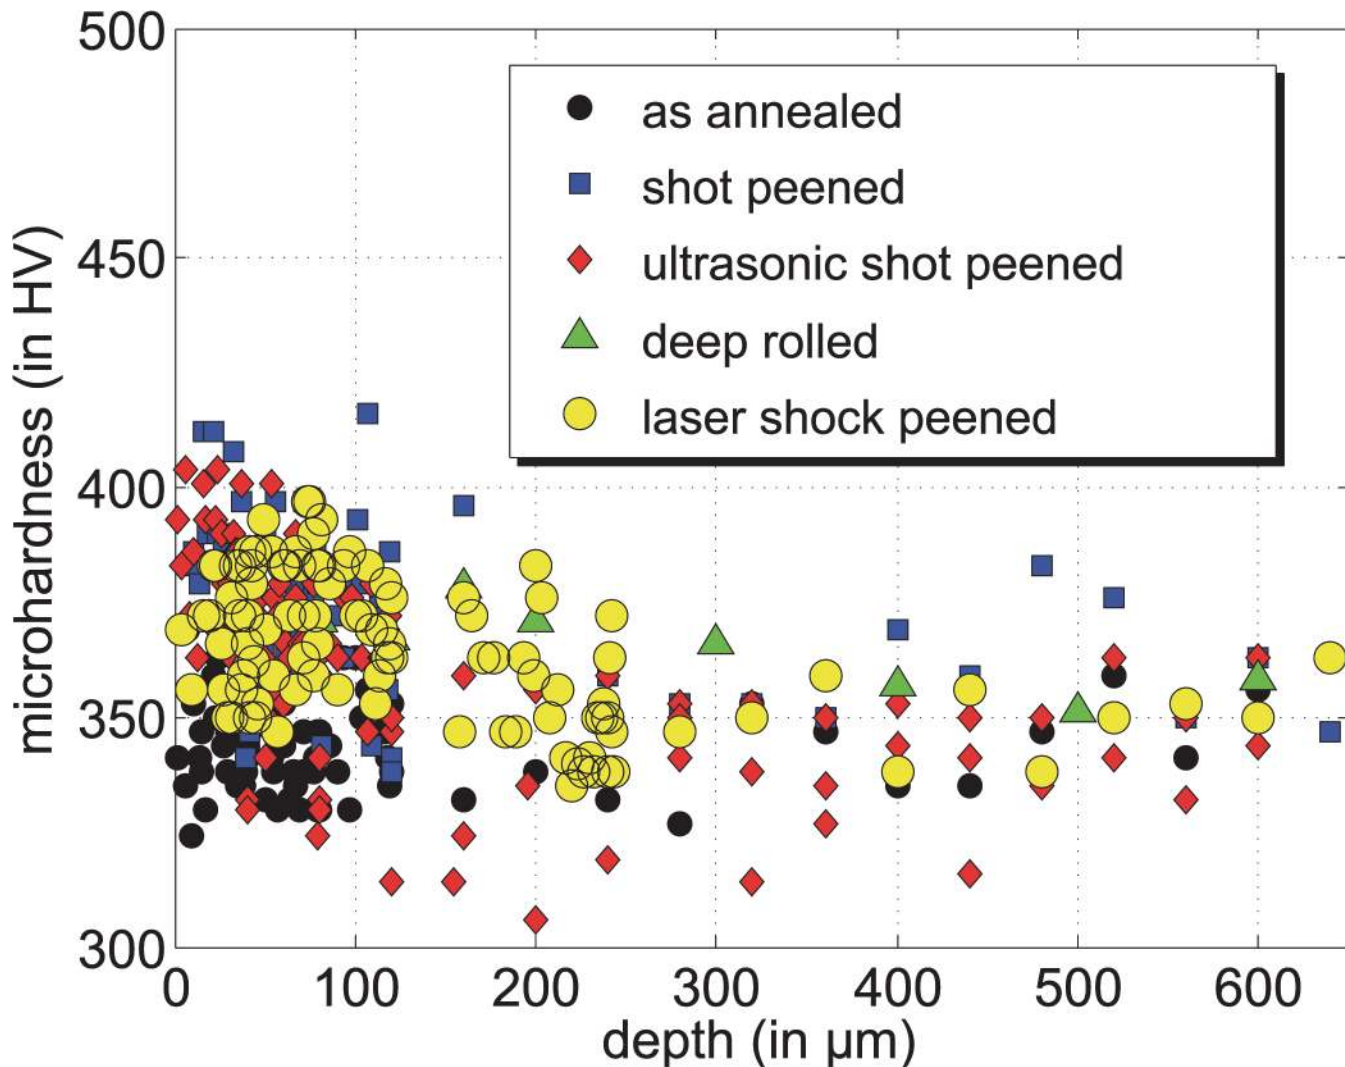
Fig 8. Exemplary comparison of microhardness depth profiles of shot peened with laser shot peened state.

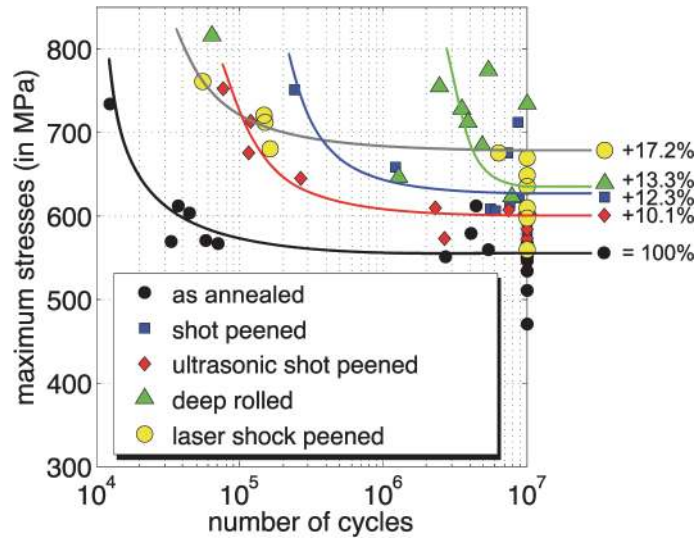
Fig 9. Fatigue testing results shown in a Woehler graph.

In a Woehler graph (Fig 9), the fatigue performance of the specimens after treatment is displayed. Each measurement point corresponds to a failed specimen except those which reached the total number of 10^7 cycles, representing specimens without any rupture. The fatigue strength of a cohort is then defined as the asymptotic stress at 10^7 cycles (high fatigue). The maximum (bending) stress at the surface varies with the external axial load that is applied

during testing. All treatments result in an increase in fatigue strength of at least 10% relative to the specimens without treatment (as annealed), whereas laser shock peening showed the highest fatigue strength of all investigated treatments (+17.2%).

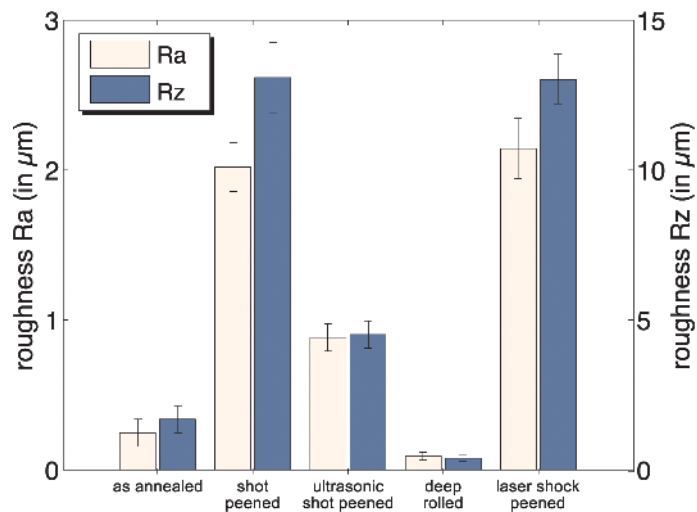
Fig 10. Mean roughness results of the treated surfaces.

Shot peening and laser shock peening increased the mean roughness R_a (R_z) of the shot peened and laser peened surfaces by over 720% (650%) when compared to the ‘as annealed’ condition ($p < 0.01$) (Fig 10). Deep rolling was the only treatment to decrease the mean roughness by 64% (77%) relative to the situation after annealing and bating.
