Title: Fault detection in a centrifugal pump using vibration and motor current signature analysis

Fault detection in a centrifugal pump using vibration and motor current signature analysis

Reference to this paper should be made as follows: Mohanty, A.R., Pradhan, P.K., Mahalik, N.P. and Dastidar, S.G. (2012) 'Fault detection in a centrifugal pump using vibration and motor current signature analysis', *Int. J. Automation and Control*, Vol. 6, Nos. 3/4, pp.261–276.

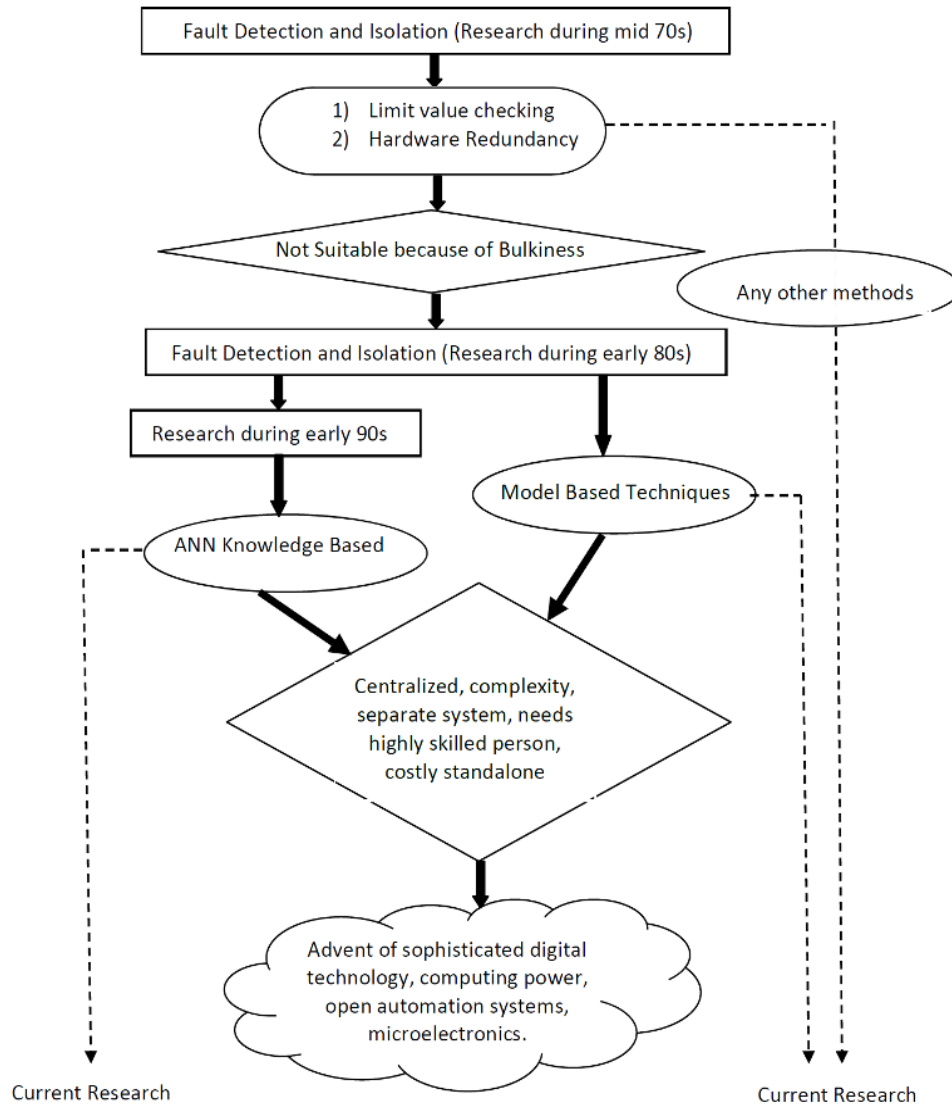
Figure 1 Progress on FDI

Next generation industrial systems will require more reliability, availability, safety, and embedded control strategy in response to provide highly customised products. The benefits that have been achieved so far through implementation of condition monitoring are now being significantly extended through the application of new theories, techniques, tools, and methods. Advances in computing tools and techniques have stimulated studies to design as well as realise autonomous machinery systems. Fault detection and isolation (FDI) is the main research topic that fall under the category of condition monitoring (Mohanty and Mahalik, 2007, 2011). Figure 1 (Mahalik et al., 1998) illustrates the progress on condition monitoring methods.

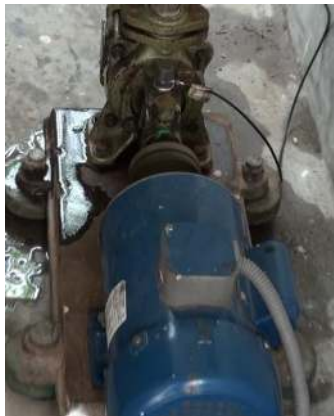
Figure 2 Accelerometer mounted on a pump (see online version for colours)

The accelerometer (PCB 353B33) was placed on the casing of the pump close to the bearing (as shown in Figure 2) to measure the vibration. Hall effect sensor (Tektronix A621, as shown in Figure 3) was kept around the phase terminal of motor current to measure the instantaneous motor current. The centrifugal pump (0.75 kW, 1,450 RPM, 240 V, make-Crompton Greaves, as shown in Figure 2) was operated under different working conditions of impeller like normal impeller (all vanes present), one vane broken impeller, two vanes broken impeller, three vanes broken impeller (as shown from Figures 4 to 8) sequentially.

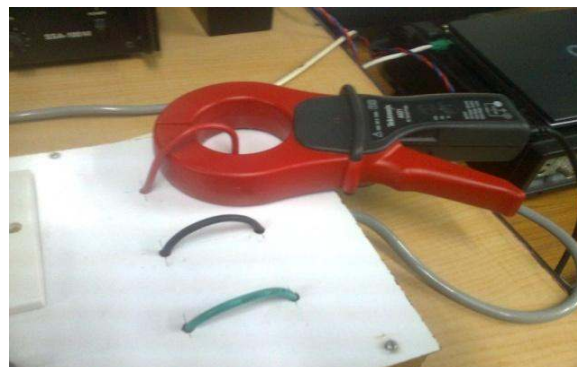
Figure 3 Hall effect sensor (see online version for colours)

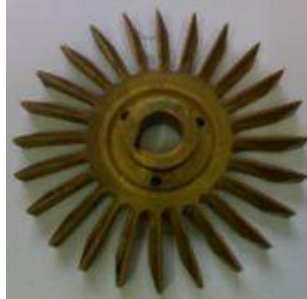
Figure 4 Normal impeller (see online version for colours)

Specification of the impellers used in pump is made of brass; with external diameter 100 mm; width 10 mm; vane length 25 mm and number of vanes are 24. The diameter of impeller hub is 13 mm. The experimental work has been performed in the following sequence:

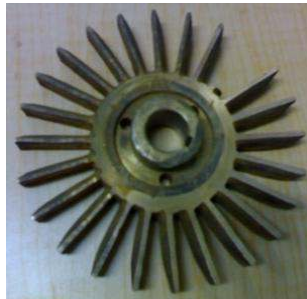
Figure 5 Broken impeller (one vane missing) (see online version for colours)

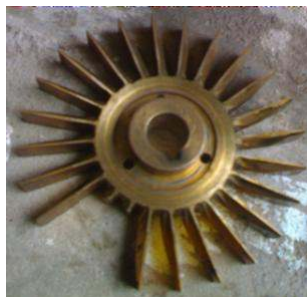
Figure 6 Broken impeller (two vane missing) (see online version for colours)

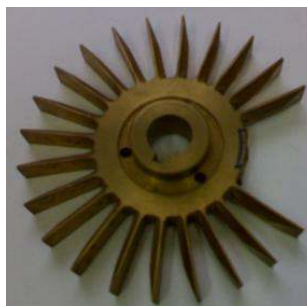
Figure 7 Broken impeller (three vane missing) (see online version for colours)

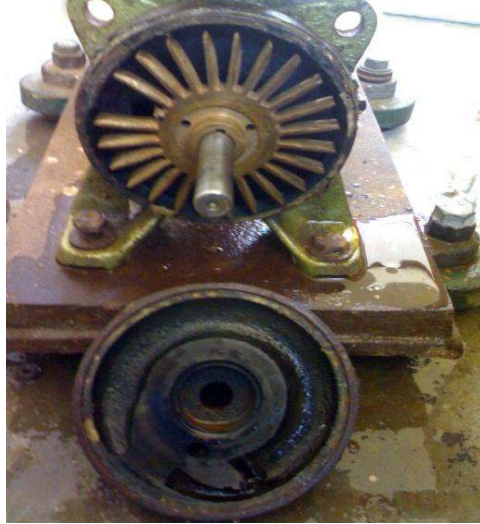
Figure 8 Broken impeller inside casing of the centrifugal pump (see online version for colours)

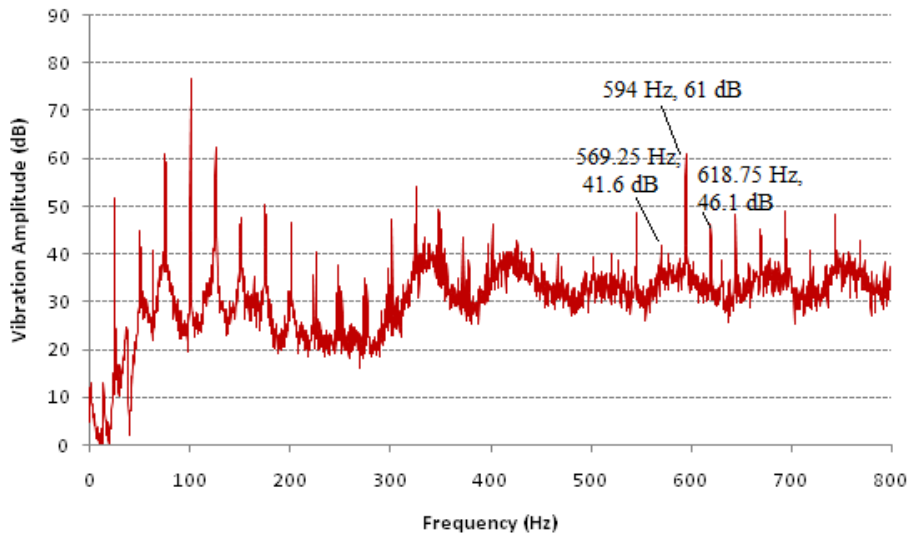
Figure 9 Vibration spectra of the normal impeller (see online version for colours)

From the vibration spectra it has been observed that the first high peak was at 24.75 Hz (52 dB) which happens to be the rotational speed (RPS) of the pump. This measurement was verified by an optical tachometer which indicated a rotational speed of 1,485 RPM. Also, the presence of VPF (i.e., $RPS \times \text{No. of vanes}$) was observed in the vibration spectra. Their corresponding amplitudes (in dB) and their SBs (at $VPF \pm RPS$) for different impellers were noticed. The observations of vibration spectra (as shown in Figures 9 to 12) for different impellers are summarised in Table 2.

From Table 2, it is observed that when the severity of the defect increases, height of SBs increases and the difference between the dB values of VPF and SBs decreases. Like as the severity of the rotor bar fault increases, the height of SB's peak increases (Thomson and Fenger, 2001). As vane/vanes of impeller of pump has/have been broken, the momentary torque exerted between two consecutive normal vanes (in between whose, vane has been broken) rises. Due to that, the amplitude of force as well as vibration at (VPF \pm RPS) increases. So, the peak height at (VPF \pm RPS) also increases.

Impeller type	VPF and its amplitude		LSB and its amplitude		RSB and its amplitude		Difference between amplitude of VPF and LSB (dB)		Difference between amplitude of VPF and RSB (dB)	
	VPF (Hz)	Amplitude (dB)	LSB (Hz)	Amplitude (dB)	RSB (Hz)	Amplitude (dB)	VPF (Hz)	Amplitude (dB)	VPF (Hz)	Amplitude (dB)
Normal	594	61.0	569.25	41.6	618.75	46.1	19.4	14.9	19.4	14.9
Defective (1 vane)	592.5	62.0	567.75	44.4	617.25	47.0	17.6	15	17.6	15
Defective (2 vane)	593	62.6	568.25	45.4	617.75	48.3	17.2	14.3	17.2	14.3
Defective (3 vane)	590	66.8	565.25	54.2	614.75	56.7	12.6	10.1	12.6	10.1

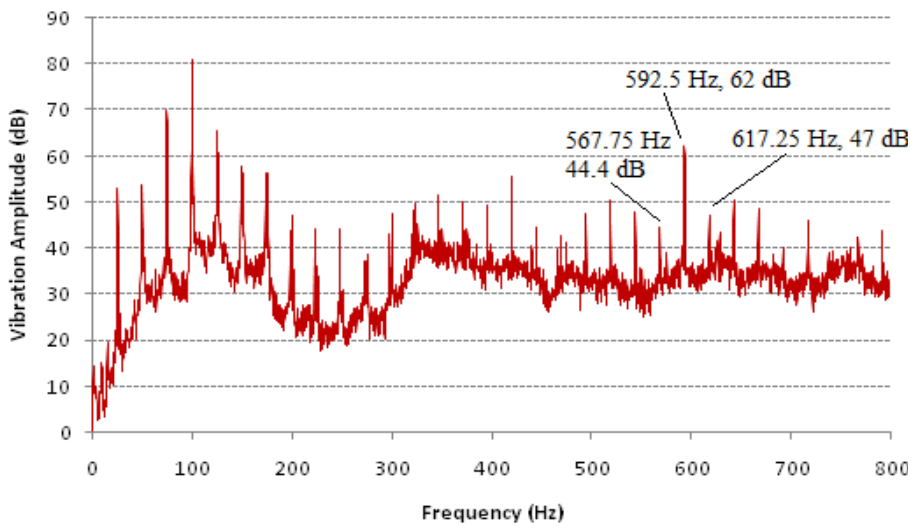
Figure 10 Vibration spectra of the defective impeller (with one vane missing) (see online version for colours)

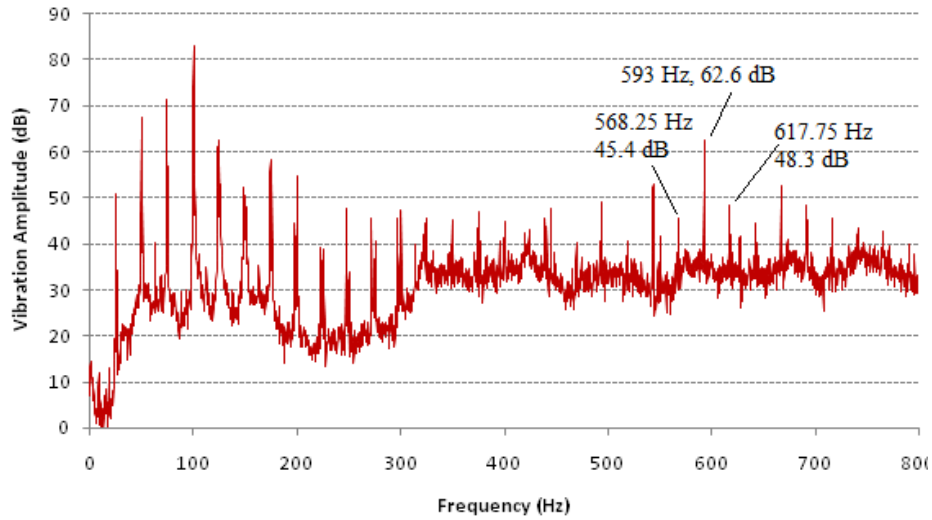
Figure 11 Vibration spectra of the defective impeller (with two vanes missing) (see online version for colours)

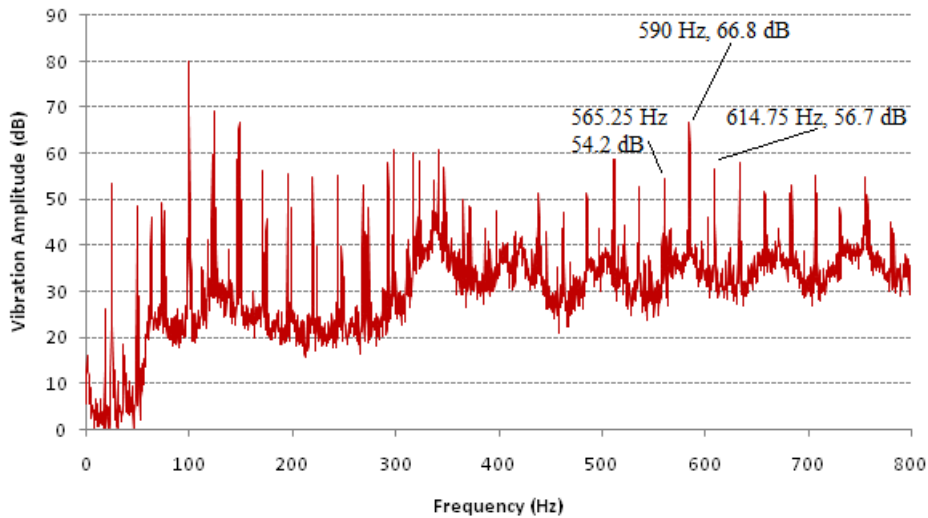
Figure 12 Vibration spectra of the defective impeller (with three vanes missing) (see online version for colours)

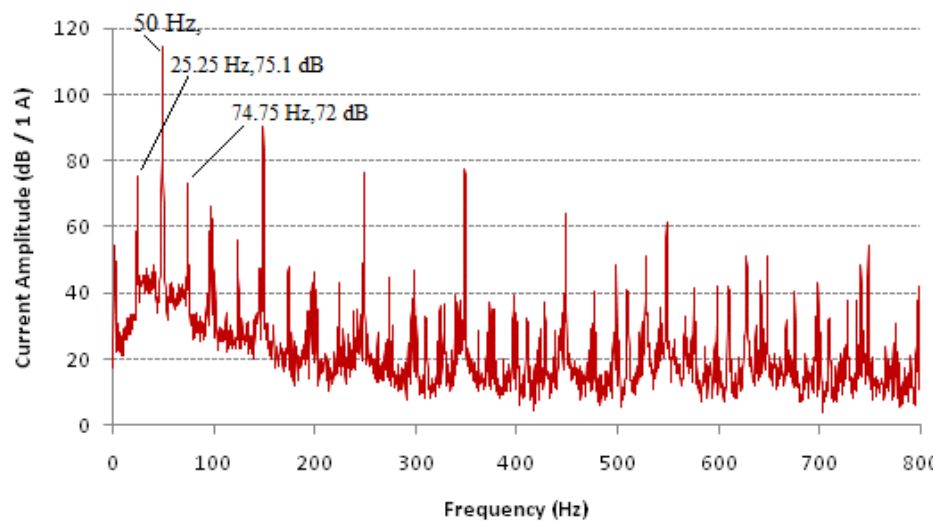
Figure 17 Current spectrum (see online version for colours)

From the current spectrum (as shown in Figure 17), it was observed that the second (and highest) peak gives the supply frequency (in this case 50 Hz).

Also, the current spectrum has been used to find out the rotating speed (RPS). From the current spectrum, it was observed that peaks are at supply frequency (50 Hz) and two SBs at $50 \pm$ RPS. These are at 25.25 Hz (75.1 dB) and 74.25 Hz (72 dB) respectively. The SBs occur because of the modulation of the current, due to variation in the air gap between stator and rotor during rotation of motor shaft. Since the rotational vibration which in turn varies the magnetic conductance and due to that instantaneous current signal is modulated. When it is demodulated in frequency domain, it shows as SBs around supply frequency.
