**FERROGRAPHIC ANALYSIS OF WEAR DEBRIS GENERATED  
IN A SLIDING ELASTOHYDRODYNAMIC CONTACT**

by William R. Jones, Jr., H. S. Nagaraj, and Ward O. Winer  
Lewis Research Center  
Cleveland, Ohio 44135

TECHNICAL PAPER to be presented at the  
Annual Meeting of the American Society of Lubrication Engineers  
Montreal, Canada, May 9-12, 1977

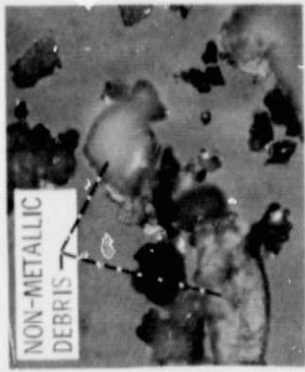
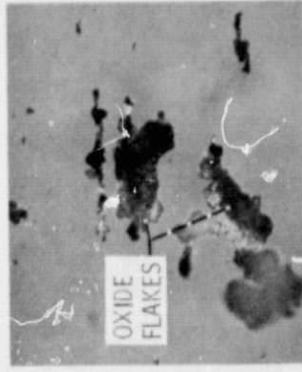
Figure 4. - Ferrogram entry deposit for smooth series.

Photomicrographs of the Ferrogram entry region for each of the tests with the smooth, medium rough, and rough ball series appear in Figs. 4 to 6, respectively. The general trend of increasing wear particle density with increasing load (or decreasing film thickness) is evident in most cases. Occasionally, nonmetallic debris or large oxide flakes, unrelated to the wear process, were observed which caused some high optical density readings. An example of this interference is shown in Fig. 4(b) for the S2 test. In fact, many of the density readings in the smooth series were caused, in part, by this type of debris.
