# **Fiber Optic Sensing for Monitoring Corrosion-Induced Damage**

## **ABSTRACT**

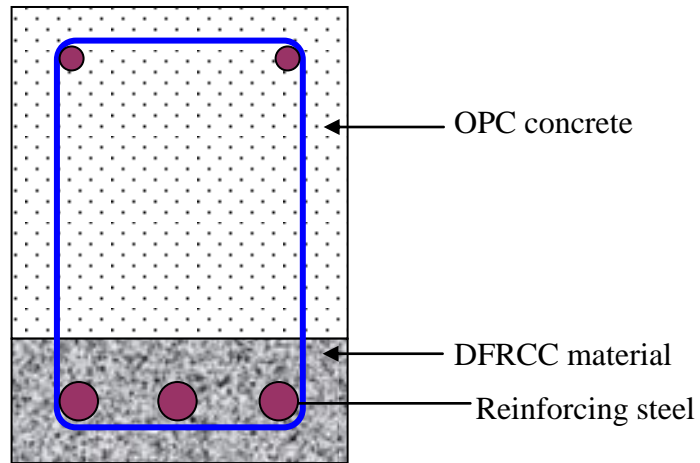
Figure 1. The concept of functionally graded concrete (FGC)

Five series of reinforced concrete beams were cast in this investigation. Each series consisted of two identical beams. The composition of the concrete mix for the first four series was varied by introducing supplementary cementing materials (SCM) such as fly ash (FA), slag (SG), and silica fume (SF) used as partial replacement of ordinary Portland cement (OPC) in the concrete. In the fifth series, the OPC concrete that surrounds the tensile reinforcement was replaced with a ductile fibre reinforced cementitious composite (DFRCC) containing 1.5% PVA (Polyvinyl alcohol) and 1.0% steel fibers resulting in the concept of Functionally-Graded Concrete (FGC) shown in Figure 1 [22]. This is done to create varying tendencies for the concrete cover to delaminate due to reinforcement corrosion.

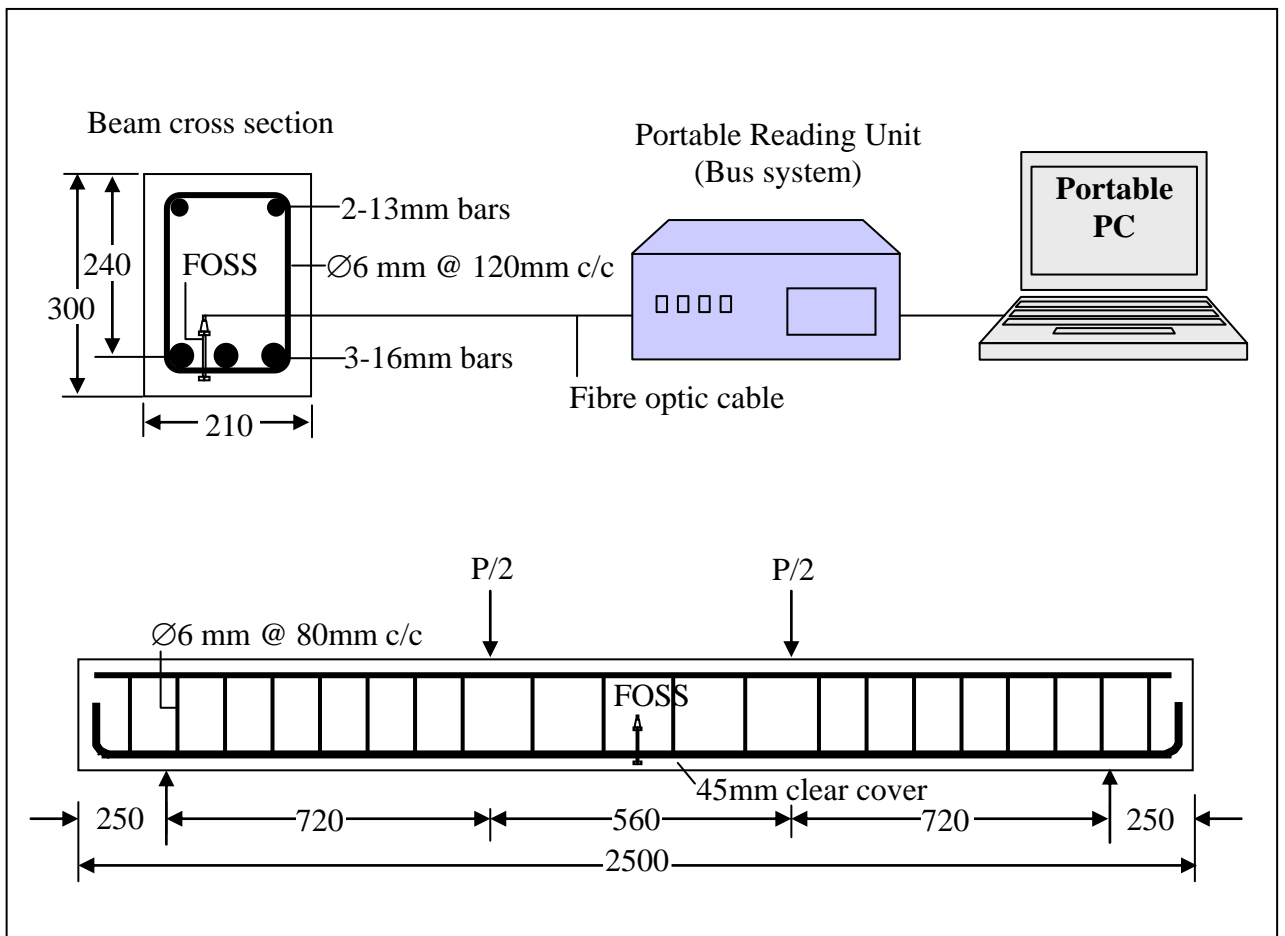
Figure 2. Beam dimensions and instrumentations (all dimensions in mm).

All RC beams were 2.5 m in length and had identical cross sections measuring 300 x 210 mm (Figure 2). The longitudinal reinforcements consisted of 3-16mm diameter deformed bars in the tension zone and 2-13mm diameter deformed bars in the compression zone, corresponding to reinforcement ratios of 1% tensile and 0.4% compressive. Shear reinforcement consisted of 6mm plane bar stirrups spaced at 80 mm c/c in the shear span and 120 mm c/c in the constant moment region.

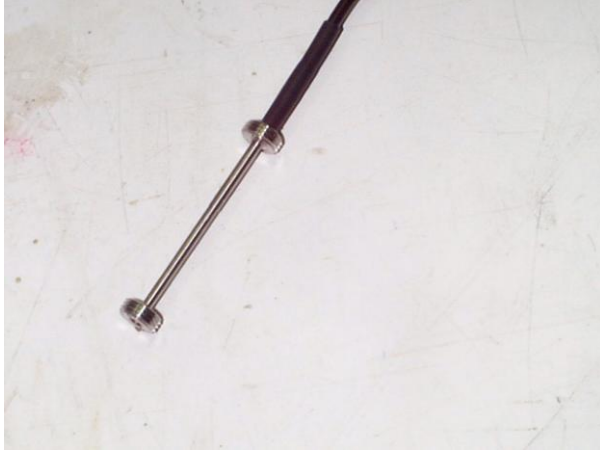
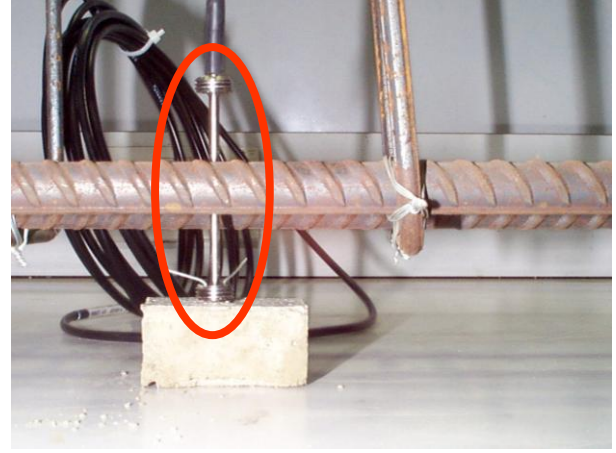
Figure 3. (a) Concrete embeddable fibre optic sensor (b) FOSS between longitudinal bars.

Concrete embeddable fiber optic strain sensors (FOSS) were installed in beams B1C, B2C, B3C, B4C and B5C, which were subjected to accelerated corrosion. In each beam, one FOSS was placed vertically between two longitudinal bars at the mid-span as shown in Figure 2. Sufficient care was taken during casting in order to avoid any possible damage to the FOSS during vibration. After casting, all specimens were wet cured for 28 days.

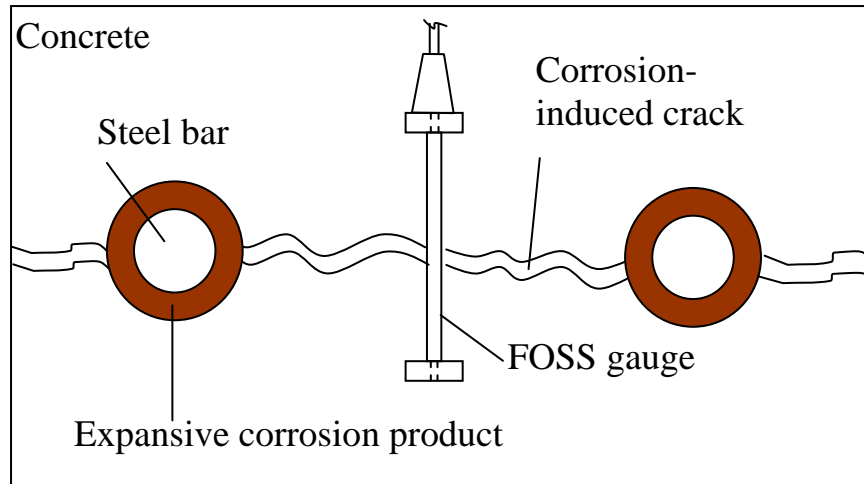
Figure 4. The concept of using FOSS to measure corrosion-induced damage.

In this study, a concrete-embeddable fiber optic strain sensor (Fabry-Perot type) was used to monitor the corrosion-induced tensile strain in the concrete at the level of longitudinal tension reinforcement where splitting cracks were likely to occur (see Figures 3 and 4). The Fabry-Perot strain gauge itself is bonded in a very small diameter longitudinal hole located in the center of a concrete embeddable stainless steel body measuring 70mm in length and having two flanges at both ends for better adherence to concrete. The advantage of this fiber optic strain sensor over its conventional counterparts is that it provides stable absolute measurement of strain needed in experiments involving long-term monitoring [24]. Fiber

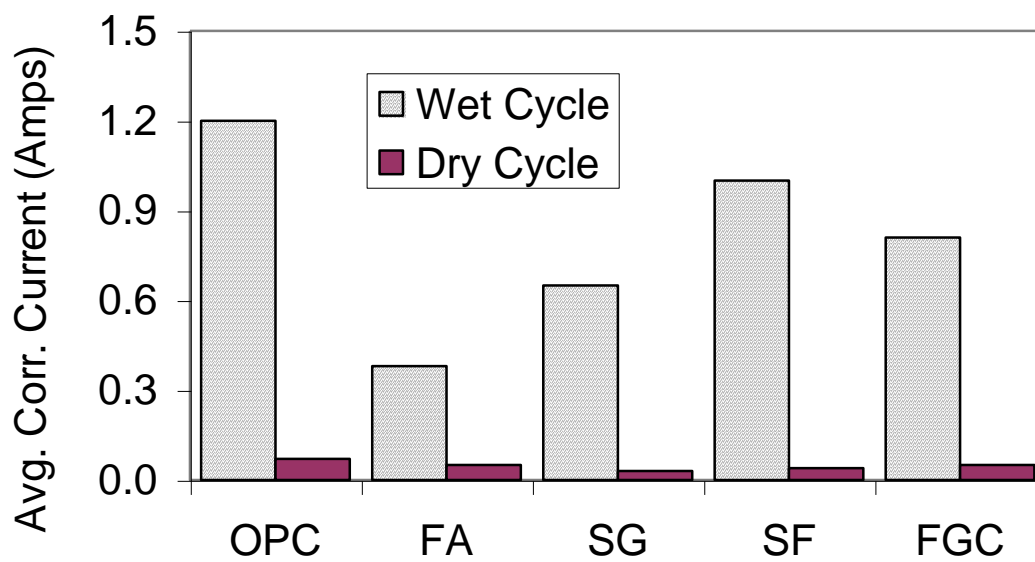
Figure 5. Average corrosion current of different RC

The FGC beam and all SCM-modified concrete beams showed better corrosion resistance, in terms of lower corrosion current and visual damage, than the OPC concrete beam. Figure 5 shows the average corrosion current for all five beams that were subjected to accelerated corrosion. From this Figure it can be seen that the OPC concrete beam attained the highest measured current among all beams. The FA concrete beam attained the lowest measured current indicating the highest corrosion resistance. During the wet phase, the measured current was higher than during the dry phase because the ionic conductivity of wet concrete is higher than that of dry concrete. As expected, the amount of steel loss in the OPC concrete beam was the highest among all beams. This beam lost 9.7% of its internal steel reinforcement. At the same age, the FA, SG, SF and FGC concrete beams lost about 3.3, 4.6, 7.0 and 6.6% of their internal steel reinforcement, respectively (see Table 3).

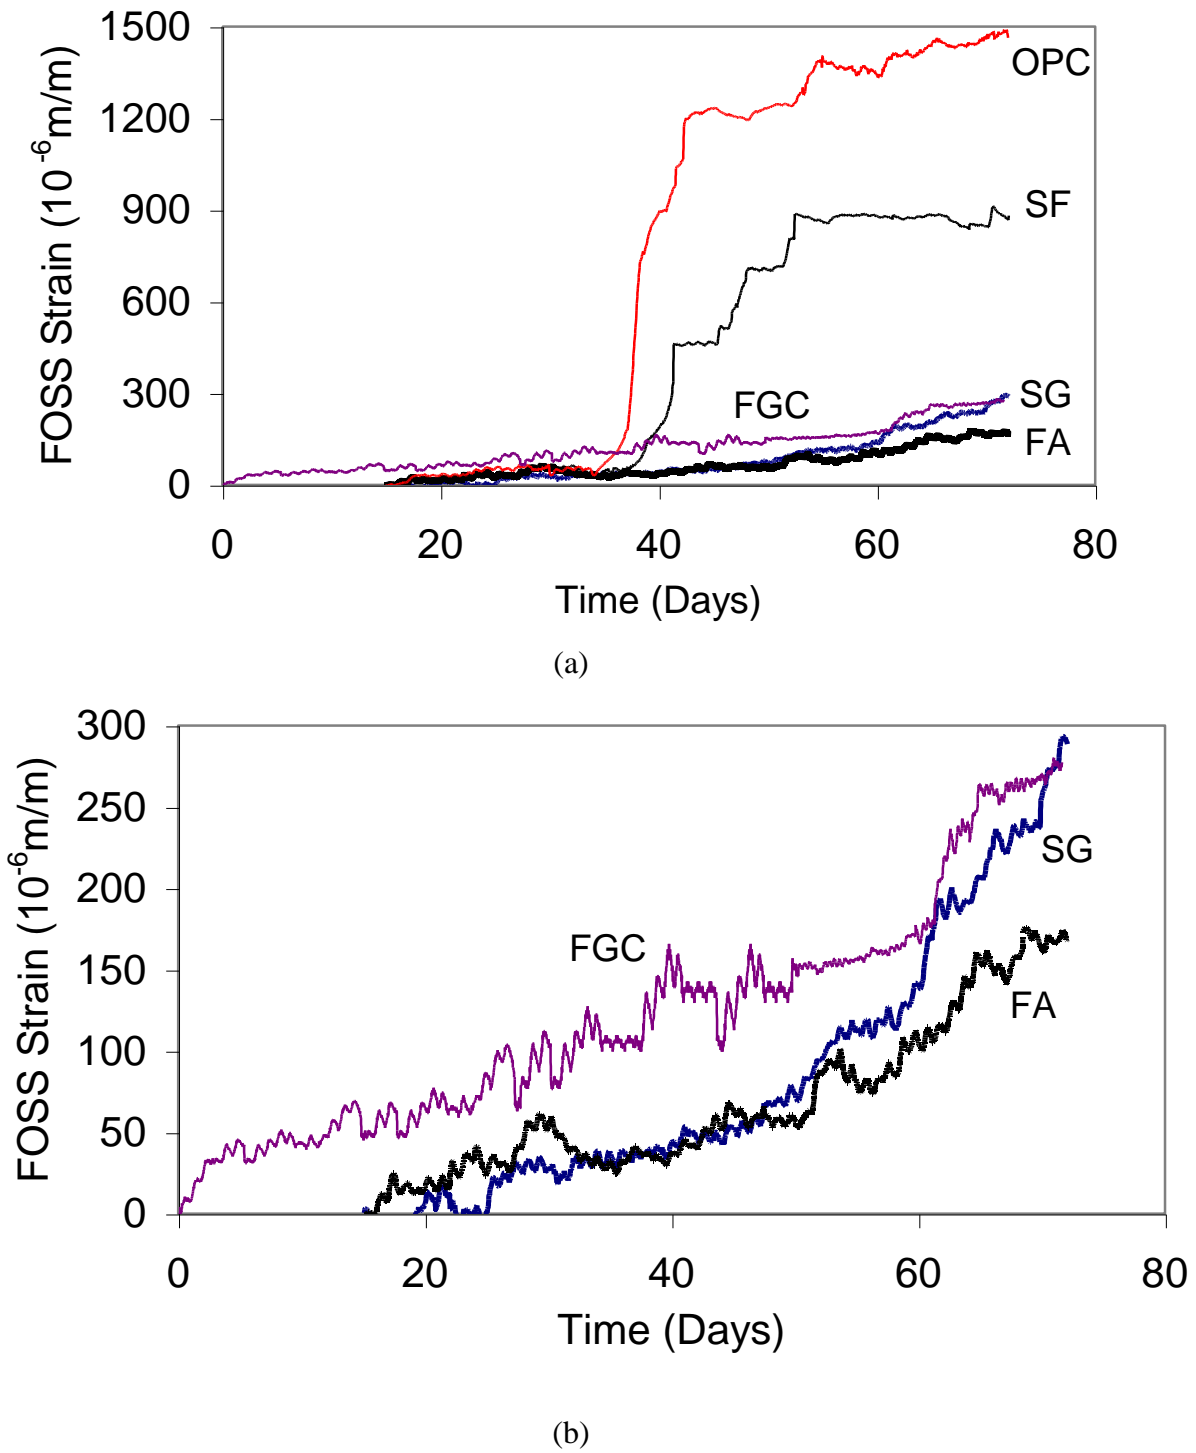
Figure 6. Corrosion-induced tensile strain in the concrete as measured by the FOSS  
(a) all beams (b) close-up for selected beams

Figure 6 shows the variation of concrete strain as measured by the FOSS over time. During the first 32 days, there was no significant change of strain in all four beams except the FGC beam. After the first 32 days, the strain in the OPC concrete beam started to increase; this was associated with the development of a longitudinal crack at the level of tension steel reinforcement. The strain in the same specimen continued to increase with the progress of corrosion. A single longitudinal crack in the SF concrete beam also formed after about 37 days. In addition, it could be verified from Figure 6 that the FOSS strain in this beam also

increased at that time. This indicates that fiber optic sensing could indeed be used to detect cracking in concrete due to corrosion of steel reinforcement.

As soon as a corrosion-induced crack forms, the crack width starts to increase allowing corrosion products to be released into the exterior. As a result, the exerted pressure due to the expansion of the steel starts to reduce. This situation is believed to have taken place in both the OPC and the SF concrete beams, where after about 42 days the rate of increase in the FOSS strains started to reduce.

In the case of SG and FA concrete beams, the highest FOSS strains measured were only about 288 and 185 micro-strains, respectively. Moreover, no sudden increase in strain similar to that observed in the OPC and SF concrete beams occurred in both beams (see Figure 6). This was because of the low level of steel loss in those beams compared to the OPC and SF concrete beams.

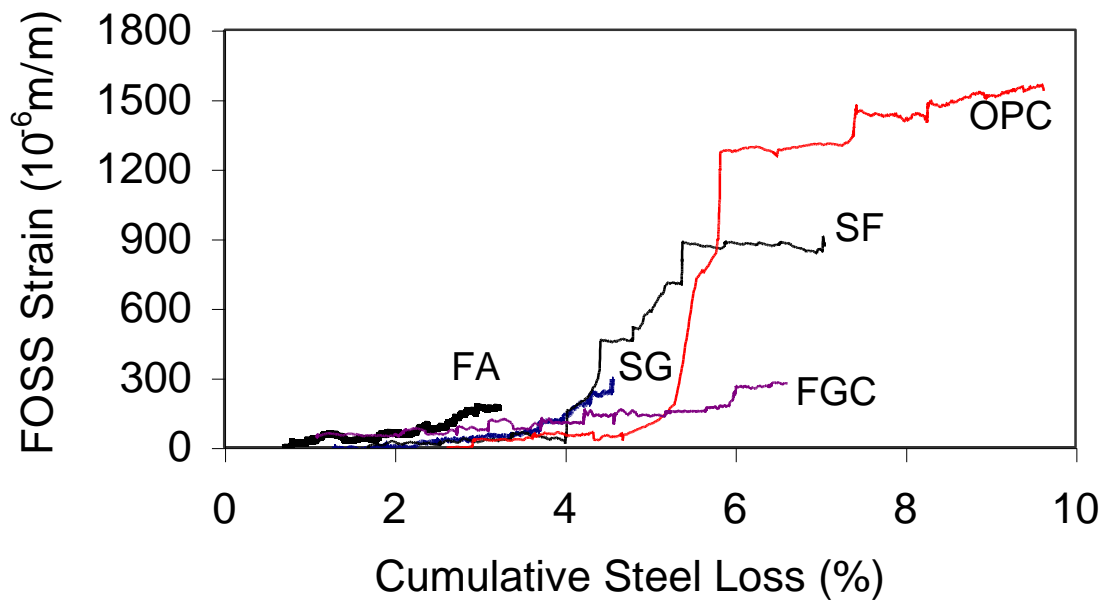
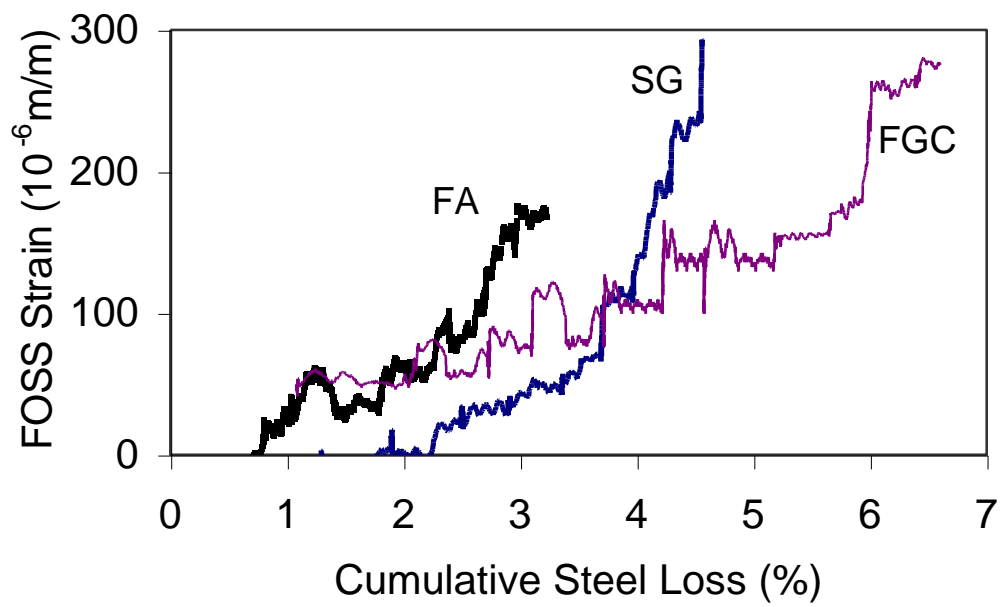
Figure 7. Increase of FOSS reading with cumulative steel loss due to accelerated corrosion (a) all beams (b) close-up for selected beams

Further evidence on the above can be seen in Figure 7, which shows the increase in the FOSS strain reading with the cumulative steel loss due to accelerated corrosion. In Figure 8, the highest FOSS strain reading is plotted against the total amount of steel loss recorded in each specimen. The figure indicates a general trend of increasing FOSS strain with increasing steel loss. A clear deviation from this general trend of behavior can be seen for the FGC specimen. Again, the figure indicates that smaller corrosion-induced tensile strain develops in the FGC specimen compared to other specimens for similar amounts of steel loss.

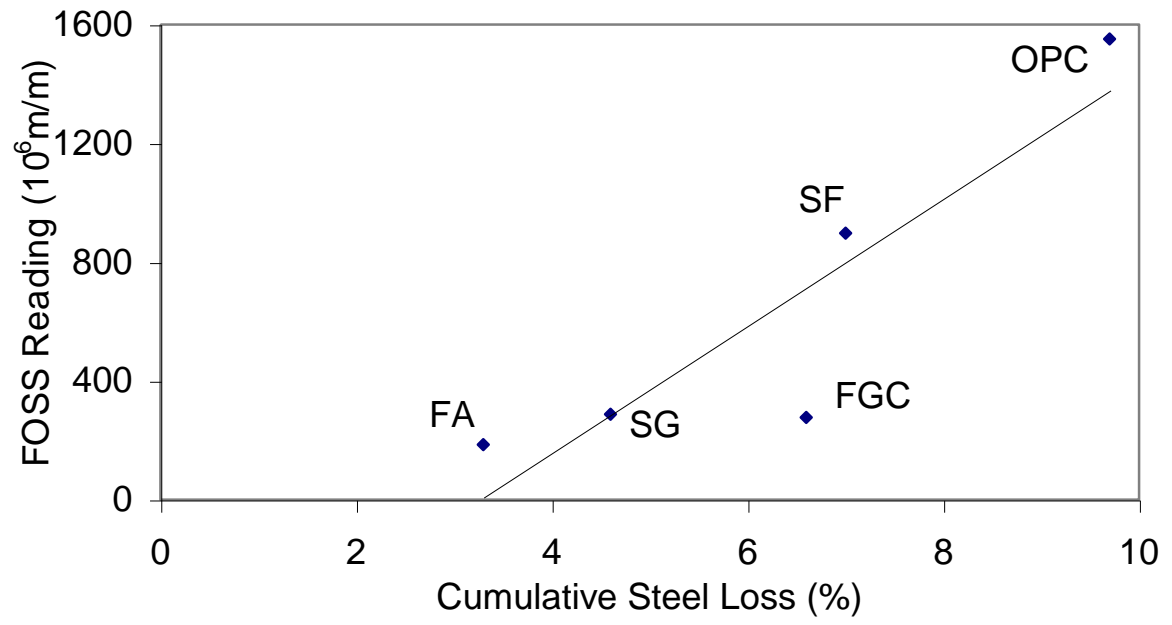
Figure 8. Correlation between steel loss and FOSS readings.

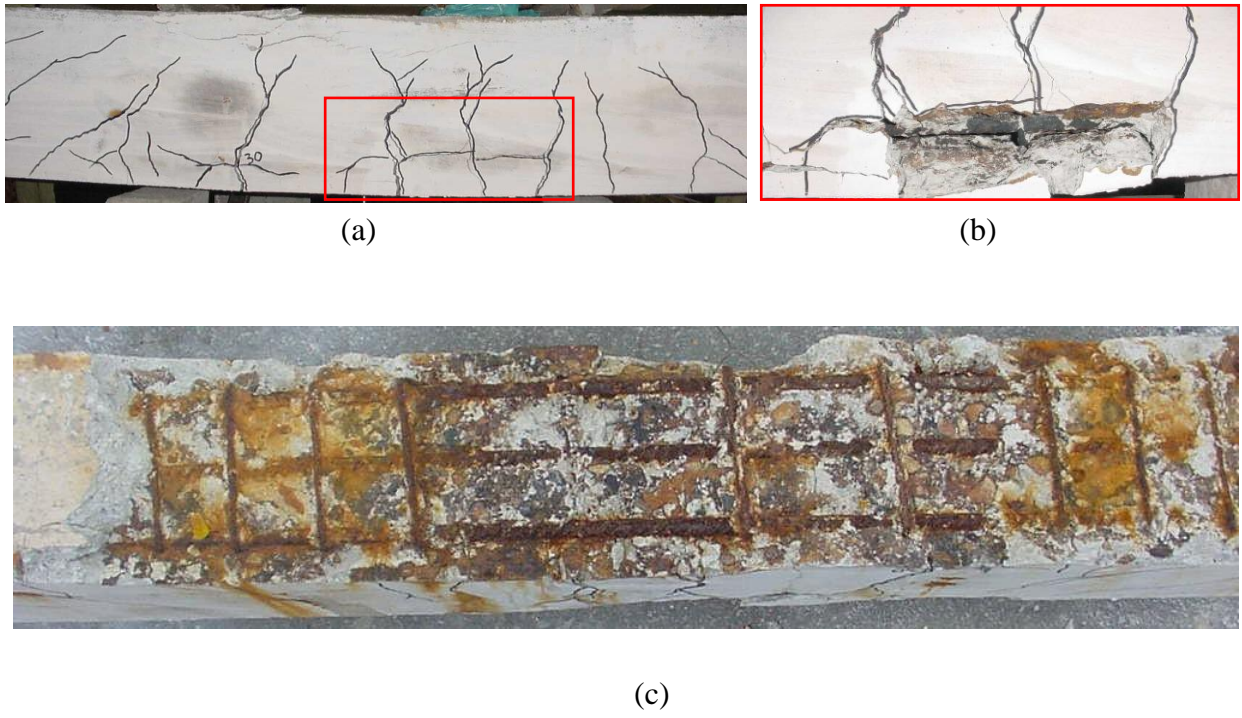
Figure 10. (a) Cracking pattern in corroded OPC concrete beam at about peak load; (b) Close-up of highlighted region of (a) after failure; (c) Status of corroded steel reinforcements

The load and the deflection capacity at failure for all corroded and uncorroded RC beams are summarized in Table 3. As the table shows, the corroded OPC concrete beam lost about 13% of its load-carrying capacity and 26% of its deflection capacity at failure. In the corroded specimen, upon reaching the yield load a longitudinal crack, which had originally formed during the accelerated corrosion test, continued to increase in width as the load continued to increase. That led to slight delamination of the concrete cover upon reaching the peak load (see Figure 10). After structural testing, part of the concrete cover in the corroded OPC concrete beam was removed to expose the reinforcing bars and the stirrups and examine the extent and the uniformity of the steel loss (Figure 10(c)). The examination revealed a fairly uniform loss of steel along the longitudinal and the transverse reinforcement. Few spots of pitting corrosion have also been observed on both the longitudinal and the transverse reinforcement.

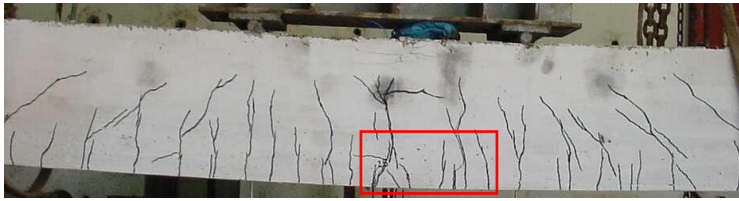
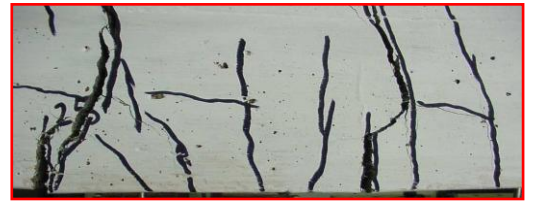
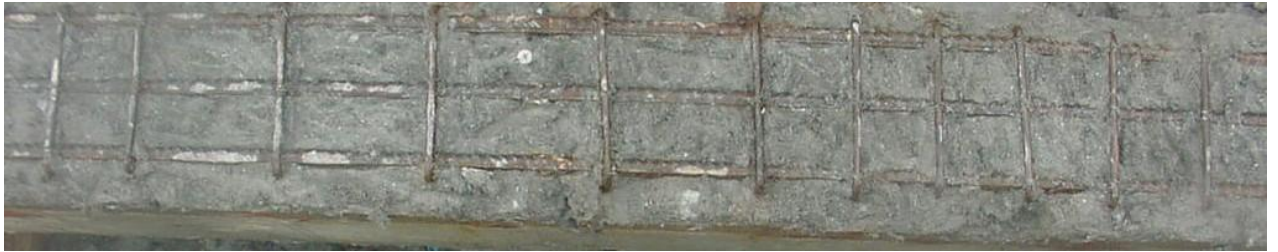
Figure 11. (a) Cracking pattern in corroded FGC beam at about peak load; (b) Close-up of highlighted region of (a) after failure; (c) Status of corroded steel reinforcements

Finally, in the case of the FGC concrete beam, the corroded specimen lost about 5% of its load carrying capacity at failure, however, there was no observable reduction in its deflection capacity at failure. Figure 11 shows the cracking patterns that developed in the beam at ultimate load. After testing and with significant difficulty, part of the concrete cover was removed to expose the reinforcing steel for examination. The examination revealed a minimum loss of steel in the longitudinal reinforcement, except for the midspan region where the load-induced precracks were largest in width. In this region, moderate loss of steel could be observed, but there was no evidence for the presence of corrosion-induced radial cracks or delamination around the longitudinal reinforcing bars. As for the stirrups, there was evidence of some pitting corrosion at the interface between the concrete and the DFRCC material, and these must have been the source of the corrosion spots observed at these locations.

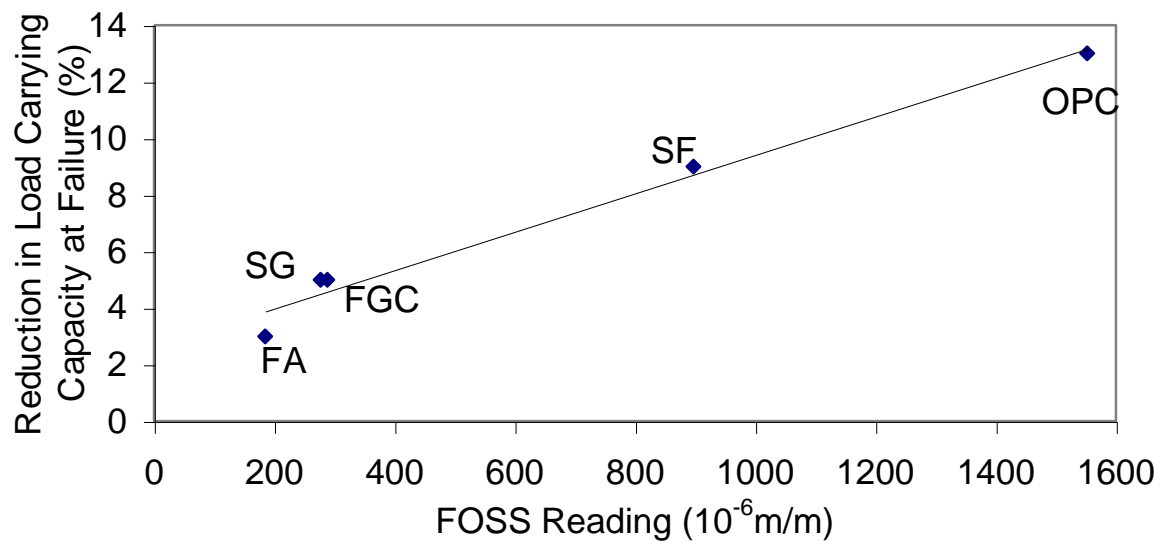
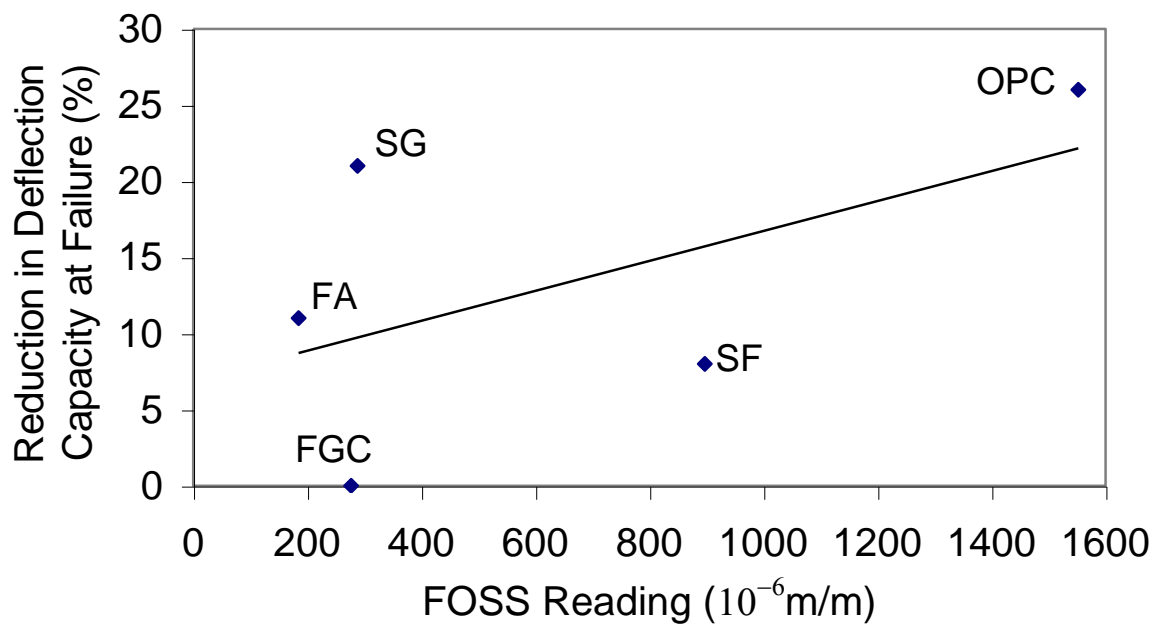
Figure 12. Correlations (a) between the FOSS readings and the reductions in load at failure and (b) between the FOSS readings and the reductions in deflection capacity at failure.

Using data from all five series of specimens, correlations between the FOSS readings and the reductions in the load carrying capacity and the deflection capacity at failure have been established as shown in Figure 12. The Figure indicates a general trend of increasing reductions in the load carrying capacity and the deflection capacity at failure with increasing FOSS strains. Deviations from this general trend of behavior can be seen for the FGC beam. Figure 12 indicates that the FGC beam retained its original deflection capacity despite undergoing accelerated corrosion. This can be explained by the fact that the FGC specimen did not suffer any type of cracking or delamination that would have reduced its deflection

capacity. The reduction in the load **carrying capacity at failure** is however consistent with the observed general trend and this is reasonable as this reduction is a function of the area of steel lost due to accelerated corrosion. The pitting corrosion that had developed in the stirrups at the interface between the concrete and the DFRCC material did not seem to affect the load-deflection behavior of the beam given the fact that the RC beams were not shear critical.
