SAND75-0616  
Unlimited Release

FILAMENT FORMATION ON PRINTED WIRING BOARDS

C. W. Jennings

December 1975

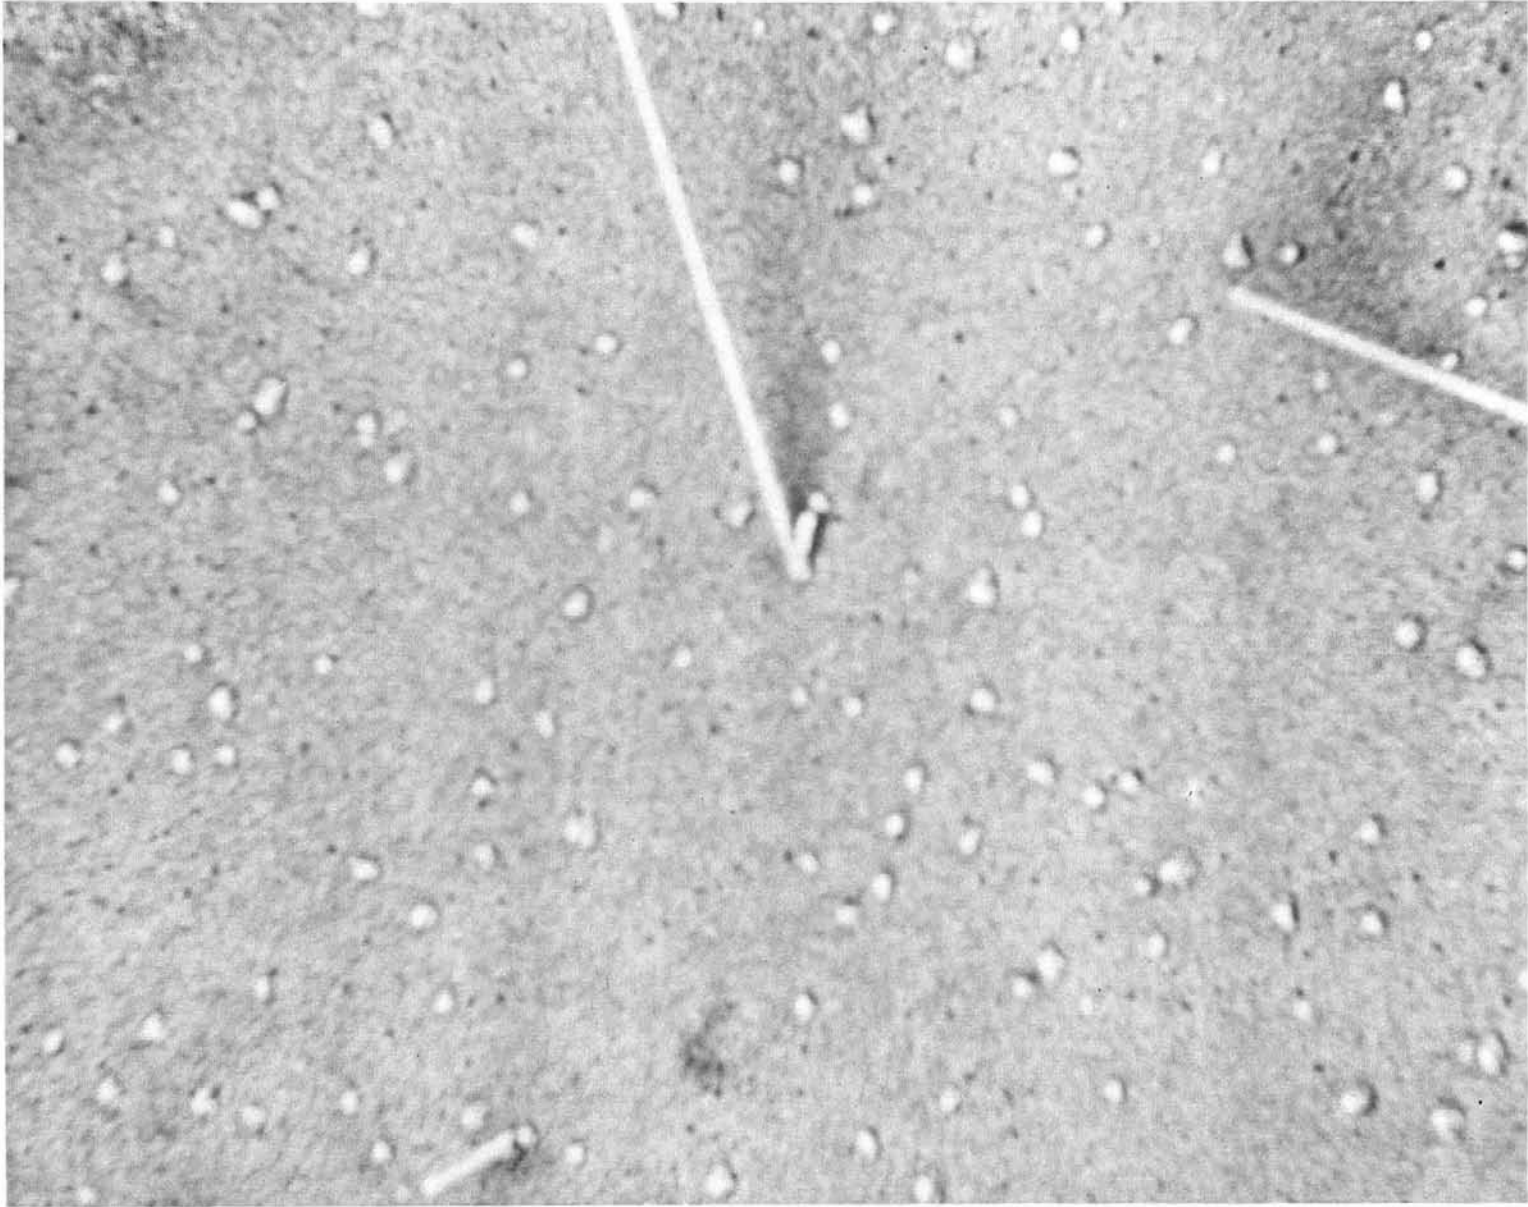
Figure 1 Tin Whisker growth on a tin plated surface.

Tin whiskers are hairlike single crystal growths of the metal which reach lengths of 1 to 2 mm and diameters of 1 to 3  $\mu\text{m}$ . A typical growth is shown in Figure 1. Exceptional growths have reached lengths of 4-5 mm and diameter of 5  $\mu\text{m}$ . They grow from the base and may even penetrate insulating coatings. Their elastic and plastic properties were reported by Herring and Galt (7A). Formerly whiskers were not of sufficient length to cause pronounced circuit bridging and were frequently burned off by circuit currents. However with the advent of closely spaced circuitry and the use of low currents one must reevaluate their threat for tin coated PWBs.

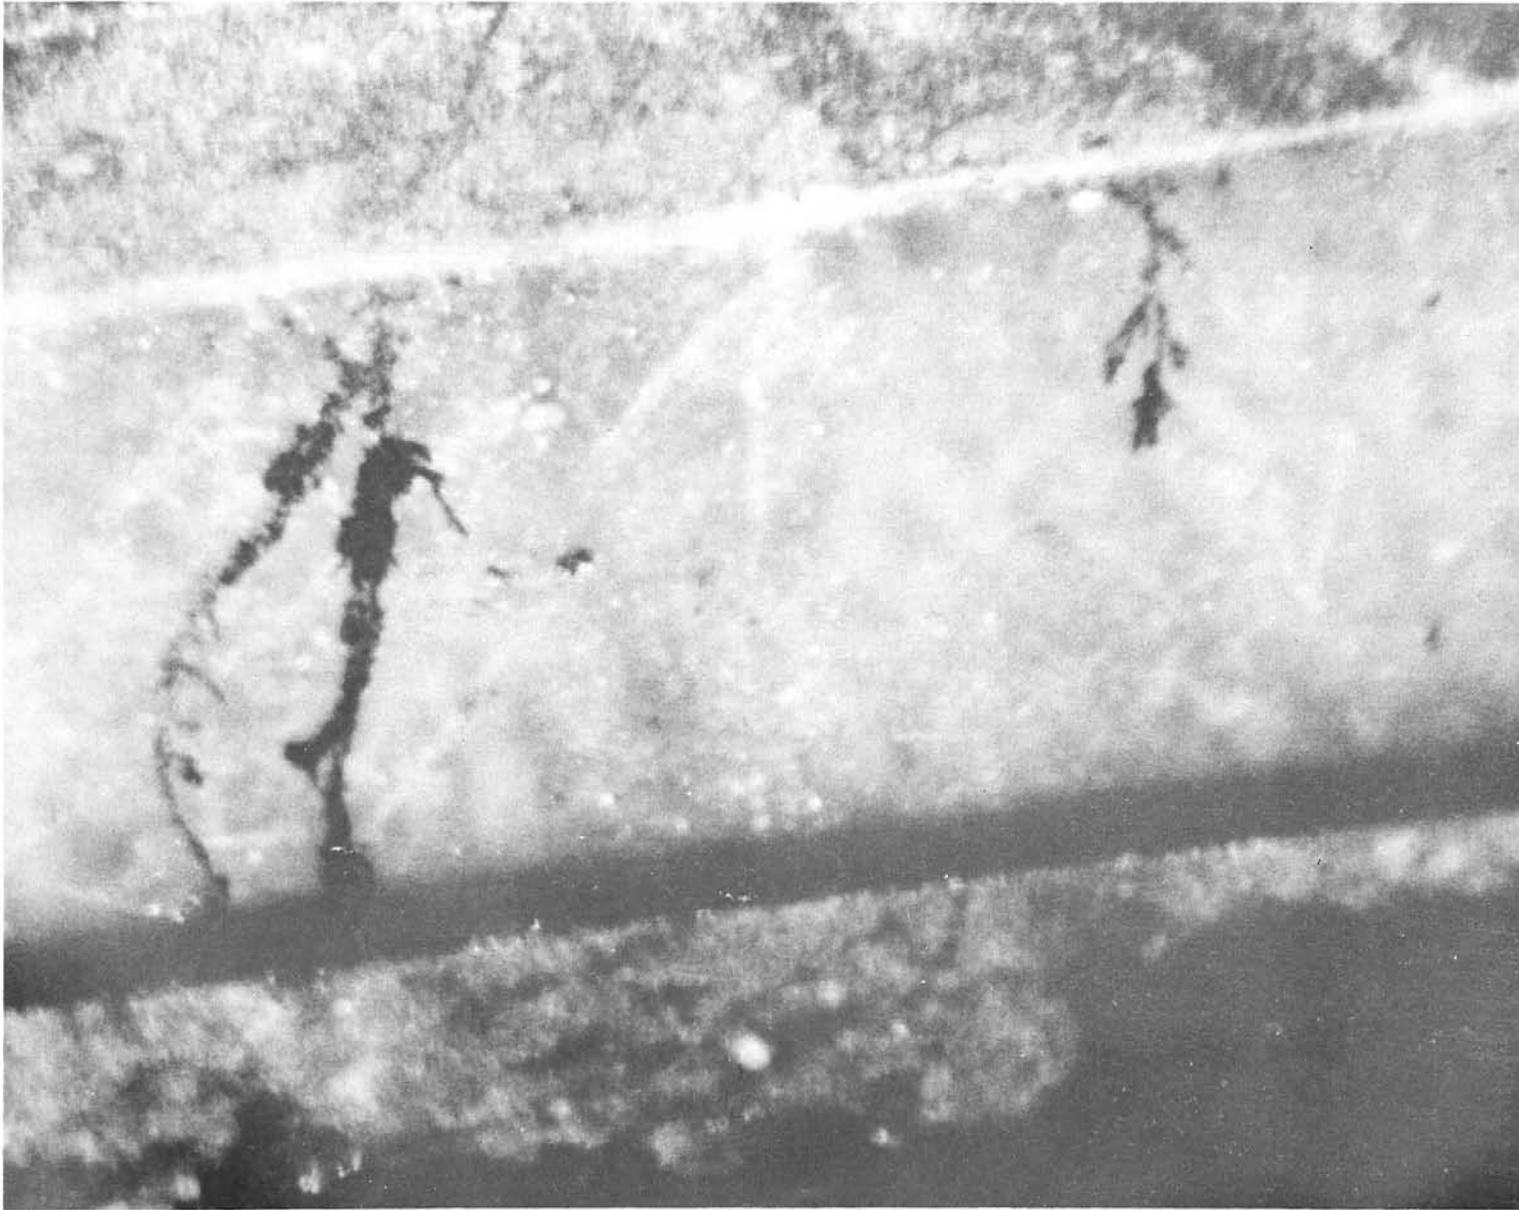
Figure 2 Filament growths formed between copper conductors .75 mm apart on a PWB with a drop of deionized water and 3 volts dc for 30 seconds.

1. All types of PWBs show filament growths which project from cathode to anode as shown in Figures 2, 3 and 4<sup>†</sup>.  
Conductor materials tested were bare copper, Sn-Pb solder coated copper (obtained by either dipping and liquid leveling or by electroplating), bare nickel, and gold plated nickel. The boards were fabricated by pattern and panel processes at different suppliers using different types and sources of laminate.

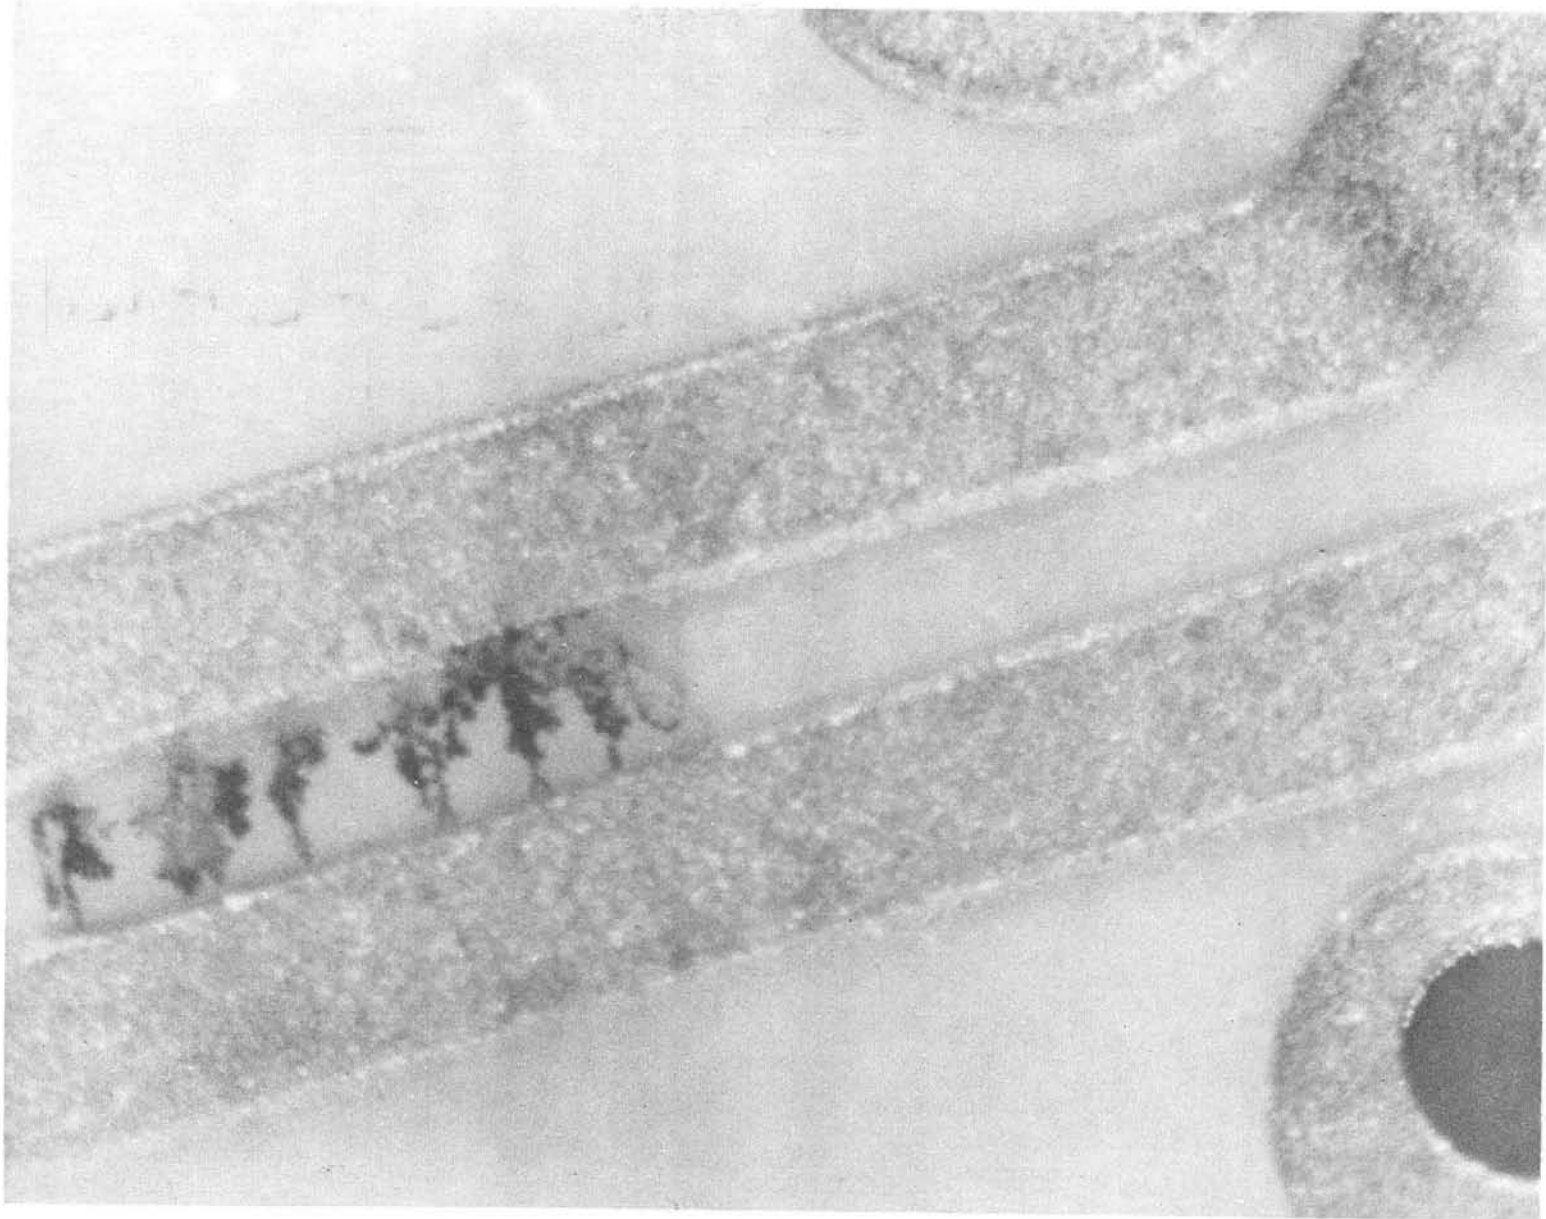
Figure 3 Filament growths between solder coated and leveled copper conductors with 20 volts dc for 1 to 2 minutes.

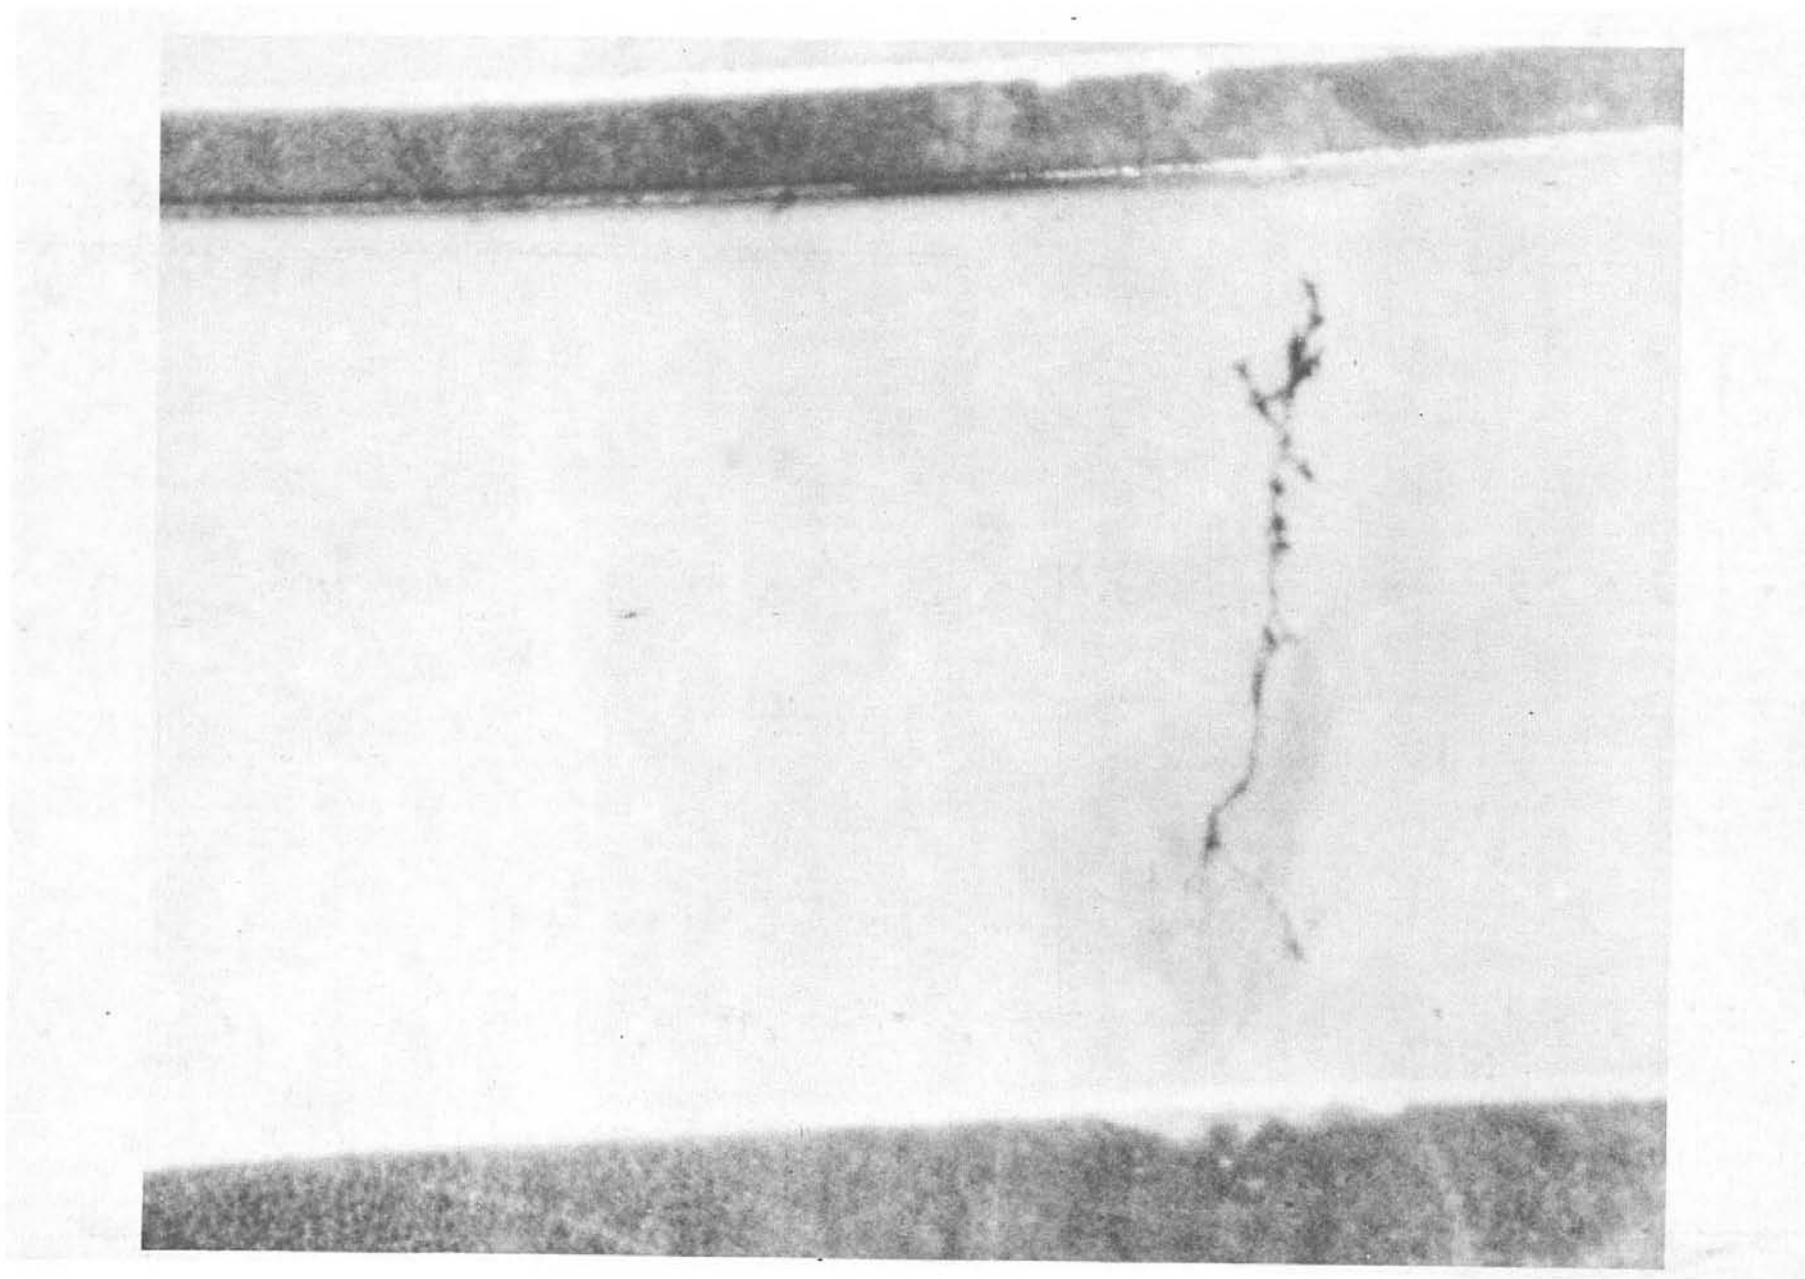
Figure 4 Filament growth interrupted before bridge was formed from cathode to anode over 5 mm separation.

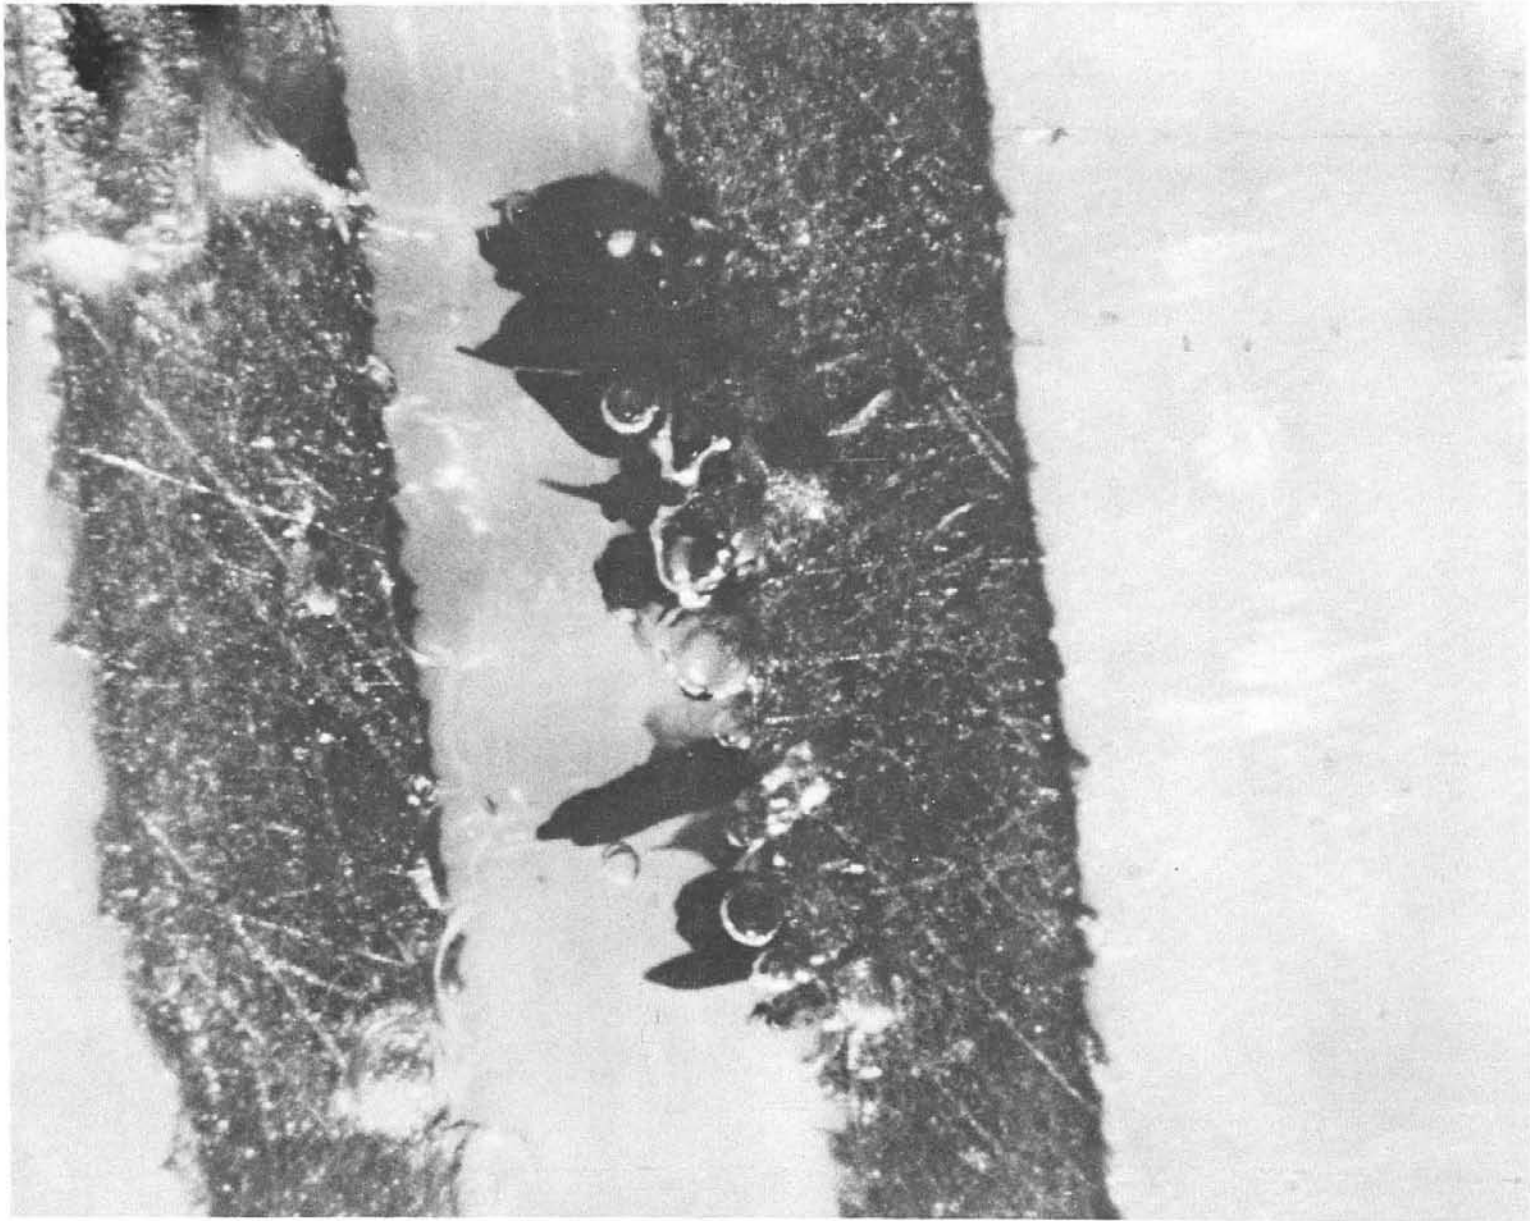
Figure 5 Growths formed between gold on nickel tabs on a PWB.

Dark deposits were produced between gold on nickel electroplated tabs as shown in Figure 5. The metal dissolved at the anode appears to have been reduced by ultra violet light or a reducing constituent from the laminate, or hydrogen prior to reaching the cathode.

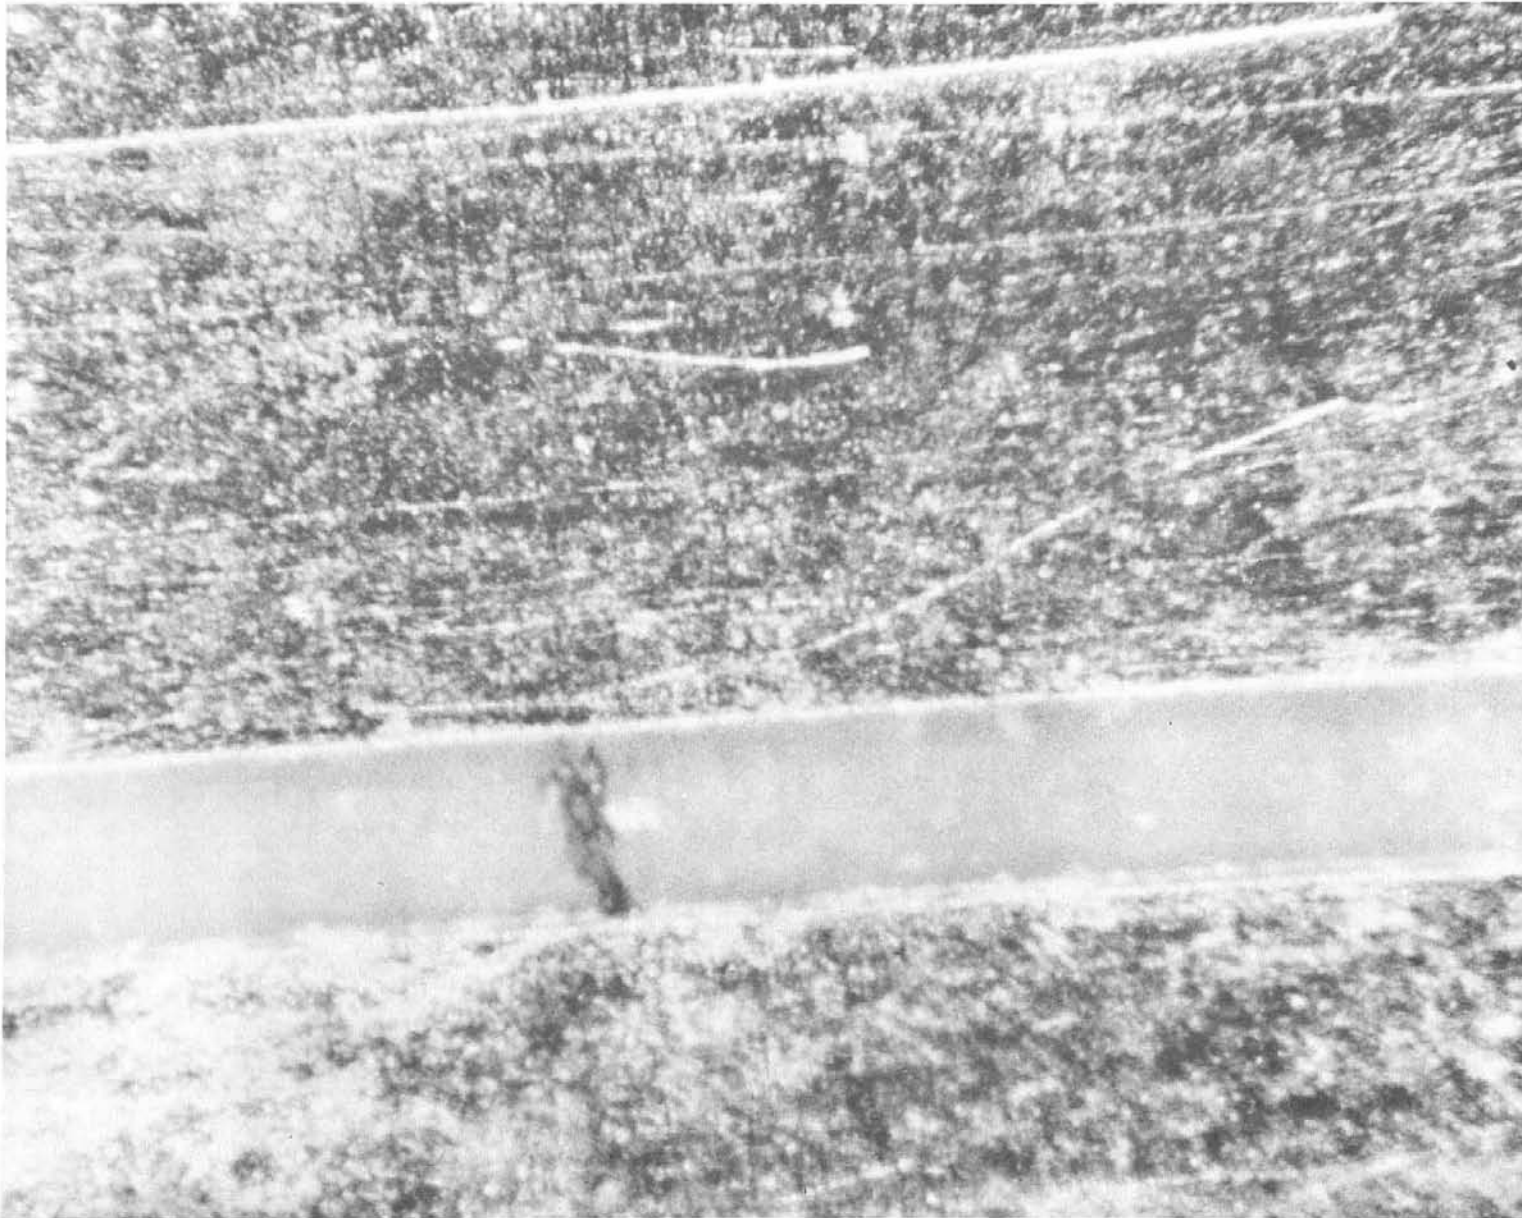
Figure 6 Filament grown on PWB under condensing moisture conditions with 20 volts, .25 mm separation.

Condensing moisture conditions were reproduced in the laboratory by removing boards from a cold chamber and placing them in a desiccator jar maintained at 92 to 97% R.H. Under such conditions filaments could be grown from cathode to anode as shown in Figure 6. For filament formation on typical PWBs it is only necessary that there be a dc potential and a moisture drop or film which bridges the conductors. The closer the conductor spacing and the greater the water watability of the separating dielectric, the less stringent the condensing conditions. Filaments have been grown on Teflon surfaces as shown in Figure 7.

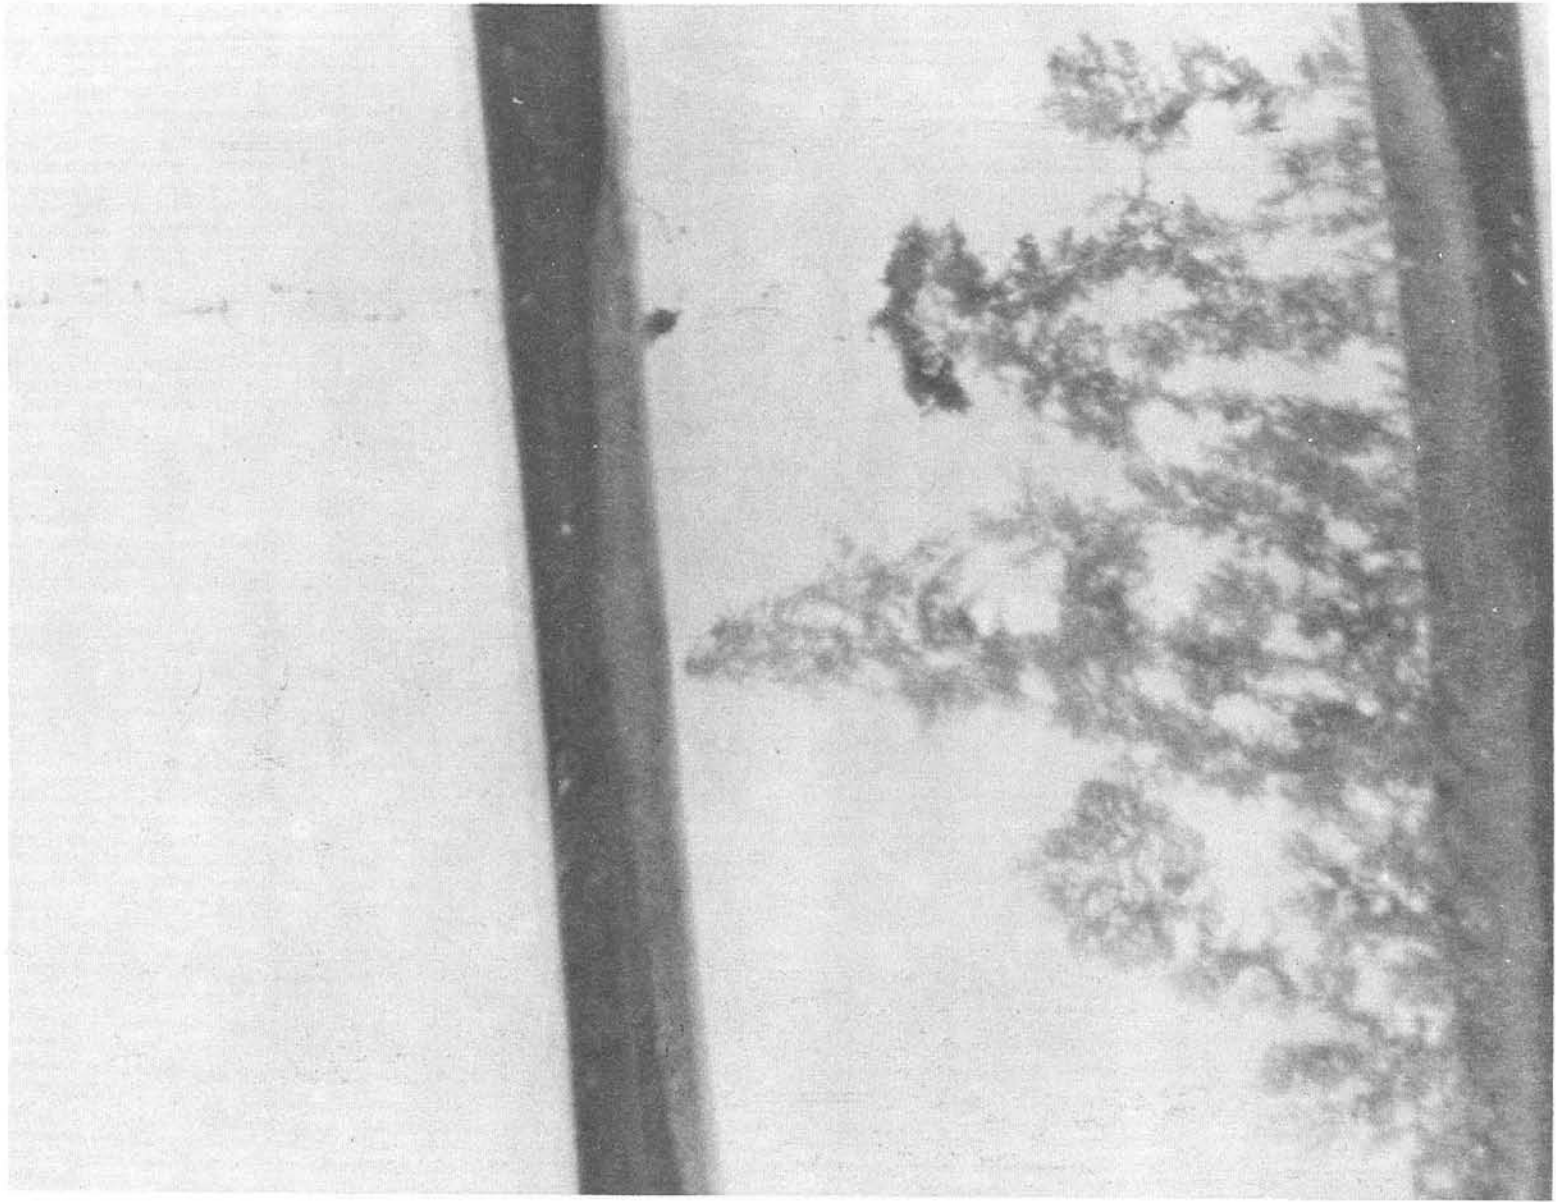
Figure 7 Filaments grown between solder wires on Teflon substrate.

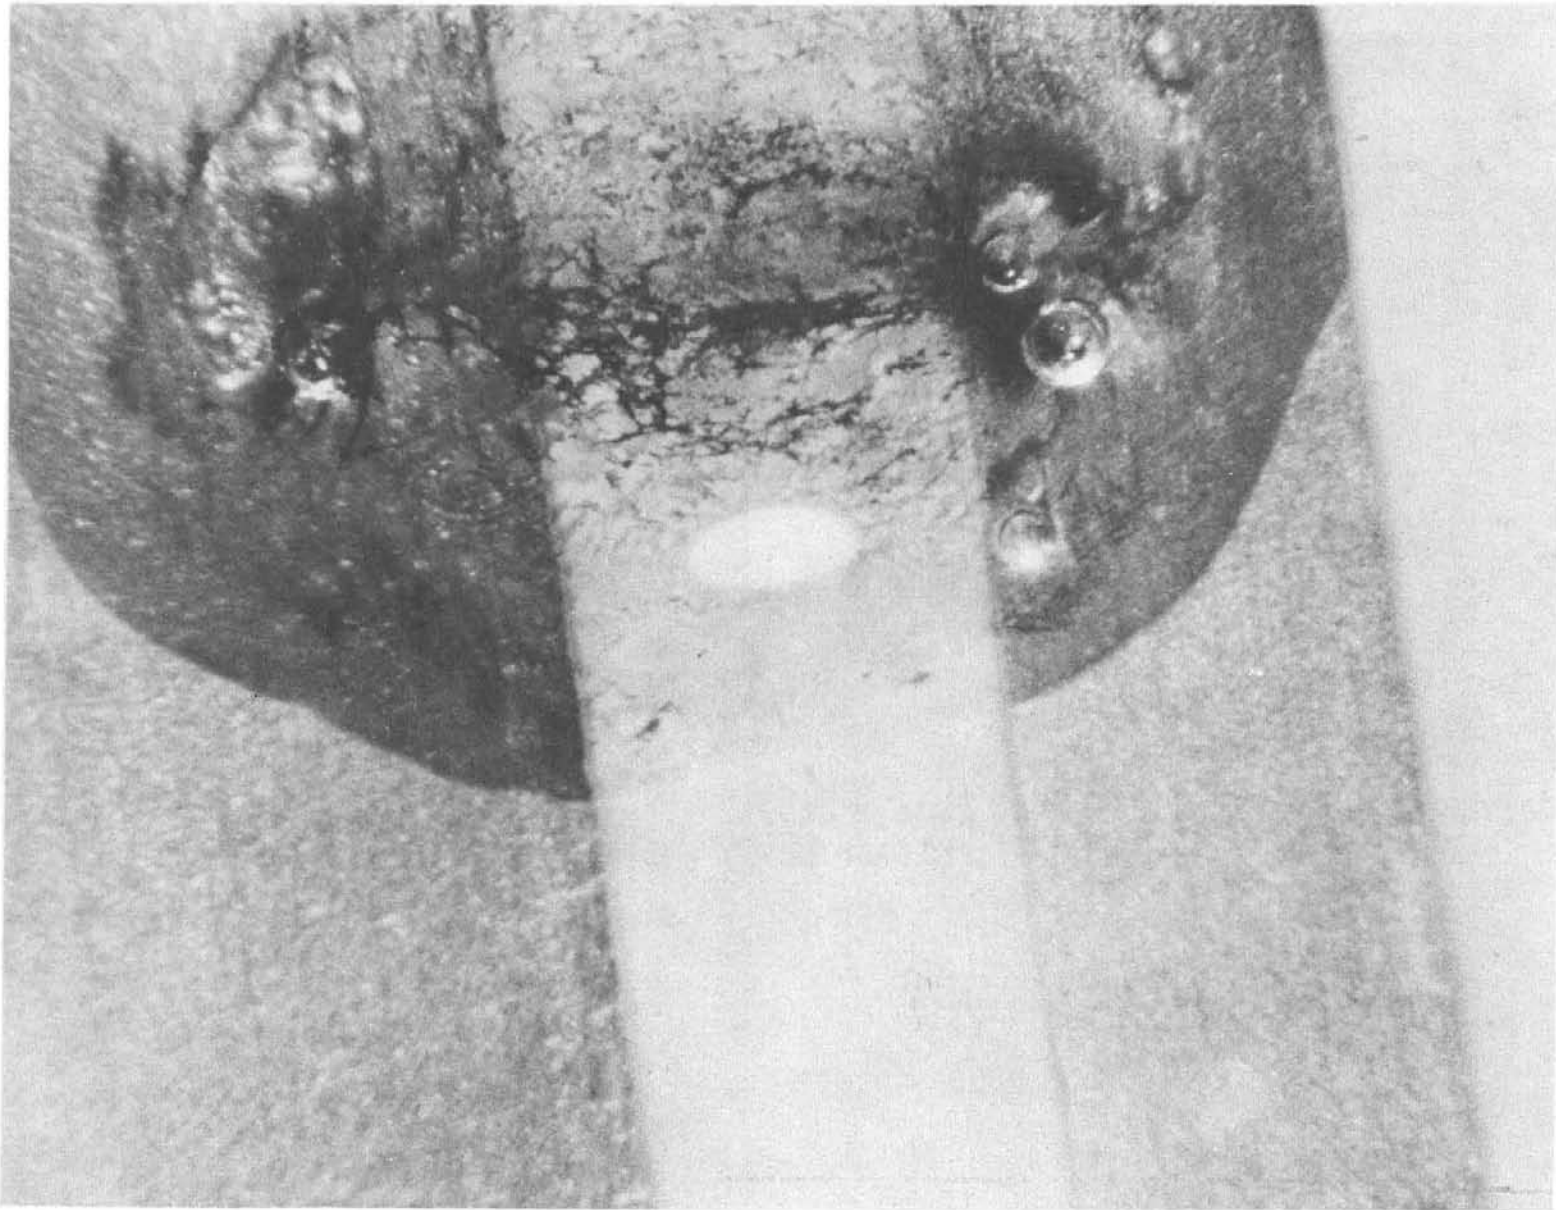
Figure 8 Filament growth from intentional scratches in urethane coated PWB, 20 volts, 1.25 mm separation.

Polymer coatings should prevent filament formation by preventing a moisture film from bridging the conductors. This was in general found to be true for most separations on coated boards. If however there is a defect or scratch in the coating which exposes the conductor to moisture then a filament can form. Figure 8 shows filaments formed from intentional scratches on a urethane coated board. Figure 9 shows filaments formed at pinholes or defects in the coating. Filaments were also grown at defective spots on poly-xylylene coated boards. The defective spots were located by immersing the board in distilled water with 20 to 40 volts applied and noting the spots where gas was evolved. It is not known if the defects were from voltage breakdown tests run earlier on the boards or if they originated during the coating and curing process. A nonbonding condition at the coating-laminate interface or the presence of hydroscopic contaminates which could cause blistering and moisture film formation from water diffusing through the coating could also give rise to filament formation. Although the probability of filament formation on coated boards is low, complete protection cannot be guaranteed unless the coating is applied and cured under conditions

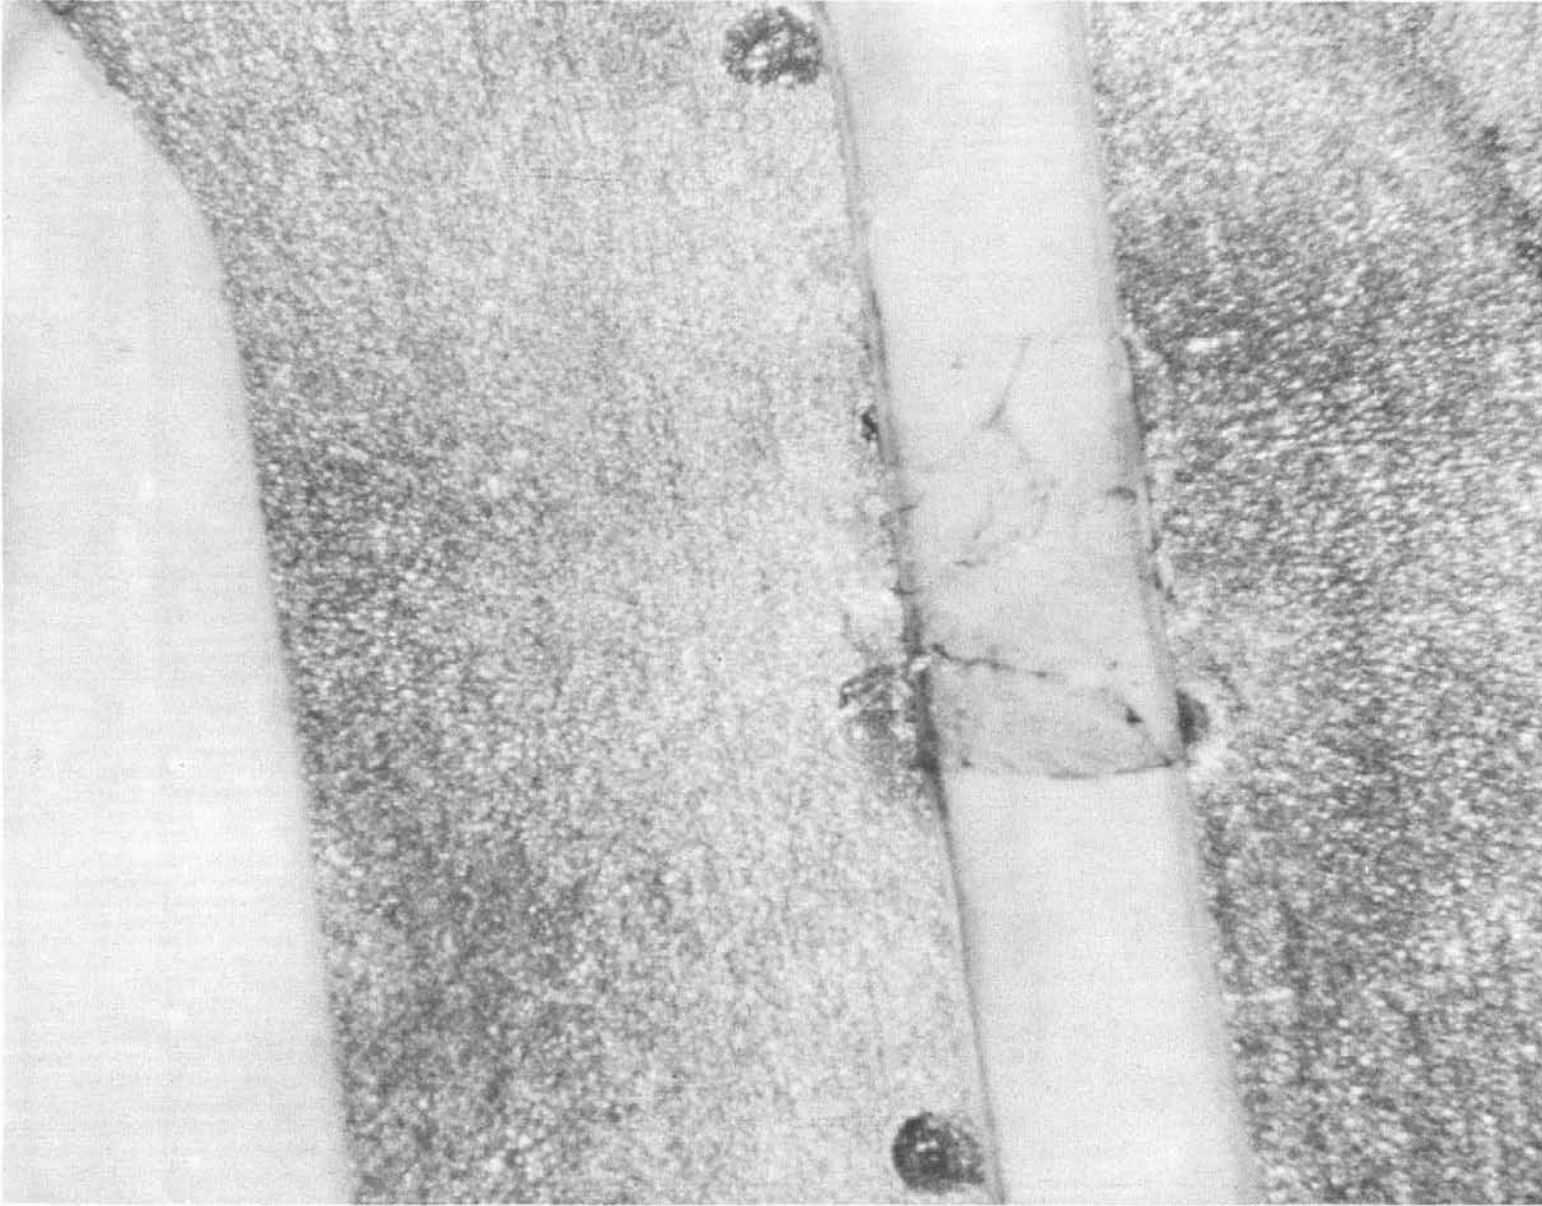
Figure 9 Filament growth from defects in urethane coating on PWB conductors, 20 volts, 0.38 mm separation.
