# Final Test and Evaluation Results from the Solar Two Project

**SAND2002-0120**  
**Unlimited Release**  
**Printed January 2002**

## Abstract

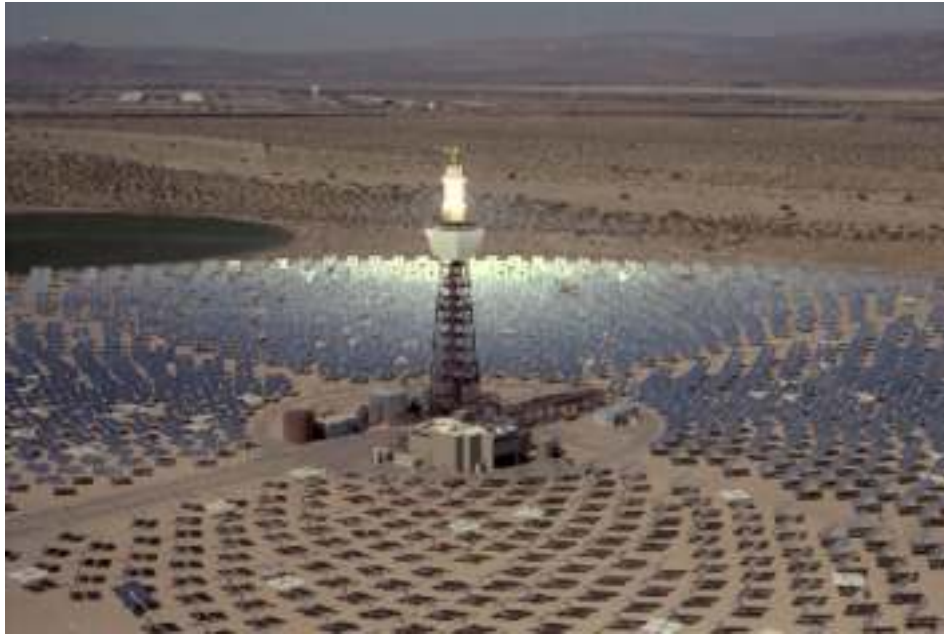
*Figure 1-1. Photograph of the Solar Two plant in operation.*

The original heliostats were reused from the Solar One project, but the facets of the inner rows of heliostats were recanted for the smaller Solar Two receiver. The Solar One heliostat field was modified at the boundary by moving north-side heliostats (which produced excessive flux on the north side of the receiver) to the sides of the field, and adding large area heliostats on the south boundary of the field. In conjunction with a carefully developed aiming-strategy, this allowed a significant reduction in receiver dimensions without exceeding its design limits. Figure 1-1 shows a photograph of the Solar Two plant.

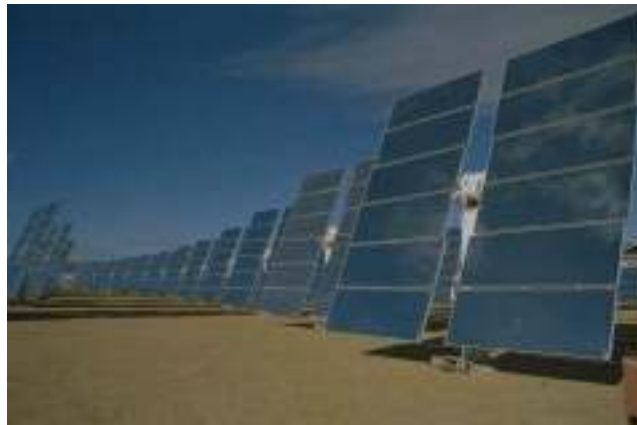
*Figure 2-1. Martin Marietta heliostats.*

The heliostat field consisted of 1818 Martin Marietta (MM) heliostats from the original Solar One project and 108 large-area Lugo heliostats (so named because many of their parts were salvaged from the defunct Lugo photovoltaic plant) added so the Solar Two project could better match the desired balance of heat flux between the north and the south side of the molten-salt receiver. Thirty-two of the MM heliostats were also relocated for this purpose. The technical characteristics of the heliostat field are listed in Table 2-1. The MM heliostats, shown in Figure 2-1, were each 39.1 m<sup>2</sup>. The MM field had a mixture of low- and high-iron glass, with an average clean reflectivity of 0.903. Each MM heliostat used 12 mirror modules mounted to a roof-truss and torque-tube assembly. An azimuth-elevation drive unit moved the assembly to the desired position. Many of the MM mirror module's reflective silver surface started to corrode, but this problem was greatly slowed by venting the modules. Some of the corroded mirror modules fell off in the early 1990s during an earthquake. Many damaged, missing, and corroded mirror modules on these heliostats were replaced with flat mirrors, cut down to size from another defunct photovoltaic power plant called Carrissa Plains. The Lugo heliostats, shown in Figure 2-2, were built with 16 Carrisa Plains flat mirror modules and had a total reflective area of 95 m<sup>2</sup>. These mirror modules consist of 1-mm thick glass mirrors laminated on 3-mm thick glass and have a clean reflectivity of 0.94. This design is more durable than the mirror module design used on the MM heliostats. The low-cost, salvaged mirror modules were judged to be acceptable for the project despite their undesirable, flat curvature. The Lugo heliostats also have a roof-truss and torque-tube structure and an azimuth-elevation drive unit.

<b>Martin Marietta Heliostats</b>	
Number	1818
Reflective Area	39.13 m <sup>2</sup>
Number of Mirror Modules	12
Type of Glass	Mixture of Low- and High Iron
Clean Reflectivity	0.903
Total MM Heliostat Field Area	71140 m <sup>2</sup>
<b>Lugo Heliostats</b>	
Number	108
Reflective Area	95 m <sup>2</sup>
Number of Mirror Modules	16
Type of Glass	Thin-glass laminated on thick glass
Clean Reflectivity	0.94
Total Lugo Heliostat Field Area	10260 m <sup>2</sup>

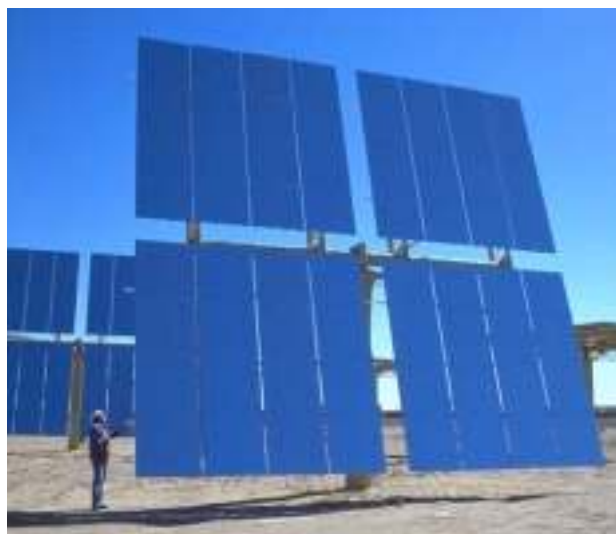
*Figure 2-2. Lugo heliostats at Solar Two.*

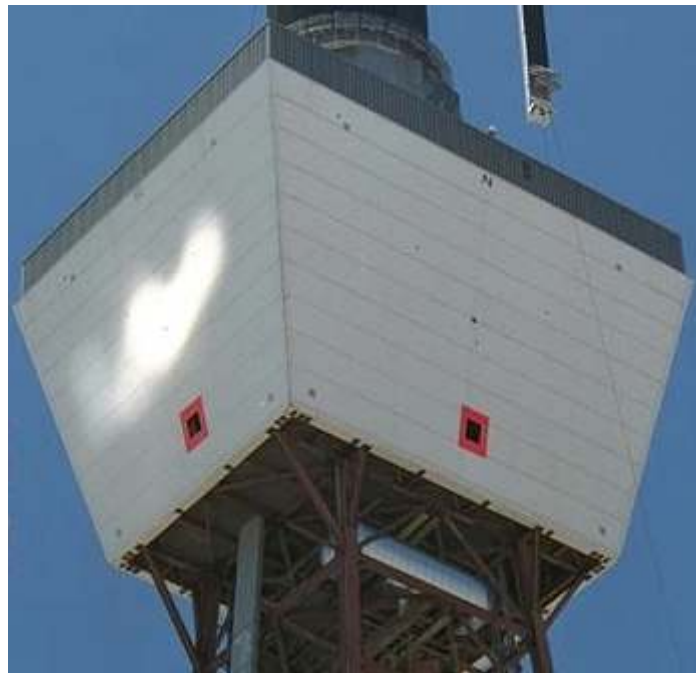
*Figure 2-3. Solar Two heliostat beam tracking the BCS target.*

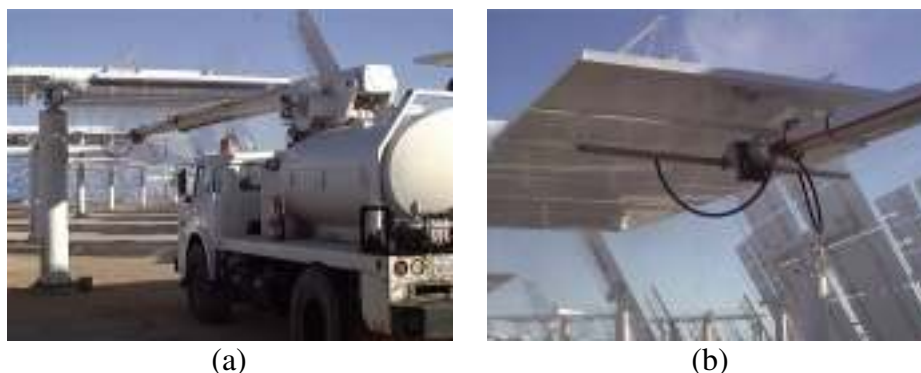
*Figure 2-6. The Solar Two wash truck (a) and close-up of spray bar (b).*

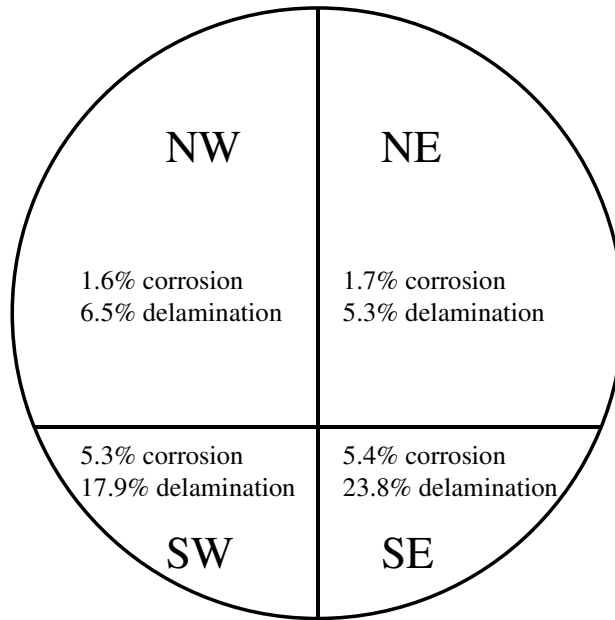
Figure 2-8. By the summer of 1996, 2.8% of the MM Field had been lost due to corrosion and 11% of the facets had lost their curvature (delaminated).

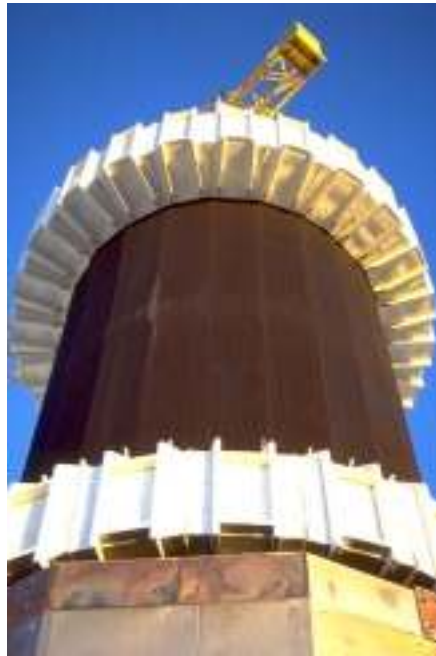
Figure 3-1. Close-up of Solar Two receiver.

The Solar Two receiver was arranged in an external cylinder. It was rated for 42.2 MWt absorbed power with a design average flux capability of 430 kW/m<sup>2</sup>. The flux distribution was designed to heat salt from 290°C to 565°C while keeping the strain and corrosion in the receiver tubes within allowable limits (Vant-Hull, 1993). The receiver was designed, fabricated, and erected by the Rockwell Division of The Boeing Company. It consisted of 24 panels arranged in a cylinder. Each panel incorporated 32 thin-walled tubes with end-bends connected to manifolds on each end of the panel. Each tube was 2.1 cm in diameter, with a 1.2-mm wall thickness constructed of 316 stainless steel. The external surfaces of the tubes were coated with a black Pyromark<sup>®</sup> paint that was robust, resistant to high temperatures and thermal cycling, and absorbed 95% of the incident sunlight. The manifolds and end-bends were enclosed in insulated, electrically-heated oven covers. Figure 3-1 shows the receiver. The technical characteristics of the receiver system are listed in Table 3-1.

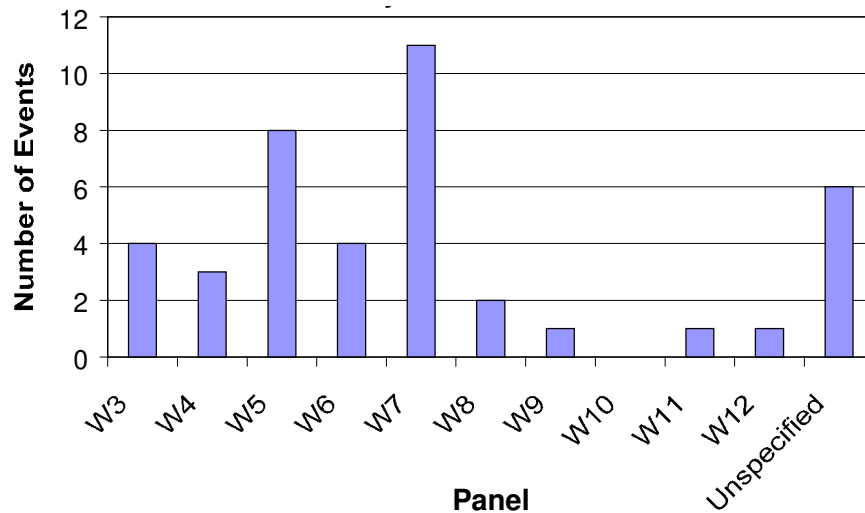
Figure 3-5. Frequency and location of tube freeze-ups in receiver during the period from July to November 1998, as observed by the operators. The panels were on the west side of the receiver. W1 was the northern-most panel; W12 the southern-most panel.

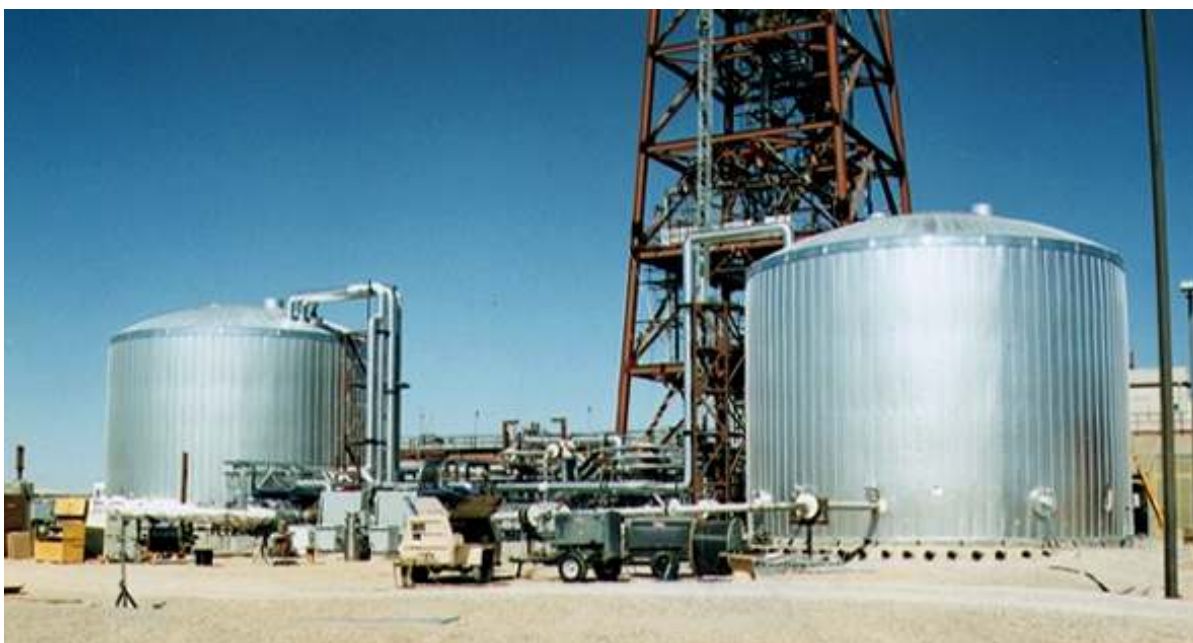
Figure 4-1. Cold (left) and hot (right) nitrate salt storage tanks.

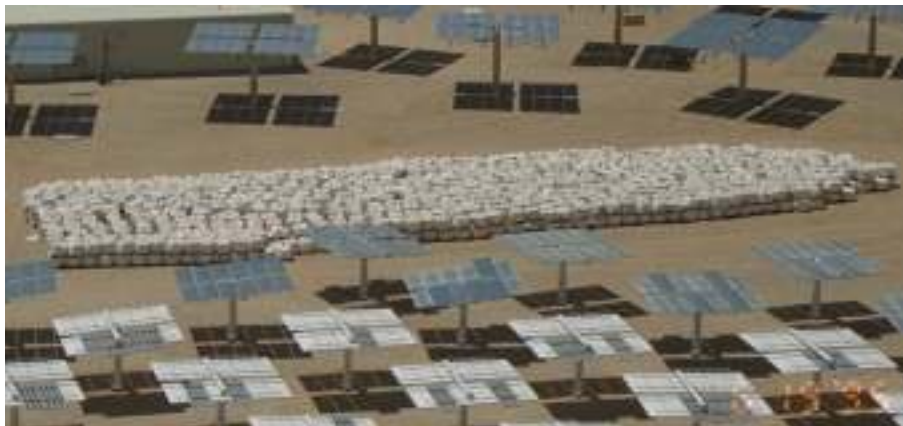
Figure 4-3. 1380 tonnes of nitrate salt awaiting melting at Solar Two.

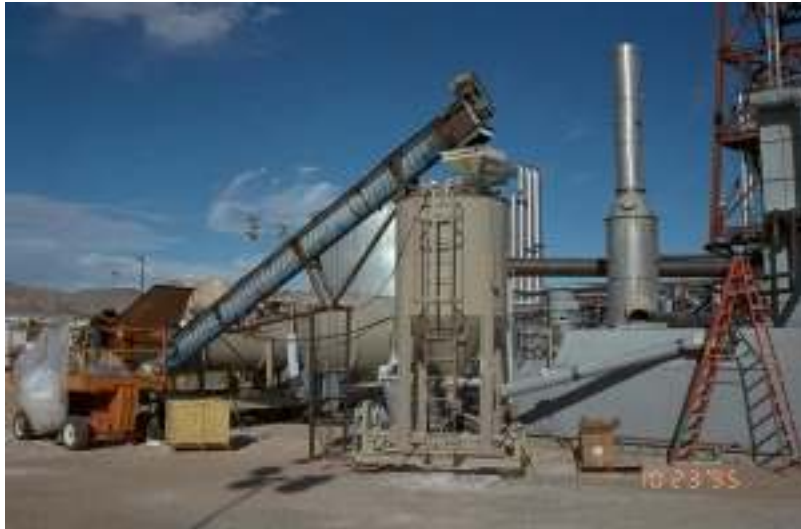
*Figure 4-4. Conveyor belt feeding crushed salt from the hammer mill into the salt hopper. The screw auger can be seen as the pipe feeding into the wall next to the ladder.*

Figure 4-3 shows the salt in bags awaiting melting. The supersacks were loaded into a hammermill and crushed into small pieces that were then sent along a conveyor belt to a feed hopper, shown in Figure 4-4. The feed hopper had a screw auger to push the salt into the melting chest. The melted salt was then fed directly into the hot tank. The salt in the hot tank was continuously circulated through a 3 MW propane heater to bring the salt temperature to 370°C. It took 16 days to add the complete inventory of salt to the hot tank. Once the inventory of salt was in the hot tank, it was slowly heated to 540°C and soaked at that temperature for 20 days to reduce the magnesium nitrate impurity. The magnesium nitrate thermally decomposed, forming gaseous nitrous oxide byproducts that, if not reduced, could have caused flow stability problems in the receiver the first time the receiver was operated.

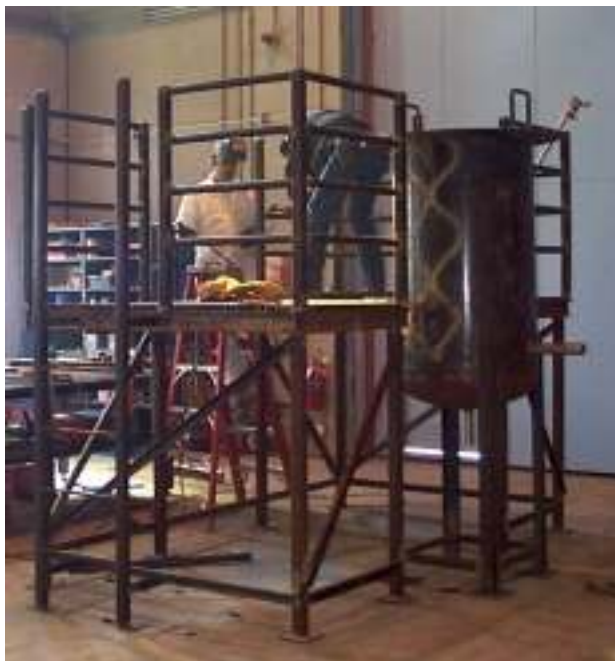
*Figure 4-5. Salt recycler used to return spilled salt to the thermal storage system.*

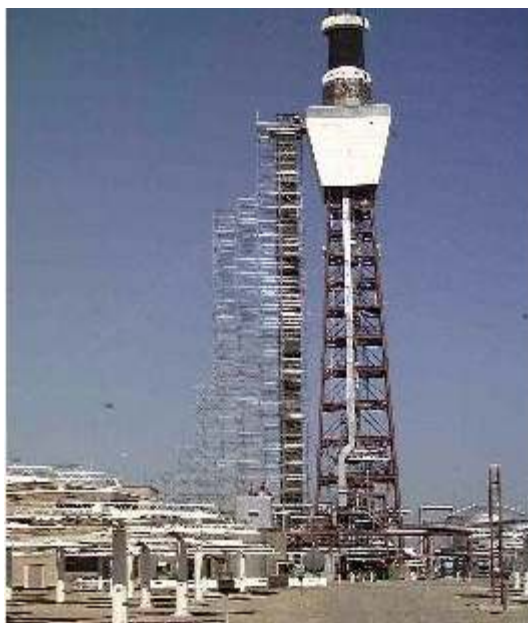
Figure 4-6. Chute on one side of the tower in which the nitrate salt was prilled for removal from the site.

At the end of the project, the entire 1380 tonnes of nitrate salt were removed from the site. Since the nitrate salt was to be recycled for use as fertilizer, the salt had to be frozen into small pellets (called prills), put into 1000-kg supersacks, and shipped offsite. A piping loop, which contained a prilling head (several plates with small holes to allow the salt to form droplets), was tapped into the downcomer at the top of the tower. The droplets sprayed down a 3m × 3m chute erected with scaffolding on the side of the tower, shown in Figure 4-6. At the bottom of the chute, a hopper fed the salt prills into a fluidized bed cooler. A conveyor carried the salt prills through another fluidized bed cooler and then to a hopper fitted with a supersack.

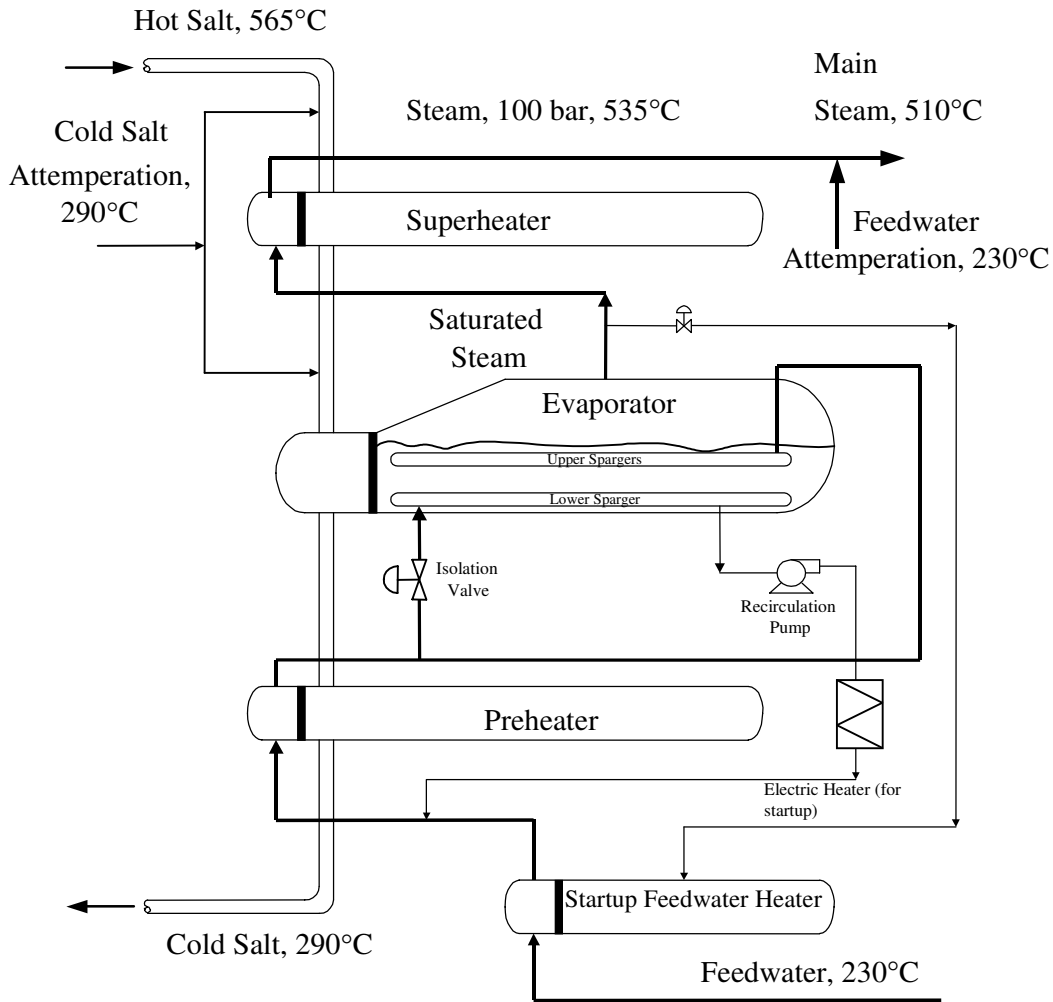
Figure 5-2. Schematic of the revised steam generator system.

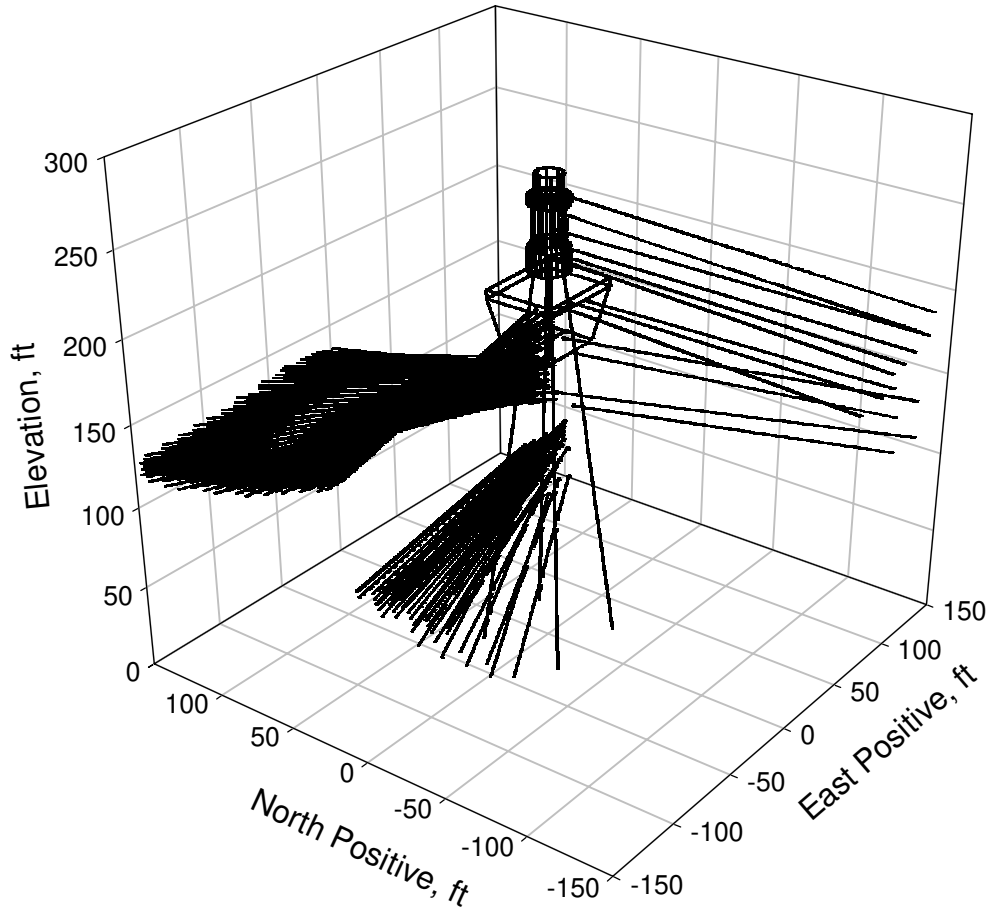
Figure A-3. Beams that walk on to the BCS targets and tower structure 40 minutes after a power failure that occurred at 7:30 AM on December 21 as viewed from the southwest. Each line represents a ray from the center of the heliostat to the point of intersection. The crosses mark the points of intersection. The tower is hit more than other components.

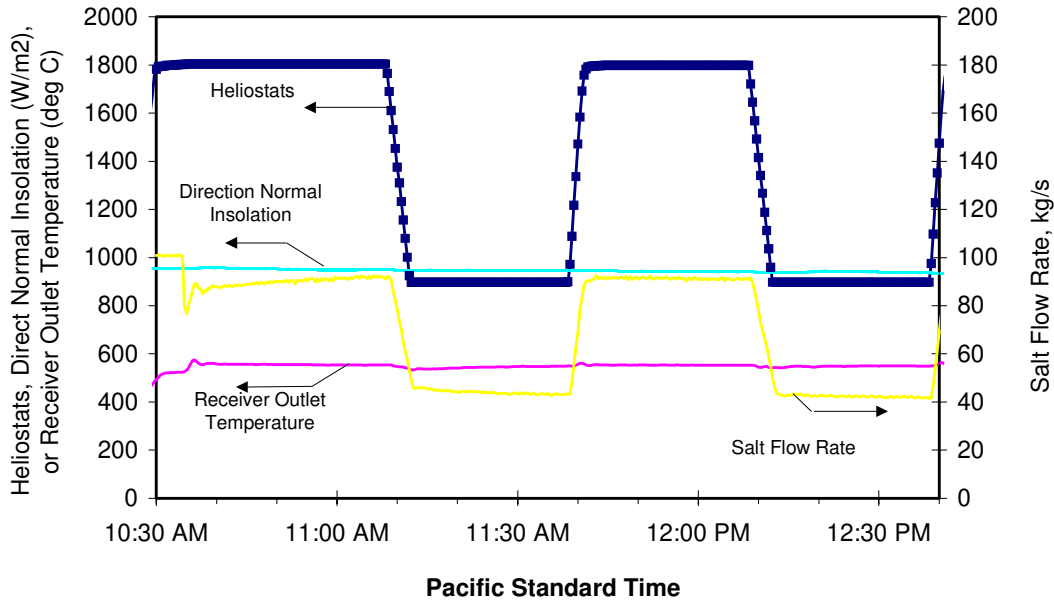
Figure B-2. Heliostats tracking the receiver, receiver outlet temperature, salt flow rate, and direct normal insolation for the receiver efficiency test on October 1, 1997. Solar noon occurred at 11:36 AM PST.

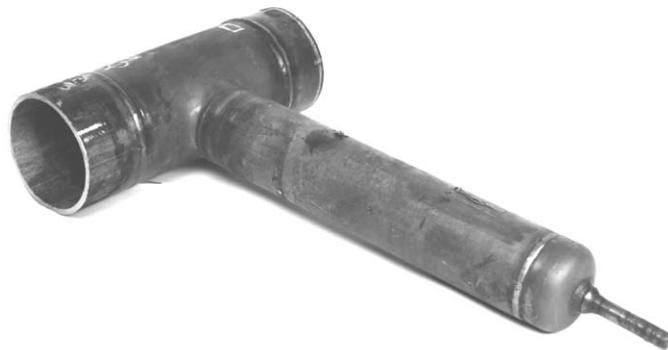
*Figure H-2. Tee-type receiver downcomer chamber Y-251 after removal from service in October 1997.*

inch)-diameter chambers were capped at the bottom and perforated along their length to allow molten salt to circulate freely within them. Corrosion coupons were mounted on a “specimen tree” fixture that was contained within the chamber. Specimen fixtures for the bayonet chambers were similar in design to those used for the tee-type chambers (Y-251 and Y-851), shown in Figure H-2 and described below. Fixtures for the bayonet chambers were suspended from the cover flange by a chain, with chamber length and chain length sized to keep the specimens continuously immersed below the minimum salt operating level.

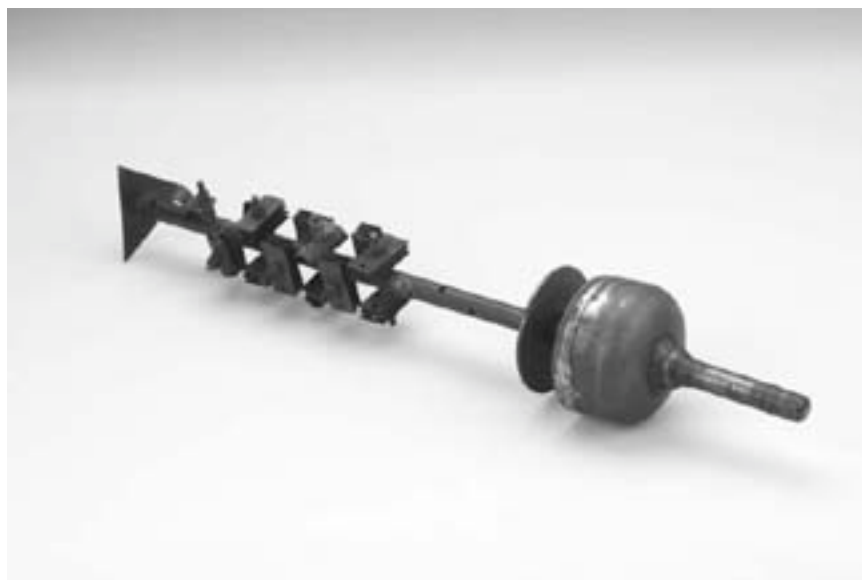
*Figure H-3. Specimen mounting tree after removal from Chamber Y-251, with branches and specimens for first sampling interval already removed from the end of the tree nearest end cap.*

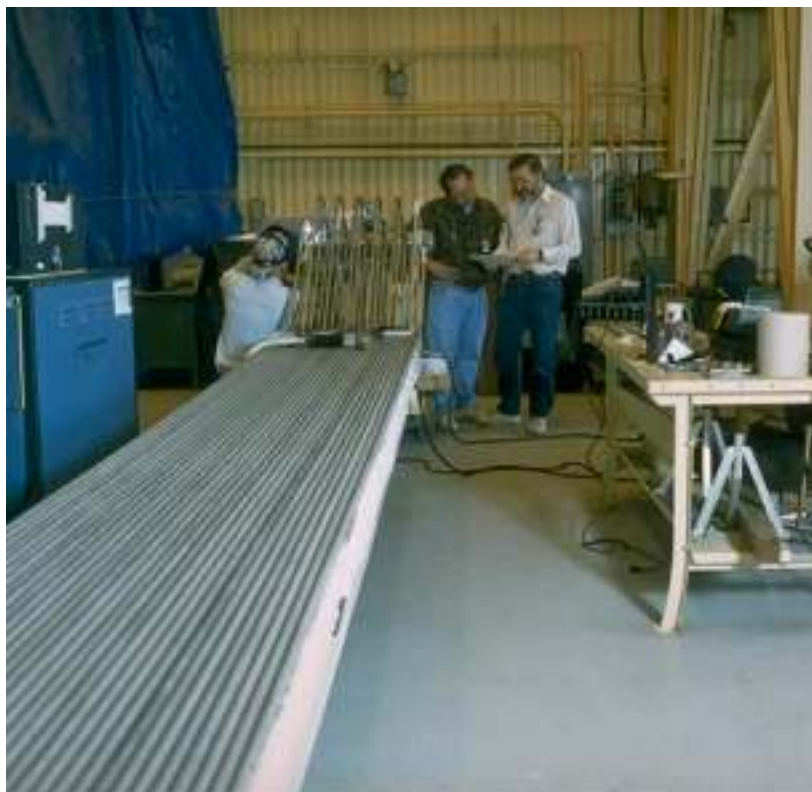
*Figure H-11. Single panel from Solar Two receiver. Individual tubes can be seen in the foreground and the headers are in the background. This is before installation vertically into the receiver.*

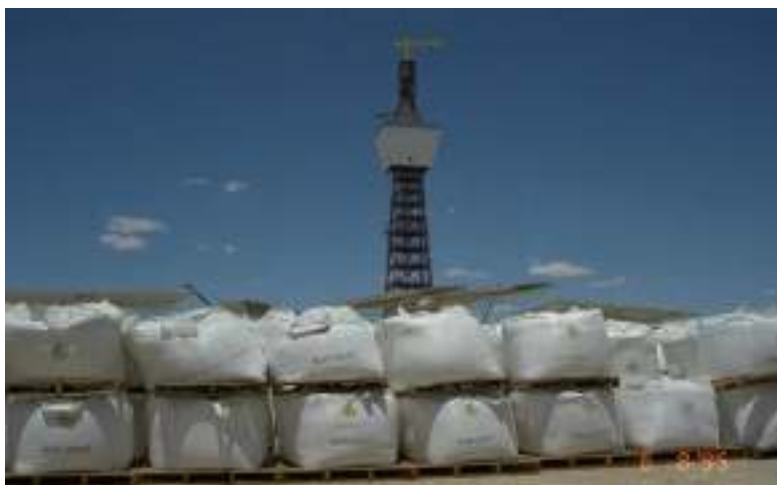
*Figure L-2. 1000 kg bags of nitrate salt awaiting melting at Solar Two. The Solar One tower in the background is being prepared for installation of the new molten salt receiver.*

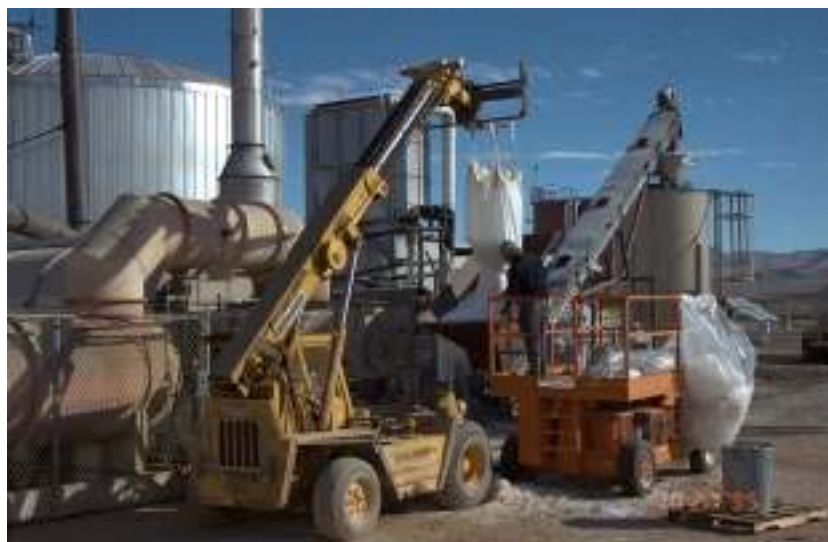
*Figure L-3. The salt handling system crushed the salt and transported it to the melter.*

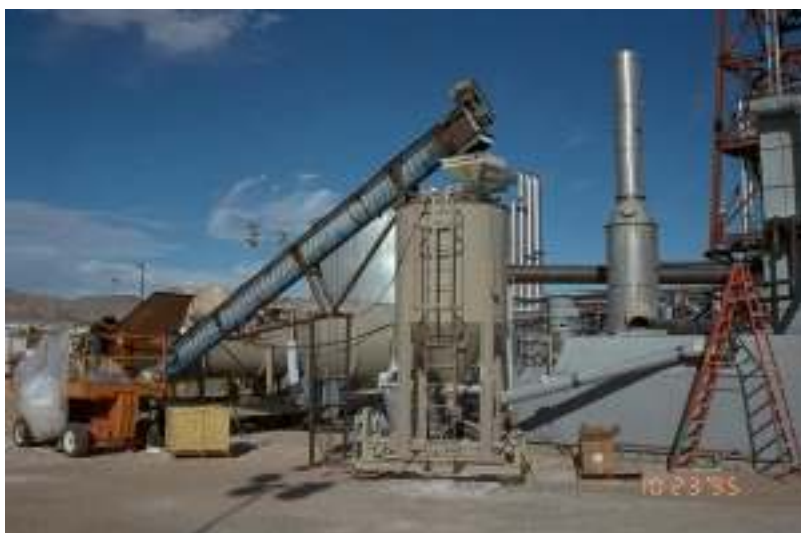
*Figure L-4. Conveyor belt feeding crushed salt from the hammer mill into the salt hopper. The screw auger can be seen as the pipe feeding into the wall next to the ladder. The vent stack to dilute the NO<sub>x</sub> can be seen in the background.*

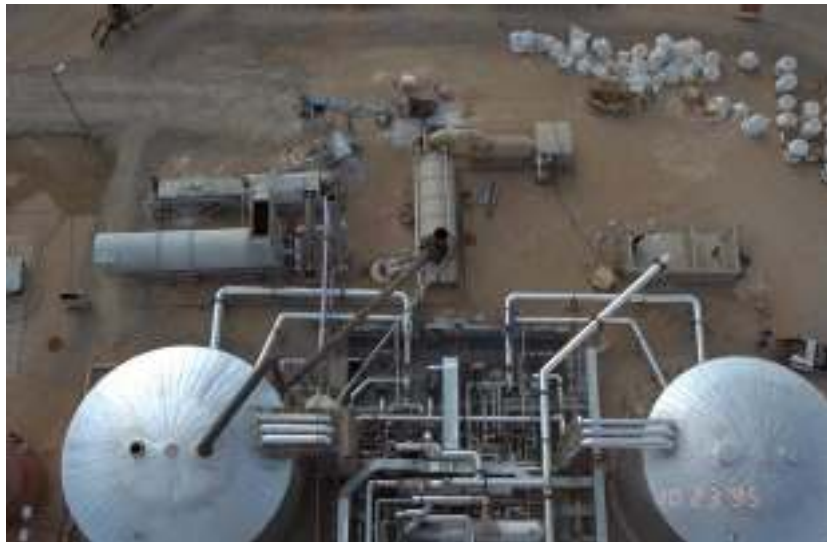
Figure L-5. Overhead view of the salt fill operation; the hot tank is on the left and the cold tank is on the right.

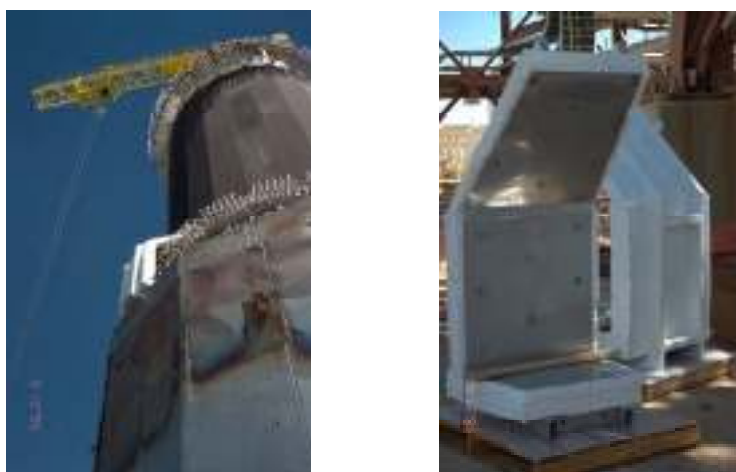
*Figure Q-2. Ovens structures surround the receiver header pipes. Seals must be good for ovens to be effective. Sealing problems often made it difficult to heat up the ovens on the windward side of the receiver.*

On top of the tower, heat trace was applied to all receiver components that could not be heated by the heliostat field. These components included the two internal control tanks, internal piping/valves, and the upper/lower receiver ovens. The ovens heated the unexposed sections of the receiver tubes just above and below the section heated by the heliostat field and the receiver headers. The ovens are box structures that contain heating elements. The elements heated the air space in the box that surrounded the unexposed tubes; the design was similar to ovens used to cook food in the home. In order for the ovens to work efficiently, a good seal must be maintained at the interface between the exposed and unexposed receiver tubes (see Figure Q-2).

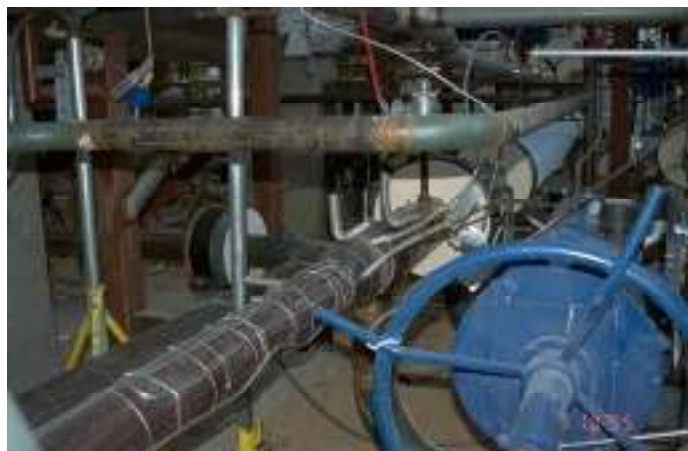
*Figure Q-3. Multiple heat trace cables were applied to pipes that drained nightly to allow a two-hour heatup time the next morning. One or two spare cables were installed as well. A lesson learned was that heat trace must be installed uniformly (i.e. constant value of W/ft); otherwise, hot spots can occur that lead to pipe corrosion. A nonuniform section of heat trace is seen in this photo (see loop back). During the rework of the heat trace system in 1996, nonuniformities were eliminated.*

The total connected load of the 212 heat trace circuits was ~850 kW. If all circuits were actuated all the time, the heat trace parasitics would exceed 20 MWh/day, whereas the goal set during the design phase was less than 2 MWh. To achieve the goal, the Solar Two designers recognized that parasitics would be high if heat trace was not turned off within the receiver system during overnight shutdown. Design features were therefore included to allow for nightly draining of the receiver system, followed by heatup in the morning; thin-walled piping and generous amounts of heat tracing were installed to allow for rapid heatup from ambient to operating temperature in ~2 hours (see Figure Q-3).

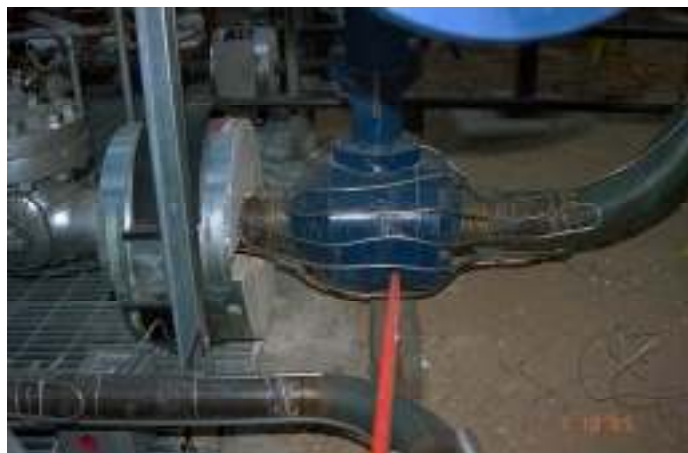
*Figure Q-4. Valves can be kept warm overnight, independently of the surrounding pipe, if a separate heat trace circuit is applied to the valve. This reduces parasitics because the pipe heaters can be turned off at night. In this photo, the same heat trace circuit was applied to the valve and surrounding pipe. During the rework of the heat trace system in 1996, separate valve circuits were installed on valves 4 inches in diameter and bigger.*
