MTL TR 90-54

FORMATION OF CONTROLLED ADIABATIC SHEAR BANDS IN AISI 4340 HIGH STRENGTH STEEL

November 1990

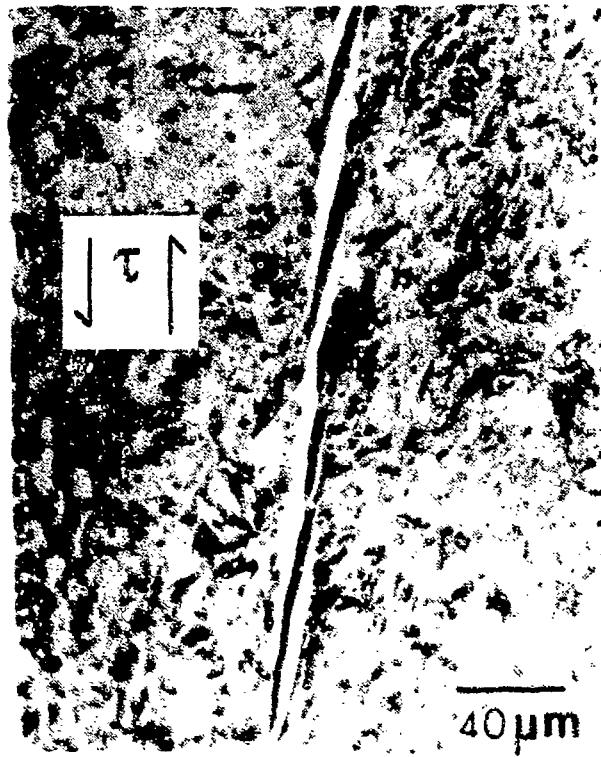
Figure 3. Tension cracks produced in the specimens upon unloading. Original loading direction is noted. Normalized at 325°C.

Some specimens undergoing larger displacements with full shear band deformation often exhibited cracks along the shear bands; these cracks along shear bands are common. Since their orientation with the original imposed shearing direction (see Figure 3) would close the cracks and not open them, it is concluded that the cracks must have formed after the removal of the imposed shear stresses. It is also indicative of the increased hardness usually associated with the shear band material after testing.

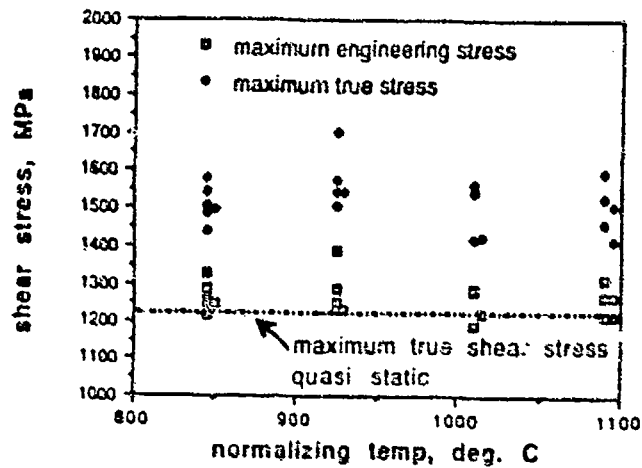
Figure 6. Maximum engineering shear stresses and true stresses versus normalizing temperature. Quasi-static data is from Cowie et al. (see References 1 and 2).

Figure 6 is a plot of the maximum engineering and true stresses reached as a function of normalizing temperature. Virtually no change is apparent as the maximum shear stress attained was independent of the four microstructures tested. The same microstructures were previously studied^{1,2} at low strain rates in pure shear, and here, too, no effect on the instability stress was found. However, significant differences between the microstructures were noted when energy absorption was considered. Figure 7 plots the energy absorbed before instability (E_i) versus normalizing temperature relationship for a strain rate of $\dot{\gamma} = 10^5 \text{ s}^{-1}$, note the energy peak for the 925°C normalizing temperature.
