Invited paper

Fracture of Reinforcing Steels in Concrete Structures Damaged by Alkali-Silica Reaction —Field Survey, Mechanism and Maintenance—

Toyoaki Miyagawa¹, Kaoru Seto², Kazunori Sasaki³, Yasuhiro Mikata⁴, Kazuhiro Kuzume⁵ and Toshikazu Minami⁶

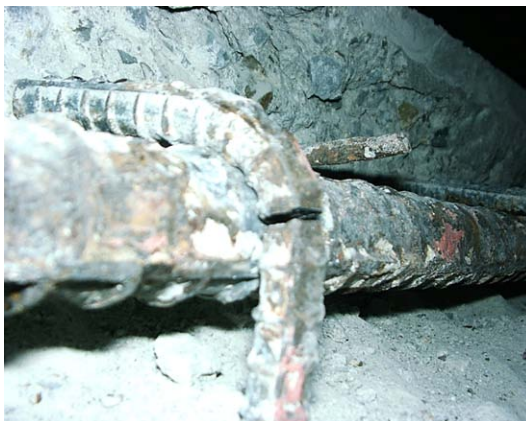
Fig. 3 Example of fractured steel bar.

During an investigation in 1999, the compressive strength of the core specimen was approximately 10 to 15 N/mm² lower than the specified concrete strength, 35 N/mm². Young's modulus of this core was down to about half the usual value of sound concrete. In order to confirm the soundness of the steel bars, chipping inspection of the corner of the beam crown (Fig. 2) was conducted. Fractures were discovered at the bent sections of the stirrups (Fig. 3).

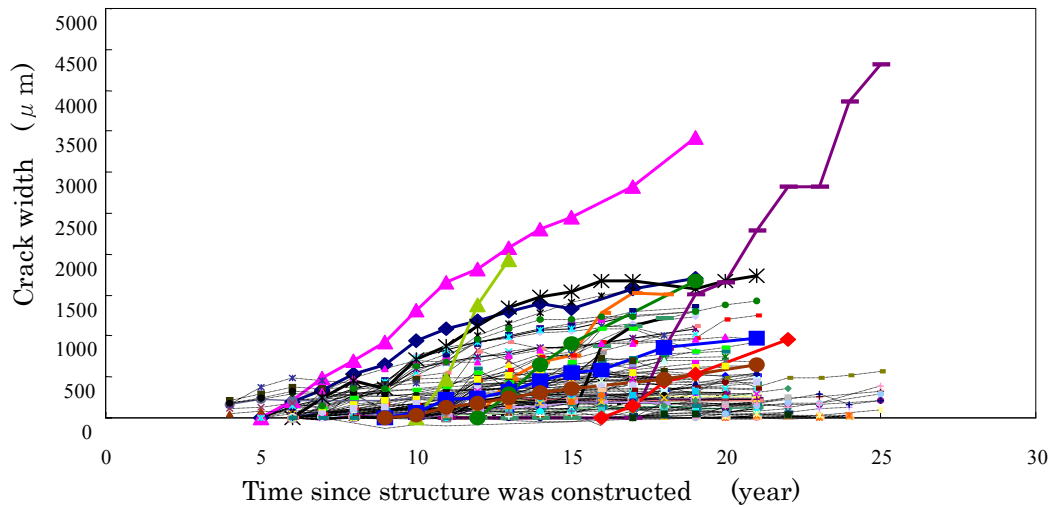
Fig. 4 Example of variations in crack width.

Figure 4 shows the increase in the average width of the specified cracks in the piers over time. Most of the cracks remained about 1 mm in width until about 20 years after the completion of the piers, but some cracks developed to exceed 3 mm in some piers. Still other cracks began suddenly increasing in width at a given time. Figure 5 shows the length expansion at each location. The rate of increase in dimensions differed according to the line of traverse, but continued to increase constantly on the lower surface of the beam, where the rate was the largest.

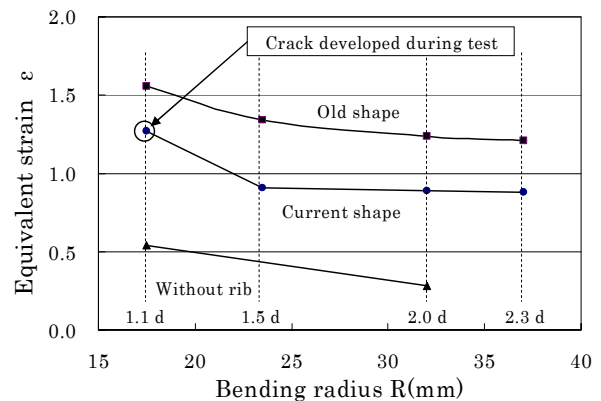
Fig. 14 Relationship between maximum equivalent strain and bending radius.

Since the steel bars were extremely deformed (non-linear) by the bending operation, the amount of strain was evaluated using the value of equivalent strain. **Figure 14** shows the relationship between the maximum equivalent strain and bending radius at the base of a rib.

For steel bars with ribs, the maximum equivalent strain is generated at the base of the rib on the inner surface. For steel bars without ribs, the maximum equivalent strain was on the inside and outside the bent section. The values were 0.54 for the $1.1 d$ radius and 0.28 for the $2.0 d$ radius. The maximum equivalent strain was 1.27 for the current shape steel bar with the bending radius of $1.1 d$. When the radius was more than $1.5 d$, the value was less than 0.91 . According to these bending test results, cracks seemed to develop when the

strain exceeded 0.91 because they were observed only at the bases of the ribs with 1.1 d radius bending.

However, the analytical results may quantitatively show slightly larger values of strain because there is no clearance between the steel bar and the rotating jig of bender as the operation is conducted under an ideal contact condition for the computer model, making it more severe than the actual bending work.

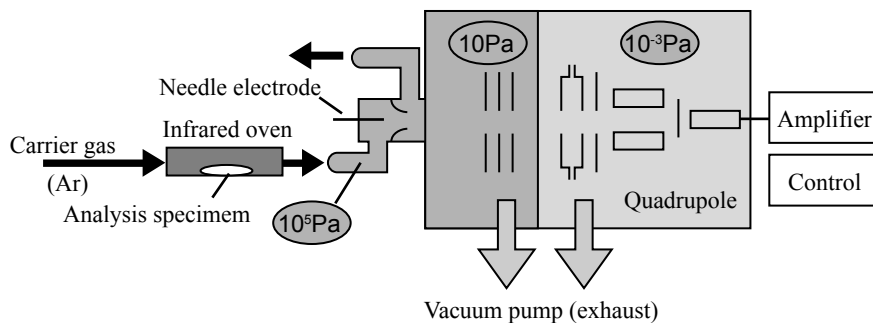
Fig. 18 Layout of API-MS.

Mesurment can be made in atmospheric pressure.
High sensitivity hydrogen analysis (quantitative low limit 0.01 ppm)

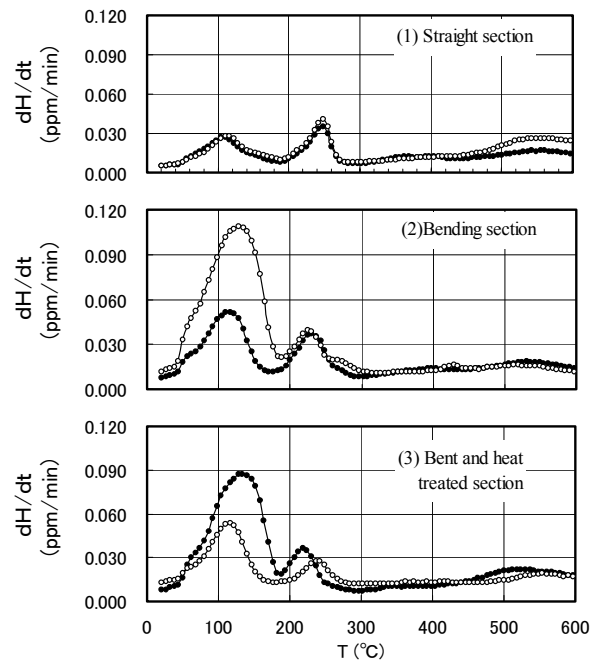
Fig. 19 Results of API-MS measurement.

The results of hydrogen analysis after hydrogen charge treatment of each specimen are shown in Fig. 19. A first peak that shows a discharge peak in the 100 to 200°C range and a second peak that shows a discharge peak in the 200 to 300°C range can be observed independently. In the temperature rising hydrogen analysis, hydrogen having higher stability in steel has been observed as a discharge peak on the high temperature side. Therefore, for the steels with two peaks, the dispersing

hydrogen of the first peak largely influences the hydrogen embrittlement in steel, and the hydrogen of the second peak is believed to be the hydrogen trapped in steel.

Two specimens were tested under same condition.

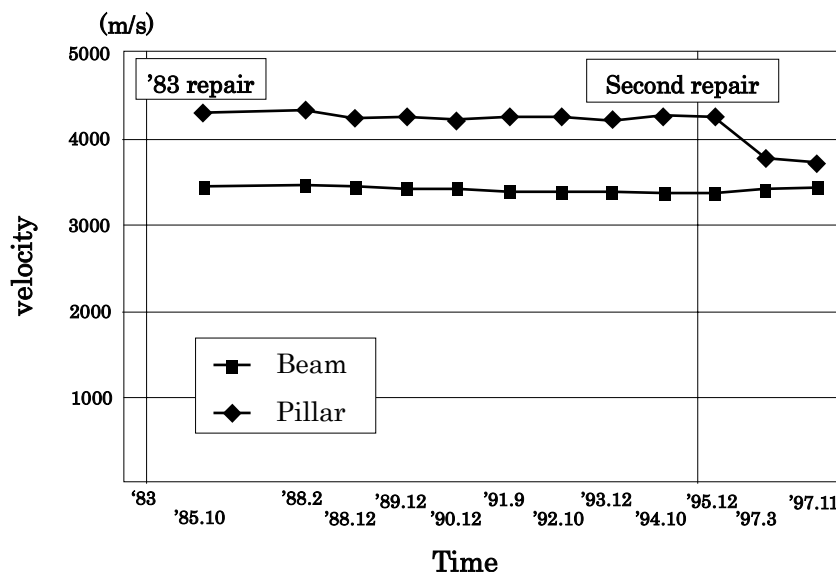
Fig. 22 Example of ultrasonic wave velocity over time.

The Hanshin Expressway Corporation has been monitoring the progress of deterioration due to ASR inside bridge piers by measuring ultrasonic wave velocity since the 1980s. **Figure 22** shows an example of the inspection results (Kojima *et al.* 2000). The ultrasonic wave method was used to obtain data showing progress over time when visual inspection became difficult because the surface was covered with coating.

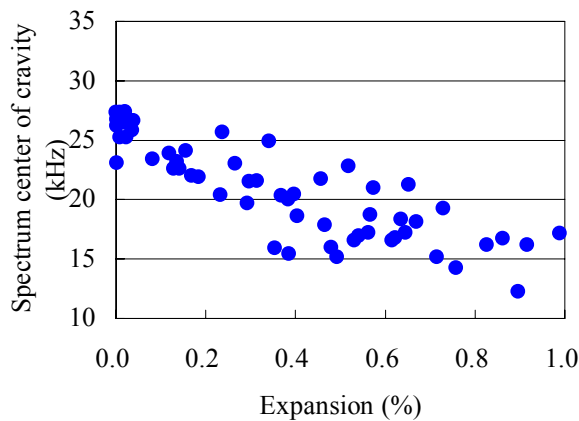
Fig. 23 Relationship between ultrasonic wave spectrum center of gravity and expansion.

information on deterioration due to ASR by focusing on the propagating waveform and energy, rather than just velocity as in the past. **Figure 23** shows the spectrum center of gravity of the obtained waveform, focusing on the ultrasonic propagating waveform. This accelerated test was carried out under the same conditions as described earlier. A decrease in the spectrum center of gravity with increasing expansion of the specimens can be observed.
