This is an author produced version of a paper published in **Journal of Earthquake Engineering**.

Full-scale shaking table tests on a substandard RC building repaired and strengthened with Post-Tensioned Metal Straps

(Short Version: Shake table tests on PTMS-strengthened RC frames)

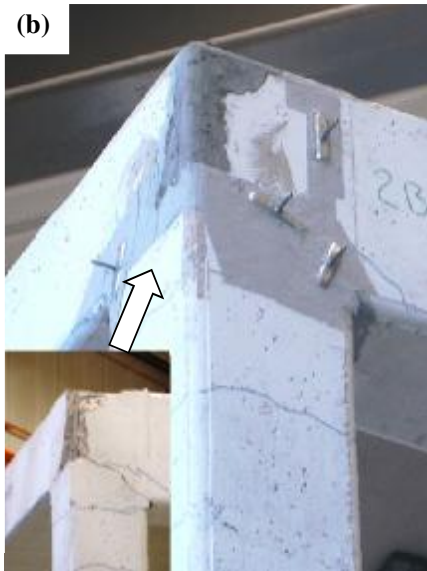
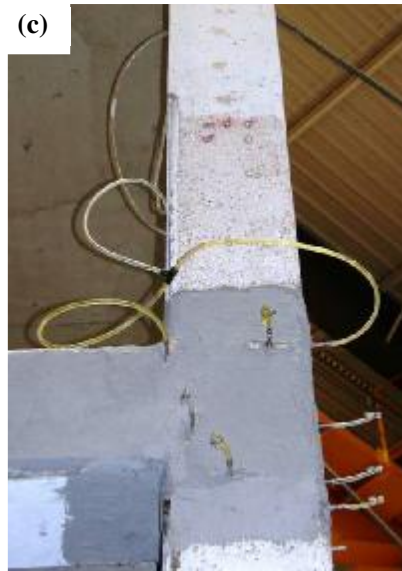
Fig. 9. Repairs after Phase 1: (a) welding of external beam bars to column bars, (b) mortar repair at J2B-2 and injection ports for crack injection, (c) crack injection in progress

b) Replacing damaged and spalled concrete with high-strength repair mortar (Fig. 9(b)), and

c) Injecting cracks with epoxy resin (Fig. 9(c)).

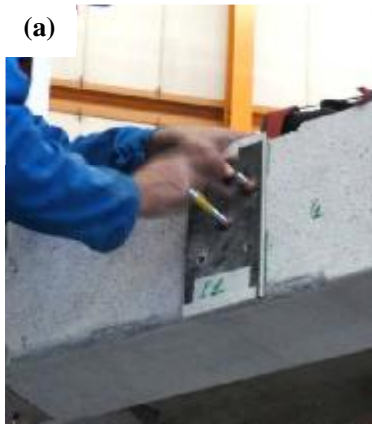
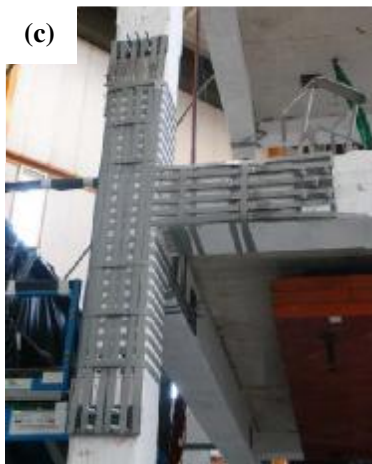
Fig. 11. PTMS strengthening of beam-column joints: (a) fixing of steel plates, (b) additional anchorage plate at interior face of beams, (c) final view of 1st floor joints, (d) final view of 2nd floor joints.
