# *Geographic information systems based demarcation of risk zones: the case of the Limbe Sub-Division – Cameroon*

**Buh Wung Gaston**

GIS/RS Officer

Limbe Botanic Garden, Cameroon

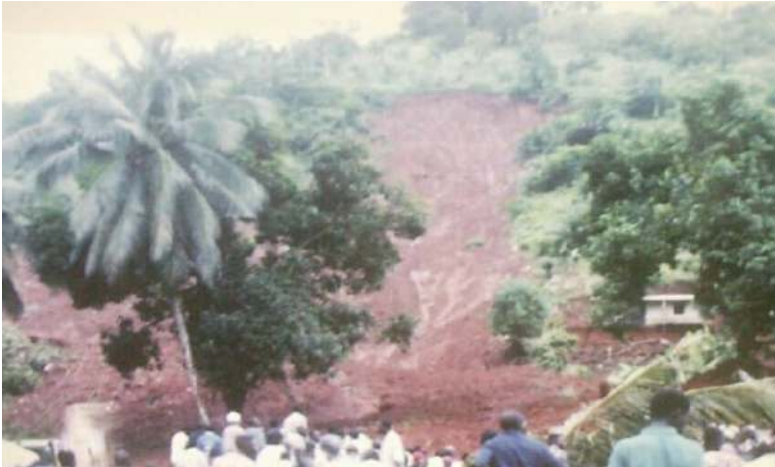
**Photo 1: Mabeta new layout, landslide, 2001**

The Mabeta-1 landslide of June 2001 was the biggest and most disastrous landslide. Over 100,000m<sup>3</sup> of soil turned to mud by rain and ground water was displaced in a quasi North-South direction for some 250m. From the line of surviving houses on the western side of the scarp, it was noted that furthest up-slope houses were located at about 108m altitudes.

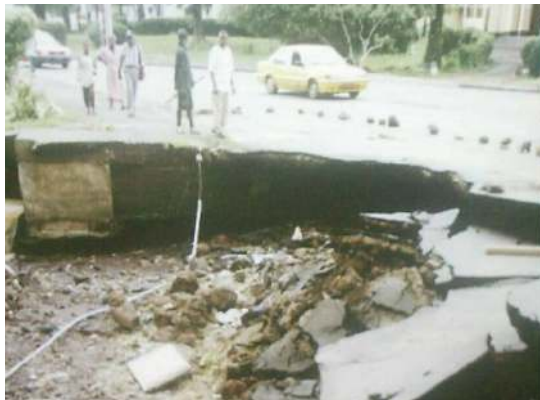
**Photo 2: Flood-effect collapsed portion of tarred road in Limbe**

Further downstream, the riverbanks are now more extensive, the floodwaters have spread out and the width reaches 100m in some places during raining months. Large boulders, some measuring  $1.8 \times 1.3 \times 1$  m torn are brought from the hills, including large tree trunks which dropped because the water current reduced on spreading out in the low-lying flat valley. Though houses are usually destroyed and a lot of property lost. In August 1989, flood caused damage to property but no human casualties were reported (Agingy-personal communication, 2005). Casualties were reported from the floods of June 2001 (At  $40^{\circ} 00.90' N, 90^{\circ} 13.89' E$ ), up stream, where two small landslides occurred near the head of the natural drainage course into a deep narrow ravine carved through the thick soil mantle down to a compact basaltic lava flow. Tar-marked road collapsed at 2 localities at Down Beach Quarters due to the flood. Close to the Provincial office of Public Works at  $40^{\circ} 00.30' N, 90^{\circ} 12.61' E$ , about  $140m^3$  of tar-marked road was broken (Aka, 2001)

Near Mbonjo Beach Inn junction at  $40^{\circ} 00.19' N, 90^{\circ} 12.69' E$ ,  $320m^3$  another portion of the same road collapsed. Concrete power supply poles were destroyed. Seawater wave front positions were observed 40m from the road along which the broken roads occurred. Houses collapsed and casualties were reported during the 2001 incident in several areas in the city of Limbe.
