# Geological and geotechnical characterisation of the Khotila landslide in the Dharchula region, NE Kumaun Himalaya

On 04 October 2016, a severe landslide had occurred in the vicinity of Khotila village in Dharchula, region of NE Kumaun Himalaya. This landslide may be classified as typical rockslide, involving thin veneer of debris on the slope as well as the highly shattered rockmass. The slide has been divided into three morpho-dynamic zones, viz., (i) Zone of detachment between elevation 1000 and 960 m, (ii) Zone of transportation between elevation 960 and 910 m, and (iii) Zone of accumulation between elevation 910 and 870 m. The landslide had occurred at the end of the monsoon season when the slope was completely saturated. It has been noted that the area received ~88% rainfall during the monsoon months which is about two times more rainfall during 2016 monsoon than during 2015 monsoon. Geotechnical testing of the soil overlying the rockmass, corroborate the soil as 'soft soil' with compressive strength of 42 kPa and friction angle of 27.4°. Granulometry confirms the soil as having >97% sand and silt size particles and <3% clay size particles, indicating higher permeability. M

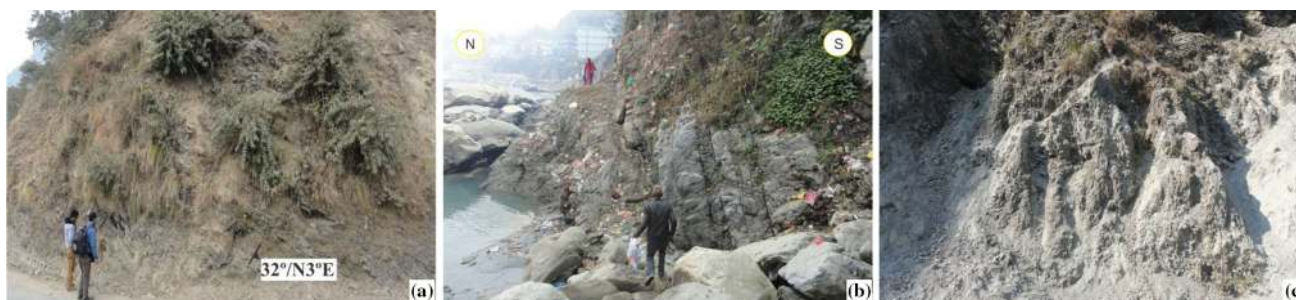
Figure 3. (a) View of the crown portion of the landslide exhibiting thinly foliated slate dipping towards north at moderate angle of  $\sim 30^\circ$ , (b) view of the E–W trending rocks at Dharchula, dipping at steep angle of  $\sim 70^\circ$  towards south and (c) close view of the shear zone located along the Lasku Gad.

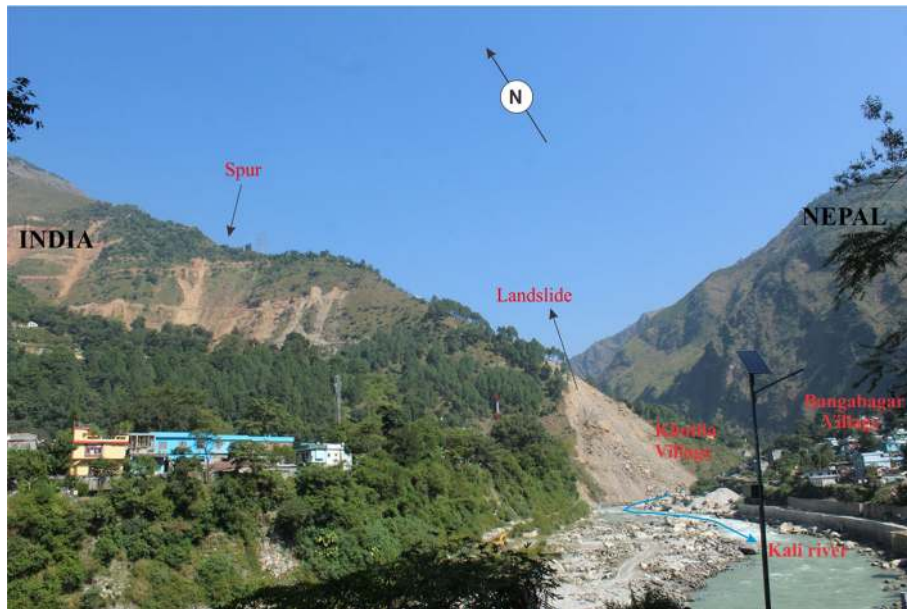
Figure 4. Panoramic view of the Khotila landslide.

The Khotila landslide is a typical rockslide on the southeast facing slope covered with a thin veneer of debris material. The material involved in the sliding process is mostly pebbles and boulders of dolomitic limestone and slates in a mixture of sand–silt–clay along with the thin debris cover lying on the slope. The dominant size of the pebble is 5–10 cm diameter. The scarp of the active landslide is arcuate in shape and is located at an elevation of  $\sim 1000$  m above msl. Its width is

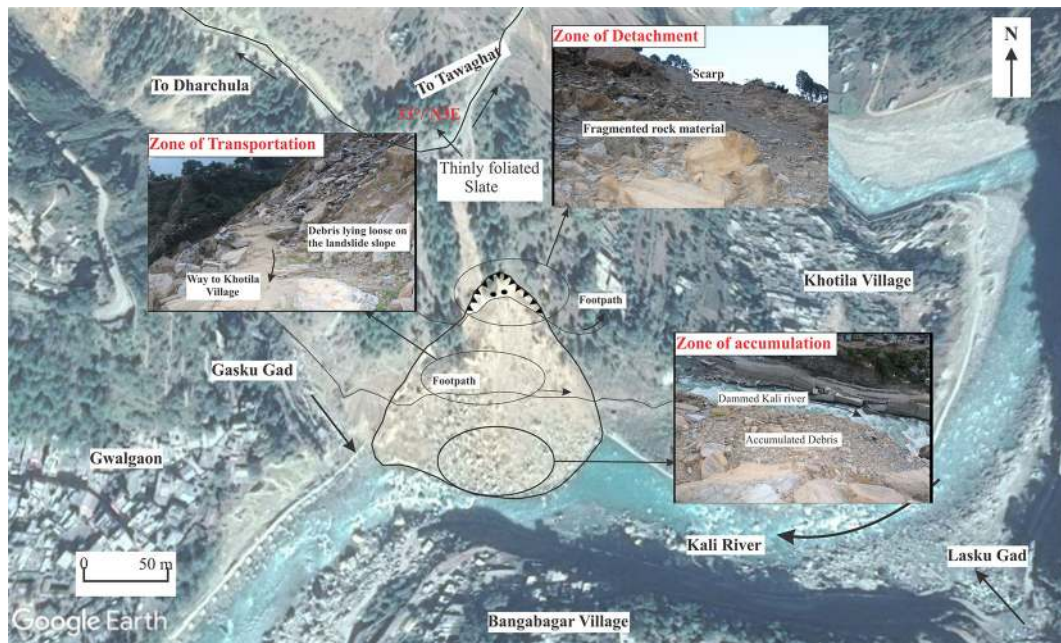
Figure 6. Google Earth image of the Khotila landslide with inset pictures indicating (a) zone of detachment, (b) zone of transportation and (c) zone of accumulation. Black dots represent the location of the soil samples.

about 10 m at the top and progressively increases to ~150 m in the central part of the landslide (figure 6).

main scarp and the active scarp itself. It is spoon shaped and is about 400 m long, 200 m wide and about 20 m deep. Approximately  $1.25 \times 10^6 \text{ m}^3$  of quaternary material has been displaced and has a total potential of about five to six times the already displaced volume. Some of the material is still lying loose on the slope (figure 6). The slope in this zone varies between  $50^\circ$  and  $60^\circ$ .

The zone of transportation lies immediately below the zone of detachment. It transports the detached material from the main scarp into the river below. All along its track, the material is lying loose on the slope (figure 6) that may eventually find its way downslope. It is slightly convex in shape and the slope angle of the transportation track varies between  $50^\circ$  and  $70^\circ$ .

The zone of accumulation is the area where the displaced material has accumulated. This zone lies at the bottom and has partially dammed the Kali river (figure 6). The debris from the debris-filled slope as well as from the fractured bedrock has detached from the crown portion, transported and has finally deposited in this zone. It is also the toe portion of the landslide. This zone is generally concave in shape and extends from 910 to 870 m up to the river bottom.

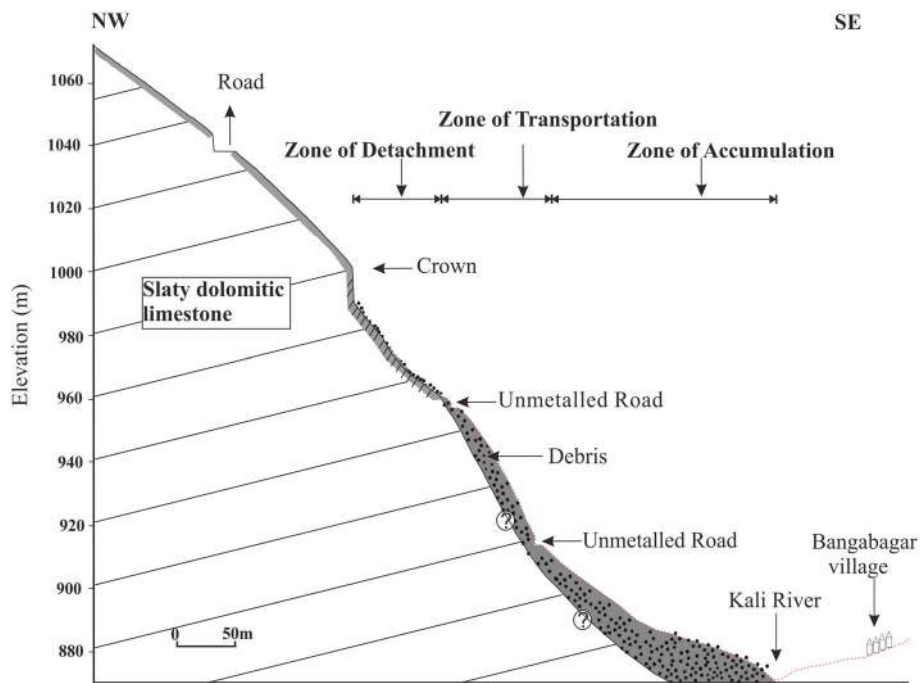
Figure 7. Cross-section of the slope passing through the Khotila landslide depicting (i) zone of detachment, (ii) zone of transportation and (iii) zone of accumulation.

morpho-dynamic zones (figure 7). These are given as follows.

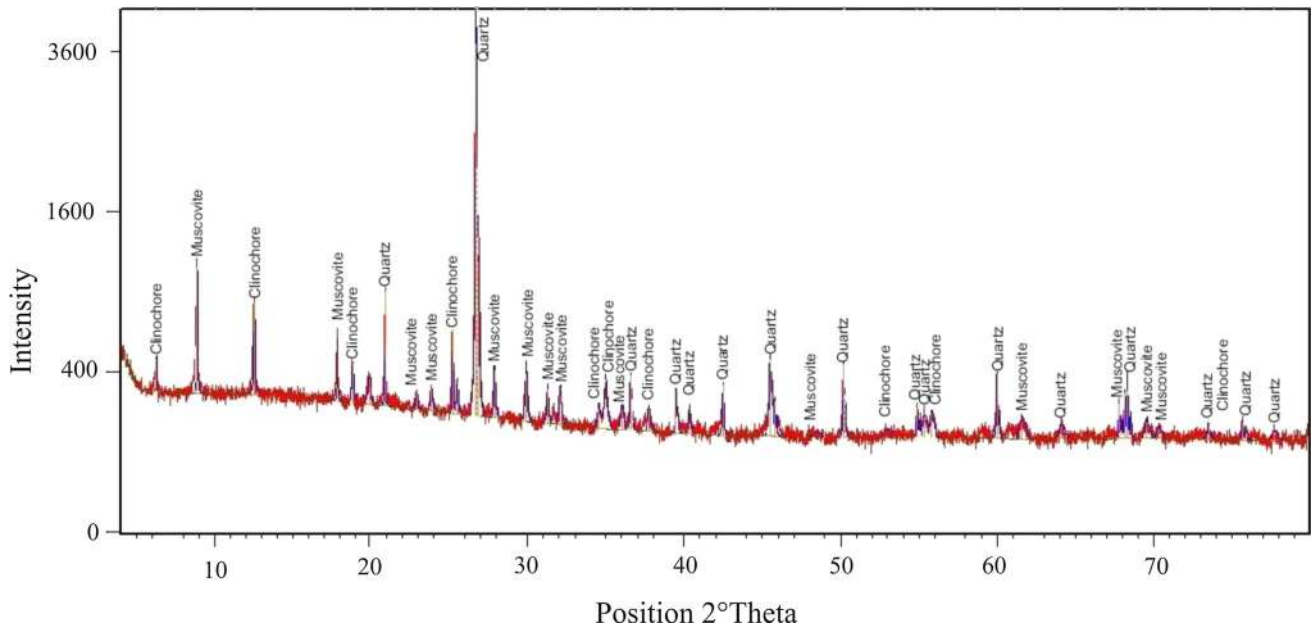
Figure 9. X-ray diffractogram indicating the dominance of quartz, muscovite and clinohore.

In order to characterise the mineralogical and chemical composition of the soil, and also to look for the presence of any swelling clay minerals, XRD and XRF analyses were carried out. XRD of bulk soil sample was carried out using Philip PANalytical XPERT PRO diffractometer. The bulk sample was crushed in the agate mortar and pestle to obtain a fine powder for the slide preparation. The sample slide was scanned at a  $2\theta$  range of  $4^\circ$ – $79^\circ$  with a count of two per step. The XRD data was interpreted using ‘X pert high score plus’ software. The XRD test clearly demonstrates the dominance of quartz, muscovite and clinohore and the absence of any swelling clay minerals, where peaks with the lesser intensity of halloysite, natronite and beidellite are observed (figure 9).

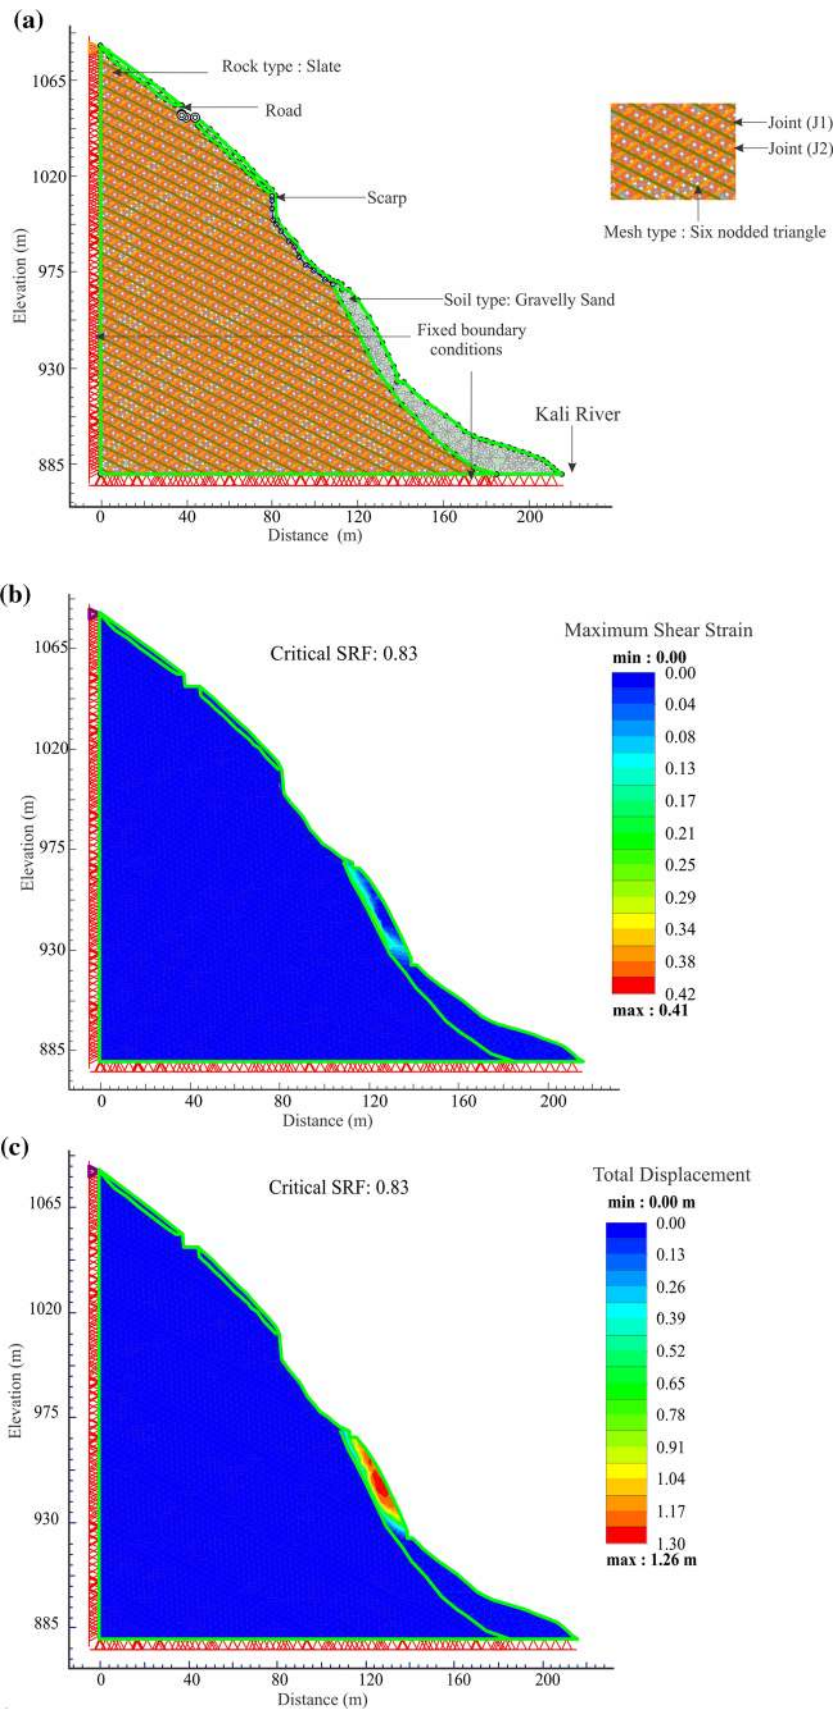
Figure 10. (a) Geometrical setting for the slope of the Khotila landslide, (b) maximum shear strain depicts higher values in the zone of detachment and (c) total displacement (m).

The SSR approach with a tolerance of 0.01 was applied to the model. The slope material was considered as an elastic–plastic substance by keeping the peak values equal to the residual ones (Griffiths and Lane 1999; Gupta *et al.* 2016a). The field load was taken as gravity which defines *in-situ* field stress that varies linearly with the depth in which lithostatic condition is assumed and hence the ratio of vertical to horizontal stress is considered as unity as suggested by Talobre (1967). The results of the FEM analysis on the slope of the Khotila landslide indicate that there is maximum strain and displacement in the zone of transportation sandwiched between two footpaths in the main body of the landslide (figure 10b and c). It is interpreted to be 0.41 and 1.26, respectively, indicating the further probability of the occurrence of a landslide in the future.

Further, the numerical modelling indicates the total displacement ranging between 0 and 1.26 m and shear strain between 0 and 0.41. The maximum value of the shear strain and the total displacement has been noted to be observed below the zone of detachment, strongly indicating its future probability to fail.
