Geomorphic and geologic controls of geohazards induced by Nepal's 2015 Gorkha earthquake

1 Geomorphic, Tectonic, and Geologic Controls of Geohazards Induced 2 by Nepal's 2015 Gorkha Earthquake

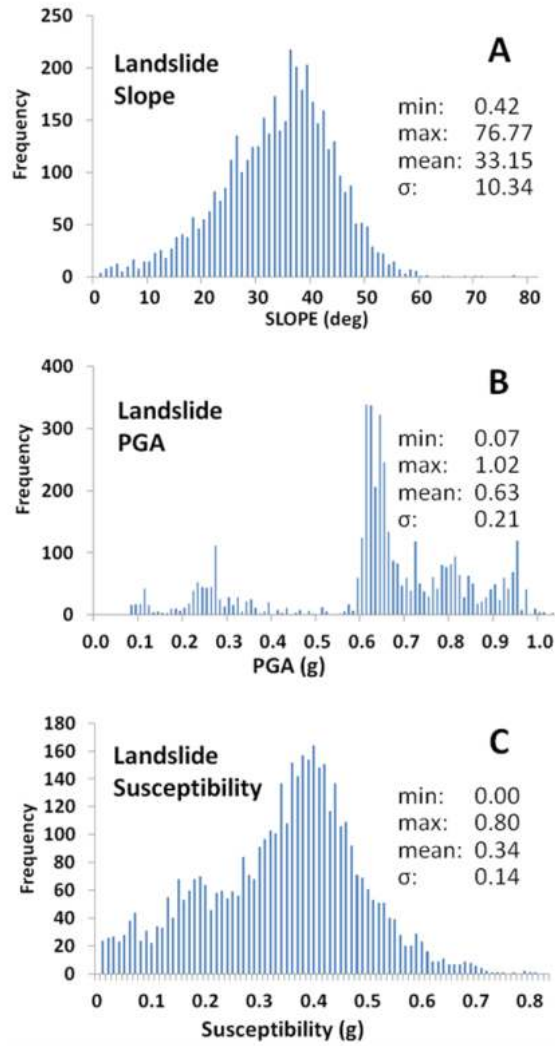
Fig. 3.

204
 205 **Fig. 3. Histograms of landslide occurrences.** Landslides with respect to: (A) slope, (B) peak ground
 206 acceleration, and (C) landslide susceptibility index. All plots $n = 4312$.
 207

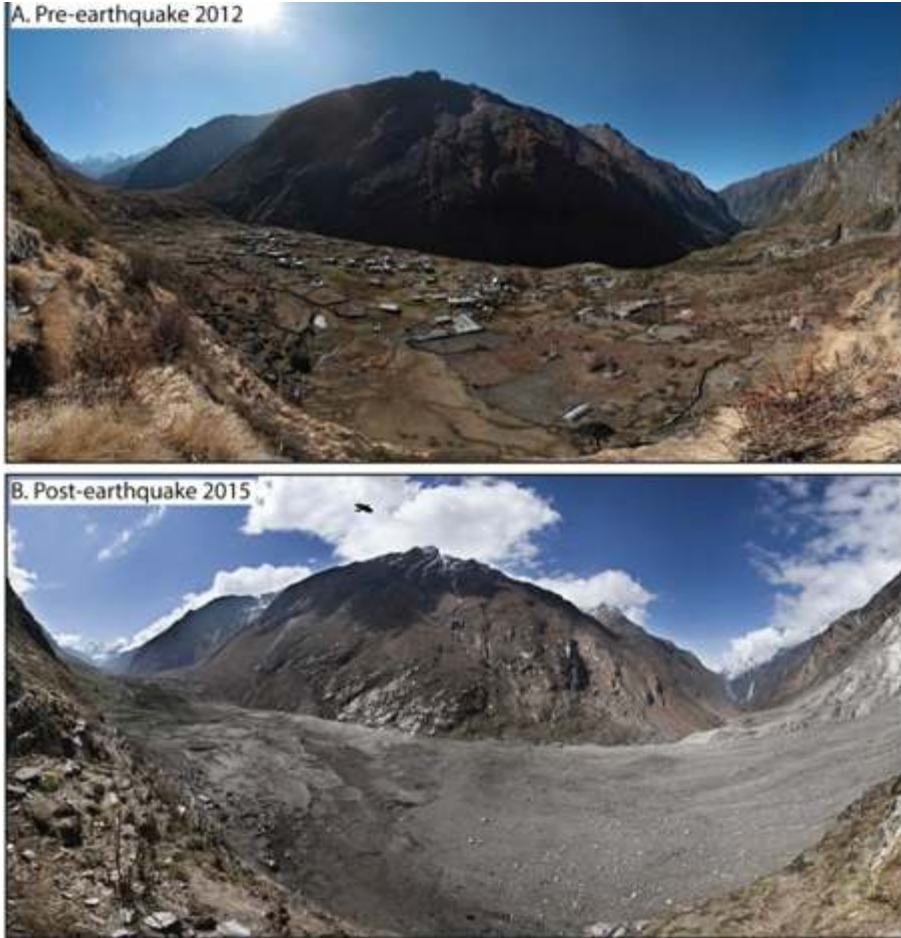
Fig. 6.

380
381 Debris from the initial co-seismic event covered $7.51 \times 10^5 \text{ m}^2$ (Fig. 6) at Langtang
382 alone, including a ~1 km stretch of the Langtang Khola (river). Stream impoundment was
383 not observed in the days following the earthquake, thus indicating that meltwater and
384 runoff tunneling rapidly cut through the icy deposit. Photos (D. Breashears) showed that
385 the deposit contained large amounts of snow and ice. Melting resulted in the formation of
386 ponds, moist debris, and cold surface temperature anomalies of the landslide
387 (temperatures in the 270s K) relative to surrounding terrain (280s-290s K) according to
388 the brightness temperatures derived from thermal band 10 of Landsat 8 on 30 April 2015.
