Geomorphological mapping and geophysical profiling for the evaluation of natural hazards in an alpine catchment

A. C. Seijmonsbergen¹ and L. W. S. de Graaff²

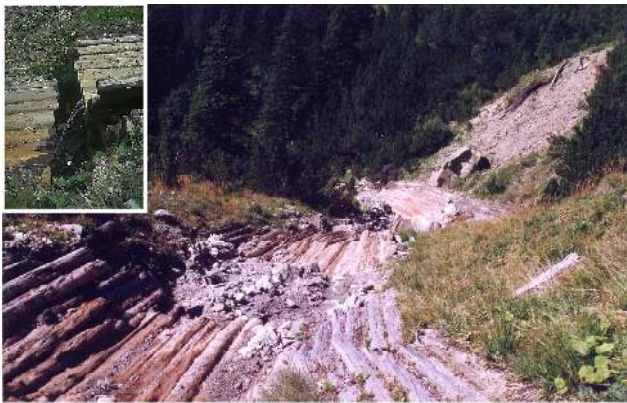
Fig. 2. The wooden drainage system is disrupted by the eroding power of debris flows, by small slides from the adjacent slopes (top right) and by differential movements within the landslide (detail top left), which leads to increased displacements rates.

displacements within the landslide and the erosive forces of debris flows (Fig. 2). The resulting infiltration increased the displacement rates. It was noticed by Wenzel (1985) that the landslide could pose a serious threat to Malbun; in the event of a sudden failure over 500 000 m³ of material could be released. We therefore decided to evaluate the landslides and especially the displacement *pattern and depth* of the landslide in the central part of the catchment (see Fig. 3). The objectives of the study were: 1. to prepare a detailed 1:3000 geomorphological map that shows the spatial distribution of all landforms and processes; 2. to carry out a geophysical analysis over the gypsum underlain landslide, and 3. to present a GIS-supported hazard zonation of debris flows.

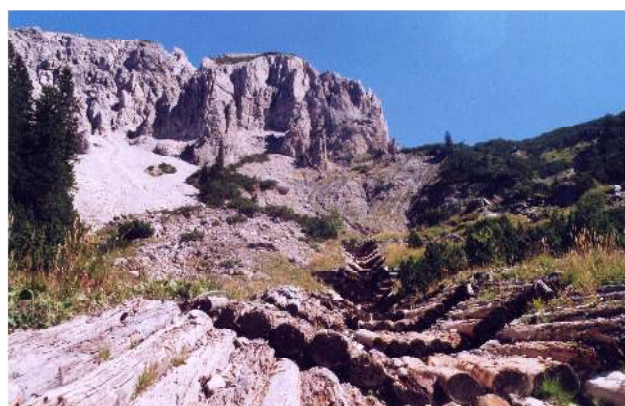
Fig. 4. Upslope view with the steep Hauptdolomite cliffs and associated scree slopes in the upper left part. The central part of the photo shows the major scarp of the gypsum underlain landslide. In the foreground the eroded drainage system is shown.
