## Geotechnical Engineering Aspect Related to Pidie Jaya–Aceh Earthquake Disaster and Mitigation

**Abstract**—Earthquake catastrophe in Pidie Jaya has caused damages to the city of Meureudu, Aceh-Sumatra Indonesia. Based on preliminary study for buildings and infrastructures, the geotechnical engineering aspects damages-related are presented. Seismic motion effect damage of earthquakes such as liquefaction of soil, lateral spreads, and ground failure were the majority effect for infrastructures and buildings. Moreover, failures of almost of multi-storey buildings and mosques along the national road lines are because the effect of peak surface accelerations and earthquake wave propagation forces which are very close with epicenter coordinates 5.308°N / 96.269°E in 4km radius. Seismic back investigates of the Aceh's fault seismic source as well as initial probabilistic seismic hazard analysis post-Pidie Jaya earthquake for city of Mereudu is offered. Liquefaction potential analysis from the estimation of peak ground acceleration was conducted. Geotechnical aspect and substructure failure characteristics to infrastructure and housing damages due earthquake are also reported. The eart

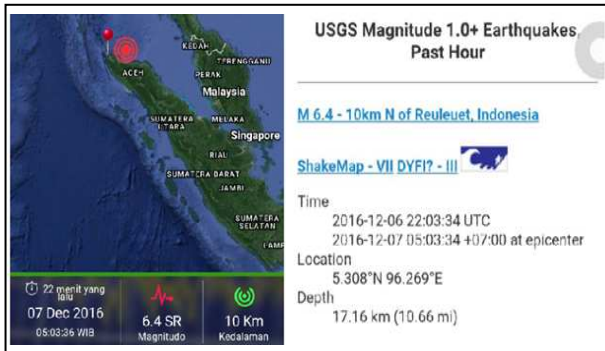
Fig.2 Pidie Jaya Earthquake M.6.4, 26 December 2004 Aceh Province, Sumatra – Indonesia (USGS, 2016).

Pidie Jaya-Aceh Sumatra earthquake has happened on December 7th, 2016. The magnitude of the earthquake was (M=6.4) at hypocenter depth of 10 km beneath the epicenter as shown in Fig. 1. The epicenter of the earthquake is 5.308°N/96.269°E at the railroad, about 4 km west of Mereudu city and 150 km east of Banda Aceh city, the earthquake was of type lateral strike-slip fault mechanism, the earthquake magnitude, and epicenter as shown in Fig. 2.

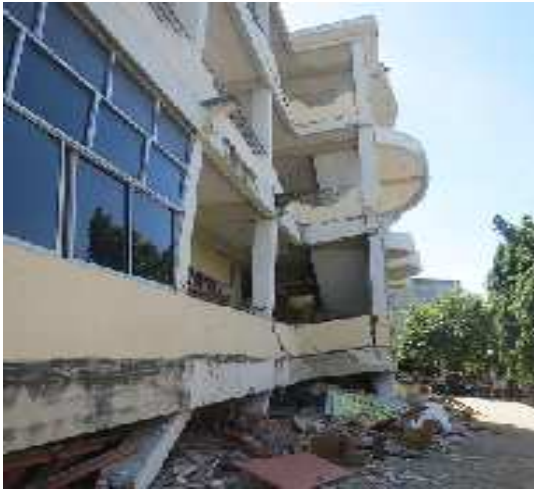
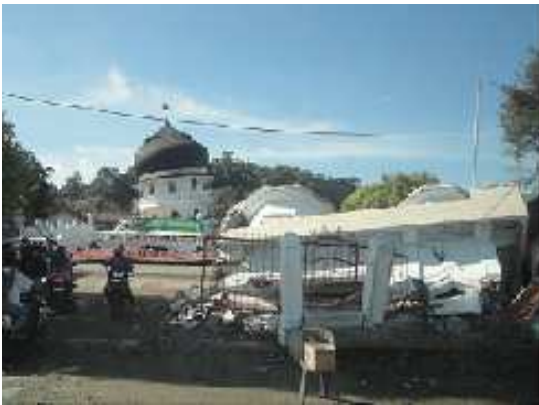
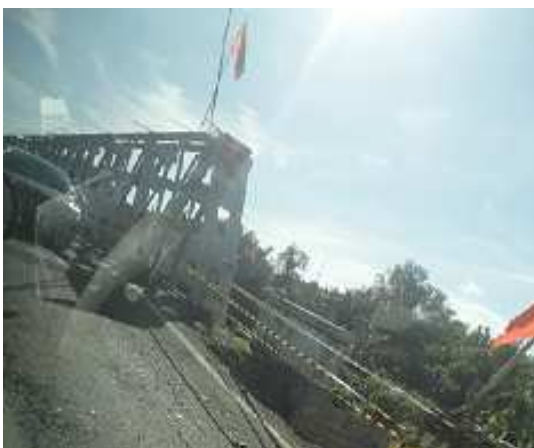
Fig. 5 shown three extreme collapsed; (a) buildings, (b) Mosques and (c) High peak base acceleration bridge abutment with possibly of low seismic amplification. Aceh province west shore is categorized in zone 5 to 6 scale (including the high score) for peak base acceleration (PBA) from 0.3g to 0.4g and nearby 0.25g to 0.3g for Banda Aceh region [2].

Fig. 5 (a) Total building collapse, (b) Mosque collapse and (c) Bridge abutment failure.

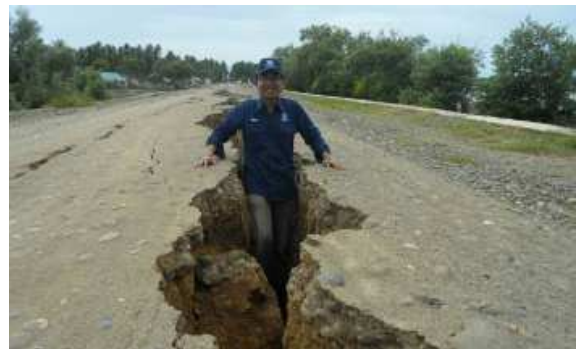
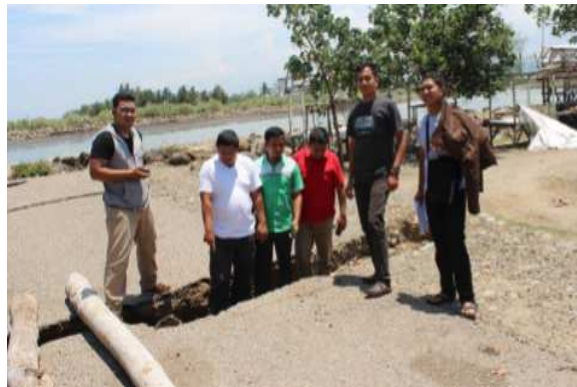
A lot of possible factors related to variation in damages level. One of the factors would be site condition effect of bedrock to ground surface seismic amplification. Fig. 6 displays ground failure of road located along fishpond with the soft ground condition. Research about soil condition and some stabilization method in Aceh [3] and [4] are necessary to conduct to understand deeper the site condition of Aceh soil histories.

Fig. 6 (a) Ground failure of the road (b) located on Manohara fishpond with soft soil ground condition

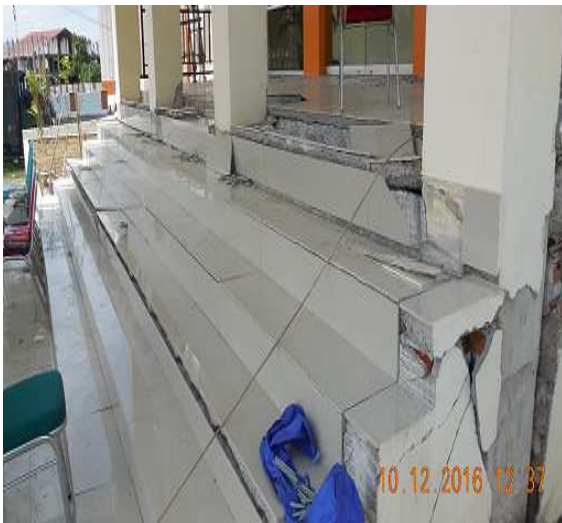
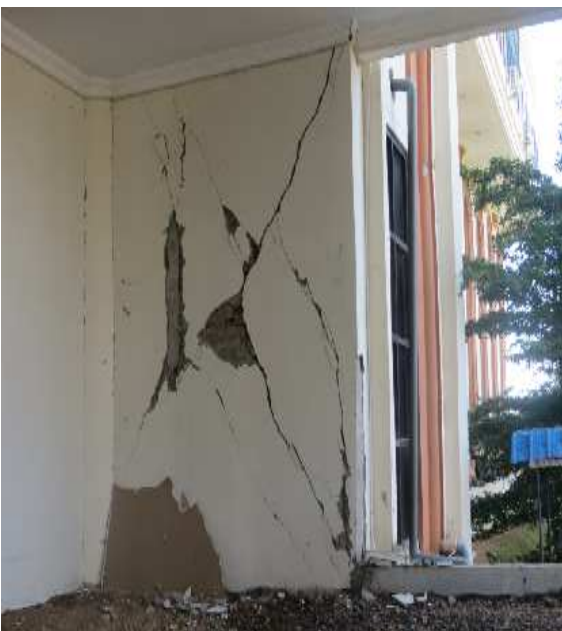
From Fig. Seven it is shown that the settlement of a structure is because of building overturning through ground shaking during the earthquake. The government office of the council for prosecution and Government office of Pidie Jaya district building failures seems because of lack of structural integrity rather than foundation failure and overburden pressure phenomena.

Fig. 7 Settlement caused by building rocking during earthquake ground shaking. (a) Office of the counsel for the prosecution and (b) Government office of Pidie Jaya district.

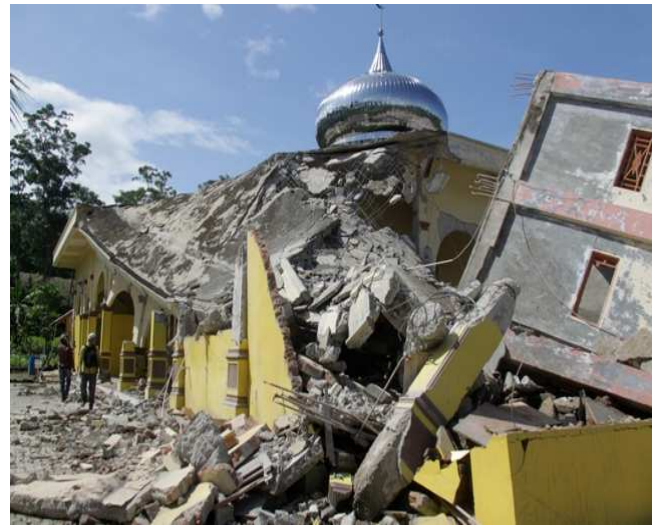
As only limited geotechnical data available, the presence of sandy like soil in a pond area inshore track is estimated. Fig. 8 displays completely collapse of mosques due to ground cyclic movement and resonance between natural soil

frequency and structures frequency during an earthquake. Embankments and foundation failures of bridges and buildings also were predicted due to resonance failures.

Fig. 8 Failures of vulnerable mosque due to high amplification of seismic ground motion inducing foundation failure.

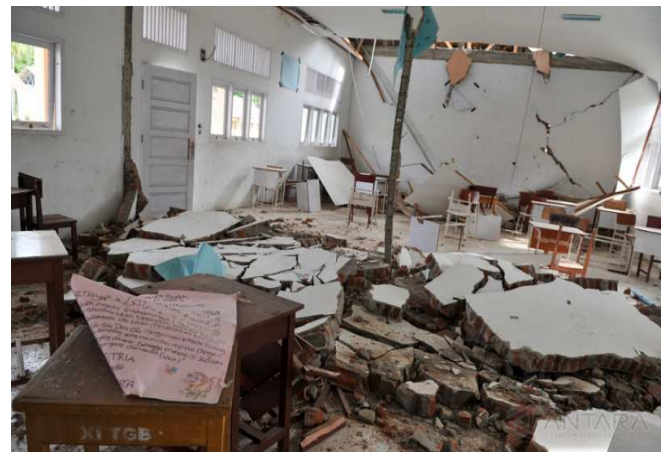
Based on investigations, specific existences of potential liquefaction also ground failure in the area along the shoreline were detected as shown in Fig. 8 and Fig.9. Considering that common conditions of geotechnical data are medium dense with silty sand layers dominate in the soil profile, it seems that liquefaction occurred within the area just after firm earthquake shake with low to medium dense loose silty sand.

Fig. 9 Failures of school due to high amplification of seismic ground motion inducing foundation failure.

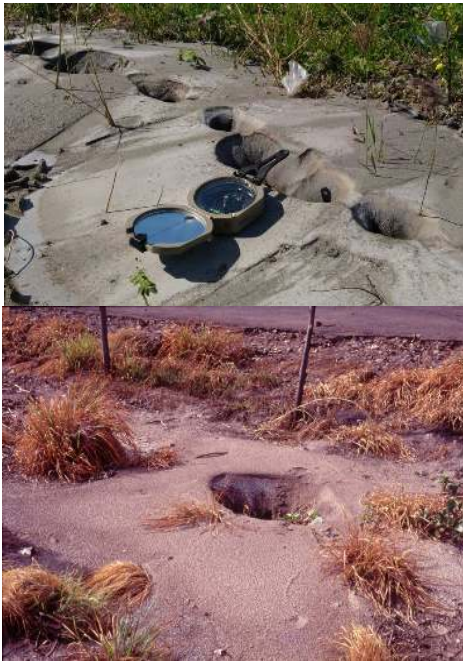
Failures of embankments and bridges seem to be caused by due to poor design. Some several issues associated with variation in damages level. One of it is the effect of soil profile at the seismic local ground condition which increases from bedrock to ground surface beneath structures. The difference in the level of damages is measured vary by buildings vulnerability and the foundations, difference in peak surface acceleration of probable different site condition which might have liquefaction and ground failure, as shown in Fig. 10 and Fig. 11 respectively.

Fig. 10 Liquefaction phenomena at Manohara shorelines Pidie Jaya Aceh earthquake 7th December 2016.

Liquefaction existences were documented in Manohara site as sand boils suggestion liquefaction at west coast along shorelines were also recognized. Most single and multi-storey structures or public community area within 500-6000 m distance from epicenter was destroyed and completely collapse due to foundations failures. For Meureudu city development, strengthen approval for new construction in this area and seismic resistance buildings with the improvement of soil must be implemented, foundation type for solving liquefaction failure must be planned.

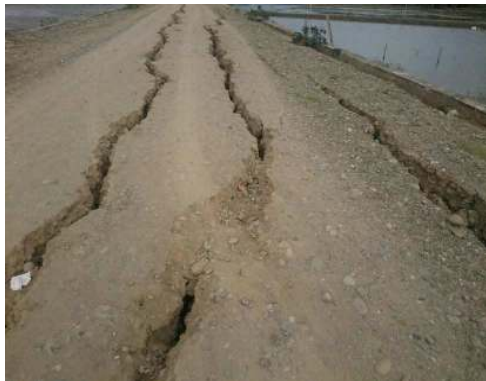
Fig. 11. Ground failure in Manohara-shorelines Pidie Jaya Aceh earthquake 7th December 2016.
