HBIM CHALLENGE AMONG THE PARADIGM OF COMPLEXITY, TOOLS AND PRESERVATION: THE BASILICA DI COLLEMAGGIO 8 YEARS AFTER THE EARTHQUAKE (L'AQUILA)

KEY WORDS: HBIM, NURBS, PARAMETRIC MODEL, LOD, LOG, LOI, FEA, TOOLS, PRESERVATION

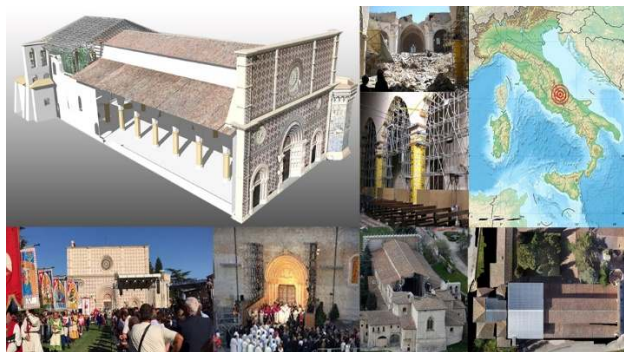
Figure 1. Earthquake damages, the Holy Door during the Jubilee Forgiveness procession, and 3D textured models

On April 6th, 2009 at 3:32 a.m. an Earthquake (Richter Magnitude 5.9) struck L'Aquila (Central Italy): 309 victims, 65000 displaced people. More than 10 billion euro of estimated damage, about 100 churches unusable and uninhabitable for the major collapses, along with thousands of historic buildings in the old town centres. Among them, the Basilica di Collemaggio was significantly stricken: the dome, the transept with the central vaults and triumphal arches collapsed, and great damage occurred to the pillars, to the apses, and to the longitudinal north front with the 'Holy Door'.

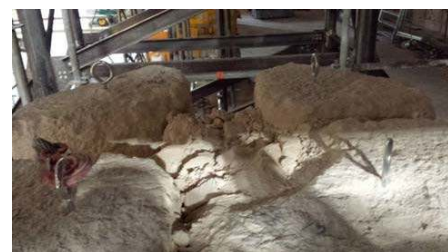
Figure 8. Top images of a pillar during disassembly; in the centre, the irregular mortar core of the column

The first phase of column restoration consisted in the removal of the vertical loads, by progressively inserting temporary metal structures under the two relevant arches (Figure 8).. This operation made it possible to continue with the on-site intervention of stone ashlar replacement or with the complete disassembly of the columns.

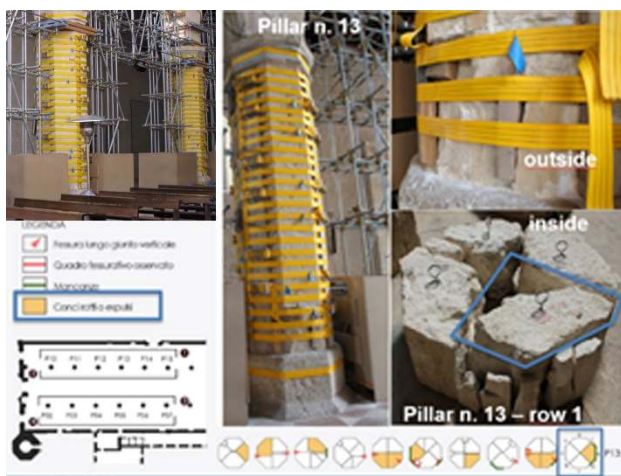
Figure 10. Pillar n. 13. A case of better ashlar stone conservation with respect to the hypothesized state of the art of the inner before disassembly and after reassembly. The external deterioration of the stone, in good condition in the inner part, is evident.

Comparing all the information gathered made it possible to validate the survey method used in the diagnostic phase and the results obtained, both in terms of geometric analysis and of the volume stone to be replaced (approximately 50% of the total volume of the columns). All in all, in fact, a good correspondence was registered between the geometry of the detected blocks and the real ones, albeit with some expected, and in some cases also important, differences. The major differences are linked to the failed detection of the broken stone elements in the inner part, along with fracture lines not visible from the outside, or covered by temporary wooden structures. As assumed in the diagnostic phase, the substantially limited thickness of the patch stone elements, mostly due to restoration work performed by the Superintendent Moretti in the 1970s, was recorded. In fact, the restoration phase gave back a multiplicity of thicknesses. In the case of Pillar n. 12 the disassembly of the central columns of the nave has shown a big difference between the shapes of the core of each row, depending on the stone ashlar dimension and disposition (Figure 10).

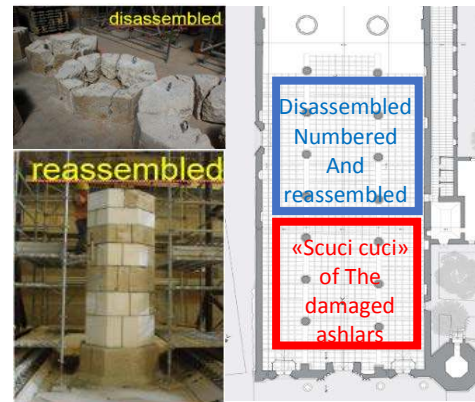
Figure 11. The two different conservation activities planned on the pillars in the design project: global disassembly & reassembly of the stone ashlars with approximately 50% of the stone volume saved and 50% replaced (red); «scuci cuci» proposal with punctual replacement of the single damaged stone ashlars (blue)

“incoherent mortar”, poor in aggregates, similar to the mortar analysed in pillar n. 6 during the diagnostic phase. Throughout the restoration activities, it was possible to recover some stone elements, in some cases using metal connections or paste, which was considered seriously damaged in the diagnostic step; in that case, their external condition did not reflect the inner one. Therefore it was possible to recover them (Figure 11).
