NASA Contractor Report 189120  
MTI Report 91TR56

# Heat Pipe Fatigue Test Specimen Metallurgical Evaluation

Steven E. Walak and Michael J. Cronin  
*Mechanical Technology Incorporated*  
*Latham, New York*

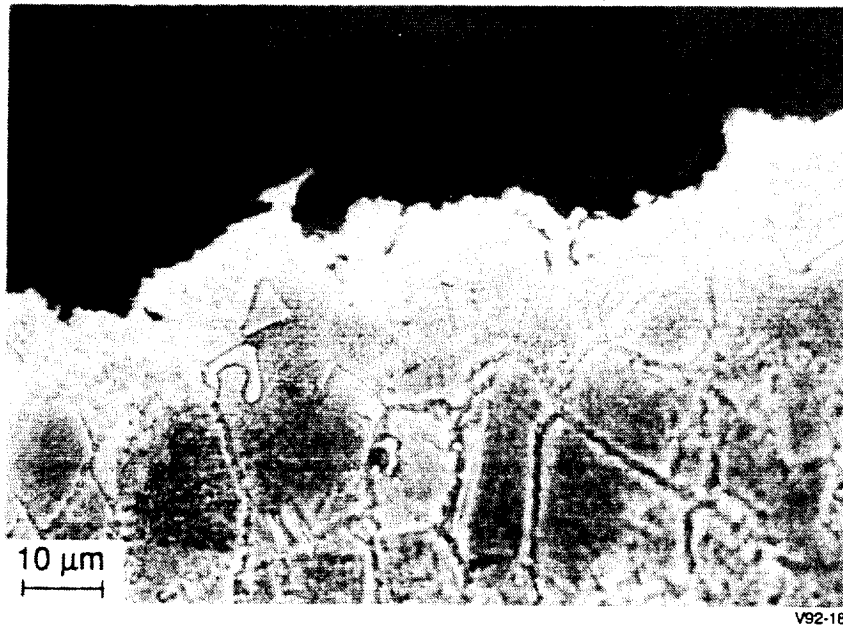
Figure 14. Optical Micrograph of Fine Surface Pitting on Heat Pipe Wall at Evaporator Base

Scanning electron microscopy was used to examine the heat pipe wall for evidence of surface corrosion. Fine surface pits, <1.5  $\mu\text{m}$  (60  $\mu\text{in.}$ ) in diameter, were observed at the evaporator base to a height of approximately 25.4 mm (1.0 in.) (see Figure 13). The pitted region corresponded with the region of the wick that was coated with the vanadium-containing deposits. Exposure to excess sodium liquid accumulated at the base of the evaporator appears to be the reason for the surface changes observed in this region. The maximum depth of the fine surface pits was <10  $\mu\text{m}$  (400  $\mu\text{in.}$ ) as revealed by metallographic sections (Figure 14). The intensity of pitting gradually decreased at distances greater than 25.4 mm (1.0 in.) from the evaporator base and no fine surface pits were observed above approximately 51 mm (2 in.) (Figure 15).

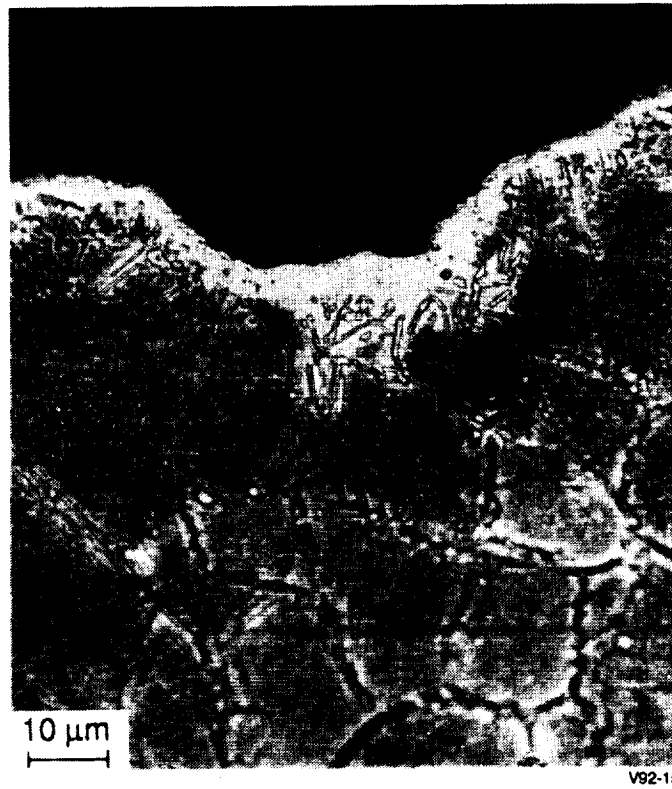
Figure 18. Optical Micrograph of Inconel 718 Surface Layer (White) in Condenser

A surface layer, appearing white in etched metallographic sections, was observed on all heat pipe surfaces exposed to sodium during testing (Figure 18). The layer is thought to result from a change in base metal surface chemistry due to interaction with the high-temperature sodium metal. The thickness of the layer was approximately 15 to 25  $\mu\text{m}$  (600 to 1000  $\mu\text{in.}$ ) in the evaporator and 5 to 10  $\mu\text{m}$  (200 to 400  $\mu\text{in.}$ ) in the condenser.

- The thickness of the white etching surface layer observed in the sodium-exposed Inconel 718 was approximately 15 to 25  $\mu\text{m}$  (600 to 1000  $\mu\text{in.}$ ) in the evaporator and 5 to 10  $\mu\text{m}$  (200 to 400  $\mu\text{in.}$ ) in the condenser. Removal of material through mass transfer is thought to be the cause for the thinner layer in the condenser. This observation also supports the theory of mass transfer in the heat pipe system.
