AEC Research and Development Report

AI-AEC-12670
METALS, CERAMICS,
AND MATERIALS

HELIUM EMBRITTLEMENT
OF
TYPE 316 STAINLESS STEEL

CONTRACT: AT(04-3)-701
ISSUED: APRIL 30, 1968

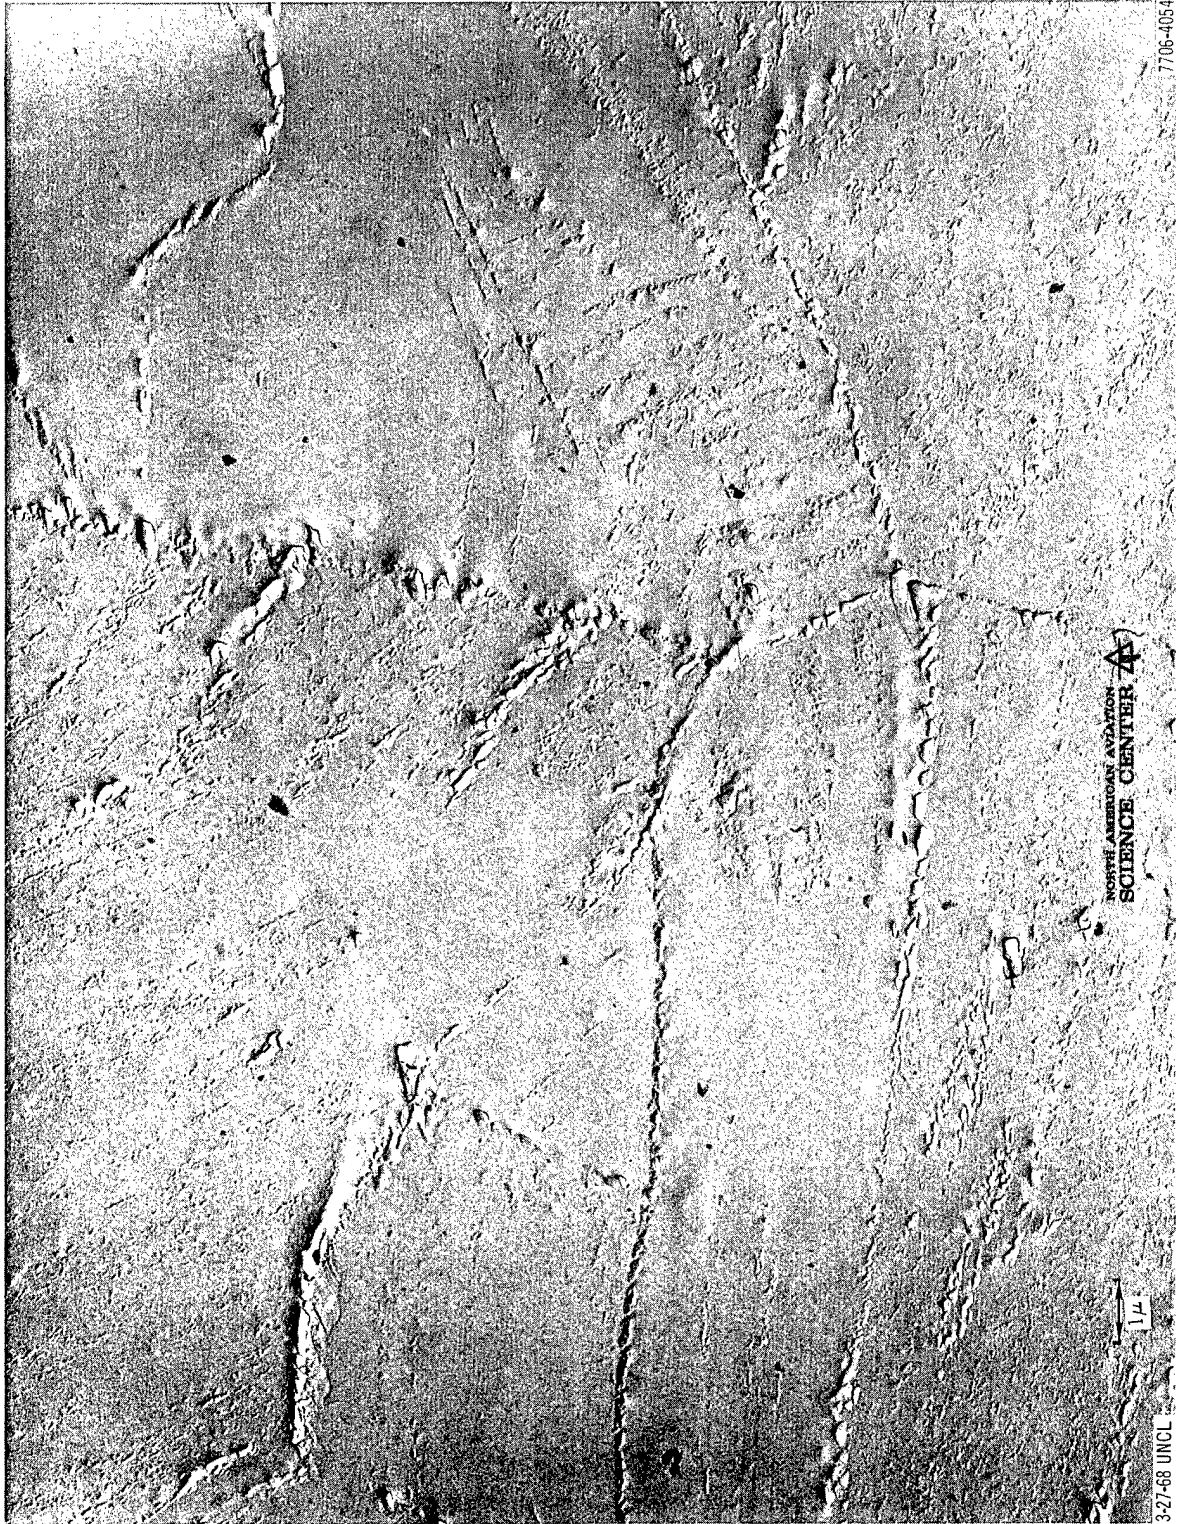
Figure 2. Replica Electron Micrograph of Type 316 Stainless Steel After Treatment 13, Showing Precipitates on Grain Boundaries and Within the Grains

Precipitation occurred from the cold-worked state during Treatment 13. Favored sites for the precipitates were slip bands, deformation bands, and grain boundaries. Electron diffraction of thin foils revealed two kinds of precipitates, $M_{23}C_6$ and σ . The majority of the grain boundary precipitates are carbides but some σ is also present. The precipitates within grains on slip bands and in deformation bands are σ . Epsilon martensite is also present to some extent. The appearance of the precipitates is shown in Figure 2. Their size lies between 500 and 3000\AA and they are present at a density of about 10^{13} cm^{-3} . Figure 3 shows the σ -phase particles within a grain.

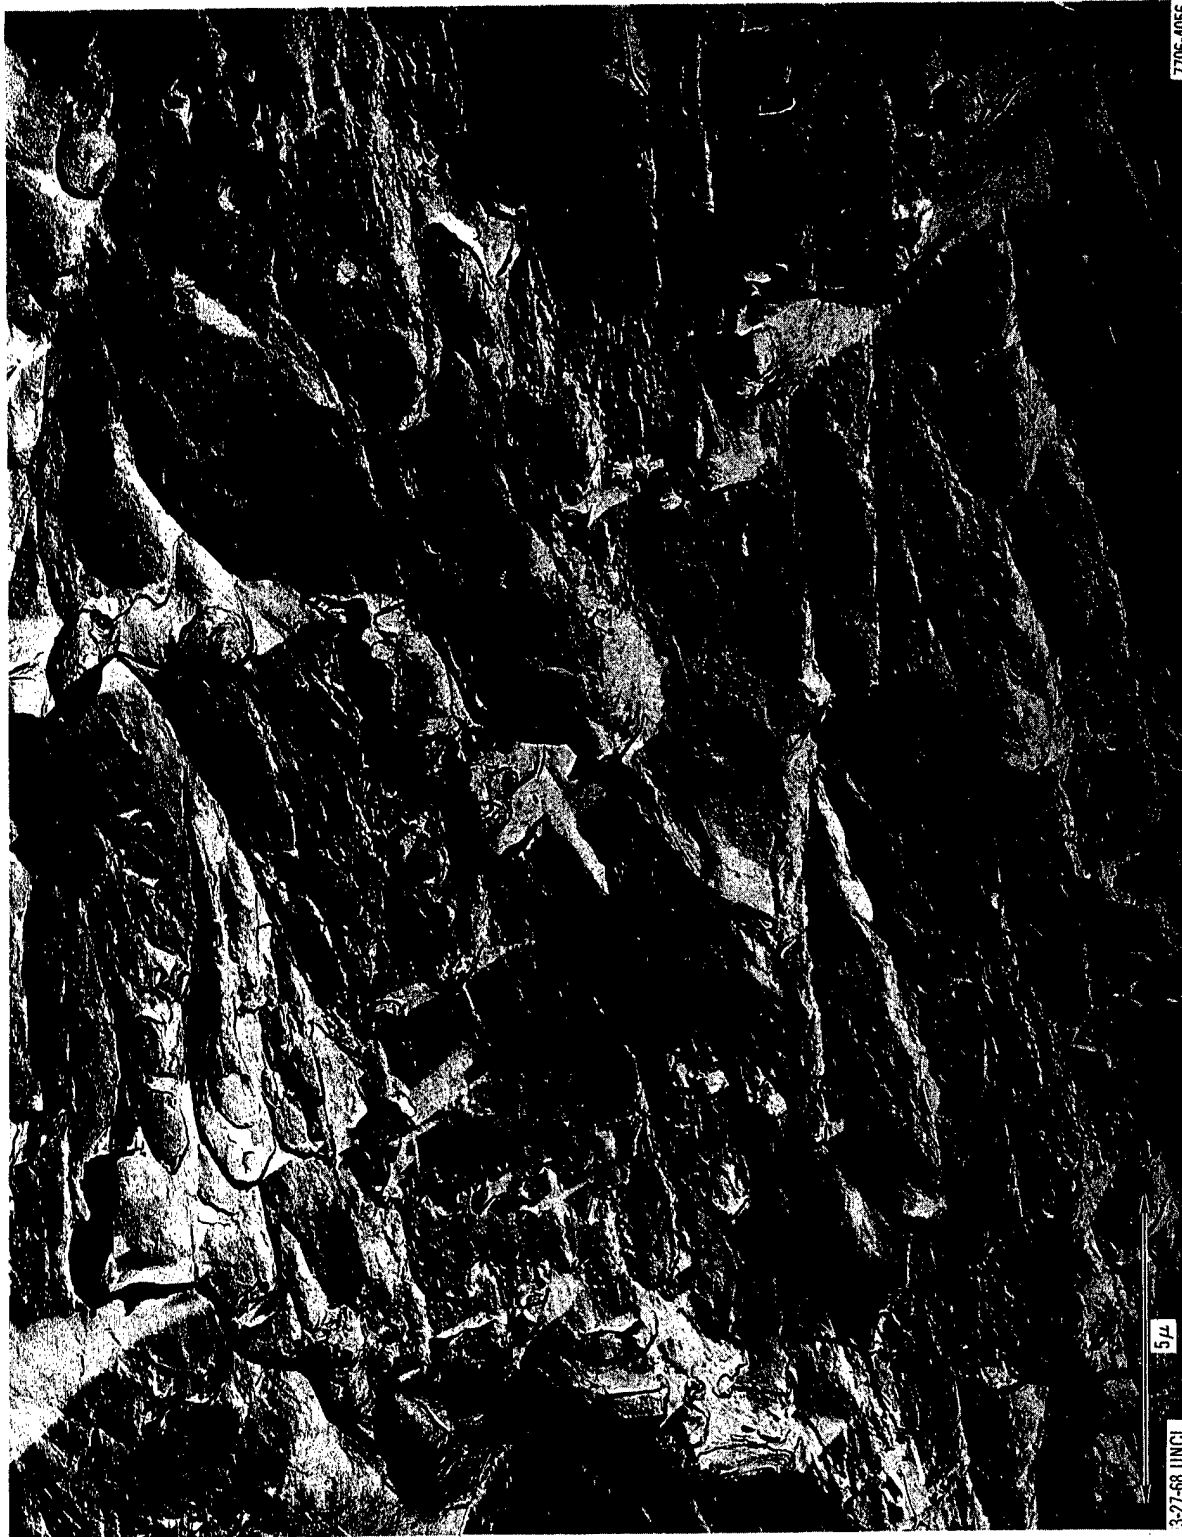
Figure 5. Fractograph of Type 316 Stainless Steel Without Helium
Tested at 540°C, Showing Shear-Rupture Dimples

At 540°C all samples given either treatment with or without He failed transgranularly. The mechanism of shear-rupture was operating as evidenced by the shear-rupture dimples in Figure 5 which typifies all fractographs of samples tested at this temperature. The mode of failure of samples given Treatment 13 with or without He, and of samples given Treatment 6 without He was transgranular at 650°C. However, samples given Treatment 6 with He showed a mixture of transgranular and intergranular failure.

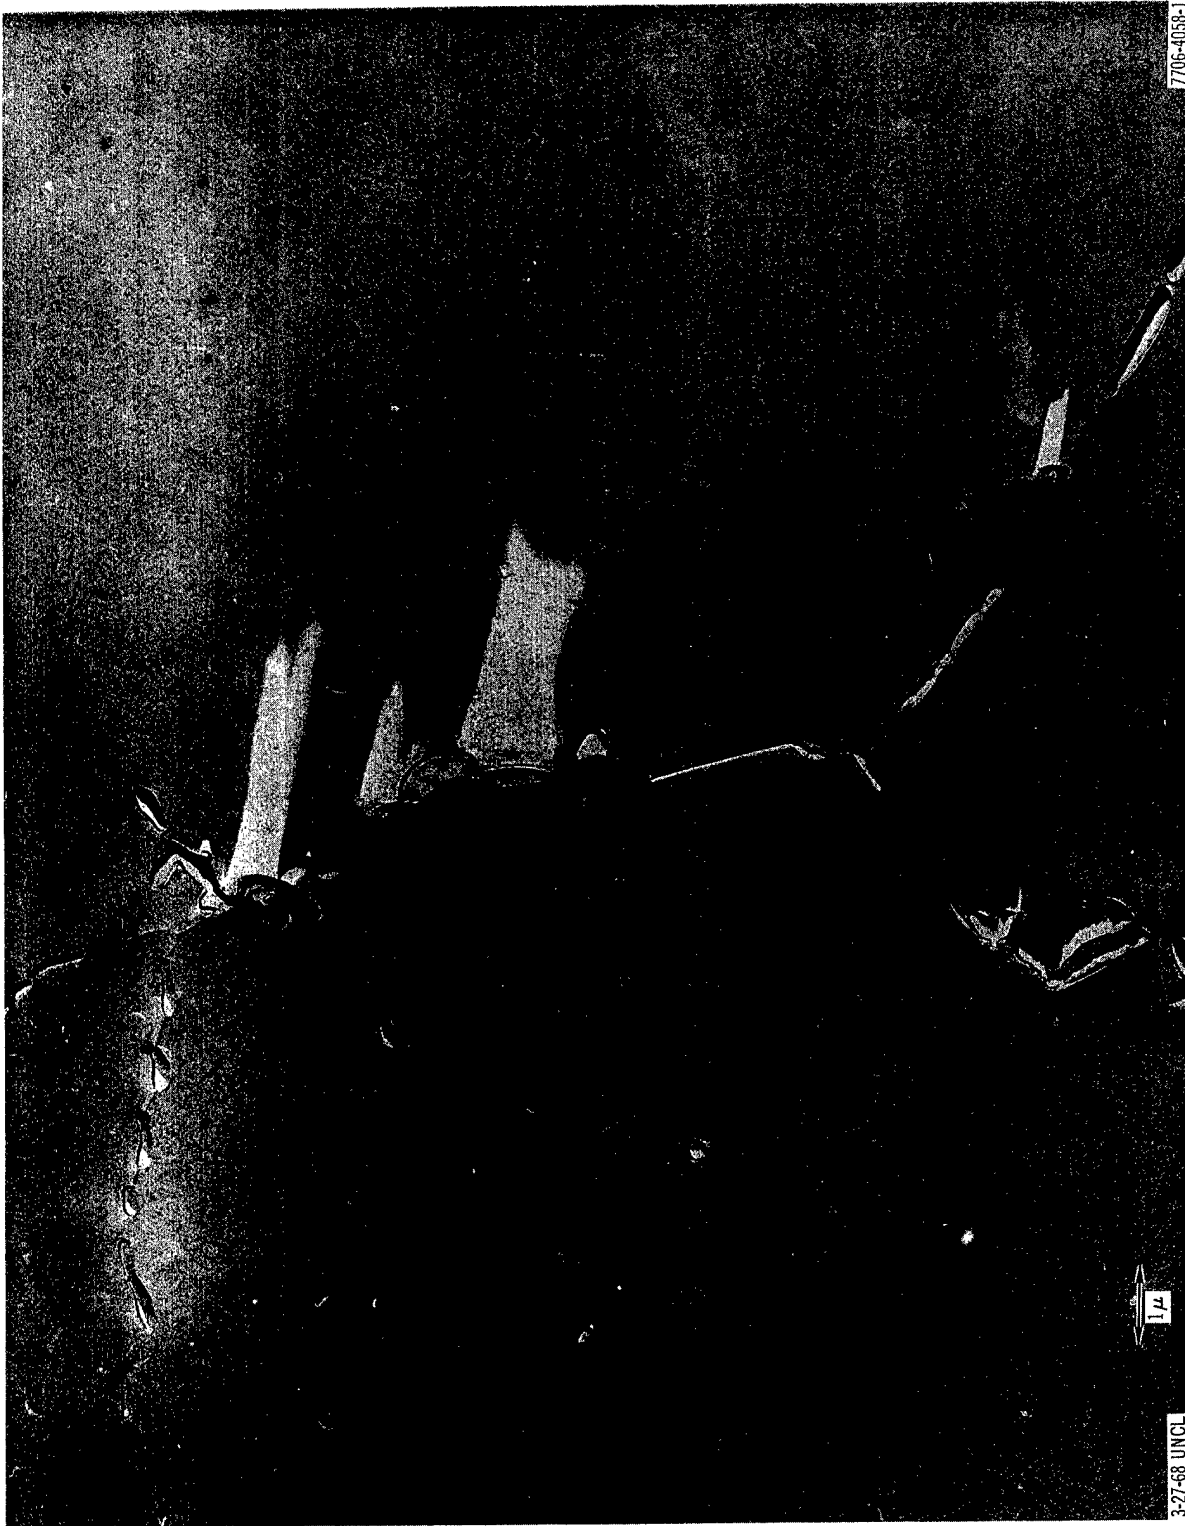
Figure 7a. Replica Electron Micrograph of Type 316 Stainless Steel
With 4×10^{-5} Atom Fraction Helium Tested at 760°C , Showing
Voids Adjacent to Grain-Boundary Carbides, Treatment 6

Figure 7 shows voids in samples with He tested at 760°C. They are situated on grain boundaries adjacent to carbide particles. The tensile axis is parallel to the direction of the white shadow. The relative frequency of these voids parallels that of grain-boundary cracks as stated above. The great majority of voids were associated with grain-boundary carbide particles, and even those which appear isolated on a grain boundary may be next to a carbide particle in another plane.

Loss of ductility due to helium is always accompanied by a failure that is partially or completely intergranular and by the presence of intergranular cracks along the gauge length. These cracks in their incipient state are located adjacent to grain-boundary carbide particles (Figure 7). Grain-boundary sliding, which probably occurs during testing, is obstructed by the presence of these carbide particles. In this situation voids are nucleated at the particle-matrix interface, and the mechanism has been described for a variety of alloys.⁽⁸⁻¹⁰⁾

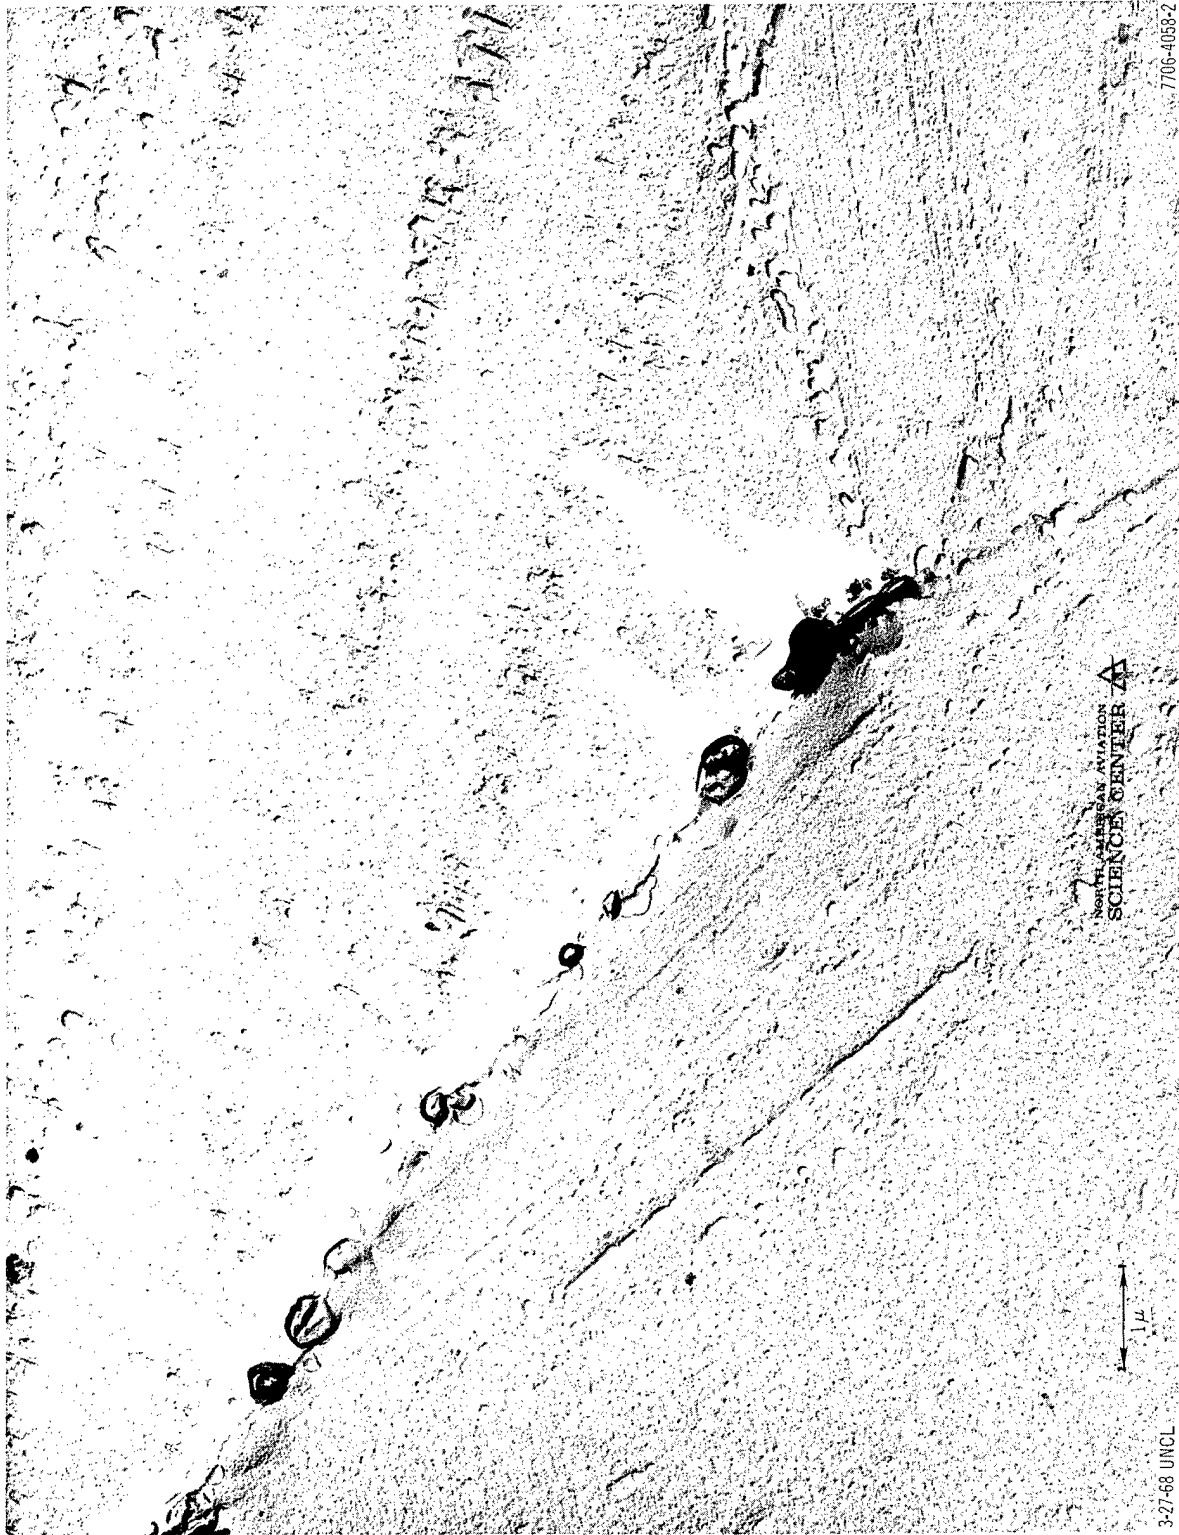
Figure 7b. Replica Electron Micrograph of Type 316 Stainless Steel
With 4 x 10⁻⁵ Atom Fraction Helium Tested at 760°C, Showing
Voids Adjacent to Grain-Boundary Carbides, Treatment 13

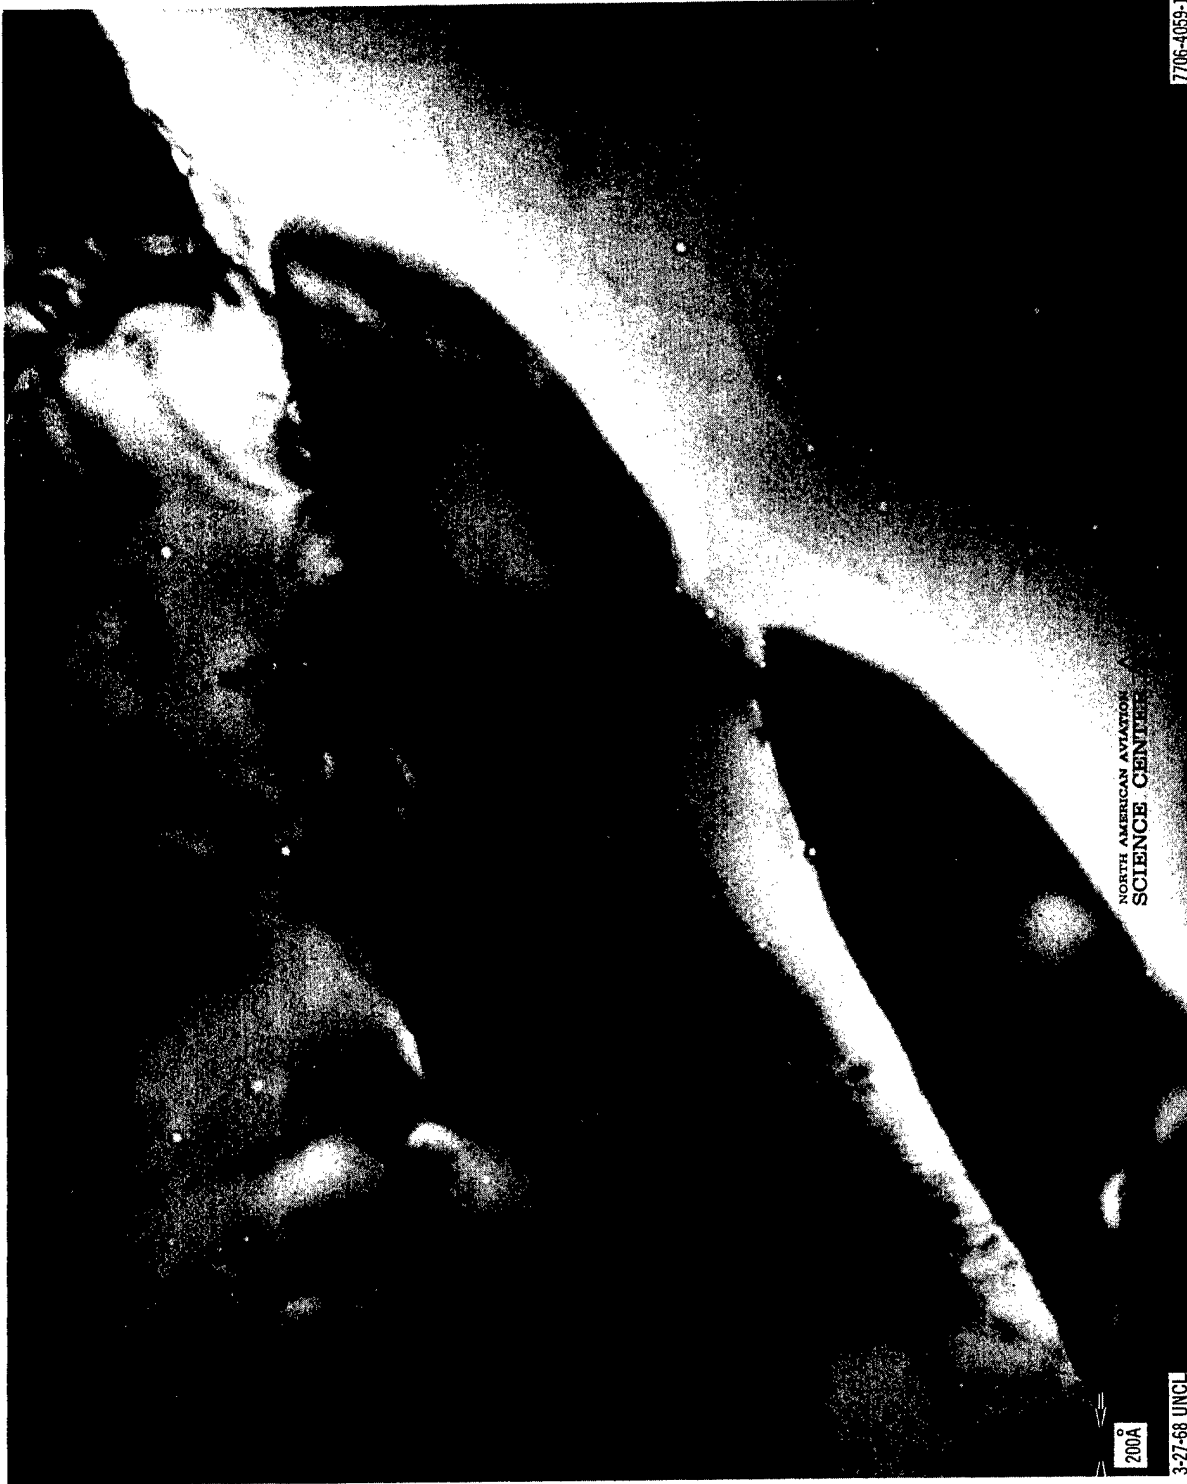
Figure 8a. Transmission Electron Micrograph Showing Helium Bubbles
in Type 316 Stainless Steel Given Treatment 6 With 4 x 10⁻⁵
Atom Fraction Helium Tested at 760°C

Helium bubbles were found in samples given either treatment after testing at 760°C (bubbles were not detected after tests at 540 and 650°C) and were generally located on grain boundaries, dislocations, and precipitates. Figure 8 shows He bubbles in samples given Treatment 6. The average bubble size is less than 100Å although some bubbles 1000Å and greater are present on grain boundaries and attached to carbide particles (see Figure 8c).

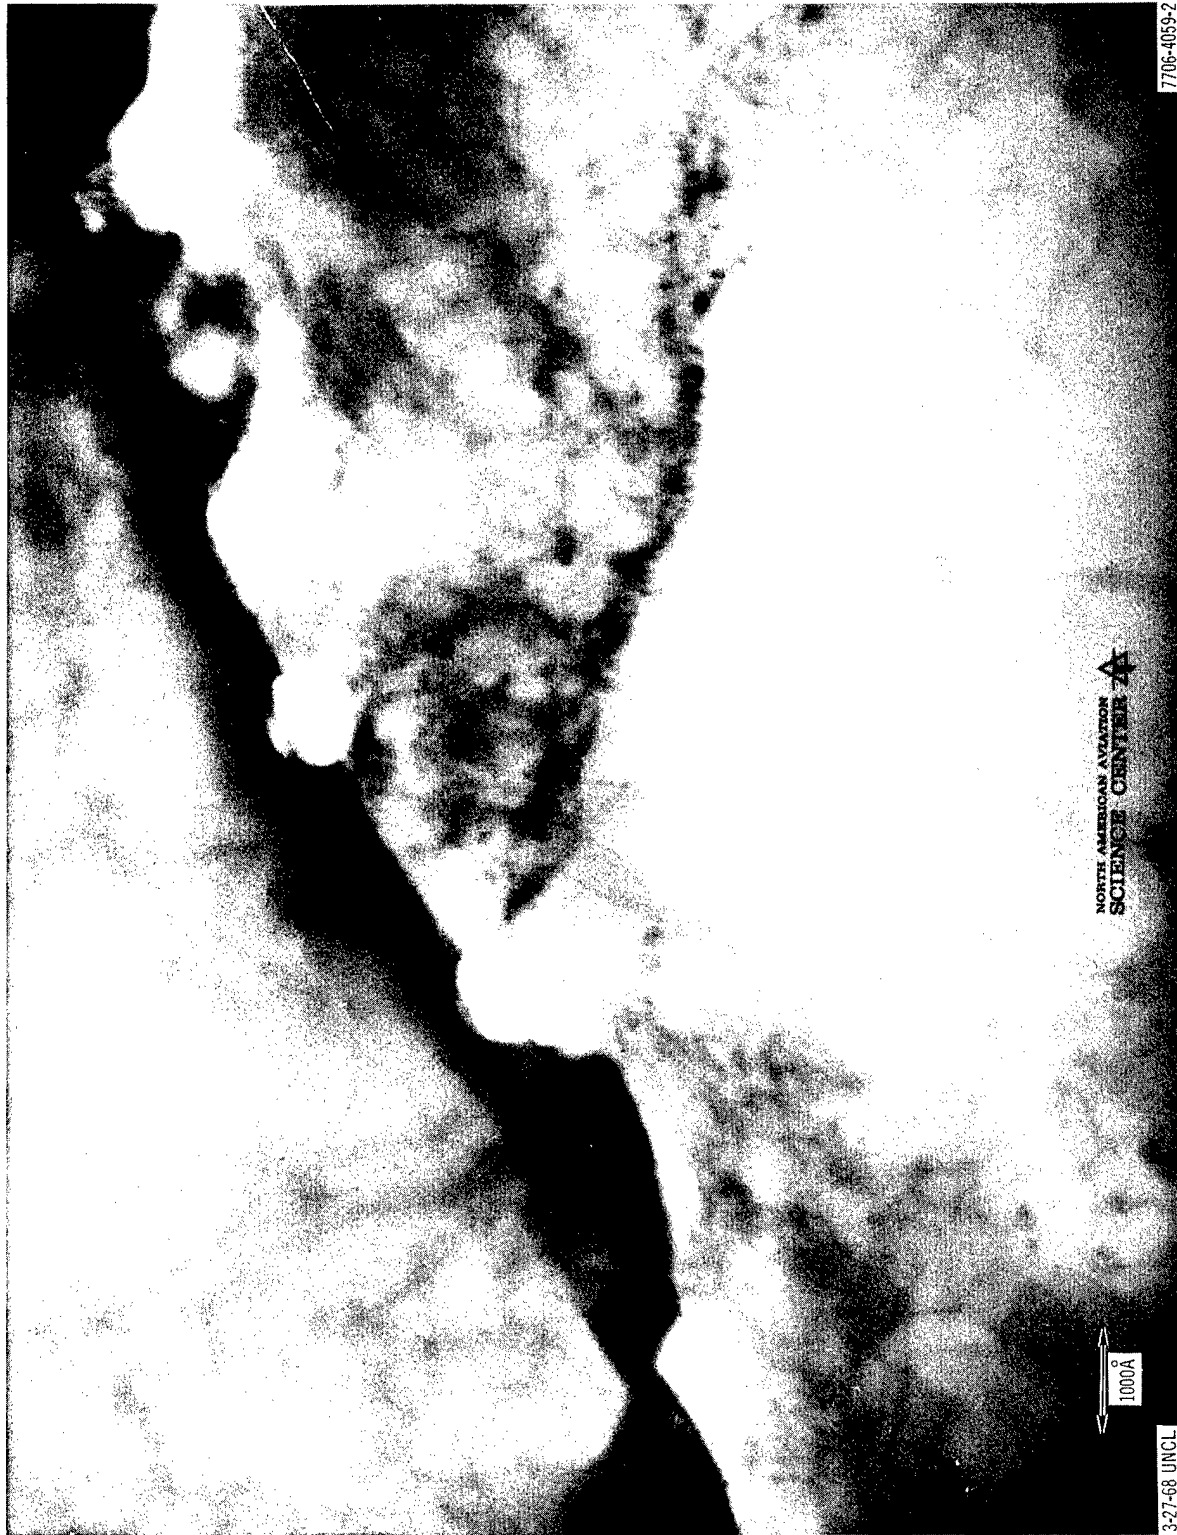
Figure 8b. Transmission Electron Micrograph Showing Helium Bubbles
in Type 316 Stainless Steel Given Treatment 6 With 4×10^{-5}
Atom Fraction Helium Tested at 760°C

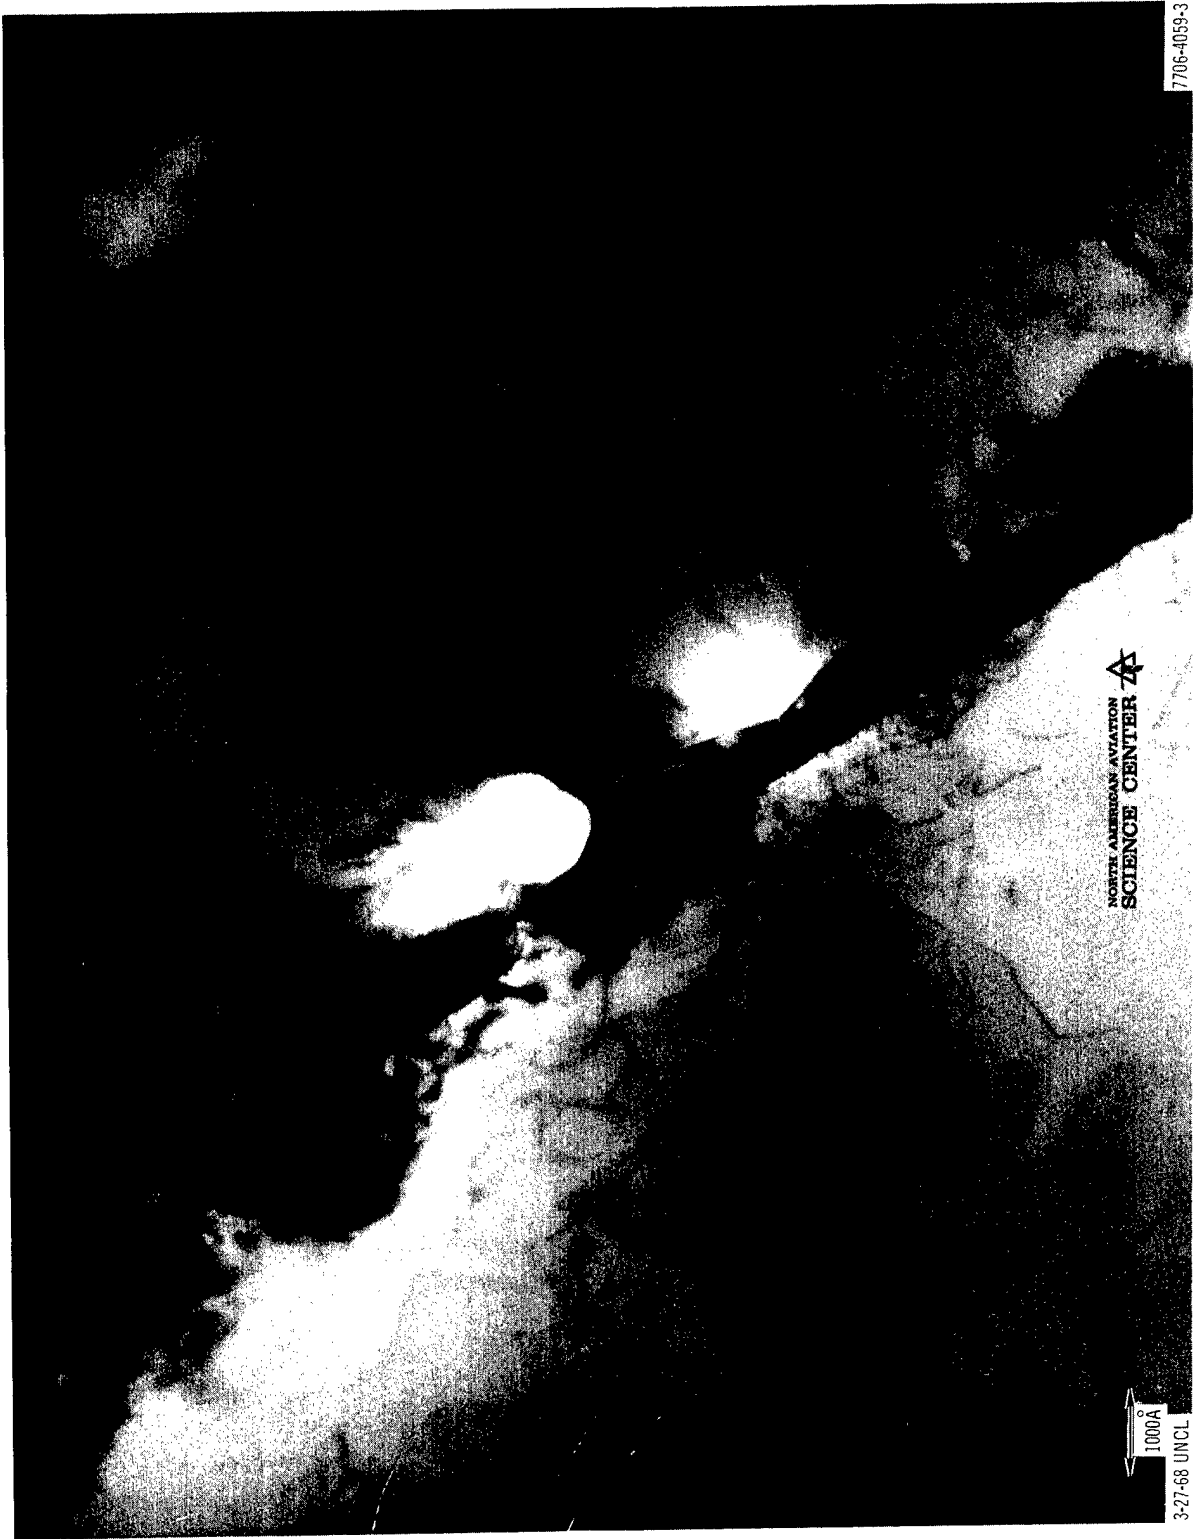
Figure 8c. Transmission Electron Micrograph Showing Helium Bubbles
in Type 316 Stainless Steel Given Treatment 6 With 4×10^{-5}
Atom Fraction Helium Tested at 760°C

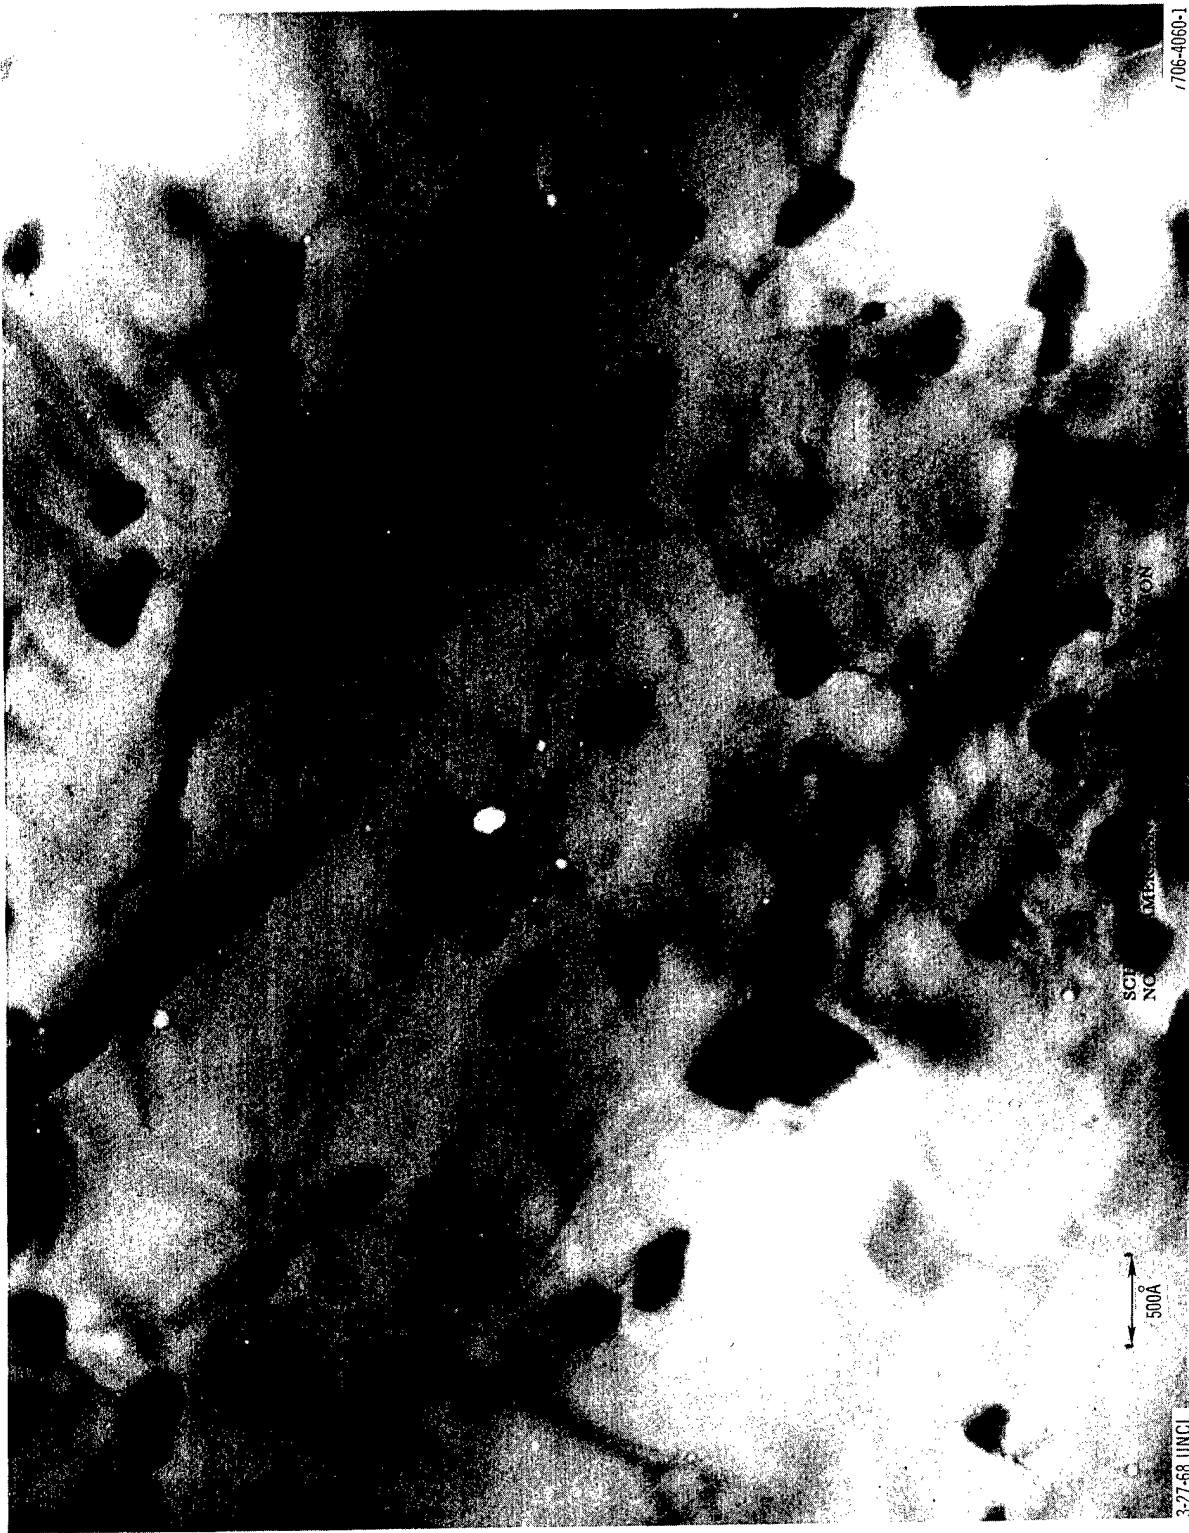
Figure 9a. Transmission Electron Micrograph Showing Helium Bubbles
in Type 316 Stainless Steel Given Treatment 13 With 4 x 10⁻⁵
Atom Fraction Helium Tested at 760°C

Figure 9 shows He bubbles in samples given Treatment 13. Their average size is also less than 100\AA but a very large bubble ($>2000\text{\AA}$ in one dimension) has formed on a grain boundary (see Figure 9b). Most of the small bubbles are attached to σ -particles. Large bubbles were significantly less prevalent in samples of Treatment 13 than in 6.

Samples given Treatment 13 show loss of ductility beginning above 650°C, while at this temperature those given Treatment 6 have already lost more than half their ductility. This is due to the effectiveness of the high density of σ -particles (10^{13} cm^{-3}) in trapping He (seen in Figure 9a as bubbles attached to the particles), thereby delaying the accumulation of He at grain boundaries.

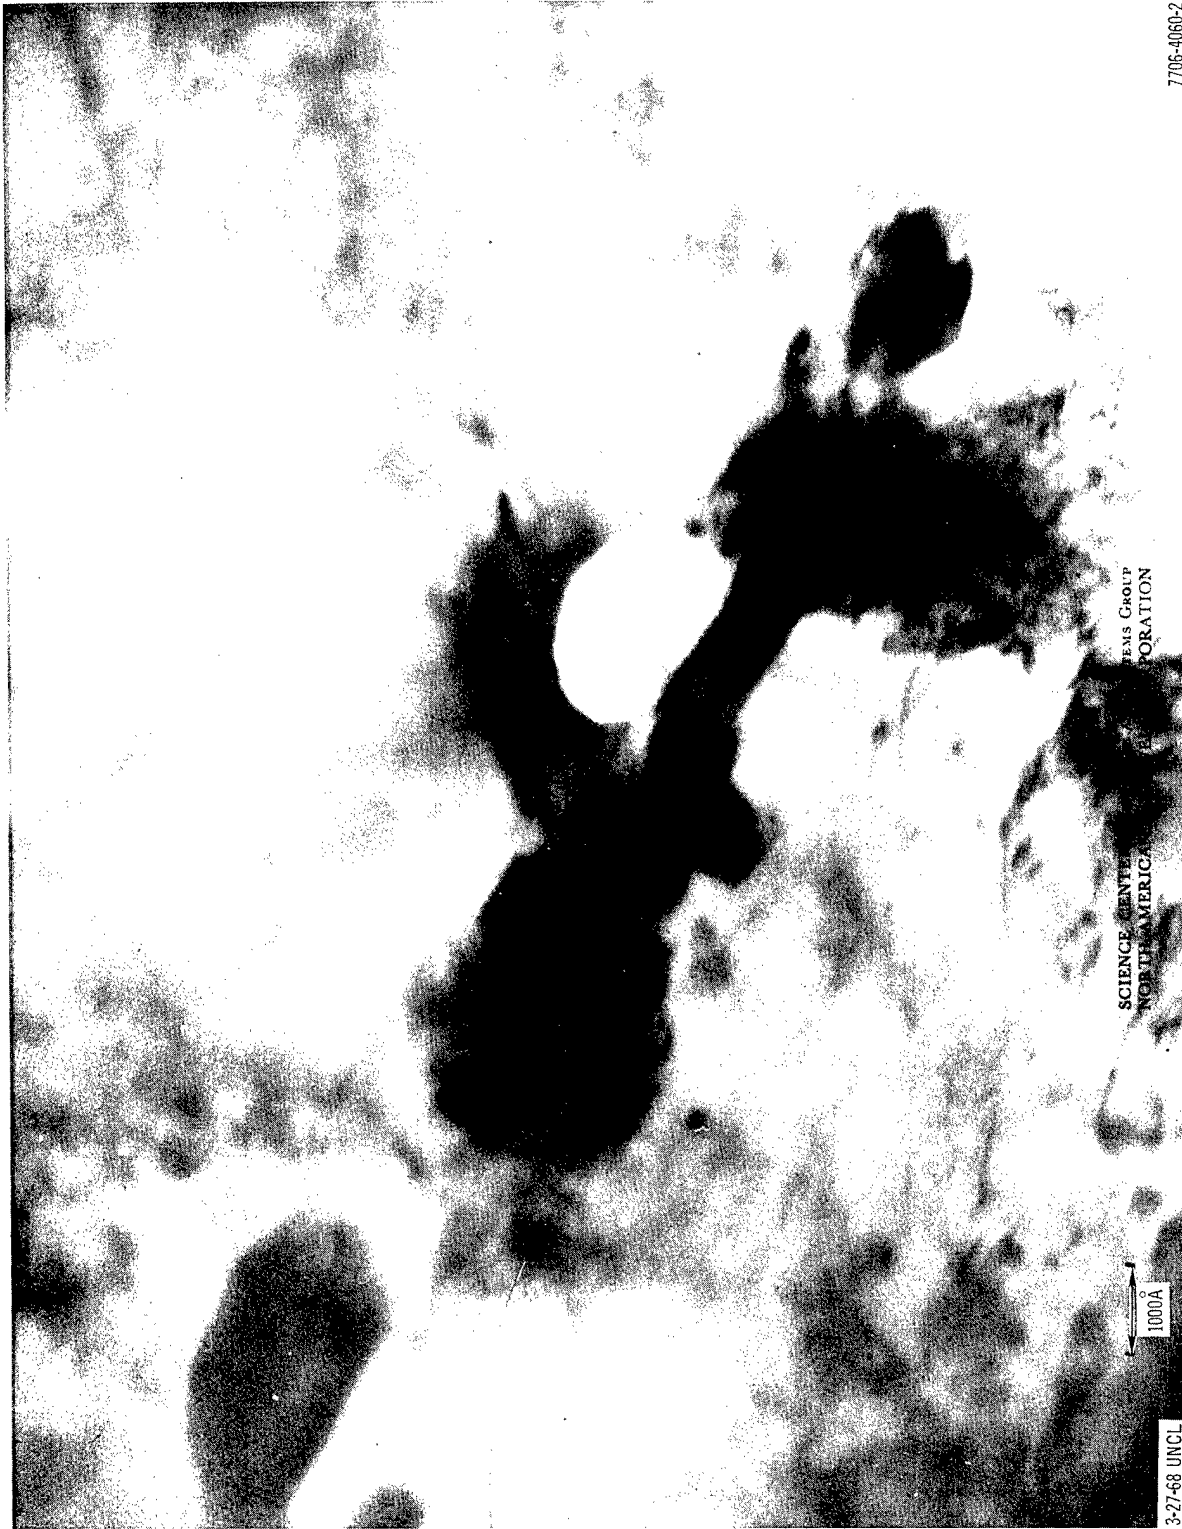
Figure 9b. Transmission Electron Micrograph Showing Helium Bubbles
in Type 316 Stainless Steel Given Treatment 13 with 4×10^{-5}
Atom Fraction Helium Tested at 760°C
