King, LA ORCID logoORCID: <https://orcid.org/0000-0002-0772-2378>, Hellstern, TR, Park, J, Sinclair, R and Jaramillo, TF (2017) Highly Stable Molybdenum Disulfide Protected Silicon Photocathodes for Photoelectrochemical Water Splitting. *ACS Applied Materials and Interfaces*, 9 (42). pp. 36792-36798. ISSN 1944-8244

# Highly Stable Molybdenum Disulfide Protected Silicon Photocathodes for Photoelectrochemical Water Splitting

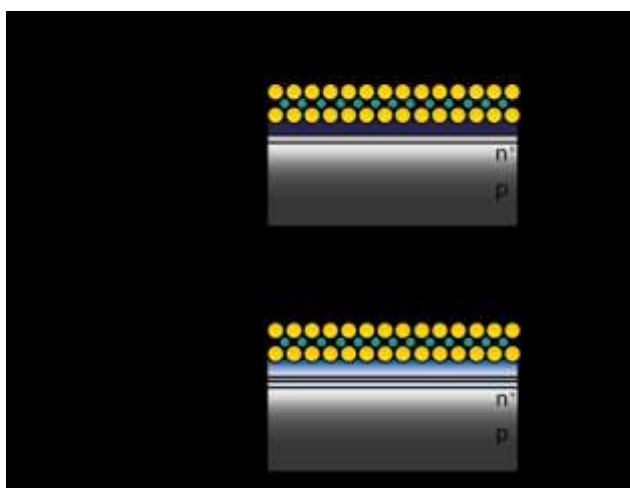
**Scheme 1.** Schematics detailing the catalyst and protection layers at the silicon interface in the synthesised (a) Si-2IL-MoS<sub>2</sub> and (b) Si-3IL-MoS<sub>2</sub> photocathodes.

In this study, we investigate the photoelectrochemical activity and stability of two similar, but distinct protection schemes for silicon photocathodes, Scheme 1a and Scheme 1b. The first protection scheme (Si-2IL-MoS<sub>2</sub>) has two interlayers (IL) between the surface MoS<sub>2</sub> and silicon composed of molybdenum silicide and molybdenum metal. The second protection scheme investigated has three IL (Si-3IL-MoS<sub>2</sub>) identified as molybdenum oxide, molybdenum silicide and silicon dioxide. The photocathodes are amongst the most stable precious metal free electrodes prepared to date, with over 1538 h of continuous and stable photoelectrochemical hydrogen evolution,<sup>21</sup> and over 64 000 C cm<sup>-2</sup> of charge passed for the Si-3IL-MoS<sub>2</sub> protection scheme. These non-precious metal photoelectrodes also show an excellent onset potential, reaching 0.5 mA cm<sup>-2</sup> at +0.31 V vs. RHE. This serves as a promising protection scheme for active and stable photoelectrochemical water splitting.

**The Si-2IL-MoS<sub>2</sub> photocathode.** The Si-2IL-MoS<sub>2</sub> photocathode was prepared following the method published in ref 15 and detailed in Scheme 1a. The protection scheme composition was confirmed (ref 15) by cross-sectional TEM and found to contain two interlayers (IL) between a surface MoS<sub>2</sub> and the silicon substrate. The uppermost IL was a Mo metal layer. The second IL was identified as amorphous Mo<sub>x</sub>Si.

**The Si-3IL-MoS<sub>2</sub> Photocathode.** The synthesis of the Si-3IL-MoS<sub>2</sub> photocathode is presented in Scheme 1b. In brief, p-type silicon was n<sup>+</sup> doped, cleaned and coated with a 3.6 nm layer of molybdenum by sputtering. The electrodes were subsequently annealed in a H<sub>2</sub> atmosphere at 550 °C (2 h), followed by a second anneal step in 10 % H<sub>2</sub>S in H<sub>2</sub> at 250 °C (1 h).

**Synthesis of the Si-2IL-MoS<sub>2</sub> Photocathode.** The Si-2IL-MoS<sub>2</sub> photocathode was prepared following the method published in Ref 15 and detailed in Scheme 1a. In brief, the n<sup>+</sup>p-Si-Mo wafer was sulfidized in an H<sub>2</sub>S environment at 250 °C for 45 mins.

**Synthesis of the Si-3IL-MoS<sub>2</sub> Photocathode.** The synthesis of the Si-3IL-MoS<sub>2</sub> photocathode is presented in Scheme 1b. In brief, the prepared n<sup>+</sup>p-Si-Mo were annealed in a H<sub>2</sub> atmosphere at 550 °C (ramp rate 5 degree/min, 2 h dwell), followed by a second anneal step in 10 % H<sub>2</sub>S in H<sub>2</sub> at 250 °C (ramp rate 5 degree/min, 1 h dwell). 99.999 % UHP (ultra high purity) hydrogen gas was used for all the syntheses plumbed into the tube furnace using swage lock stainless steel pipping.

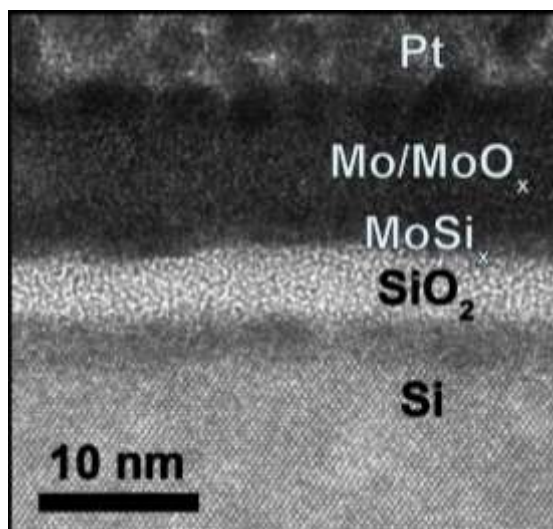
**Figure 3.** Transmission electron micrograph (TEM) of the as prepared molybdenum protected Si-3IL-MoS<sub>2</sub> photocathode. Platinum is deposited during cross sectional TEM preparation as a protection layer for the FIB ion beam milling so is not present during the photoelectrochemical measurements.

Cross sectional transmission electron microscope (TEM) images of the as prepared sample is shown in Fig. 3. evidencing the formation of a ~3.7 nm silicon oxide (SiO<sub>2</sub>) layer directly above the silicon, and a ~10 nm layer of molybdenum/molybdenum oxide (Mo/MoO<sub>x</sub>) above the SiO<sub>2</sub>. There is also evidence of an additional thin (1 – 2 nm) layer between the MoO<sub>x</sub> and

SiO<sub>2</sub> which is likely molybdenum silicide (MoSi<sub>x</sub>). Platinum is the uppermost layer, deposited during cross sectional TEM preparation as a protection layer for the FIB ion beam milling.

The overall thickness of the Si-3IL-MoS<sub>2</sub> protection scheme (~14 nm) is greater than the Si-2IL-MoS<sub>2</sub> protection scheme. This is due to a thicker MoO<sub>x</sub> layer, in combination with an additional layer of SiO<sub>2</sub>. Interestingly, the distinct basal plane *d* spacing (0.62 nm) of MoS<sub>2</sub> are absent in the Si-3IL-MoS<sub>2</sub> TEM (Fig. 3) indicating a non-continuous film of MoS<sub>2</sub>. The Si-3IL-MoS<sub>2</sub> photocathode synthesis requires a pre-reduction in a hydrogen atmosphere, which has been shown to limit the growth of MoS<sub>2</sub>,<sup>23</sup> however, XPS (Fig. 4) verifies the growth of MoS<sub>2</sub> at the surface of the photocathode.

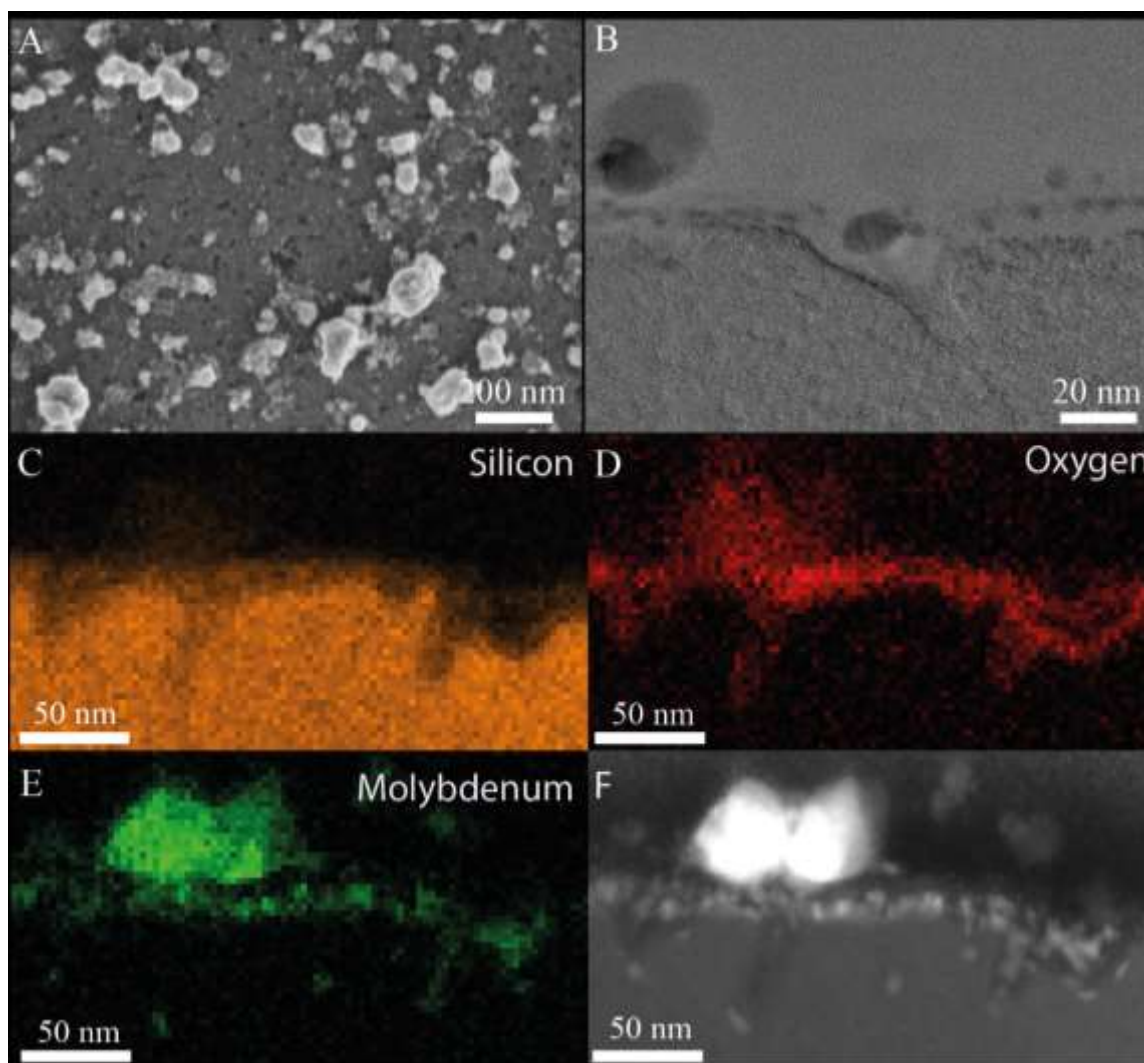
**Figure 6.** (A) Scanning electron micrograph (SEM) and (B) cross-sectional transmission electron micrograph (TEM) of the Si-3IL-MoS<sub>2</sub> photocathode post failure. Both pits and agglomerates are clearly visible at the surface of the electrode. STEMEDS mapping of silicon (C), oxygen (D) and molybdenum (E) of the sample after failure (64 days of testing). (F) The STEM micrograph of the same region is also shown.

To further probe the failure mechanism of the Si-3IL- $MoS_2$  photocathode, scanning electron microscopy (SEM) and cross sectional TEM were used. SEM reveals a highly-roughened surface with both pits (10 – 40 nm) and agglomerates (up to 100 nm) scattered across the surface (Fig. 6 a). The cross sectional TEM images of the same sample (Fig. 6 b and Fig. S1) reveal significant roughening across the surface with pits up to 30 nm deep, as well as the addition of particles (10 – 20 nm). Behind the cavity, silicon lattice planes remain visible suggesting the cavity is only a few nm wide. Scanning TEM energy dispersive x-ray spectroscopy (STEM-EDS) elemental maps (Fig. 6.c-f) show that the pits extend through the protective molybdenum based layers, into the silicon and that silicon is etched away. The particles that decorate the surface were found to contain predominantly molybdenum, and in some cases silver (contaminant). Discussion regarding the origin of the contaminant is provided in the supporting information. In light of the cross sectional TEM (Fig. 6 b) whereby large pits and a broken protection layer is observed we speculate that such morphological changes are likely the eventual cause of electrode failure. Given that these failures occur during chronoamperometry testing we conclude that failure is not as a direct consequence of the cyclic voltammetry sweeps.
