Hydraulic performance assessment of Tahtay Tsalit small scale irrigation scheme, Tigray, Ethiopia

Key words: Hydraulic structures, hydraulic performance, small scale irrigation scheme.

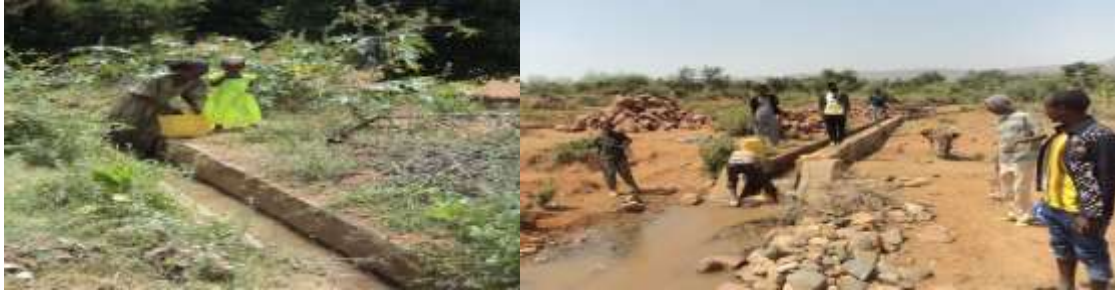
There were many different factors that affect irrigation water deliveries in the study area. The community in T.Tsalit SSI scheme both irrigate beneficially and non-beneficially use water from Tsalit River, diversion and canals of the irrigation scheme for all water demand purposes particularly in the dry period (Figure 2). As a

Figure 2. Water used for other purpose than irrigation.

result, loss of irrigation water from the intended purpose was high in this irrigation scheme.

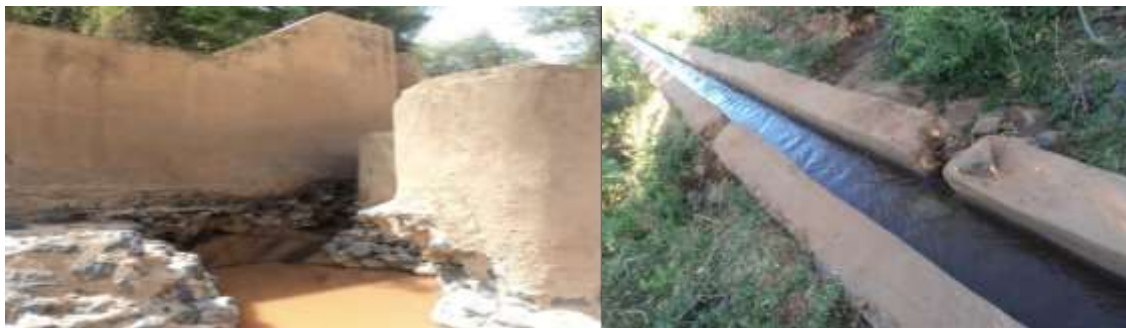
**Figure 3.** Mal-functioned hydraulic structures.

reach of the hydraulic structures DPR was estimated to be 0.09 which is greater than 5%, which needs maintenance and this also agrees with the field observation (Figure 3) and response from the focus group discussions. Part of diversion nearest to the inlet of the main canal was damaged and two sluice gates were flushed by flood during 2011.

The result at head reach was greater than middle and tail which have the same value 0.06 for each reach, this show the head reach of the canals was affected by siltation of the irrigation canals and scouring the downstream of the diversion. Tahtay Tsalit SSI scheme need more maintenance in November than the remained months (September and October).

In Tahtay Tsalit irrigation scheme both the spill way sluice gates at the weir nor the flow control gates at the off-take were functional and hence, are not effective yet. On the other hand, no failure was observed at the main and branch canals. Beyond the mal-functionality of sluice gates, off-takes and other hydraulic structures were also mal-functioned (Table 7).

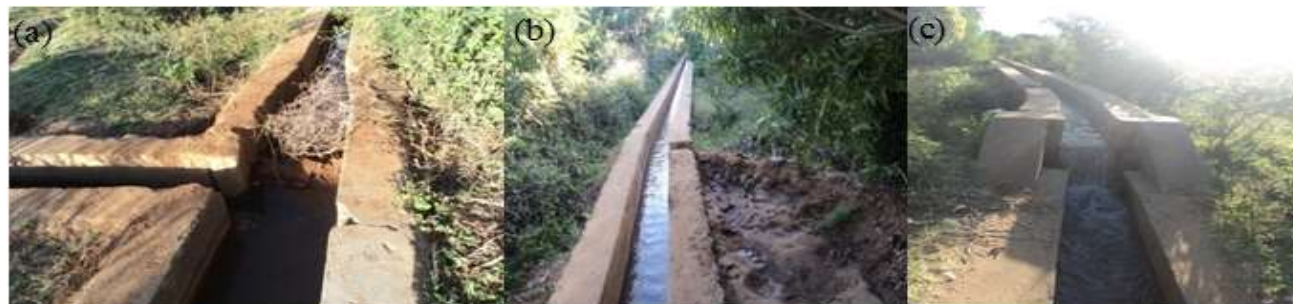
The main causes of failure of the hydraulic structures in T.Tsalit SSI scheme could be attributed to the occurrence of high flooding in 2011. During that time a number of sluice gates were damaged by the flood and also more amount of sedimentation entered in to the irrigable lands. After the damage, maintenance was being done routinely using temporary materials such as sand bag, mud and stone to the structures and this further adds siltation to the canals.

Based on the filed observation and focus group discussion; the failure of some irrigation structures was observed to be design problem (Figure 4c). For example, due to the high slope difference between the constructed off-takes and irrigable farm lands (the variation of the off-take and the irrigable land was averagely about 0.5m). As a result, farmers didn't use this irrigation off-takes as it could erode their farm land and hence, use other alternative off-take faraway from their farm land. This leads into soil erosion, siltation, seepage, deep percolation and mal-functioning of the irrigation structures.

Figure 4. Main causes of hydraulic structure mal-functioning of T.Tsalit SSI scheme.

Due to the stealing of flow control gates from the off-take irrigation canals farmers were forced to use soil and wooden logs (Figure 4a) to control flows of water and this creates siltation problem mainly at the canals. The tertiary unlined canals which were constructed by the individual farmers has a problem in its dimension (very wide) which creates an opportunity of water loss through percolation, evaporation and even flow to unwanted areas (Figure 4b) and additionally leads soil erosion.

Deforestation, free grazing and non-treating the upper catchments by different soil and water conservation structures due to the existing disagreements between *Hagere Selam* and *Kola Tembien* Woredas were also mentioned as the most important source of siltation in the irrigation scheme.

- i) Awareness creation and capacity building should be given to local administrations, development agent, irrigation water users and farmers on management of irrigation water and irrigation structures.
- ii) There should be integration between *Hagere Selam* and *Kola Tembien* Woredas in the watershed development.
- iii) All tertiary off-take flow control gates should be constructed so as to control the discharge of the irrigation

water and minimized the sedimentation accumulation of the next off-takes.

- iv) There should be water fee by-laws for all the irrigation water users; which will later used for maintenance of failed irrigation structures.
- v) Watering procedure should be based on the crop water requirement and irrigation scheduling.
