Original article

Hydrological effects of the hydraulic structures constructed in the valley of the River Little Vistula in Poland from the mid-18th century to the present

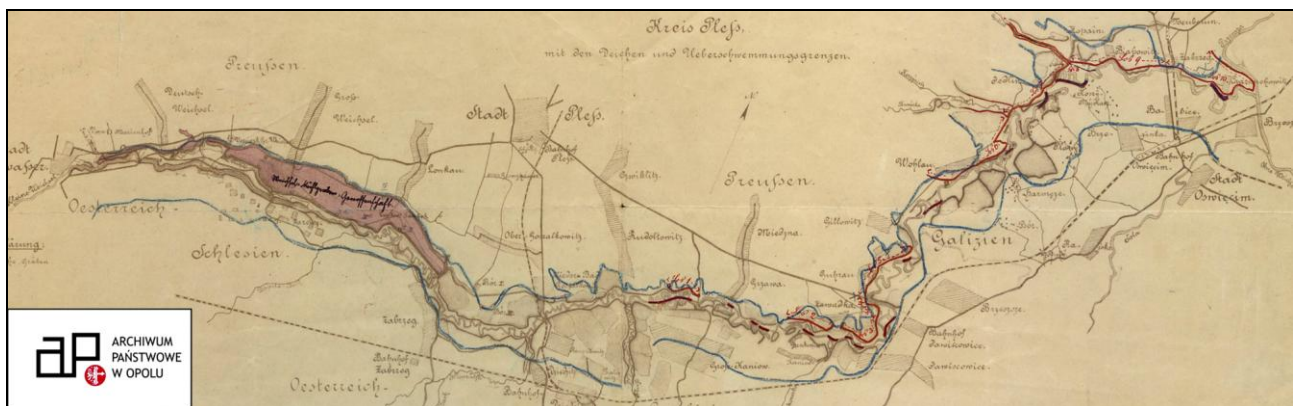
Fig. 1. Map of the River Little Vistula valley from the late 19th century with the natural flooding zone marked (after Lageplan..., 1895, original scale: 1:75,000, State Archives in Opole)

climate, which resulted in the strong development of solifluction and slopewash processes. At that time, intensive accumulation of sediments from the Middle Polish Glaciation period occurred in the valley of the River Little Vistula. Those were Pleistocene alluvial soils, silts, sands and gravels, which formed one or two terrace levels in the valley of the River Vistula. The study area covers the valley reaches situated within the zones of maximum flooding observed until the end of the 19th century. The surface area of the valley reach studied is 87.3 km² and its length is around 41.0 km. In the second half of the 18th century, the River Vistula channel was around 87.1 km long, whereas today it is 52.8 km long (Fig. 1).

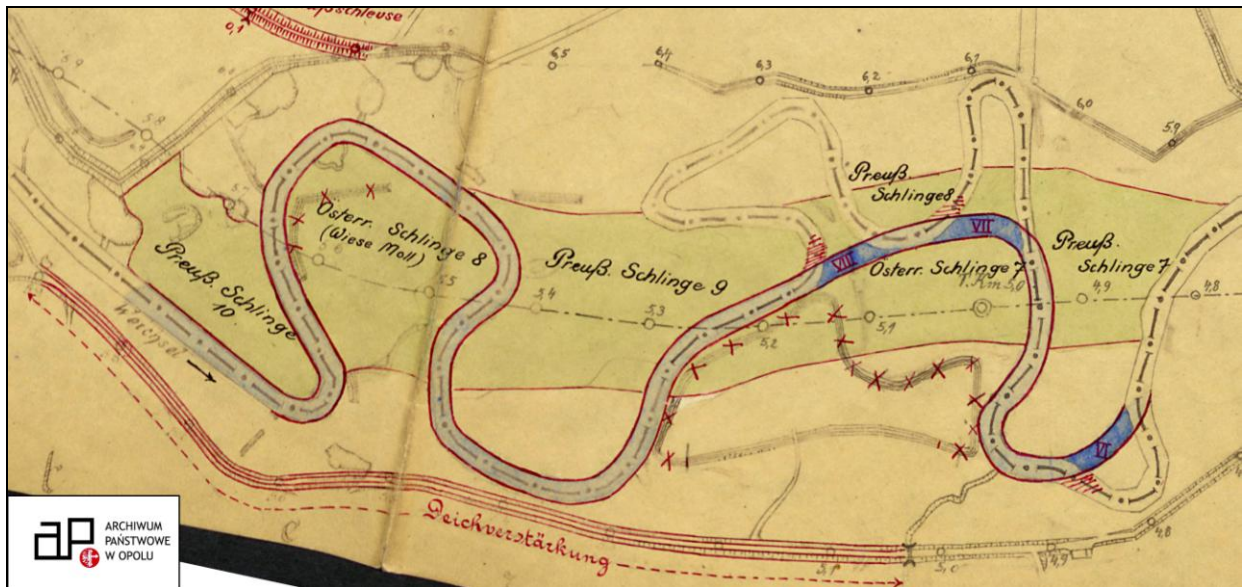
Fig. 9. River engineering work design – River Vistula valley (after Regulierung der Österreichische Weichselstrecke, 1892–1901, original scale: 1:5000, State Archives in Opole)
