## Hydromorphological evaluation of the river training impact on a multi-thread river system (Belá River, Carpathians, Slovakia)

Anna Kidová<sup>1✉</sup>, Artur Radecki-Pawlik<sup>2</sup>, Miloš Rusnák<sup>1</sup> & Karol Plesiński<sup>3</sup>

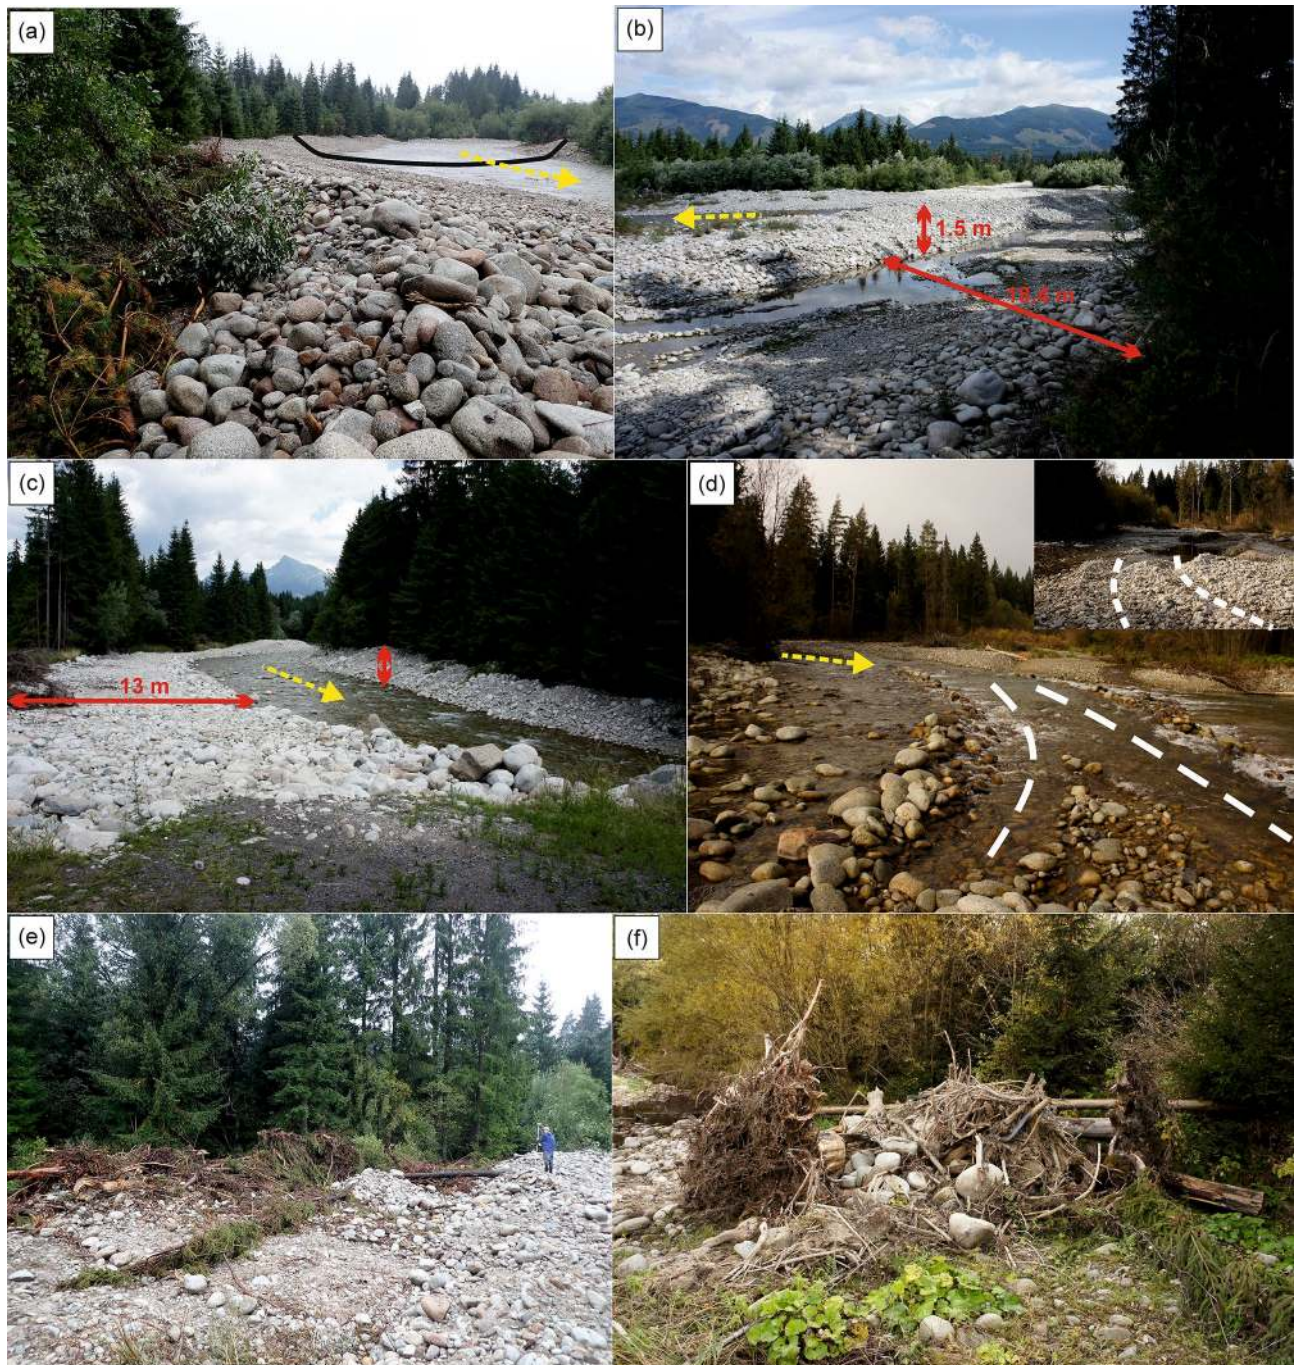
**Figure 2.** (a) Photographic documentation of how gravel has formed into a wide “U”-shaped channel and (b) of the artificial formation of backwater surfaces and elevated gravel barriers in the middle of the braidplain area near Pribylina settlement during field reconnaissance in 2018 and 2019. (c) We recognized the formation of artificial lateral bar surfaces and elevated gravel banks (marked with red arrows) further upstream at Kokavský Bridge in RR10. (d) Visible traces of heavy equipment transfer (white dashed lines) at two sites between the individual treated river reaches between Vavrišovo and Pribylina settlements. (e) On the edges of riverbanks, we documented the rolling up of large woody debris mass (f) mixed with granite boulders. Yellow arrow represents the flow direction (photo: Anna Kidová; A, E, F: 13.8.2018; B, C: 17.7.2019; D: 19.10.2018).

During field reconnaissance, several characteristic examples of the management interventions were found in the Belá braidplain area (Fig. 2). The river training in RR7 consisted of extraction or shifting of gravel to form a wide “U”-shaped channel with high banks, i.e. forming a shallow, quasi-artificial channel (Fig. 2A). By carrying

out these management interventions, the original multi-thread river system was seriously or completely destroyed and the water flow was concentrated in a single shallow main channel. Upon the intervention of heavy equipment, unnatural backwater surfaces with stagnant water arose on the artificial bar surfaces in the river’s active zone (e.g. RR3, Fig. 2B). The next management intervention example is represented by shifting gravel into the high banks (Fig. 2C). Uplift of the original left bank line isolated it from the other sidearms on the floodplain. At the same time, a 13 m-wide artificial bar surface was created where the original 5.2 m-wide lateral bar occurred in

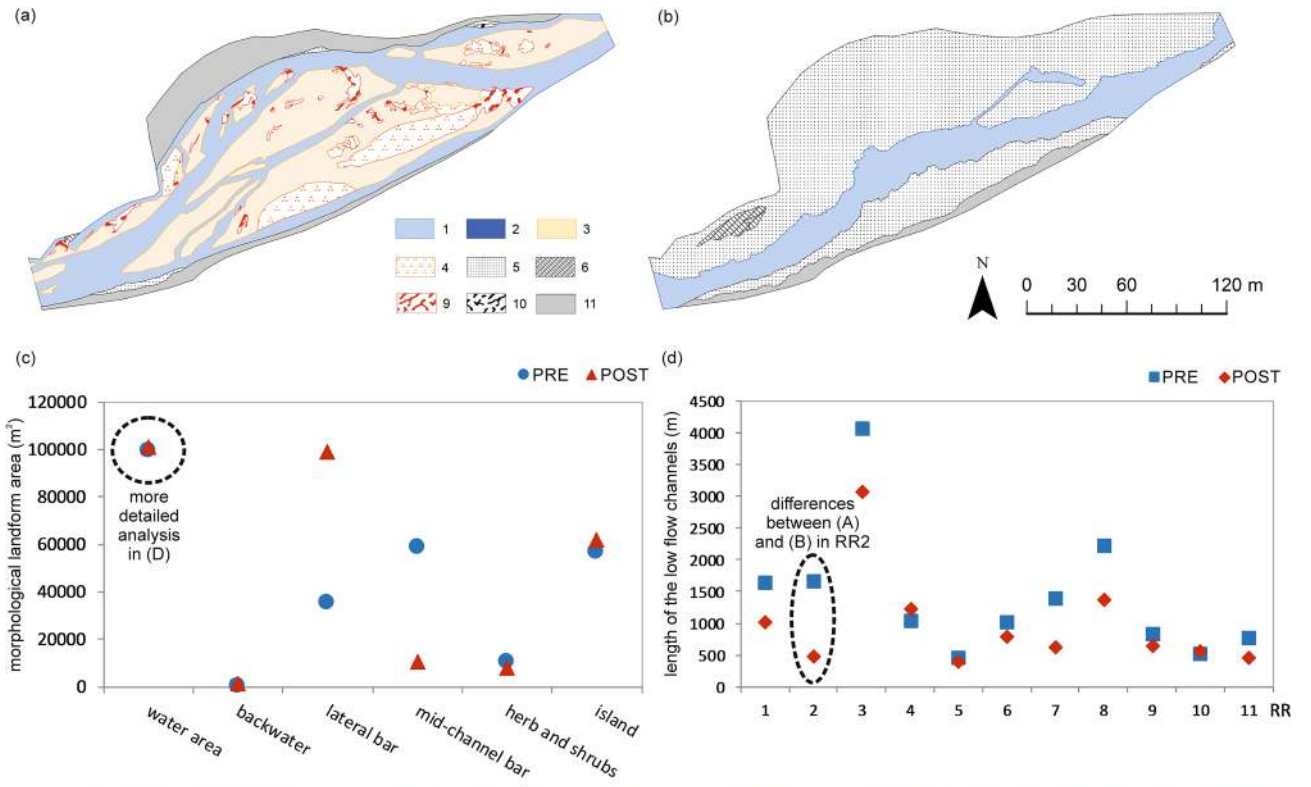
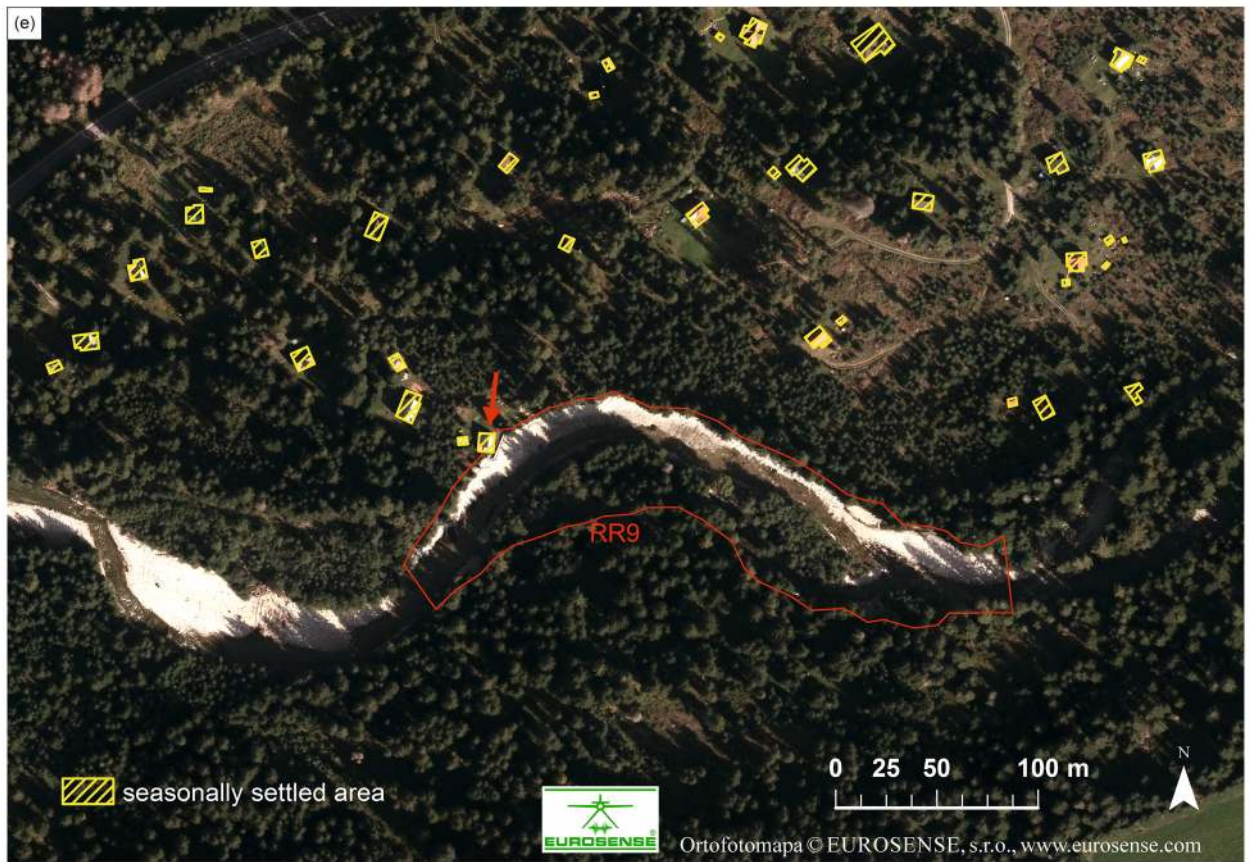
◀ **Figure 3.** (a) Example of reduced low flow channels on RR2 near Dovalovo settlement in 2015 with natural braidplain before management intervention and (b) in 2018 after intervention with an artificially created lateral bar on both banks of the Belá River generated in ArcMap 10.3 software. (c) Comparison of area of studied morphological parameters in total for all studied 11 river reaches in the natural (2015) and artificial river active zones after river training (2018). (d) Differences in the length of low flow channels between 2015 and 2018 in all studied river reaches (RR1–11). For legend of studied channel landforms for (a), see Fig. 1C. (e) Holiday cottage at real flood risk (marked by a red arrow) in the seasonally settled “Cottage area 2” (Fig. 1) on the Belá River floodplain. This risky position of the cottage probably requires management intervention in RR9. Background orthophoto image is from 2018 and was generated in ArcMap 10.3 software.

Based on a comparison of the area and length of selected morphological parameters (Fig. 3C,D), several changes in the morphology of the Belá River’s active zone were evident. Although the results indicate that there has been no significant decrease in the water surface area (low flow channels) after the river training, the data on the length of the low flow channels, which refine these results, showed the opposite. After adjustments, the length of the flow channels decreased overall by almost 5 km. The decline was due to the shifting of gravel to the sides, destroying the original multi-thread pattern and creating a wide, single-thread one (Fig. 3A,B). The area of artificially created isolated water surfaces (backwater areas) on lateral bars was increased 30 times. There was a noticeable increase in lateral bar area overall due to the accumulation of gravel from the center of the main channel to its edges and to the banks, respectively. The area of the mid-channel bar, the most important and dynamic in-channel landform of a braided-wandering river system, decreased significantly after management intervention, from 59,015 to 10,313 m<sup>2</sup>. This intervention in the braidplain area resulted in a decrease in the bar area with herb and shrub vegetation cover as well, from 10,435 to 7881 m<sup>2</sup>. A slight increase in island area indicates the maintained continuity of vegetation succession.

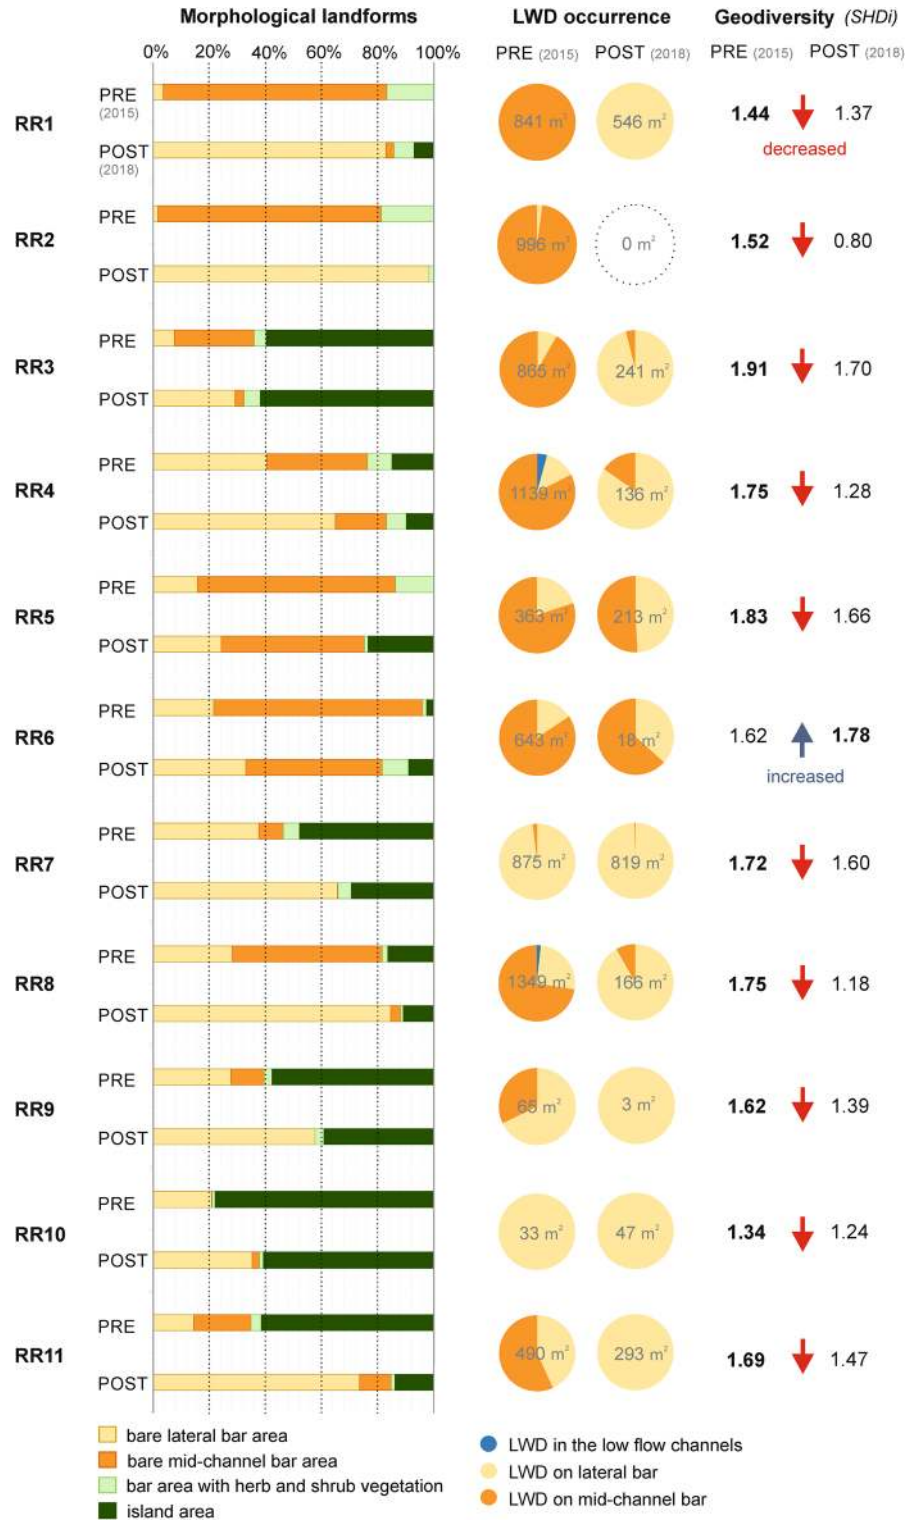
**Figure 4.** Differences in the morphological landform area of the braidplain, geodiversity status (increased/decreased SHDI) and comparison of LWD accumulation area in PRE-flood (2015) and POST-flood management periods (2018) in all studied river reaches (RR1–11). Numbers inside a pie chart represent the total area of LWD accumulation identified in monitored river reaches.

The four main morphological landforms of the braidplain, bare lateral/mid-channel bars, bars with herb and shrub vegetation cover, and islands, were evaluated for all studied river reaches (Fig. 4). A specific quantifiable parameter, the presence of LWD in the braidplain area, was monitored especially in the low flow channels and on lateral and mid-channel bar landforms (Fig. 4). The equal scenario, with a significant decrease of the mid-channel bar area as well as a significant increase of the lateral bar area on all river reaches (RR1-9, RR11), prevailed. On a prevailing number of river reaches (RR1, RR2, RR4, RR5, RR11), vegetated bars with herbs and shrubs decreased in area after river training. The original island area occurred on seven river reaches in 2015. On six river reaches (RR4, RR7, RR8, RR9, RR10, RR11), island area decreased and only on two did it increase in 2018 (RR3, RR6). On two river reaches (RR1, RR5), a brand-new island area arose after management interventions.

The presence of LWD accumulations reduced significantly after river training in the Belá braidplain, from 7666 to 2482 m<sup>2</sup> in total. We noticed a very significant decrease in LWD especially in mid-channel bars (from 5676 to 168 m<sup>2</sup> in total), of which the lateral ones were artificially created. However, we registered only a slight increase (about 395 m<sup>2</sup> in total) in LWD between 2015 and 2018 on lateral bars as well. LWD occurrence in 2018 prevailed in lateral bar areas (RR1, RR3, RR4, RR7-11) in comparison with the prevailing occurrence in 2015 on mid-channel bars. On two river reaches (RR4, RR8), we registered natural occurrence of LWD also in low flow channels. Calculation of geodiversity status (Shannon diversity index) proved a decreasing trend in geomorphic diversity for 10 river reaches after river training. We registered the largest difference (decrease) in geodiversity status between pre- and post-flood management periods mainly for RR2 (−0.72) and RR8 (−0.57).

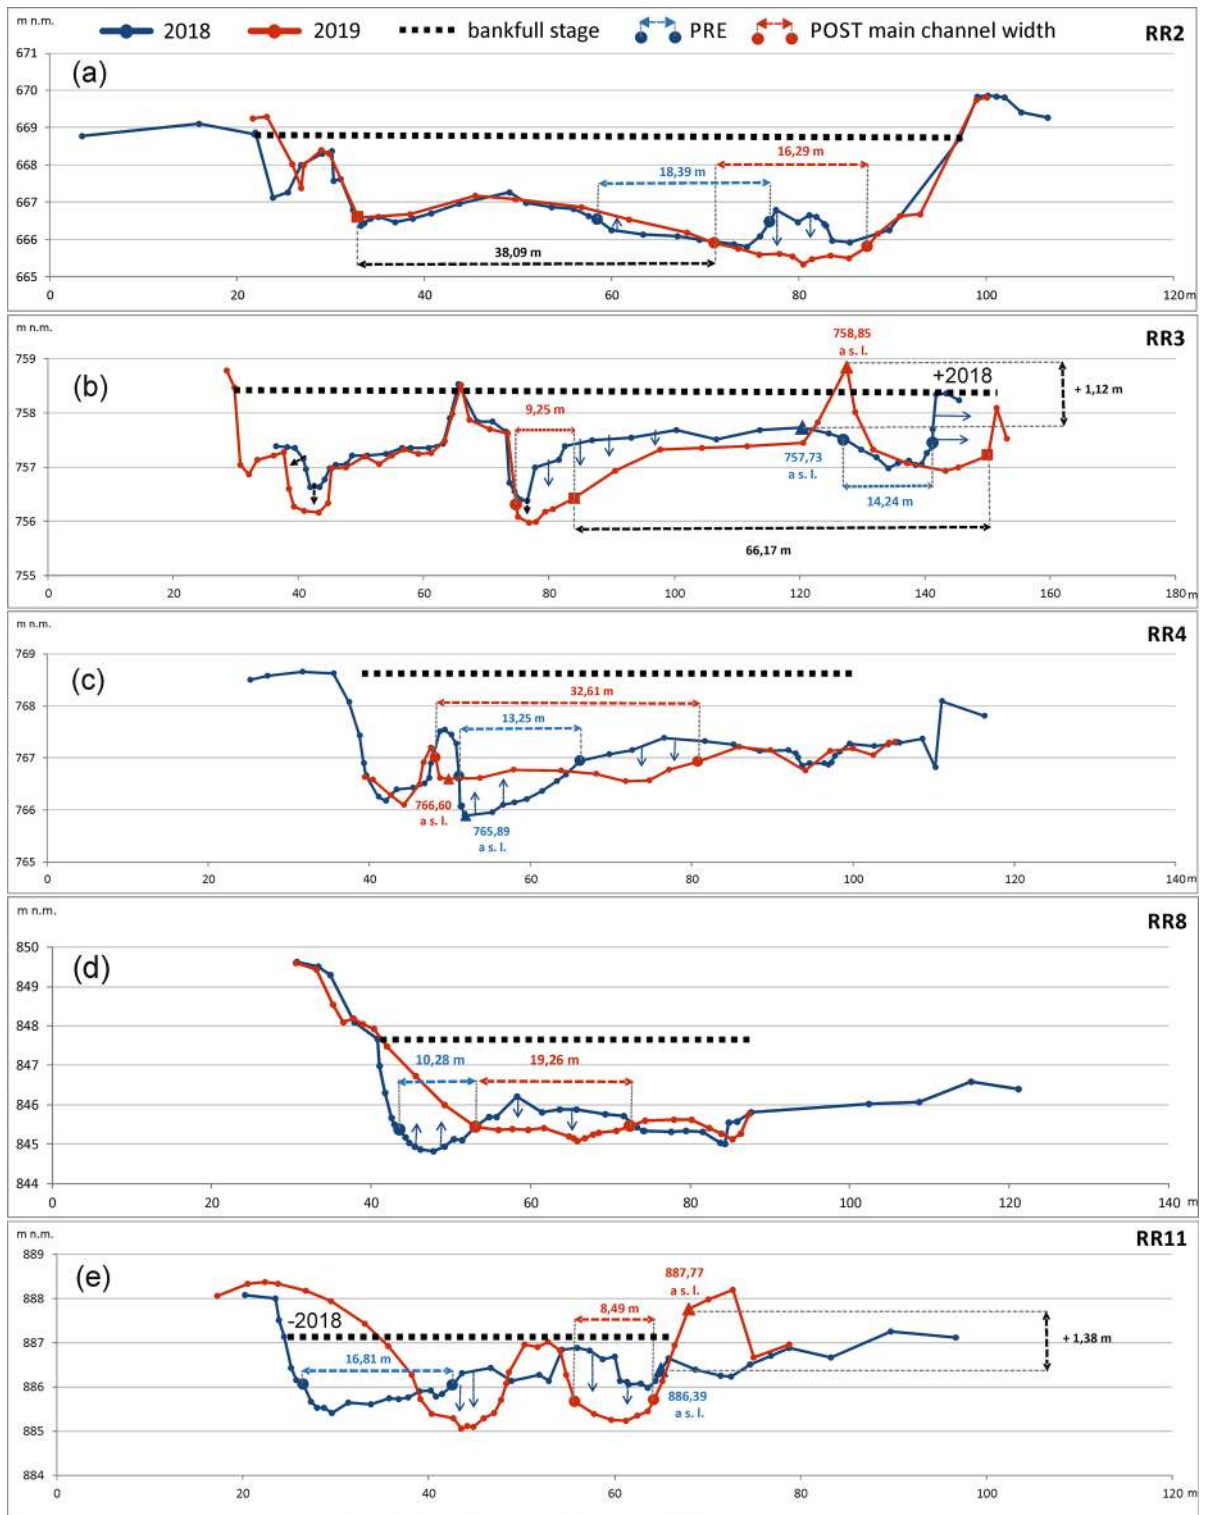
**Figure 5.** Geometry of cross-sections on the selected river reaches (a) RR2, (b) RR3, (c) RR4, (d) RR8, (e) RR11 on the Belá River where river training were carried out. The blue cross-section represents the reference state (PRE) of the river before the flood in July 2018; the red cross-section represents the state after this flood event and river training during August 2018 (POST). At each cross-section, the width of the main channel (m) is marked (red and blue numbers). Bankfull stage at each cross-section reflects measured bankfull width where value  $\pm$  2018 points out differences in width between pre- and post-flood management periods. The direction of the arrows marked in cross-sections represents surface modification of the river’s active zone during river training.

The first cross-section RR2 (Fig. 5A) is situated in the village of Dovalovo (urban part of the town of Liptovský Hrádok). The original multi-thread pattern was destroyed across its entire width. The original main channel was transferred from the central part to the left side of the braidplain, while two original island landforms were removed. The width of the artificial bar surface was 38.09 m, representing two-thirds of the total width of the river’s active zone at this cross-section.

Cross-section RR3 (Fig. 5B) is located in the settlement of Pribylina. On the left side of the river’s active zone, a 66.17 m-wide artificial bar surface was formed. The top of this artificial bar surface (in the form of a dike) exceeds the original top of the mid-channel bar by 1.12 m (Figs. 2B and 5B). This cross-section is further characterized by a reduction of the erosion base of both the main and side channels by about −0.5 m. The position of the main channel was artificially shifted to the center of the braidplain, reducing its width and depth.

The third cross-section RR4 (Fig. 5C) is situated under the road bridge between the settlements of Pribylina and Liptovská Kokava. At the cross-section, the bottom of the main channel was levelled and raised by 0.71 m. The main channel was artificially extended from the original 13.25–32.61 m, while the original mid-channel bar was removed.

Cross-section RR8 (Fig. 5D) is located near the right-side tributary of the Bystrá creek to the Belá River. At this cross-section, on the right side of the river’s active zone, there was massive accumulation of gravel material

Cross-section RR11 (Fig. 5E) is located upstream on the Belá River, above the Kokavský Bridge site. Piled-up gravel on the right bank caused destruction of the original 16.81 m-wide main channel. By adding gravel on the left bank, the original bank height increased by 1.38 m. A new 8.49 m-wide main channel was artificially created on the right side of the river's active zone. The management intervention raised the riverbanks, notably increasing the isolation of the main channel from the surrounding floodplain.
