Impacts to agriculture and critical infrastructure in Argentina after ashfall from the 2011 eruption of the Cordón Caulle volcanic complex: an assessment of published damage and function thresholds

Heather Craig^{1*}, Thomas Wilson¹, Carol Stewart², Valeria Outes³, Gustavo Villarosa³ and Peter Baxter⁴

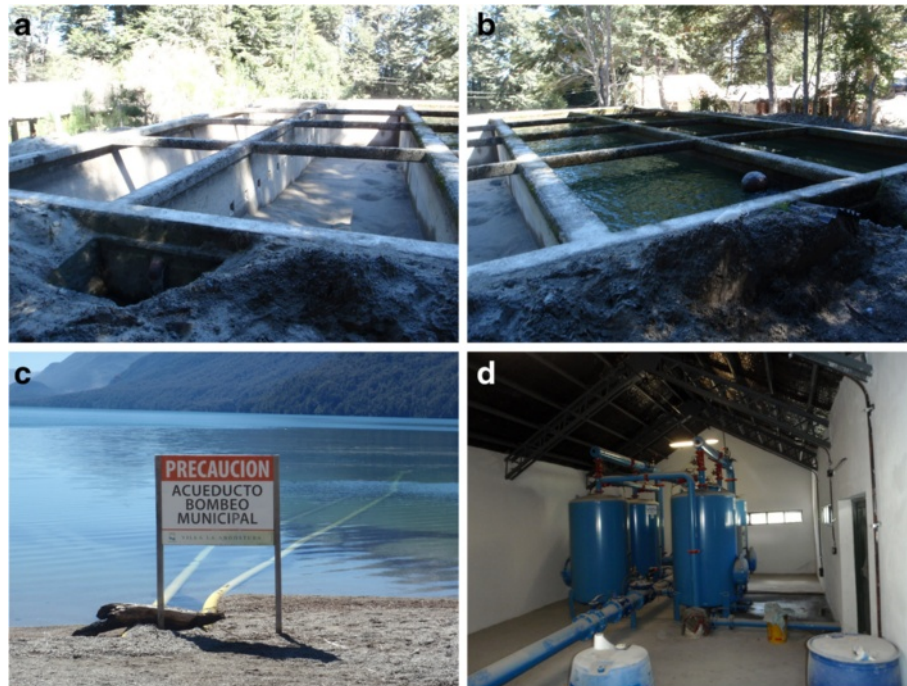
Fig. 8 Villa la Angostura water supplies **a** non-operational sand filters of the Las Piedritas stream-fed system, filled with ashfall; **b** operational sand filters at the Las Piedritas treatment site; **c** Lomas del Correntoso intake from Lake Correntoso; **d** Chlorination plant

Villa la angostura In Villa la Angostura, the town centre is supplied with water by a relatively advanced treatment system. From dual intakes on Lago Correntoso and Lago Nahuel Huapi, water is pumped 80 m uphill to a treatment plant where there is an initial filtration step followed by pressure sand filtration then chlorination (Fig. 8). The eruption increased the level of ash suspended in the lakes, which caused high levels of wear and tear on pumping equipment. For instance, one pump had been in service since 1997 with no problems, but had to be completely replaced after the eruption. Power outages also caused problems for this system, which relies on pumping, and generators were brought in to maintain pumping.

Outlying neighbourhoods are served by a range of smaller and more rudimentary systems with intakes either in the lakes or in streams, followed by initial passage through flow control/settling basins then treatment via slow sand filter beds followed by chlorine dosing. These systems are in general poorly maintained, with inadequate removal of suspended solids and organic

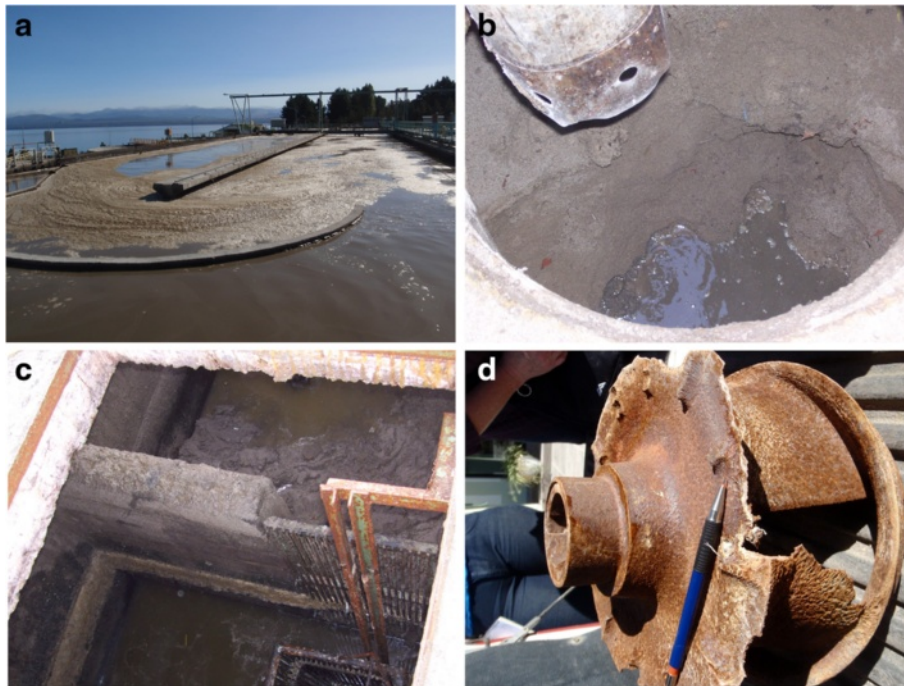
Fig. 11 Bariloche wastewater treatment system **a** biological reactor showing some Nocardial foaming; **b** and **c** sewer lines and junctions inundated with ash; **d** ash-accelerated pitting and thinning damage to sewage pump impeller

the functioning of the microbial population in the pond, but did reduce the plant's capacity. The ash caused few problems for the initial screening of wastewater (manual screening through static bars, followed by pumping up to a decanter for primary sedimentation).

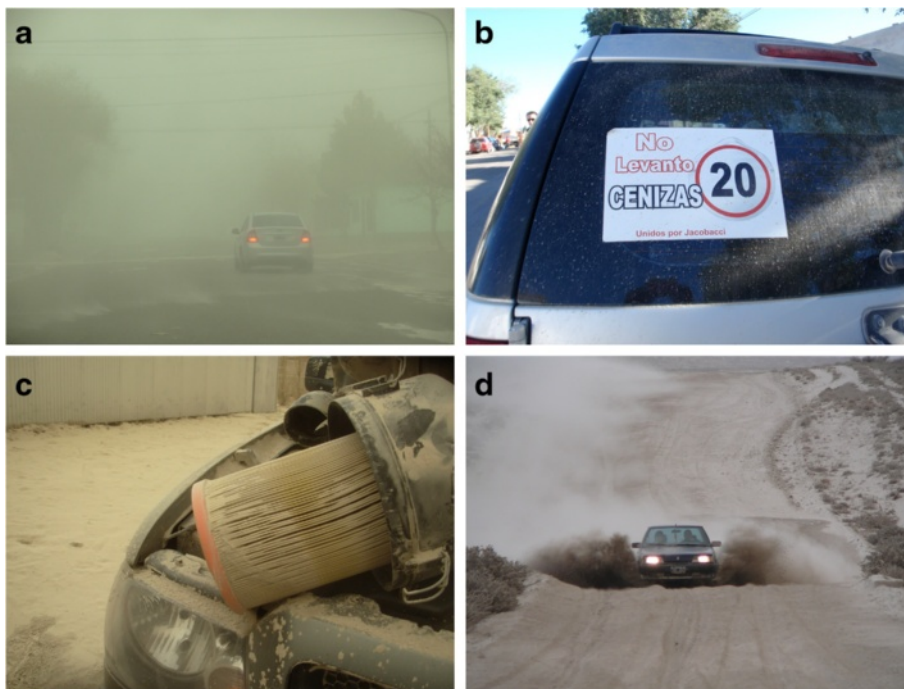
Fig. 12 Road conditions in Jacobacci **a** poor visibility In Jacobacci (11/7/2011); **b** 2WD car outside Jacobacci in ~50mm ash; **c** car air filter clogged with ash; **d** sticker on car window in Jacobacci advising drivers to restrict their speed to 20km/h in order to not "stir up the ash." (Photo credit: Ailen Rodriguez)

started for the first week, slowing the reopening of the town’s major roads. Driving conditions in the steppe area remained treacherous for many months after the initial eruption, especially in areas where the ashfall was thicker than 100 mm (Fig. 12a & b). Due to remobilisation in the area, visibility issues persisted in the steppe region and air filters became clogged with ash and needed cleaning and replacing regularly (Fig. 12c; Table 10). Dampening down ash and restricting vehicle speeds was employed to try and allow traffic on the roads to continue to be used (Fig. 12d; Table 10). Despite these measures driving remained a challenge on windy days due to low visibility even up to 18 months after the eruption.

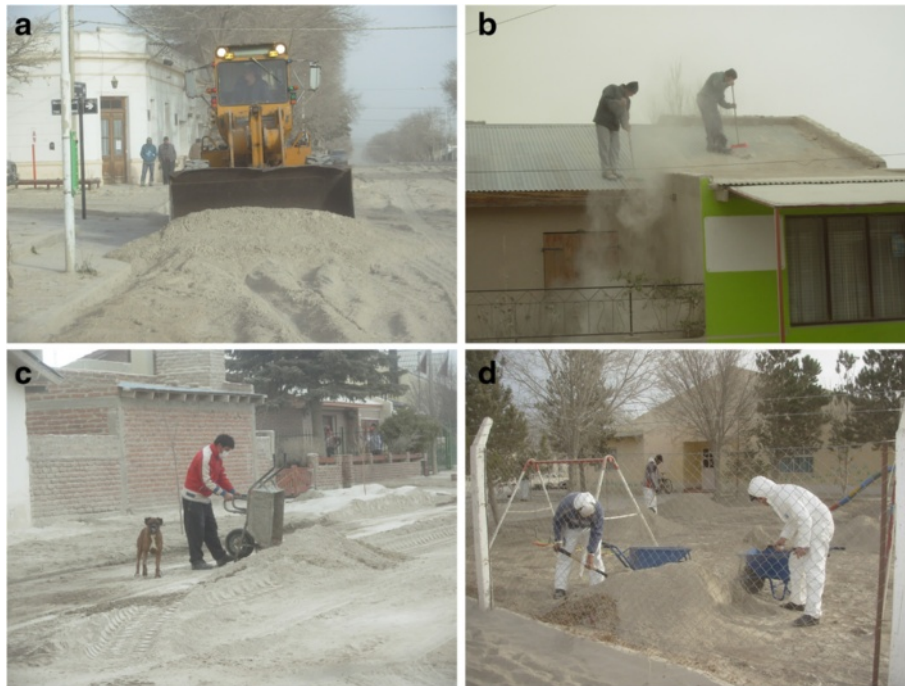
Fig. 17 Ash removal from main street of Jacobacci (9/6/2011); **a** Bulldozer removing ash from the main street; **b** Residents sweeping dry ash off roofs with brooms; **c** Piling ash into collection piles on the road for municipal collection; **d** People cleaning ashfall from a community playground. Photo credits: Ailén Rodríguez (**a**) and Jose Mellado (**b, c, d**)

In Jacobacci, clean-up operations were delayed for a week because of extremely poor visibility. The main streets were cleared first, using all available trucks, diggers and bulldozers in the town (Fig. 17a). Following this, residents were provided with large sacks to fill with ash cleared from their own properties (Fig. 17b, c, & d). Collected ash was dumped in natural depressions to the east (downwind) of the town, and weighed down with waste building materials in a short-term attempt at stabilisation. In the longer term, there were plans to vegetate the deposits. Clean-up operations in Jacobacci were significantly more difficult by constant problems with wind remobilisation of unconsolidated ash deposits, not only within the urban area but also from upwind sources. This meant that clean-up operations had to be coordinated and carried out numerous times following every major wind storm tephra remobilisation event.
