TECHNICAL REPORT

NO. 13100

Improvement in the Fatigue Behavior of Tank Track Pins

J.F. Wallace & A.M. Said
Case Western Reserve University
Department of Metallurgy & Mat'l Sci.
10900 Euclid Avenue
Cleveland, Ohio 44106

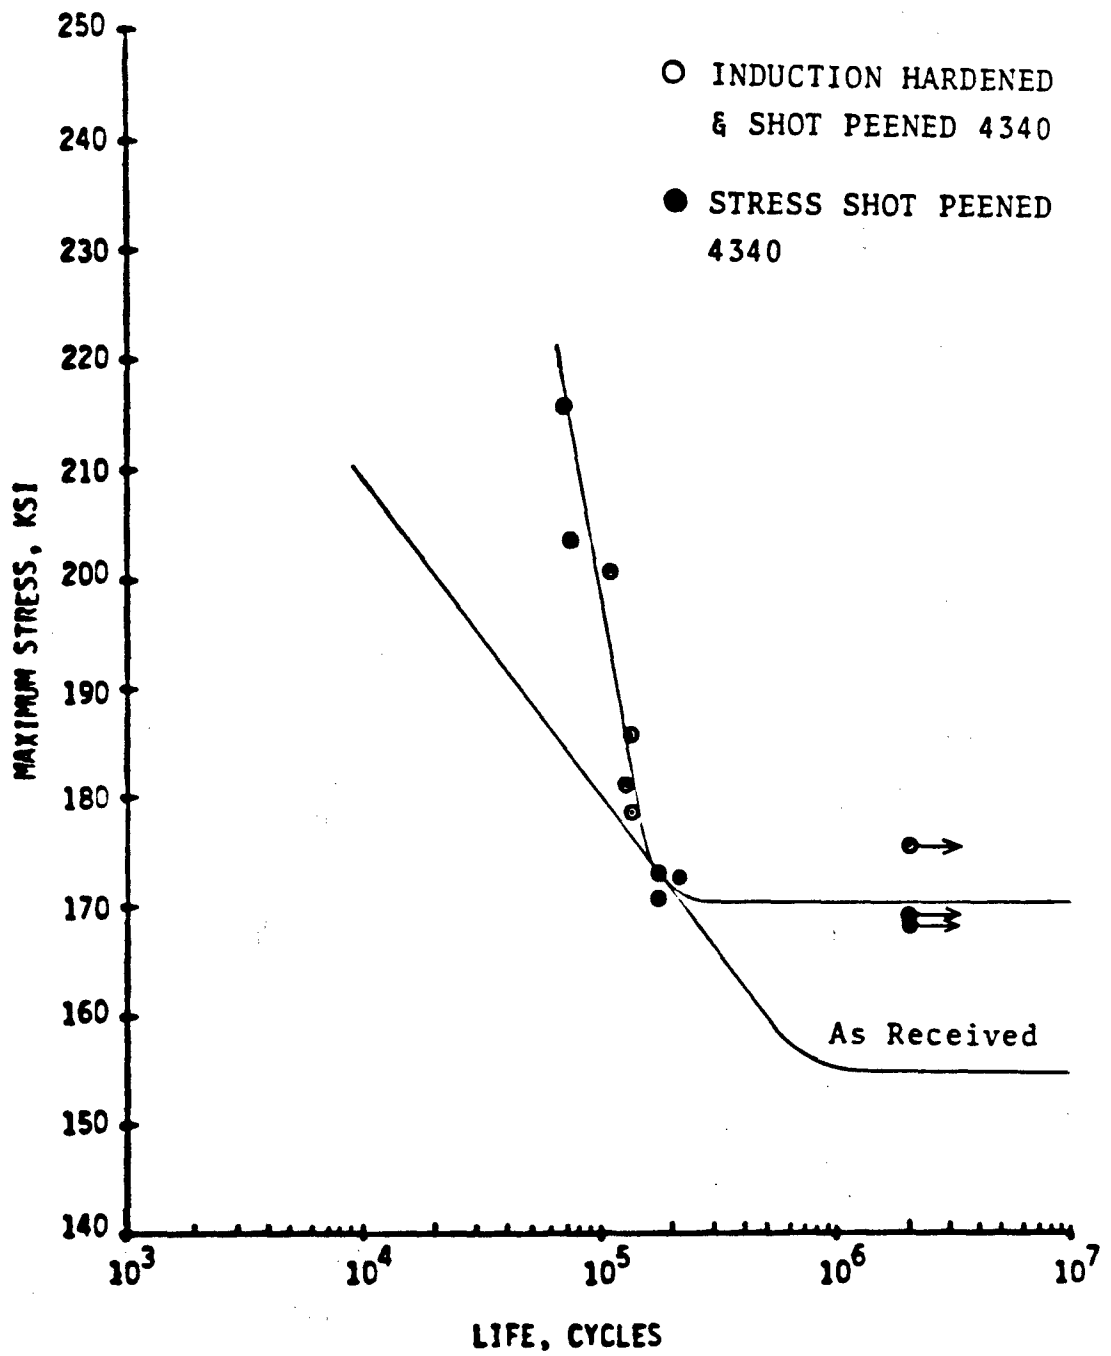
Figure 5-8. S-N Curve for Induction Hardened SAE 4340 Steel Pins.

5.3.1.2. Stress Shot Peened 4340. The fatigue test results on stress shot peened 4340 pins are listed in Table 5-4 and the S-N curve shown in Figure 5-8. Although these pins might be expected to perform somewhat better than the stress shot peened 8650H pins because of its superior hardenability, the results did not indicate so. The endurance limit of stress shot peened 4340 is 170 ksi compared to 198 ksi for the stress shot peened 8650H pins. The fatigue fracture surfaces of the 4340 pins did not reveal subsurface failure as in the case of 8650H pins but instead showed fatigue cracks that originated from the inner surface as indicated by the arrow in Figure 5-16. The compressive residual stress at the outer surface have the same magnitude as that of 8650H which is -212 ksi. When a maximum bending stress of 200 ksi is applied, this high compressive stress keeps the surface in compression with a net stress of -12 ksi. This sufficiently strengthens the outer surface since the stress does not become high enough for a fatigue crack to develop. The 4340 pins have a 0.6 inch bore hole diameter which is 0.1 inch larger than that of as received 8650H pins. Plots of stress and strength gradients across the cross section of the two pins (Figures 5-17 and 5-18), show insufficient strength gradient in the core to resist the applied stress gradient. The tensile stress at the inner surface of 4340 pin is 16 ksi larger than that of 8650H when subjected to equal bending stress of 200 ksi (see also Tables 5-10 and 5-11). Apparently the larger bore diameter has a greater effect than anticipated in weakening the inner surface, probably through the increased stress concentration and the higher tensile stress. Accordingly cracks originate at the inner surface

5.3.1.3. Induction Hardened and Shot Peened 4340. Fatigue test results on induction hardened and shot peened 4340 pins are listed in Table 5-5 and the S-N curve shown in Figure 5-8. The results indicate no significant difference between the fatigue limit of the the induction hardened pins and the stress shot peened 4340. For this reason, only a single curve is drawn for the two type of pins, both with a fatigue limit of 170 ksi. However, the fracture surfaces of induction hardened pins exhibited two different type of crack origins which indicate that they experienced different modes of fatigue failure. These two types of crack origins are indicated by the arrows in Figures 5-19 and 5-20. At maximum bending stress level of about 180 ksi and above, crack origins were observed to be at the outer surface. At bending stresses below 180 ksi, crack origins were found to be at the inner surface of the pins. The stress-strength gradient analysis for maximum and minimum applied loads are illustrated in Figures 5-21 and 5-22 and Tables 5-12 and 5-13. These figures indicate that subsurface failure should occur at the case-core interface of the induction hardened pin. Nevertheless, no such failure was observed in any of the failed specimens. The compressive residual stress at the surface is not high enough to keep the surface in a compressive region. At high bending stresses above 180 ksi, the tensile stress at the surface is high enough to produce significant tensile stresses and to cause crack to originate at the outer surface. However, at low bending stresses, below 180 ksi, the tensile stresses at the inner surface that is not shot peened becomes high enough to cause cracking to start at this surface. Figures 5-23 and 5-24 show fatigue cracks arrested in the pin before total fracture occurs. These cracks were initiated at the inner surface and have travelled to the outer surface. AB in Figure 5-24 represents the fatigue crack propagation zone while BD is the instantaneous failure region when the remaining cross-sectional area could no longer sustain the applied load. CD is the instantaneous crack portion through the induction hardened layer.
