Alex A. Volinsky, W. Miles Clift*, Neville R. Moody* and William W. Gerberich
University of Minnesota, Dept. of Chemical Engineering and Materials Science, Minneapolis,
MN 55455, volinsky@cems.umn.edu

ABSTRACT

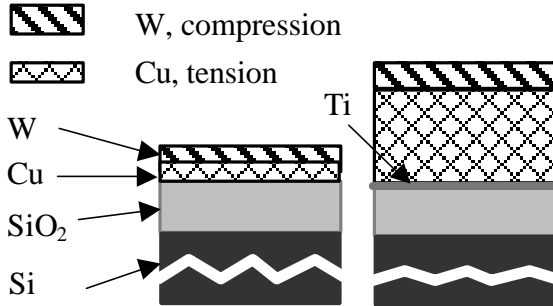
Figure 1. Thin film system.

Cu films of eight thicknesses between 40 nm and 3 μm were sputter deposited on top of oxidized Si wafers with and without a 10 nm thick Ti adhesion-promoting layer. All films were passivated with a 1 μm thick layer of W for adhesion measurements (Figure 1). Thin film deposition and adhesion measurement details are described in [3]. A 1 μm radius conical diamond tip was used in all indentation experiments. In our previous study [3] we looked at the

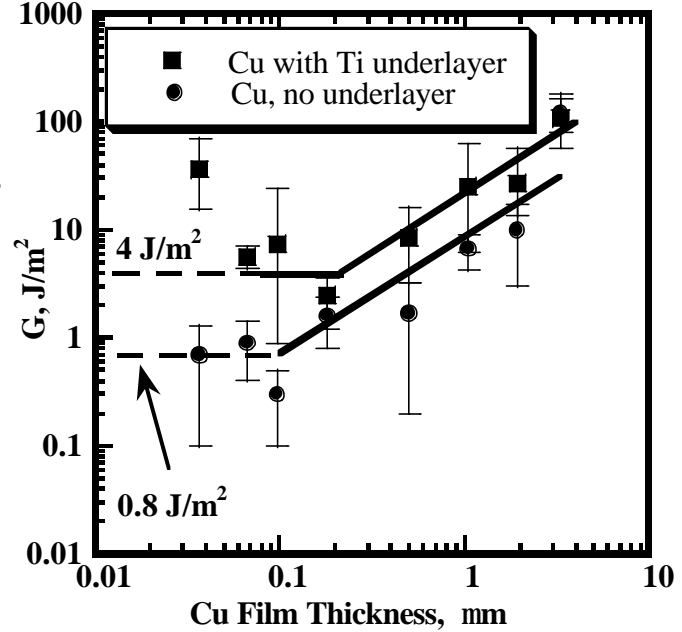
Figure 2. Cu film adhesion as a function of film thickness.

adhesion of Cu thin films with and without a 10 nm Ti adhesion-promoting underlayer as a function of Cu film thickness (Figure 2). On average, for Cu (under 100 nm thick) without a Ti underlayer, 0.8 J/m^2 was measured. This value corresponds to the thermodynamic work of adhesion of Cu to SiO_2 (W_T) measured by the contact angle technique [6]. This means that for films less than 100 nm thick there is almost no plastic deformation at the crack tip [3, 5]. For thicker films there is a definite contribution of crack tip plastic deformation (U_f) to the practical work of adhesion (W_p), which scales with the film thickness (Figure 2).

true work of adhesion was only a 27% higher than the thermodynamic work of adhesion, which perfectly agreed with the actual experimental measurements (Figure 2).

For thicker Cu films having strong adhesion (Figure 2), those over 200 nm thick could not be removed with an adhesive tape (they “survived” the pull-off test). The only Cu film with a Ti underlayer removed was a 40 nm thick film. Unlike films without the Ti underlayer, instead of removing islands of film around the blister (Figure 3), the whole film with the Ti underlayer was removed with an adhesive tape. Some Cu films with the Ti underlayer also exhibited fiducial mark formation. However, no fiducial marks were found for indents, where the indenter did not penetrate through the bilayer thickness, and where no radial cracks were present. It seems like the delaminated interface has to be exposed to the atmosphere for the marks to exist. From Figure 6 showing AES data for the tape and substrate side, it may be concluded that Cu films with a Ti underlayer failed along the Ti/Cu interface. There is no Cu peak on the substrate side scan, but there are two distinct Ti peaks. Opposite, on the tape side there is Cu, but no Ti.

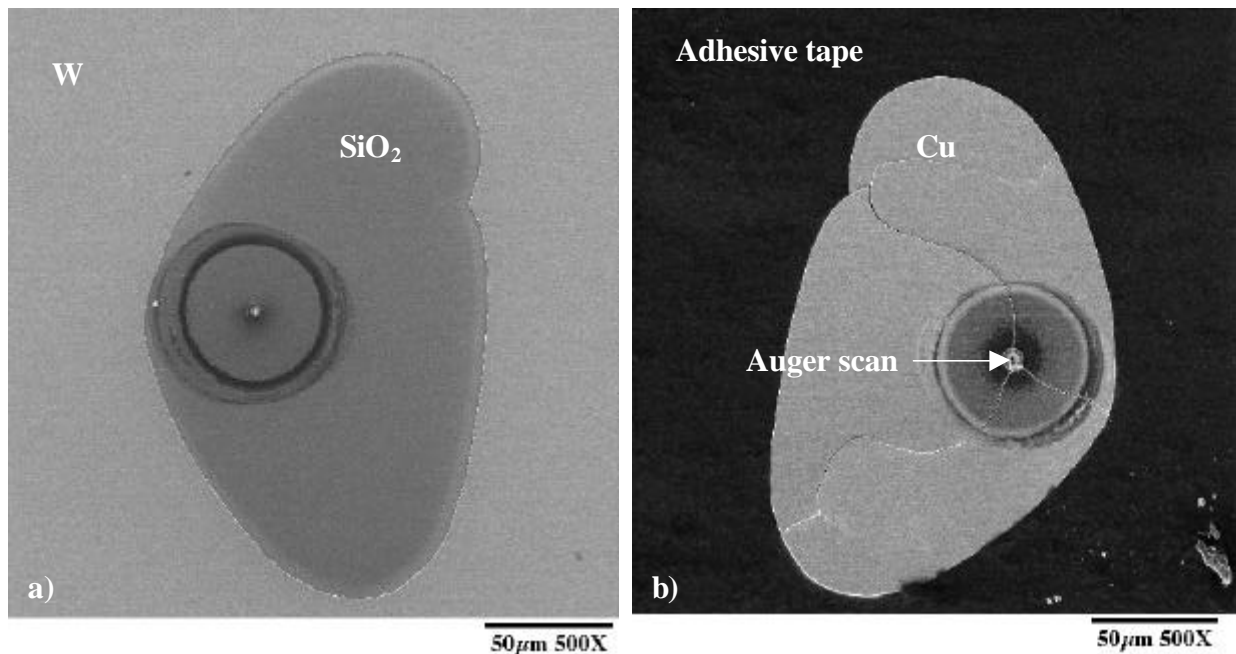
Figure 3. Cu 120 nm fiducial marks on the substrate a) and on the tape b) sides.

Conceptually it is important to know along what interface the fracture occurs during the blister formation. To evaluate this blisters were removed with carbon adhesive tape for analysis. Auger electron spectroscopy analysis showed that the failure occurs along the Cu/SiO₂ interface [4]. The delaminated area of a 120 nm thick Cu film after blister removal is shown in Figure 3a. As in the previous experiments [4], fiducial marks are clearly seen on the SiO₂ side, and correspond to the original blister diameter. Figure 3b shows the removed portion of the film adhered to tape. Note that inside the blister the light areas on the substrate side correspond to the dark areas on the tape side and visa versa.

In our previous study [4] we used Auger electron spectroscopy to identify the contents of the fiducial marks. The results were somewhat inconclusive due to the small volume of the marks' matter and SiO₂ charging problems. In the current situation the removed conductive film contains most of the mark (black area inside the blister in Figure 3b), and it is on a conductive tape. This allowed for a more accurate AES analysis. Figure 4a shows an AES line scan data superimposed on the corresponding portion of the SEM image from Figure 3b. The carbon concentration jumps from a background value of 55% to almost 85% inside the mark, at the same time Cu concentration of 30% drops to about 10% inside the mark. Carbon concentration increases in the darker areas, and decreases in the whiter areas of the mark (Figure 4a). Inside the blister the Cu film is covered with a substance that contains carbon. There are three possible sources for carbon: adhesive tape, the diamond indenter [8] and hydrocarbons from the atmosphere [4]. Adhesive tape as a contamination source can be eliminated, since several blisters were removed using a micromanipulator, but the marks were still present.

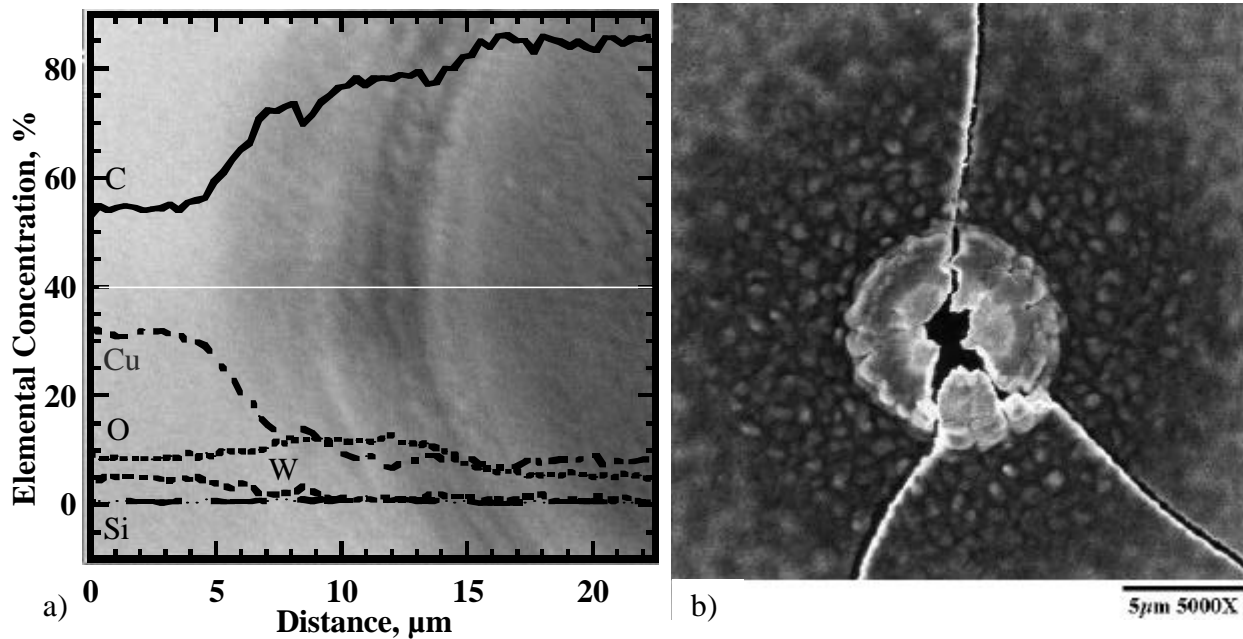
Figure 4. a) AES scan superimposed on the SEM image from Figure 3 b), b) Center of the blister from Figure 3 b).

Since the only element besides carbon, which exhibits a concentration increase inside the mark is oxygen (Figure 4a), it is possible that carbon contamination comes from hydrocarbons and moisture in the atmosphere. Due to the radial cracking the two newly formed surfaces are exposed to the atmosphere during indentation-induced delamination. The crack itself can suck relatively mobile moisture and hydrocarbons into its tip, leaving behind the fiducial mark (Figure 3). This is identically analogous to India ink being sucked into a crack tip of bulk K_{IC} specimens [10]. Initially, India ink was put into the crack to outline the stable crack growth region, but this practice was abandoned later due to the finding that this promotes stress corrosion cracking and hydrogen embrittlement. Similarly, it has been shown that the test temperature and hydrogen charging both affect Cu film adhesion [7, 9]. Analogous behavior may then exist in the case of fiducial mark formation, where the interfacial toughness may be easily reduced with the contamination present. Indentation fracture experiments in vacuum or in partial pressure of environmental contaminants should resolve the question of atmospheric influence on the fiducial marks formation and Cu film adhesion. The origin of carbon in fiducial marks will be addressed in greater detail in future work.

The carbon contamination layer on the Cu film (tape) side does not appear to be uniform, since there is structure to it. Figure 4b shows the magnified center region of the fiducial mark from Figure 3b. There is a 10 μm diameter circular residual impression left by the diamond indenter with three radial cracks emanating from its center. The fiducial mark starts right around the indentation contact area within a rough region of carbon-containing black particles (Figure 4b). There is a distinct transition at about 20 μm from the indent center in terms of the surface roughness. This is seen even more clearly on the contact mode AFM images of an 80 nm thick Cu film (Figure 5). The Cu film is relatively smooth outside the original blister delamination area. However, the surface roughness increases inside the blister area, and it increases more

closely to the center of the blister. As the transition zone diameter is about twice the indenter contact diameter (Figure 4b), it is possible that the roughness transition is associated with the plastic zone in a thin Cu film. Being capped under the W superlayer, Cu undergoes severe plastic deformation upon indentation. Cu is not allowed to pile-up, being underneath the superlayer, so the plastic zone “tunnels” in the plane of the Cu film [7]. Even though Cu is capped with the superlayer, the effective yield stress of the bilayer composite, s_{ys} can be calculated using the plastic zone size model developed by Harvey et al [12]:

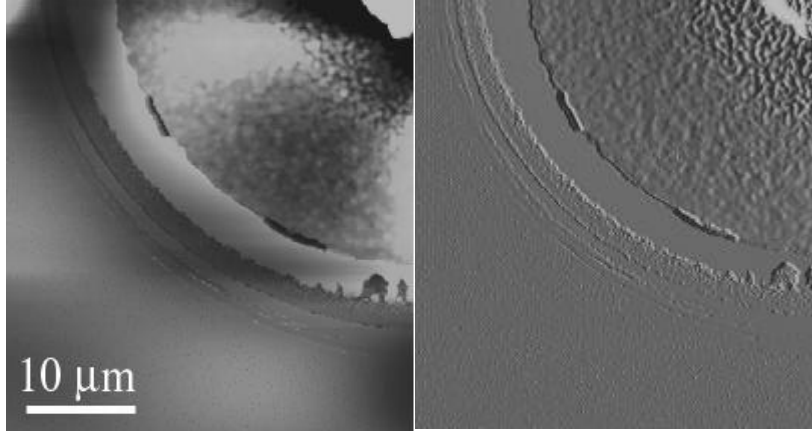
transition zone in fact may correspond to the plastic zone size. Note that these are contact mode AFM images, and a regular sharp SiN contact mode AFM tip does not cause any surface damage.

Figure 5. Contact mode AFM height (300 nm Z range) and deflection images of an 80 nm Cu blister.

where P is the maximum indentation load and c is the plastic zone radius around the indentation. A yield stress of about 1.2 GPa would result for a 250 mN indentation and a 10 μm plastic zone size (Figure 5). This seems to be a reasonable number for a W/Cu bilayer, so the fiducial mark

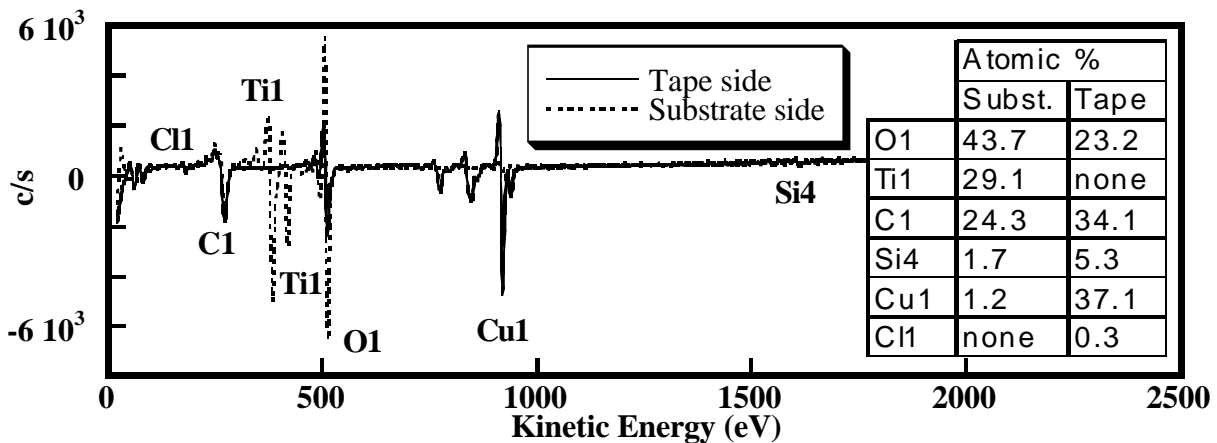
Figure 6. Auger Electron Scans on the substrate and film sides for Si/SiO₂/Ti/Cu/W.

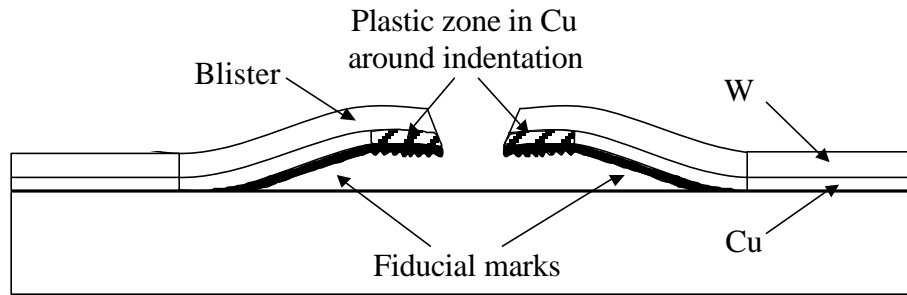
Figure 7. Fiducial mark schematics.
