INFLUENCE OF HEAT TREATMENT ON THE FATIGUE CRACK GROWTH RATES OF A SECONDARY HARDENING STEEL

Horn, R.M.

August 1973

Inorganic Materials Research Division, Lawrence Berkeley Laboratory and  
Department of Materials Science and Engineering, College of Engineering;  
University of California, Berkeley, California 94720

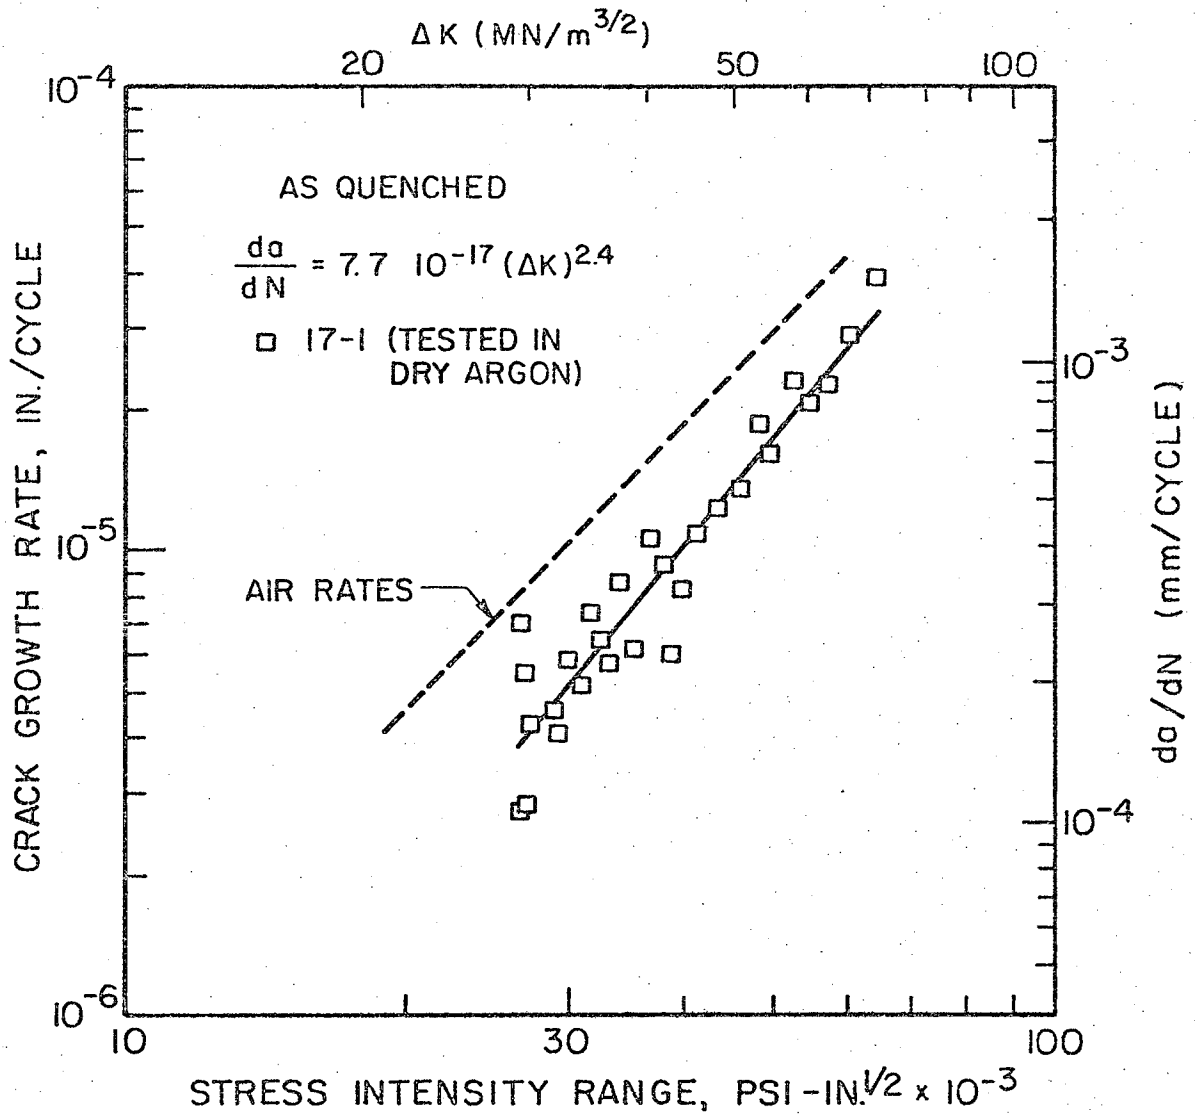
Fig. 3a

- Fig. 3. (a) Fatigue crack propagation rates vs stress intensity range for the as-quenched 5Mo-0.3C steel carried out in dry argon. Data from specimen 17-1. Dashed line represents rates in air.

Figures 3(a) and (b) show the fatigue crack growth rates in dry argon for the as-quenched and 600°C tempering treatments, respectively. The broken lines represent the ambient properties. It is clear that moist air environments enhance crack growth rates in the as-quenched steel. This has been repeatedly shown on similar high strength steels.<sup>8,29</sup> The 600°C tempered material showed less sensitivity to environment, however. The fatigue fracture surface for the specimen tested in dry argon still showed evidence of intergranular failure modes both in low and high  $\Delta K$  regions. For this microstructure, having unusually poor fracture toughness, the undesirable features dominated environmental effects.

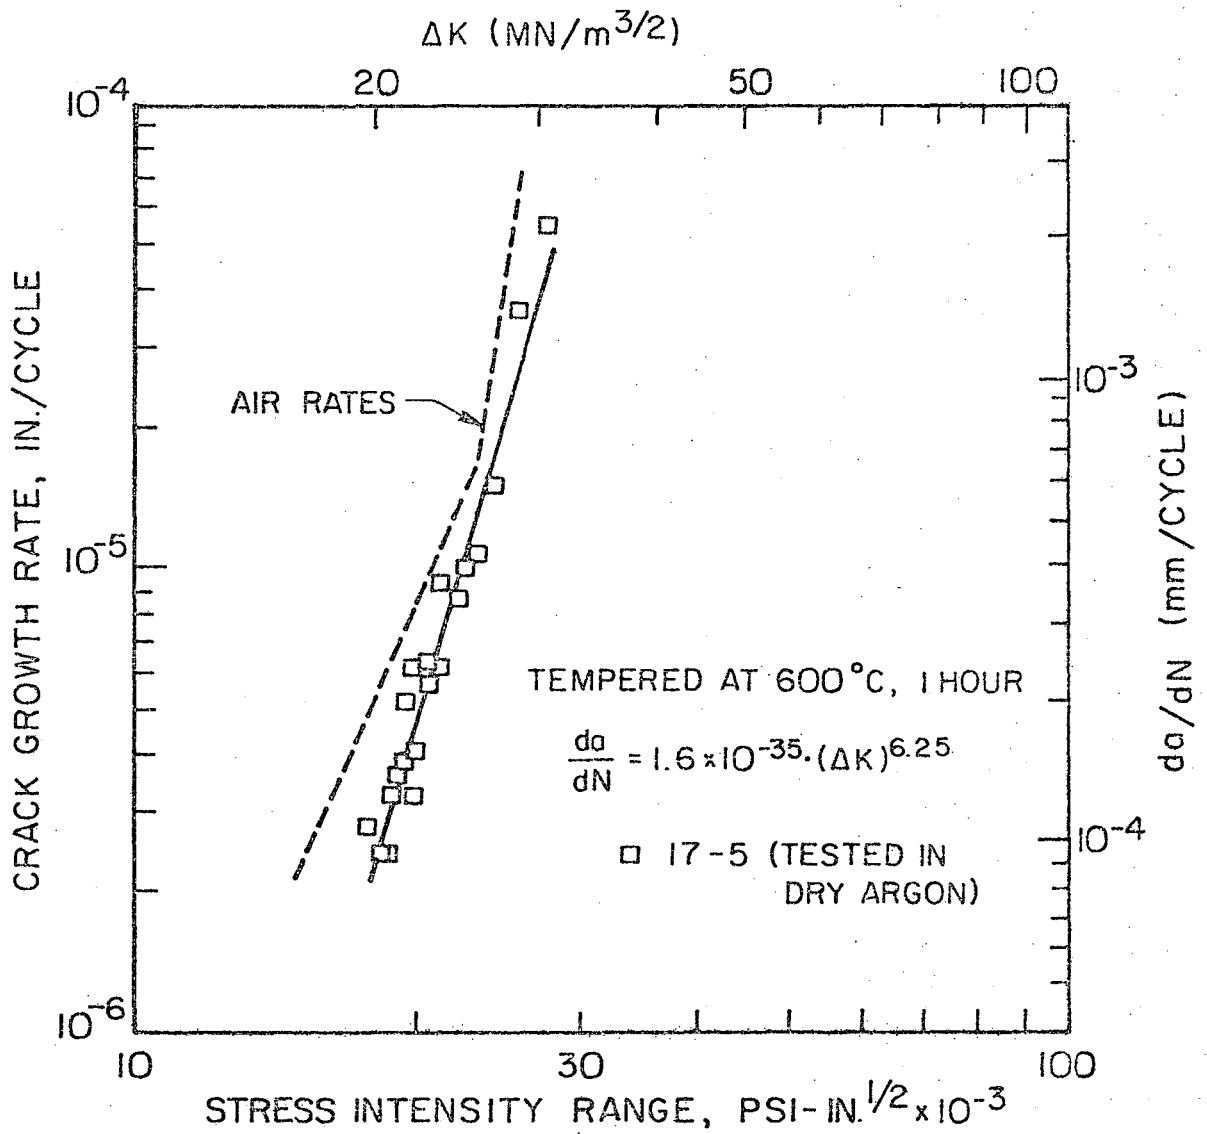
Fig. 3b

(b) Fatigue crack propagation vs stress intensity range for the 600°C tempered steel carried out in dry argon. Data from specimen 17-5. Dashed line represents rates for steel in same condition in air.
