## Inner-Bank Erosion Processes and Solutions at Coastal Inlets

by William C. Seabergh

1. REPORT DATE <b>SEP 2002</b>	2. REPORT TYPE <b>N/A</b>	3. DATES COVERED <b>-</b>	
4. TITLE AND SUBTITLE <b>Inner-Bank Erosion Processes and Solutions at Coastal Inlets (ERDC/CHL CHETN-IV-52)</b>		5a. CONTRACT NUMBER	
		5b. GRANT NUMBER	
		5c. PROGRAM ELEMENT NUMBER

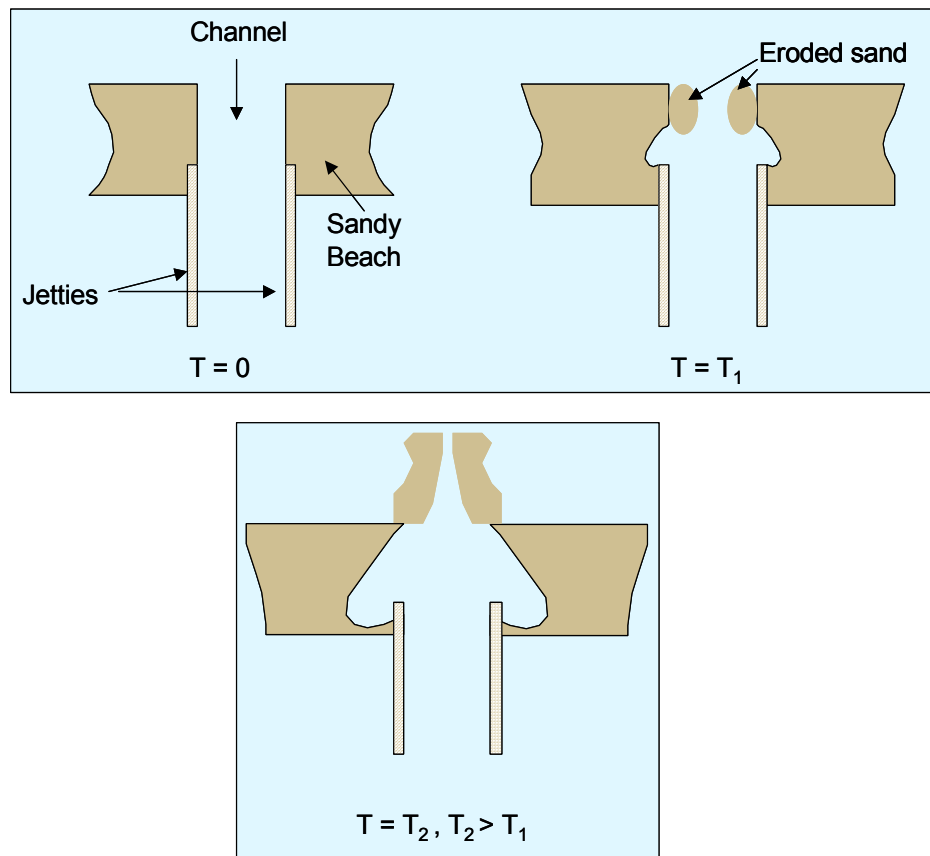
Figure 1. Sequence of inner-bank erosion over time, from time  $T = 0$  to time  $T = T_2$

**BACKGROUND:** Jetties at inlets often terminate in the alluvial soil of the barrier island or mainland of the entrance that they stabilize. The termination area, exposed to waves and currents, is frequently observed to erode (Figure 1). If erosion is permitted to proceed unabated, a crenulate-shaped shoreline region will develop from the terminus of the jetty, extending both bayward and laterally into the adjacent beach. The expansion of erosion leads to loss of property and difficulties in reclamation if a shallow-water environment develops. The eroded sediment may move into the channel, contributing to shoaling.

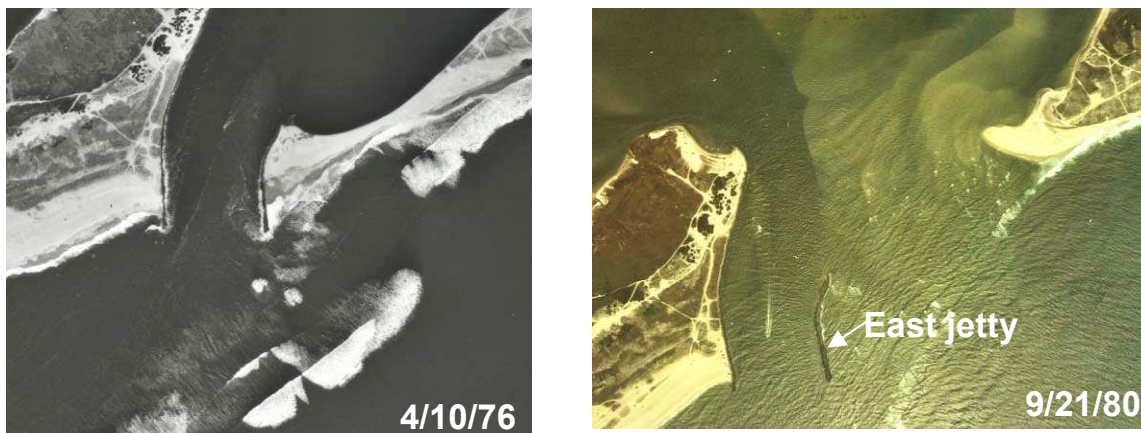
Figure 2. Left panel shows Moriches Inlet, NY, before it breached on 15 January 1980. East jetty was flanked, after it breached, as shown in the right panel

The eroded region may flank the jetty, leaving it isolated from the shore. Figure 2 shows an example before and after breaching. This breaching at Moriches Inlet, NY, has been described by Sorensen and Schmelz (1982). Isolation of the jetty may lead to potential problems of tidal current scour near the structure, opening the already eroded embayment to increased wave activity and additional erosion, and permitting increased wave attack on the jetty itself. As part of the Coastal Inlets Research Program (CIRP) being conducted at the U.S. Army Engineer Research Development Center (ERDC), Coastal and Hydraulics Laboratory (CHL), erosion at the bay side of jetties was studied in a movable bed physical model of an inlet. After the governing processes were understood, preventive techniques were investigated.

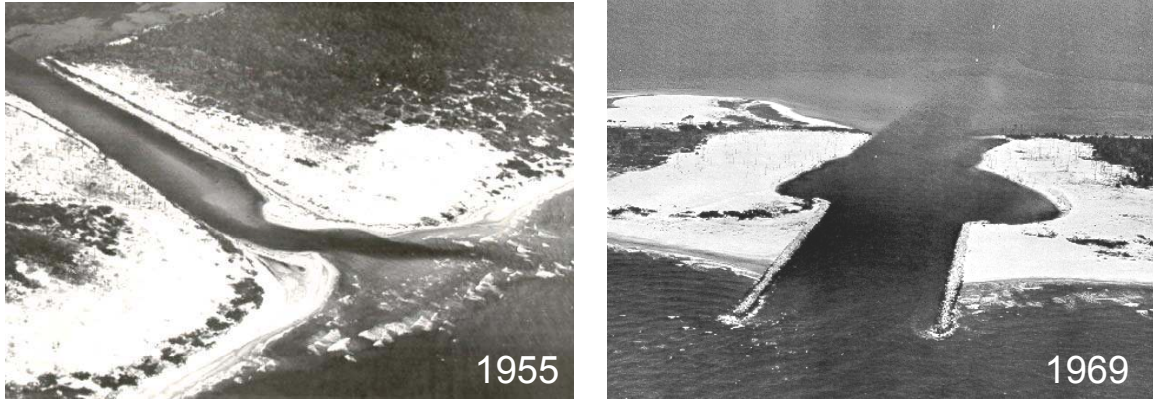
Figure 3. Before and after jetty construction at St. George Inlet, FL, on Gulf Coast

Erosion occurred at St. George Inlet, located on the Gulf Coast in the eastern part of the Florida panhandle. Figure 3 shows the inlet in its natural state (left panel), and the right panel shows the inlet 12 years after parallel jetties were constructed. An erosive force created the curved shorelines at the base of the jetties. Figure 4 shows the entrance channel at Panama City Harbor, FL, created by cutting through an elongated spit in 1933. The construction included jetties extending to the -3.7-m-mllw (mean lower low water) contour. The inner 90 m of the jetties flared outward and were anchored in sand. Between 1935 and 1956, landward extensions of the jetties were made to prevent continued erosion of the inner-bank shoreline. Flanking of the jetties was a major concern.

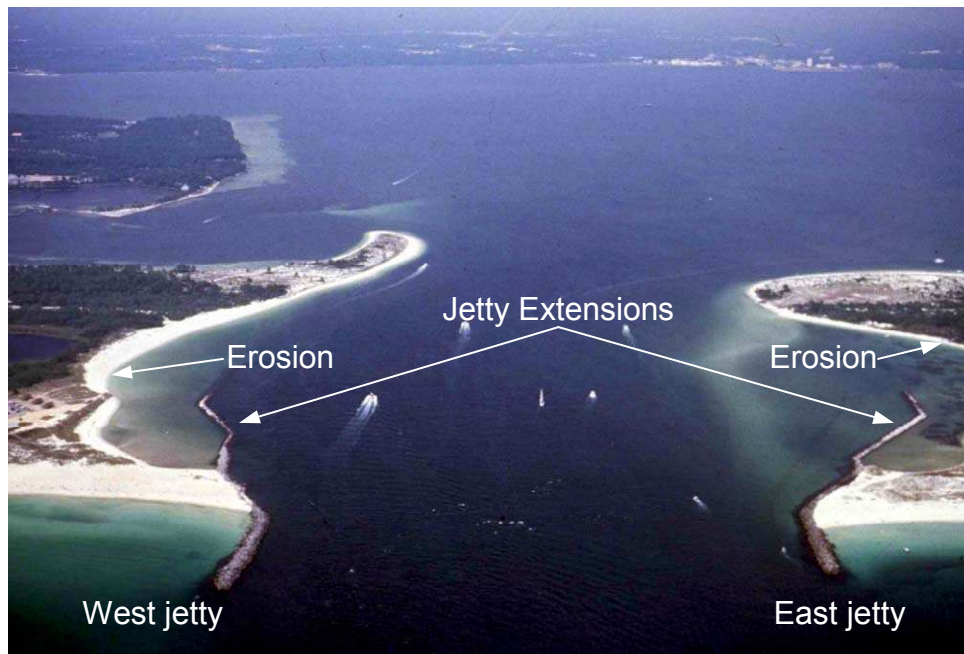
Figure 4. St. Andrews Bay Inlet (Panama City, FL) 1992. Jetty extensions added to prevent flanking

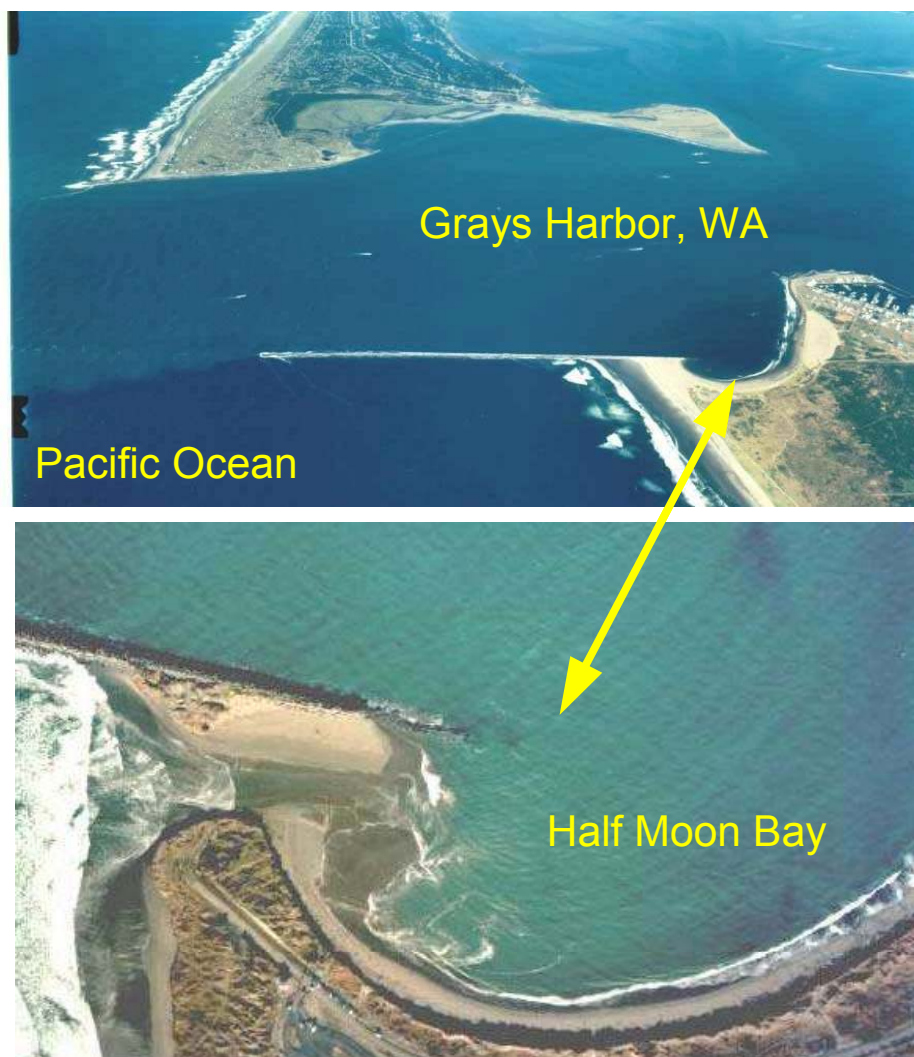
Figure 5. Jetty flanking at Half Moon Bay, Grays Harbor, WA

Figure 5 shows flanking of the south jetty at Grays Harbor, WA. The region behind the shoreline is called Half Moon Bay. This “bay” was created after the south jetty was raised from +3.65 m mllw to +6.10 m mllw. With the jetty at the +3.65-m elevation there was continual sand transport from the ocean shoreline to the region inside the inlet, probably due to the strong wave climate of the region pushing sediment over the landward intersection of jetty and beach. After the jetty was raised, the sediment supply was cut off and creation of Half Moon Bay began. The jetty was raised in 1936, and by 1993 the distance between the beach and Half Moon Bay was short enough that a winter storm caused a breach or flanking of the inlet (Seabergh 1999b).

**FIELD APPLICATION:** Referring to Figure 5, Grays Harbor, facing the Pacific Ocean of Washington, has a large entrance channel. South jetty construction commenced in 1898, and north jetty construction was completed in 1913. By 1929, the inlet entrance was as shown in the top map of Figure 9. Focusing attention on the shore end of the south jetty, which had a crest elevation of +2.4 m, mllw, there was a continuous shoreline from ocean side to bay side at the south jetty junction with the shore. Apparently, in this region of severe wave climate (average significant wave height of 2 m, with storm waves of 5 m not unusual) and large tide range (diurnal tide range of 2.7 m), sediment can move over and through the jetty at the shoreline during high water and storm conditions. Earlier maps of the inlet, after the jetties were built, showed this continuous shoreline through the south jetty also.

In late 1993, the region just south of the south jetty was breached during a storm (Figure 5), and emergency measures had to be taken to repair the breach. The navigation channel was in close proximity, located on the inner edge of the south jetty, and tidal flow could potentially enlarge the breach and cause additional erosion to the region. Increased exposure to wave action was also a possibility for the city of Westport, located east of the eroded area. The ocean-side beach had also been receding, so the combination of inner-bank erosion and beach recession had greatly increased the potential for breaching. The gap was filled with dredged material in this emergency. As part of a plan to reduce likelihood of future breaches, the U.S. Army Engineer District, Seattle, designed a mound structure based on the conceptual model experiments of CIRP as previously described. A model study was conducted to replicate the shoreward region of the south jetty and some of the navigation channel in the laboratory facility. This work validated the design. Figure 10 shows the initial condition as shown in the model and the plan selected for construction. The wave angle sweeping along the shoreline is modified by the mound, directing it more perpendicular to the inner bank shoreline. Also, wave heights were significantly reduced in this region. Figure 11 shows the structure shortly after construction in August 2000.

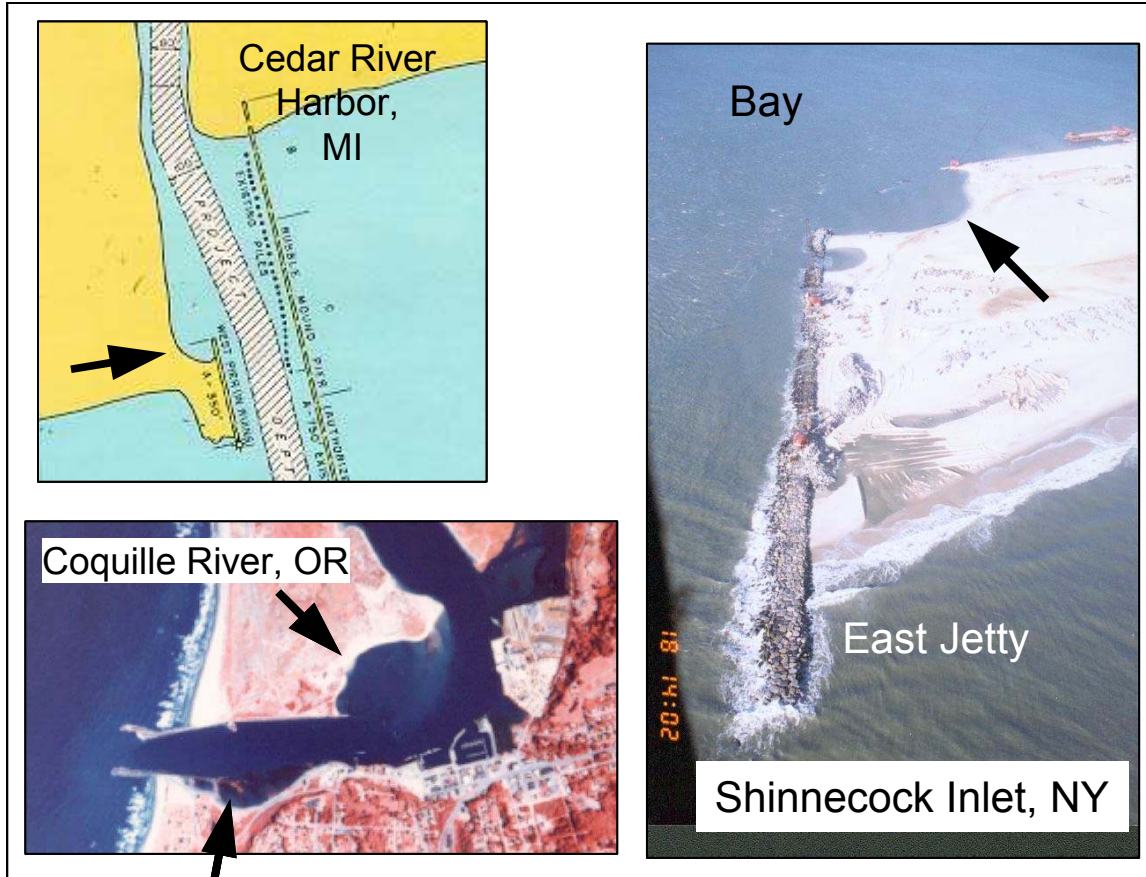
Figure 6. Examples of inner-bank erosion at coastal inlets on Atlantic, Pacific, and Great Lakes coasts

This commonly occurring recession of the inner bank of an inlet is found at jetties on all United States coasts, including the Great Lakes (Figure 6). The basic condition necessary for this erosion to occur is the termination of a jetty in a sandy area that is not receiving any sediment into the local region of the jetty termination. The forcing mechanisms are discussed next.

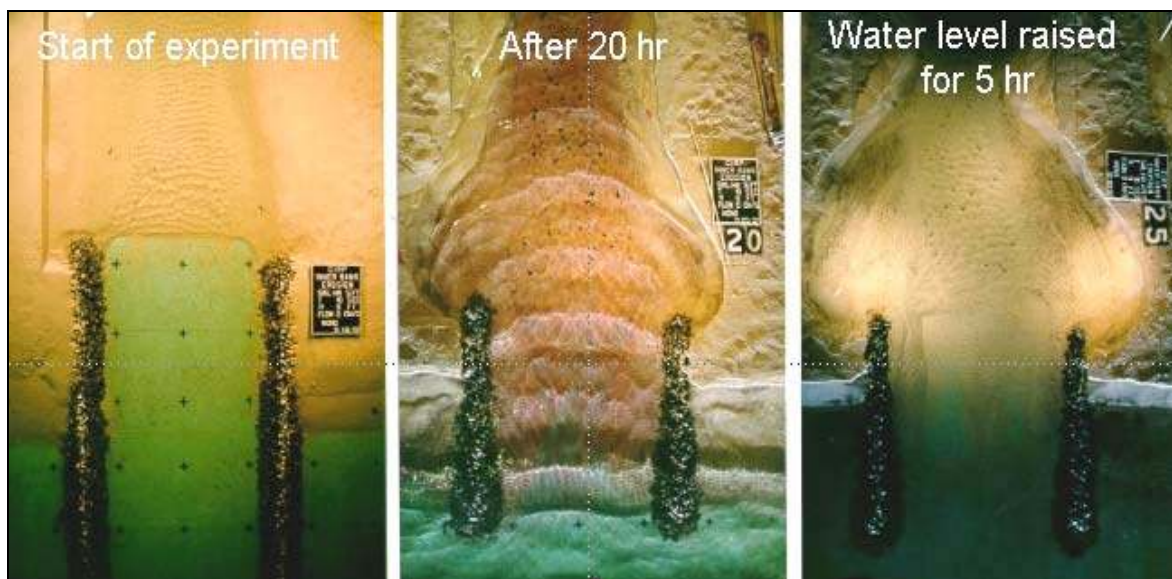
Figure 7. Physical model experiments showing inner-bank erosion development

The erosion region developed from a straight bank line into the crenulate shaped embayments as seen in Figure 7. It reached an equilibrium shape after about 20 hr model time. Raising the water level with the same incident wave conditions produced a greater erosion area (right side of Figure 7). The addition of currents with the waves increased the size of the embayment, but the initiating process was observed to be the same as the no-current experiment. Sediment eroded from the embayment moved along the edge of the inlet channel. With the no-current condition, sediment built out into the center of the entrance channel and reduced the rate of removal from the eroded region. The flood current increased the angle of wave attack and movement of sediment out of the embayment. With a tide-plus-waves condition, a similar shape embayment formed as for previous conditions, larger than the no-current condition, but smaller than the wave-plus-steady-state flood current. The variation in tidal elevation permitted a deeper cut in the embayment. With currents (steady-state or tidal) present, the eroded volumes increased in the range of 8 to 45 percent.

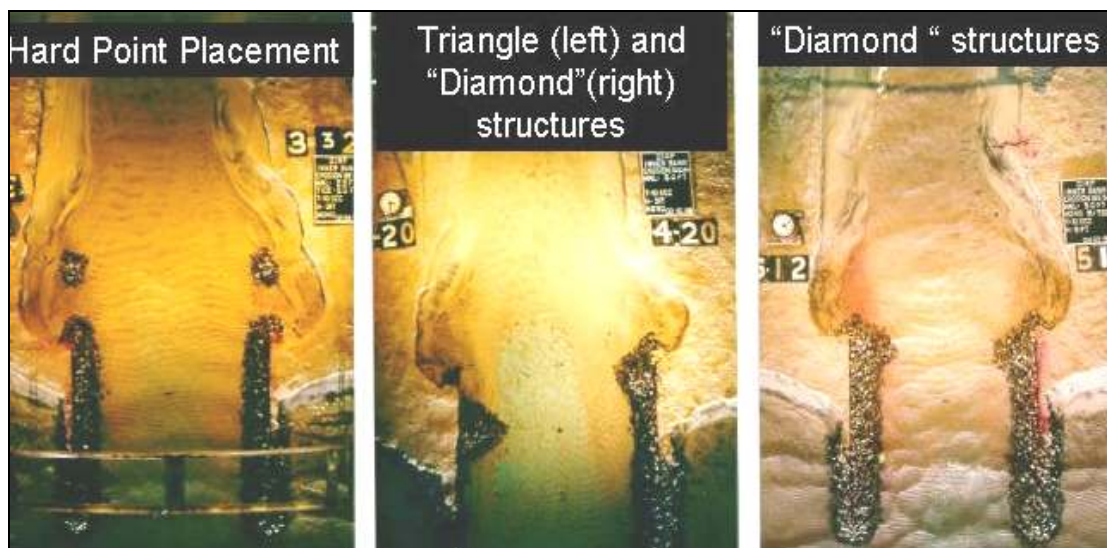
Figure 8. Inner-bank erosion prevention experiments

**Inner-Bank Erosion Prevention Methods.** Follow-up experiments examined potential solutions to minimize erosion by placing hard points to create smaller embayments or altering jetty structure slope and lateral extension into the channel. A diamond shape (in plan view) was built on the end of the right jetty and functioned to reduce wave energy at the end of the jetty. Because of its extension into the beach, it also prevented flanking, as shown in Figure 8, right side. On the left side of the middle photograph, Figure 8, a channel-side structure is placed seaward from the jetty terminus, and flanking of the jetty occurred because there was no tie-in to the beach. The headland concept was adopted by adding a hard point (a rock mound) on a line bayward of the jetty, to create a smaller embayment region than was created without the additional structure (Figure 8, left panel). These are compared to the nonstructure experiment in Figure 7 for wave and tidal current conditions. Volumes eroded and surface area removed were reduced for the prevention methods. The diamond structure reduced erosion and prevented flanking of the structure, reducing volume loss 58 and 47 percent on the right (initially steep slope) and left (initially relatively flat slope) inner-bank regions, respectively.

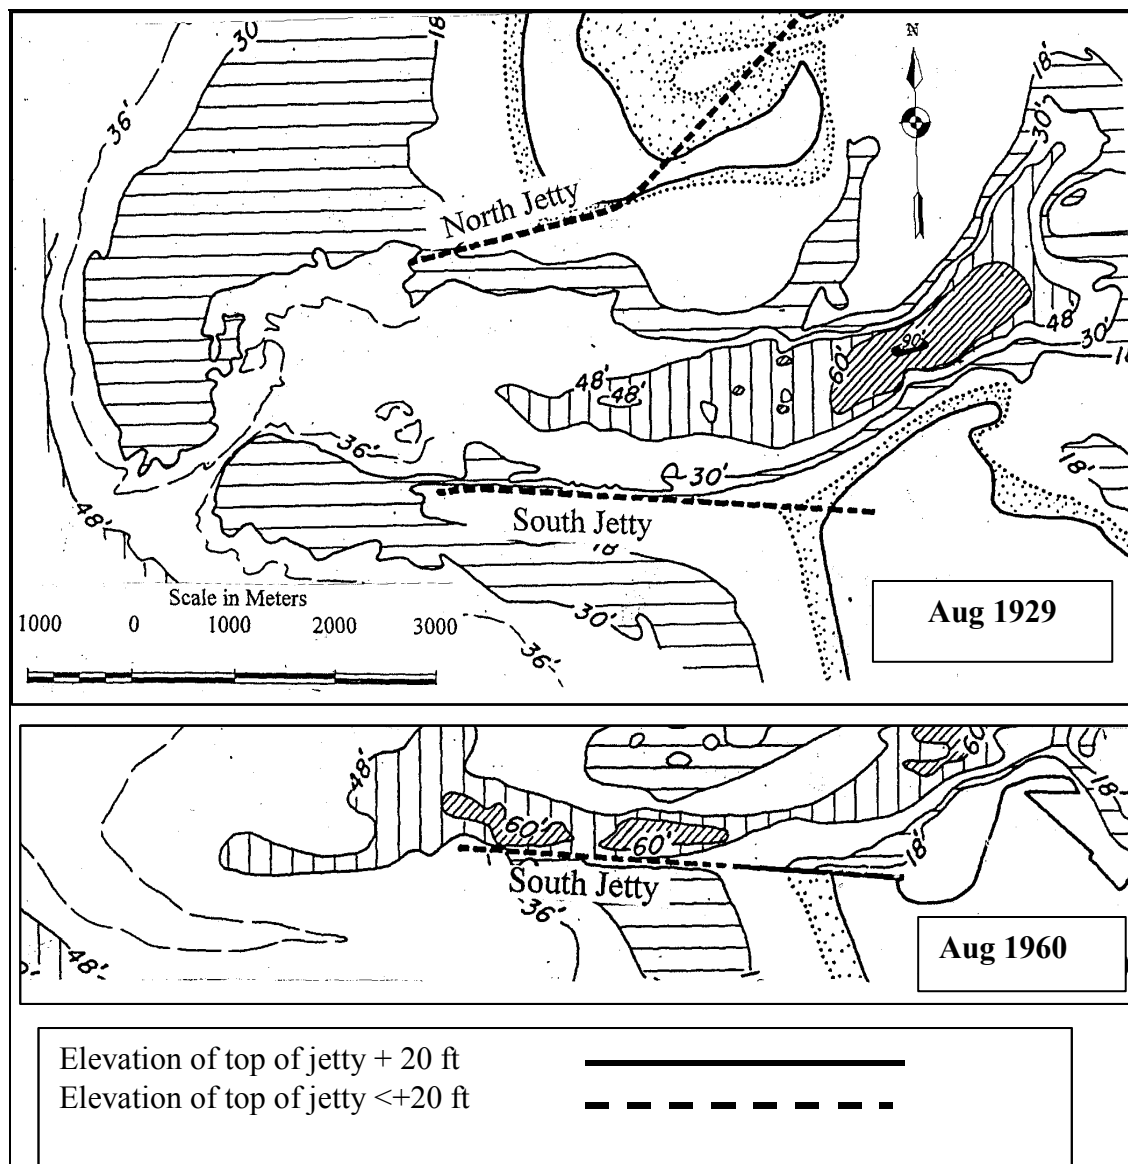
Figure 9. Grays Harbor, WA, entrance channel and adjacent shorelines. August 1929, before south jetty shoreward portion raised, and August 1960, about 24 years after south jetty raised to +6.1 m, mllw. Note inception of inner-bank erosion at landward end of south jetty

In the 1936-1939 time frame, the south jetty crest elevation was increased to +6.1 m, mllw. This addition in elevation was sufficient to reduce or cut off the sediment supply from the beaches to the inner-bank shoreline. As seen in Figure 9, initially the inner bank was receding eastward, and by 1946 the jetty terminus was exposed. An eroded region evolved at the south jetty terminus, as seen in the 1960 time frame. In 1960, the curved notch extended approximately 640 m landward from the jetty terminus, and was recessed 200 m laterally into the inner bank. By 1993, the eroded region had increased to dimensions of 730 m long by 275 m wide. From 1946 to 1960, it expanded at a rate of about 46 m/year in length and 14 m/year in width. From 1960 to 1993, the rate of increase decreased significantly.

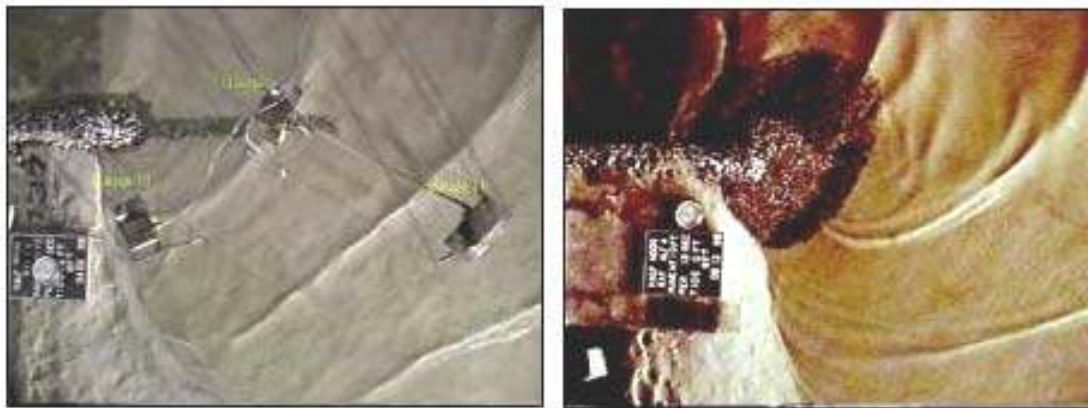
Figure 10. Model study photographs: left picture shows the prediffraction structure condition and right picture shows the mound structure diffracting waves

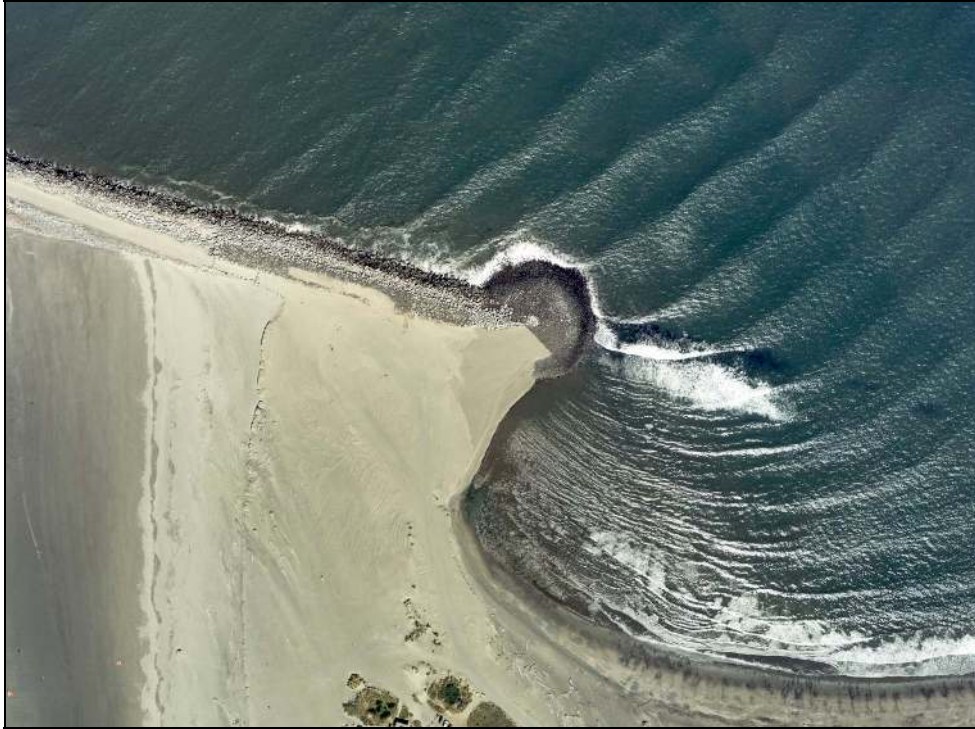
Figure 11. Mound diffraction structure as constructed at Grays Harbor, WA (2000)

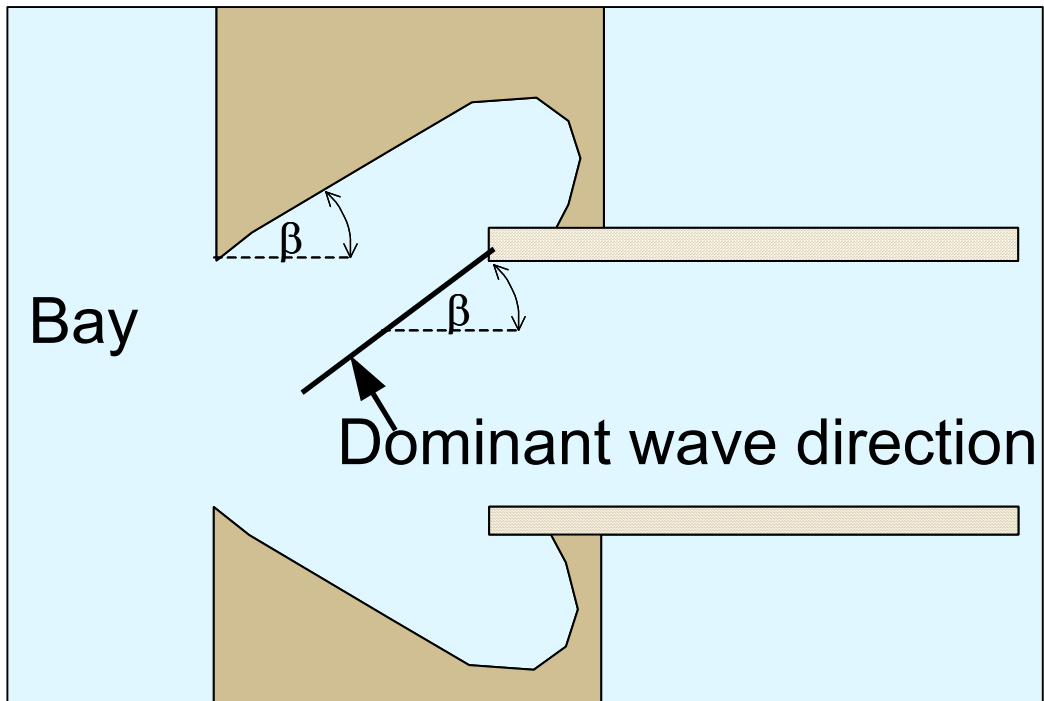
Figure 12. Equilibrium inner-bank erosion showing dominant wave angle and shoreline orientation angle,  $\beta$

**ANALYTICAL EVALUATION:** Analytical expressions for the shape of an equilibrium inner-bank eroded region can be adapted from work developed for shapes of headland-bay beaches. Originally log-spiral curves were developed to fit the beach shape, but more recent work indicates parabolic or quadratic equations can represent the equilibrium form well (Silvester and Hsu 1993). Charts are also available (Silvester and Hsu 1993) which relate the indention, to elongation ratio of an embayment to the dominant wave angle  $\beta$ , which, once equilibrium is reached, is the angle that the downcoast portion of the shoreline makes with the original shoreline. Figure 12 shows  $\beta$  for the case of inner-bank erosion. These analytical methods were developed for the open coast, but it appears reasonable to use, with caution, these techniques for inner-bank erosion. As was noted in the physical model tests discussed earlier, the effect of currents (especially flood current) and increased water level, can increase the size of the equilibrium eroded area. The dominant wave angle  $\beta$  can be fairly small for a large inlet, high-wave-energy system, such as Grays Harbor. Dominant wave angles compare with those for open coast angles for such large inlet systems. For smaller, narrow inlets, the wave angle will be larger, and less confidence should be placed in these analytic techniques.
