Investigation of accident scenarios between pedestrians and city buses in Thailand

S. Lakkam* and S. Koetniyom

The Sirindhorn International Thai-German Graduate School of Engineering,
King Mongkut's University of Technology North Bangkok,
Bangkok, 10800, Thailand
*Email: bus_supachai@hotmail.com
Phone: +66894834600

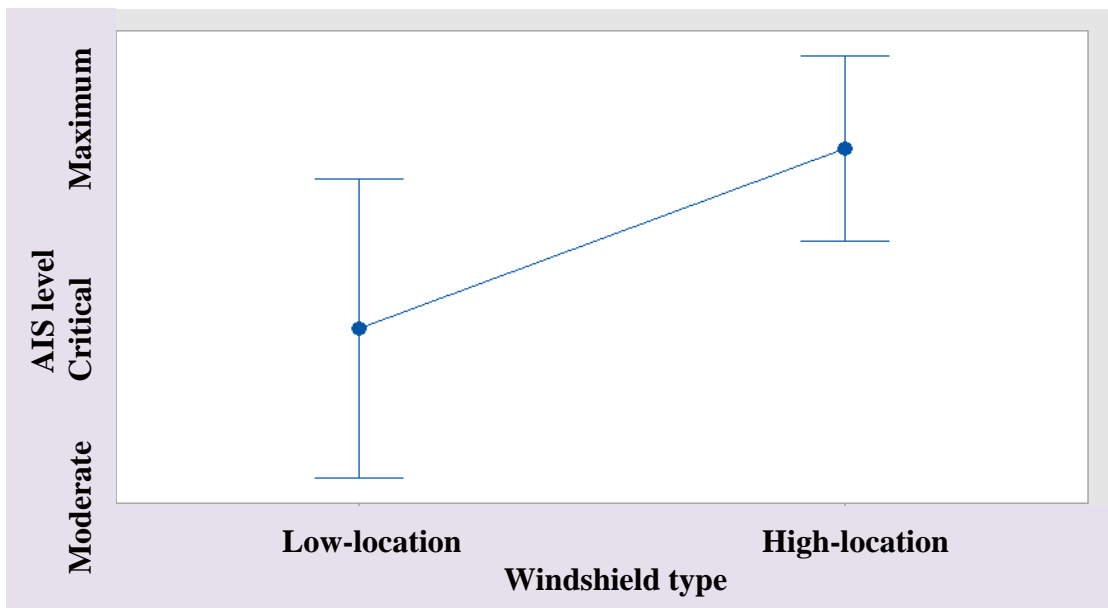
Figure 4. Height of windshield type VS effect (AIS based level).

The mean ages for both the low-location windshield type buses and the high-location windshield type buses are identical at 37 years old with Serious AIS-based level. The average impact speed of bus is assumed since the city bus should be typically decelerated by a bus driver before the incident. From the experimental study of bus speed at the incident, there are 19 cases which were not over a speed of 30 km/hr (as the 90th percentile) while only two cases were over 30 km/hr. The median impact speeds from the low- and high-located windshield types of public buses were at 22 km/h and 20 km/h, respectively. Table 3 shows the cumulative frequency of impact speed for each type. It also reveals that there are two significant parameters: the windshield location and the impact speed of the public bus. In accordance with data in Table 2, the adequacy of the developed relationship was tested using the analysis of variance (ANOVA) technique to suggest the significant additional factors. The ANOVA technique was used to ensure that the order function and regression model was adequate, as well as testing the significance of the model coefficients ANOVA was related to the independence of data and its uniformity. Table 4 and Figure 4 show the results of ANOVA for time period and windshield type response. The P statistic conveys that terms with P-value ≤ 0.05 are significant to experiment response and the probability level is over 95%, while terms with P-value ≥ 0.05 are insignificant to the response.

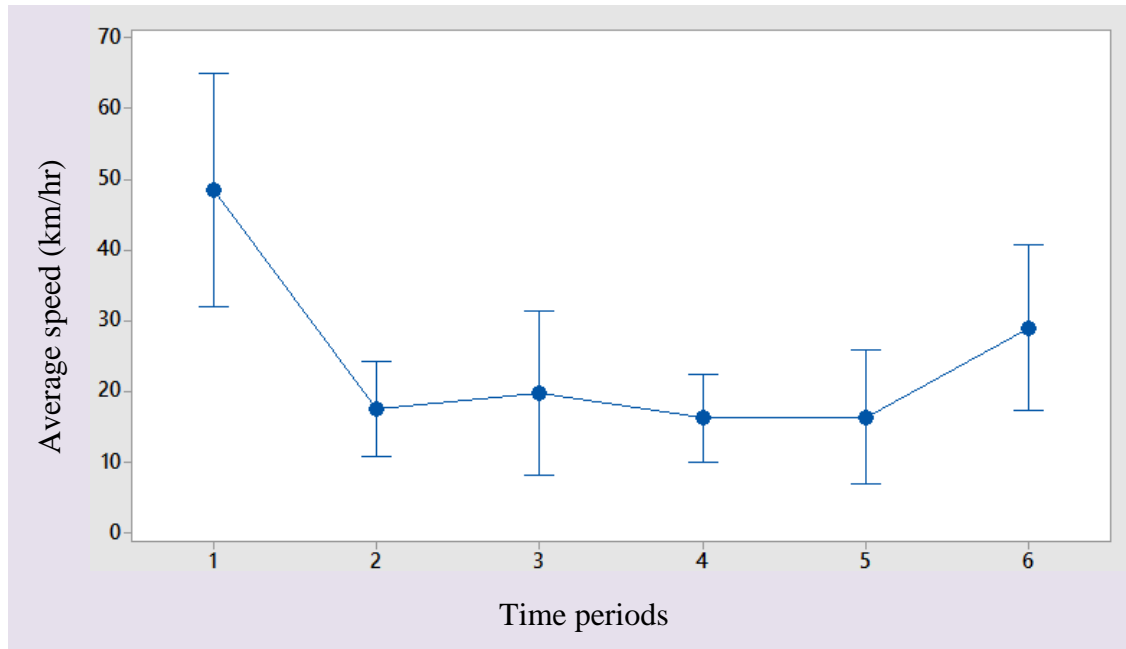
Figure 6. Time period vs. average speed.

that induced the traffic accidents. Based on the result presented in Table 7, the adequacy of the developed relationship was tested using the analysis of variance (ANOVA) technique as seen in Table 8 and Figure 6. Furthermore, the in-depth information represents that midnight to dawn (00.00am – 5.30am) is the interval time of the highest rates of death, for which the same is true for the early evening (3.30pm – 9.00pm). Besides, both of interval times were also the periods where drivers speed more than other durations on road. These data are similar to the fatal school bus crash data in the United States of America. A majority of the school bus-related fatal crashes occurred between 6 am to 9 am and 2 pm to 5 pm [12].

From the total 21 cases, the time-shift period of the incidents of city bus collisions with pedestrian was also investigated. In Bangkok traffic police operations, the 24-hour time period is classified into 6 durations (see Table 7). There were two durations of the high accident frequency (5.30am -8.00am and 12.01am – 3.29pm). In the first duration (5.30am -8.00am), 6 cases among 21 collisions (29%) occurred. This is the rush hour time in which the urban people hastily go to work with lack of circumspection. In the second duration, 12.01am – 3.29pm, 7 cases among 21 collisions (33%) emerged. From a primary inquisition, the drivers who work in the morning shift need to finish their work immediately. Thus, they are not only careless, but also have a higher tendency of fatigue
