INVESTIGATION OF GEOMETRICAL DETERIORATION OF TRAMWAY TRACKS

Purpose. The authors' aim is to demonstrate their results of analysis of deterioration of tramway tracks' geometry. **Methodology.** This article is a start of a PhD research. At first, the superstructure systems and the used instrument were summarized, after that the examination of running track, tramway stops, crossings and turnouts. **Findings.** The authors examined separately the running track, tramway stops, level crossings and turnouts. In case of examination of running track, we evaluated the measurement results according to two methods. To clarify the superstructure systems' deterioration factor the authors had to do further measurements on other tramway lines too. **Originality.** The fulfilled analysis is the first step to the complex method that can consider and determine the optimisation of life-cycle costs of tramway superstructures. For this goal a lot of parameters, factors have to be taken into consideration in the future. There are available methods and models for different civil engineering areas, e.g. there is very complex methodology related to road pavements, but there is no special one related neit

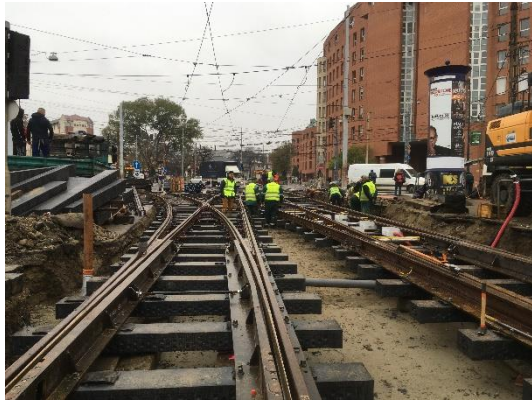
Fig. 4. Concreted ballasted track superstructure during construction

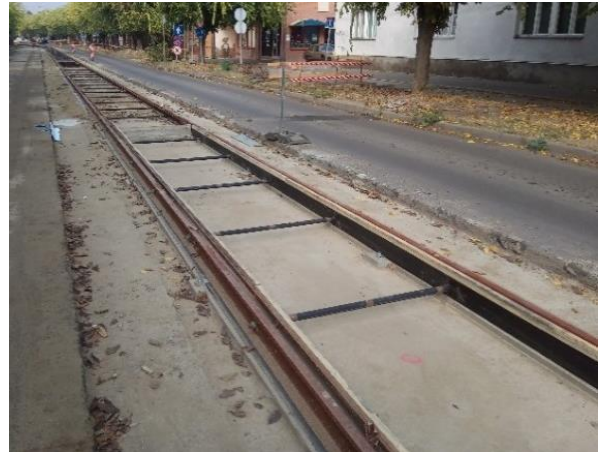
Fig. 8. ESCR B I. track system during construction

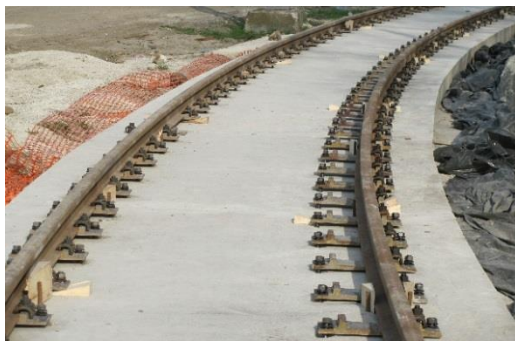
Fig. 6. Concrete slab track during construction

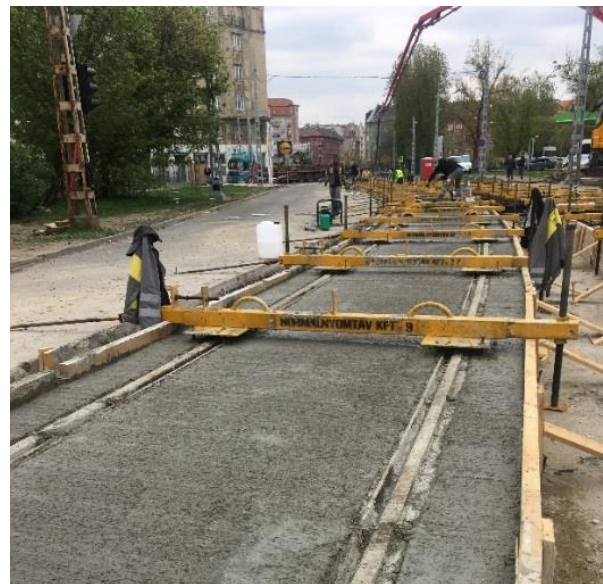
Fig. 10. ESCR B II. track system during construction

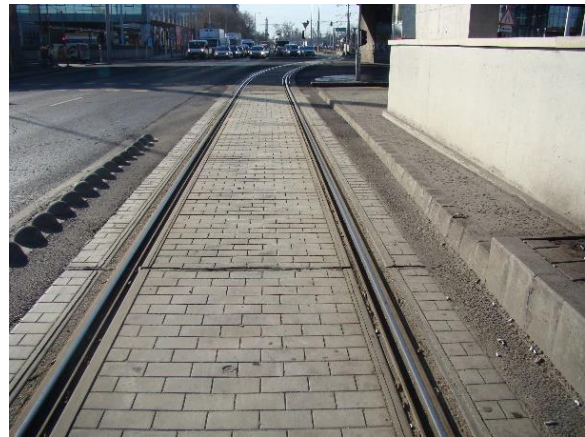
Fig. 14. «Large slab» superstructure

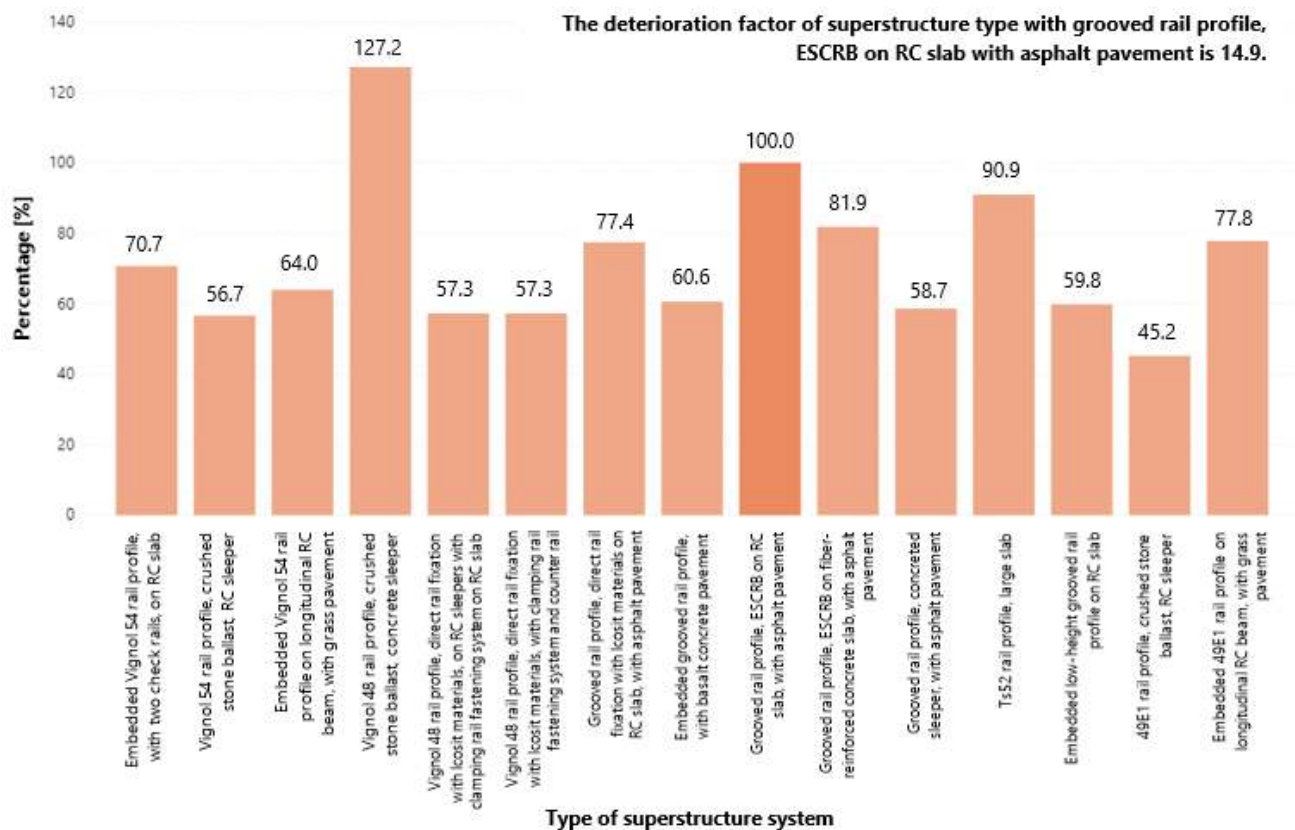
Fig. 17. The percentage of deterioration factors relative to each other – first version

Using the subjective scoring system, the results are shown in Fig. 17. Figure 17 shows the percentage of the deterioration factors of the various superstructure systems. The benchmark is based on the most common superstructure system on the tramway line which is grooved rail profile, ESCRB on RC slab, with asphalt pavement. Its deterioration factor is 100% (see Fig. 17). It seems the deterioration of the superstructure type with Vignol 48 rail profile, crushed stone ballast, and concrete sleepers is outstanding. The type of the defaults is mostly narrowing of the track gauge.

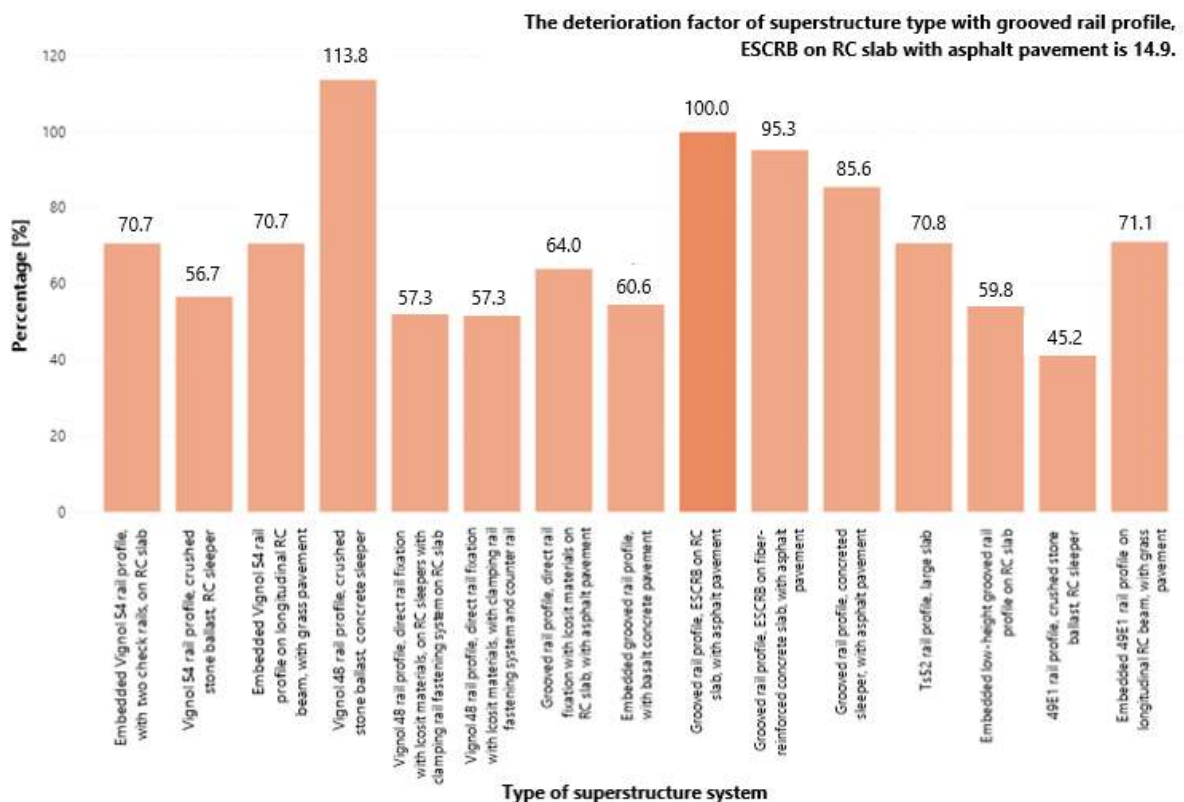
Fig. 18. The percentage of deterioration factors relative to each other – second version

The analysis of the measurement results shows that as in case #1, the deterioration of the superstructure type constructed with Vignol 48 rail profile, crushed stone ballast, and concrete sleepers has the highest value – 14% higher than the benchmark grooved rail profile, ESCRB on RC slab, with asphalt pavement superstructure system (Fig. 18).

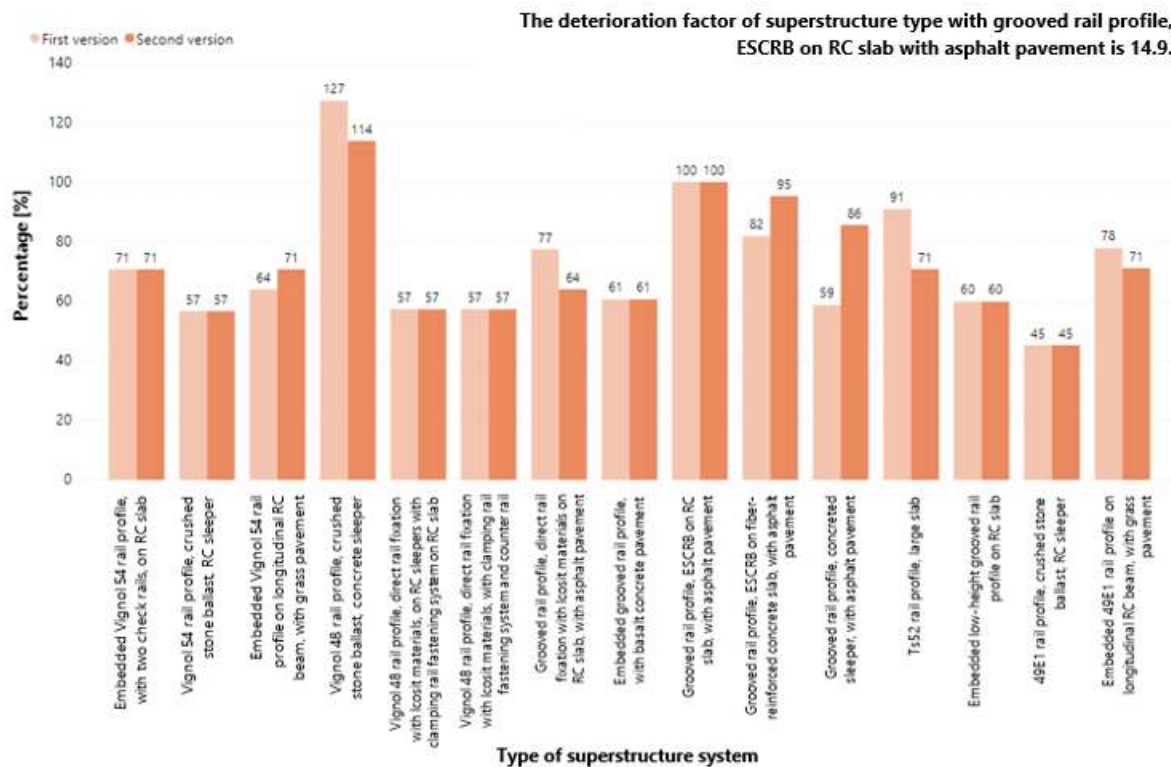
Fig. 19. The percentage of deterioration factors relative to each other – first and second version

Comparing the results from cases #1 and #2, it is noticeable that by modifying the parameters, the values of deterioration factors for each superstructure system have also been modified (Fig. 19). This can be explained by the fact that these superstructure system types are only found in small lengths over the entire tramway line, but many defaults have occurred since they were constructed.

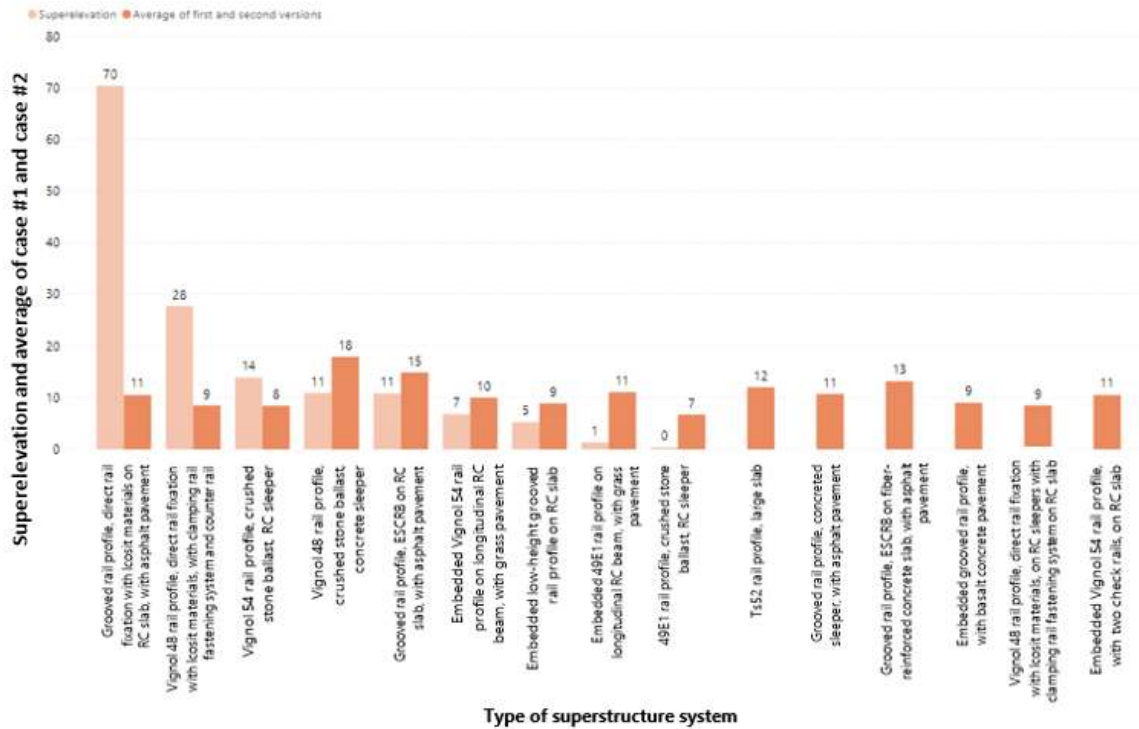
Fig. 20. The joint analysis of length of superelevation defaults and average of first and second versions' deterioration factors

The ratio of the length of the given superstructure system to the superelevation defaults on that is also evaluated. This value is compared to the average of the deterioration factors (average of cases #1 and #2), it should be noticed that the deterioration of the superstructure type with grooved rail profile, direct rail fixation with Icosit materials on RC slab, with asphalt pavement is outstanding (Fig. 20).

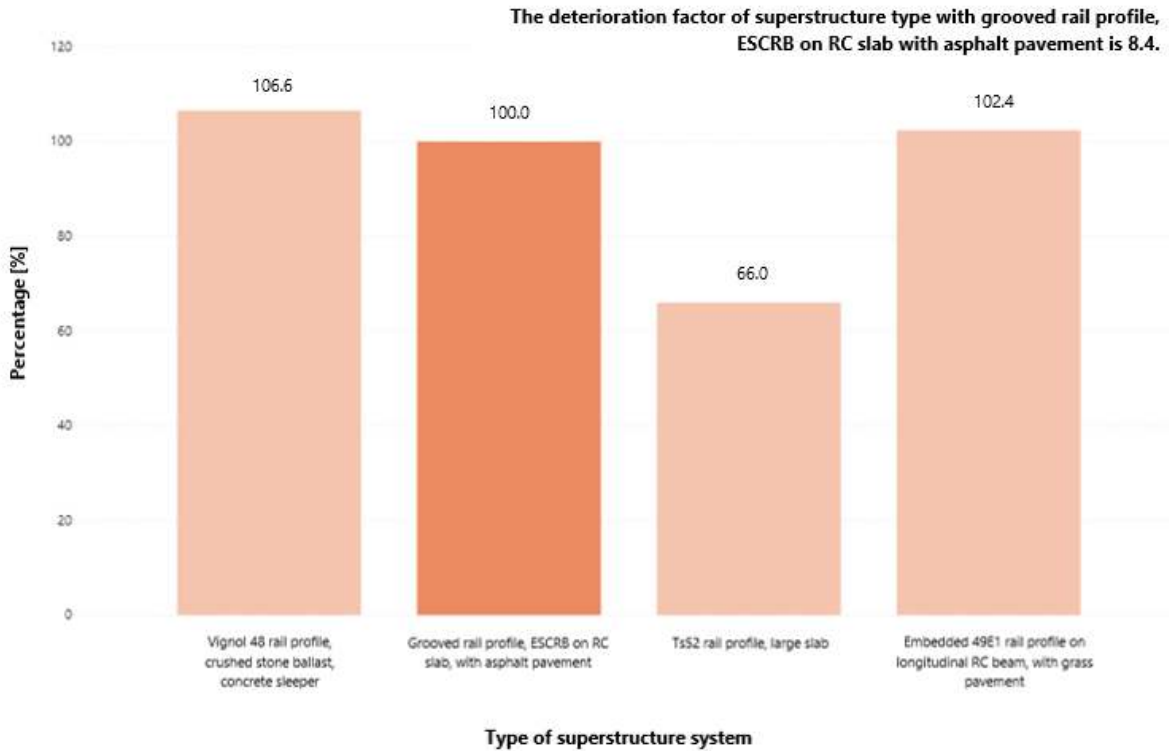
Fig. 21. The percentage of deterioration factors relative to each other at tramway stops

Using the subjective scoring system, it should be noticed that the deterioration of the superstructure type with Vignol 48 rail profile, crushed stone ballast, as well as concrete sleepers is outstanding – as in the case of running track (Fig. 21). The benchmark is based on the most common superstructure system on the tramway line which is grooved rail profile, ESCRБ on RC slab, with asphalt pavement. Its deterioration factor is 100%.

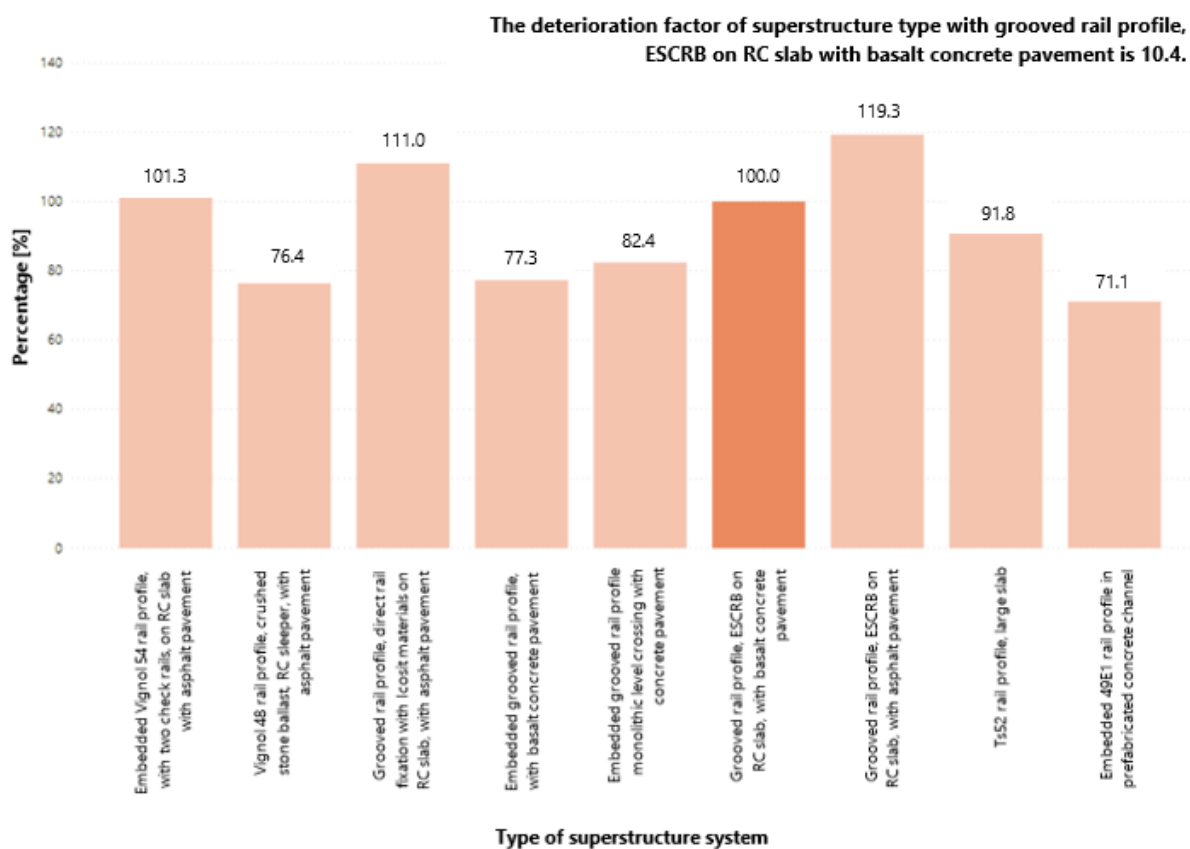
Fig. 22. The percentage of deterioration factors relative to each other – in level crossings

The results show that the deterioration of the grooved rail profile, ESCRB on RC slab, with asphalt pavement superstructure system is outstanding (Fig. 22.). In this case, the benchmark is the grooved rail profile, ESCRB on RC slab, with basalt concrete pavement superstructure system.
