<b>Title</b>	Investigation of the Rail-Induced Vibrations on a Masonry Historical Building
<b>Authors(s)</b>	Erkal, Aykut; Laefer, Debra F.; Fanning, Paul; Durukal, Eser; Hancilar, Ufuk; Kaya, Yavuz
<b>Publication date</b>	2010-10
<b>Publication information</b>	Advanced Materials Research, 133-134 : 569-574
<b>Publisher</b>	Trans Tech Publications
<b>Item record/more information</b>	<a href="http://hdl.handle.net/10197/4081">http://hdl.handle.net/10197/4081</a>
<b>Publisher's version (DOI)</b>	<a href="https://doi.org/10.4028/www.scientific.net/AMR.133-134.569">10.4028/www.scientific.net/AMR.133-134.569</a>

# Investigation of the Rail-induced Vibrations on a Masonry Historical Building

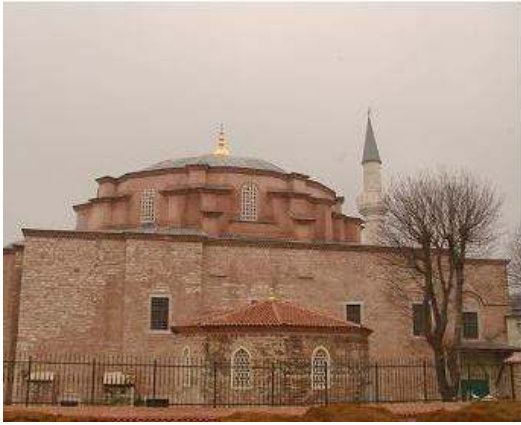
a) Overview

Figure 2. Close-up of Little Hagia Sophia Mosque

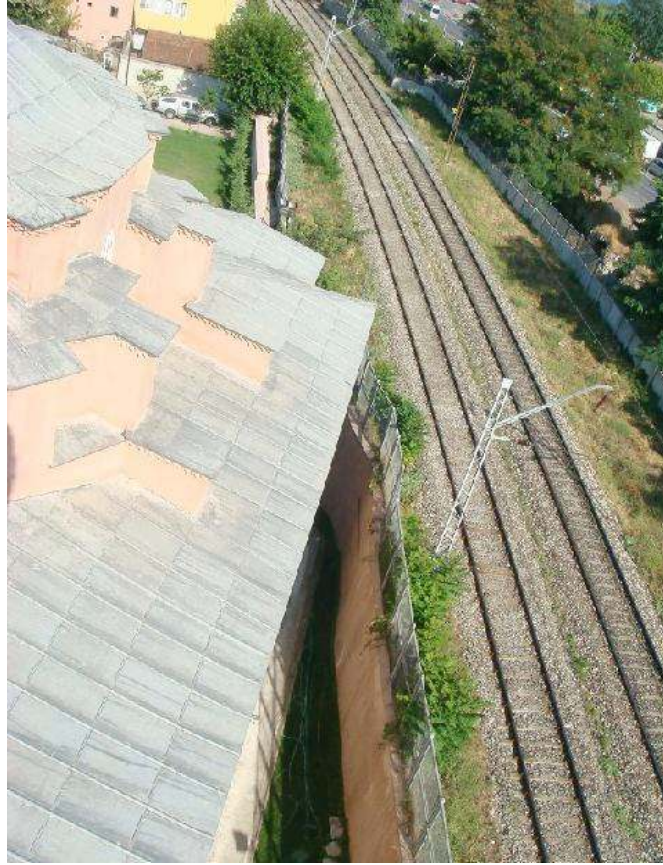
c) Proximity of the mosque to the railway line

Turkey. Although previous analyses of the building have been published [7, 8, 9], transmission characteristics of nearby rail-induced vibrations have not been presented before. The Mosque is located in the district of Eminonu in Istanbul, close to the Marmara Sea from which it is separated by the Sirkeci-Halkalı railway line and the coastal road (Fig. 1). The site soil is composed of clay and marl of early Pliocene period. It is a cohesive type of soil composed of fine particles. A plan view of the building and the proximity to the transport lines, along with instrumentation in the garden of the mosque can be seen in Fig. 2. At their closest points, the mosque is 4.8 m from the railway line. Two tests are presented herein.

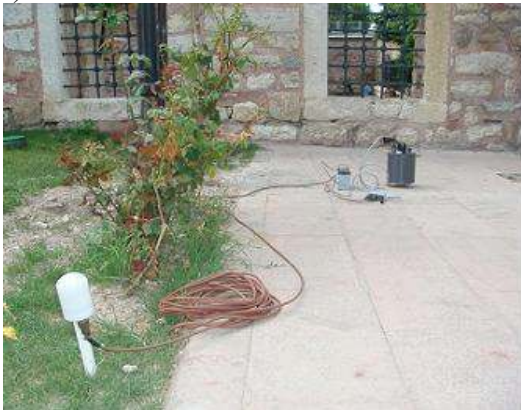
b) Sample instrumentation in the garden

For Test 1, within the physical constraints of the site, an area was chosen where 4 instruments could be placed in a straight line. For each passing train, ground vibration measurements were taken at 4 equidistant offsets from the railway. Seismographs are labelled as A-D, and each preceding number indicates the test [e.g. 1A means instrument A in Test 1]. Instrument A was the closest seismograph to the railway, while instrument D was the furthest (Fig. 3a). For Test 11, instrument C was placed next to the structure and A and D were placed in windows of ground and first floor respectively, while B was placed on the mid-slab close to the railway line to evaluate floor vibrations (Fig. 3b).

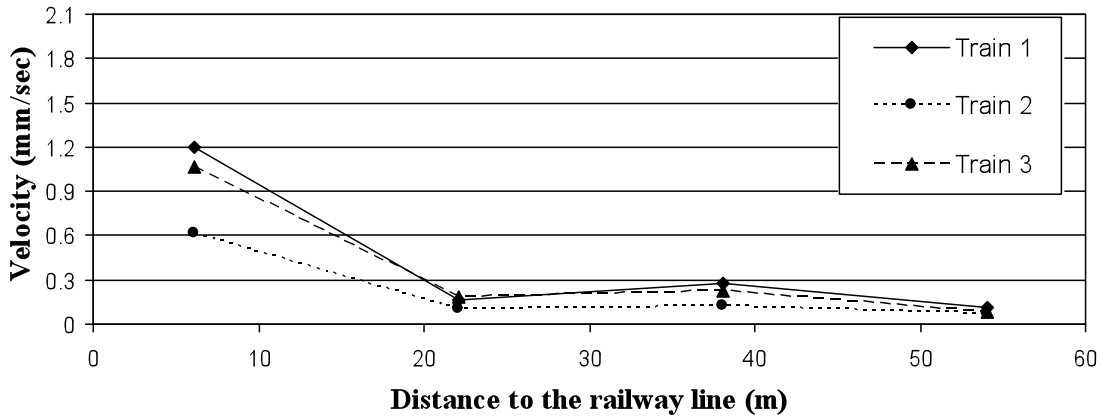
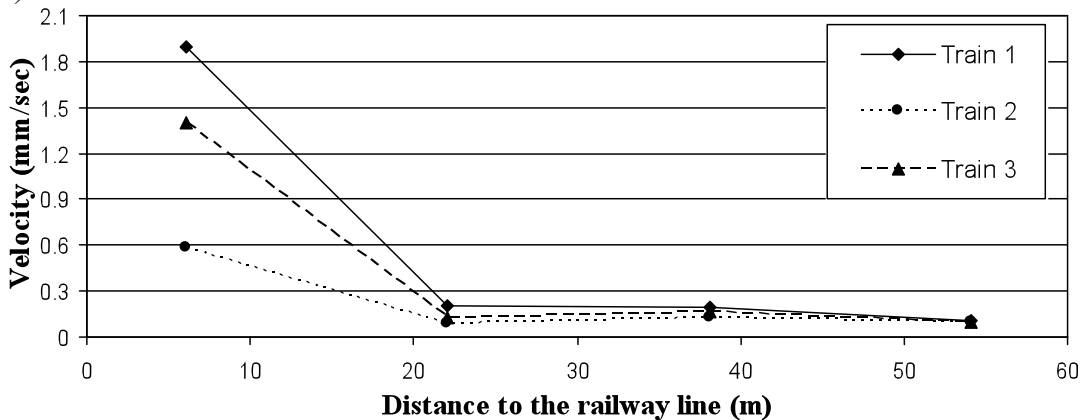
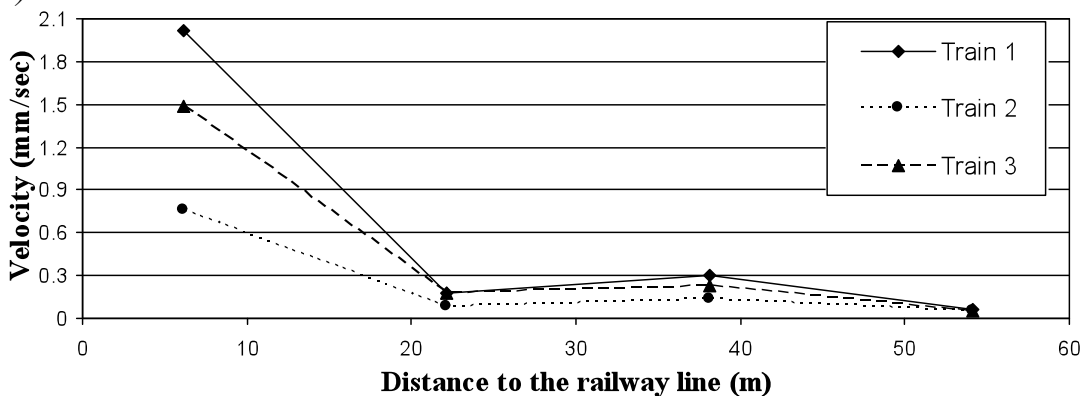
Figure 4. Wave transmission of train-induced ground vibrations during Test 1

Peak particle velocities in 3 vertical directions at each point for 3 trains are presented for Tests 1 and 11 (Figs 4 and 5, respectively). In Fig. 4, ground surface wave transmission patterns comprised 2 regions. Up to ~25m from the source, amplitudes varied significantly depending on train input,

thus representing a critical region. Beyond this point, response was quite uniform, although of importance's is that in this second region amplitudes exceeded 0.3mm/sec, putting them within human perception and possible structural damage, if building amplification occurs [12]. Vertical vibration components were slightly larger than the east-west and north-south components. This is attributable to the fact that Rayleigh waves predominate on the ground surface, and their vertical components are dominant over horizontal components. Moreover, the anisotropy and heterogeneity of the soil may also cause that [13].

Additionally, an amplification zone in the ground was discovered 35-45m from the source (Fig. 4). Similar to that reported by Xia et. al. [11]. Such amplification zones may be critical during design. Furthermore, source vibration levels varied greatly (Fig. 4). For example, vertical vibration level differences between trains 1 and 2 in Test 1 was about 62%. The variation is mostly attributable to train speed (generally varying 70-90km/h) as equipment and live loading changed little as reported by Xia et. al. [11]. Measurements of ground-borne vibrations showed slight dominance of the vertical component on the ground (Fig. 4). This was more noticeable in falling weight studies [14].

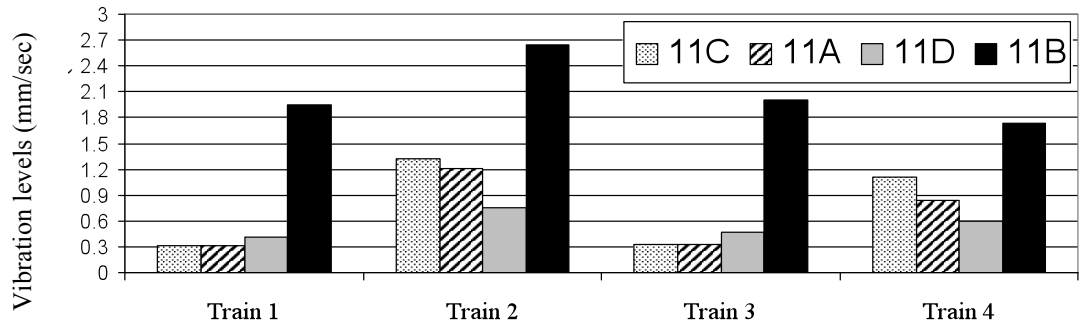
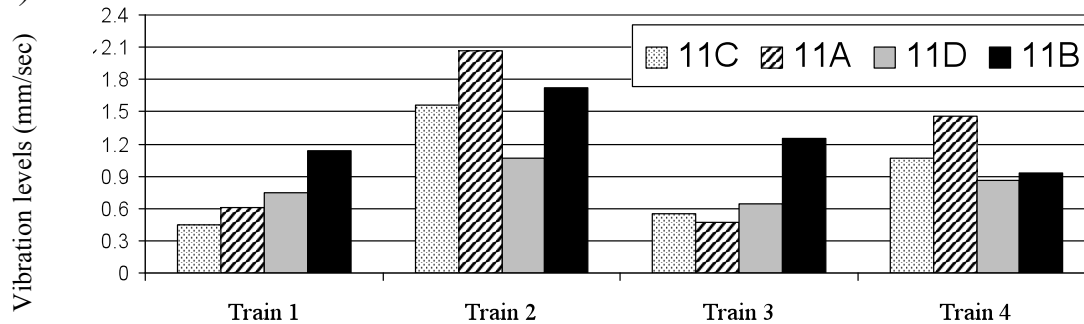
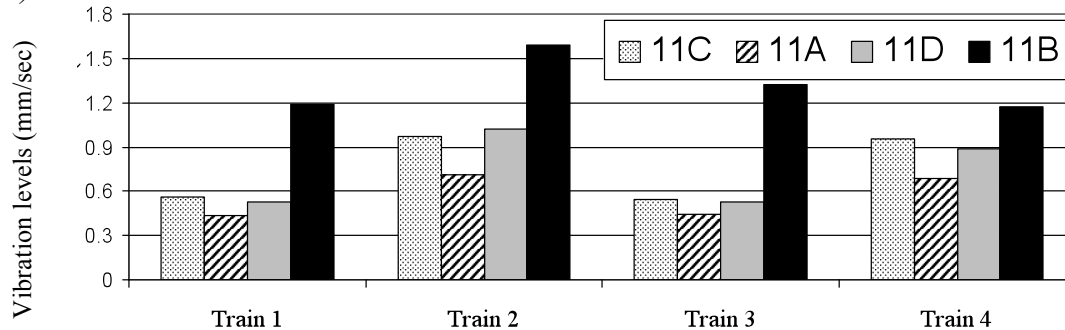
Figure 5. Vibration levels on the structural system of the Mosque during Test 11.

Most codes and studies rely on a maximum PPV to evaluate the severity of traffic-induced vibrations. Figure 5 depicts PPV values of vibrations on the building (Test 11). Although the PPV are not sufficiently large to generate severe structural damage, in some cases the vibration levels exceeded the lowest damage PPV threshold found in literature (1mm/sec) [6], All PPV values were larger than 0.3mm/sec as perceptible to human body [5] and many of them larger than 0.8mm/sec as distinctly perceptible [16]. Furthermore, in each direction, mid-slab vibrations predominate, due to the flexibility of the slab compared to heavy carrying system of the masonry building. Vibration levels was as high as 2.65mm/sec on mid-slab on the first floor and 2.06mm/sec on the structural core of the building. Since human beings are very sensitive to traffic-induced vibrations and are often disturbed by intensities well below those required to overstress structures, in the retrofit of old masonry structures, human response to traffic-induced vibrations should be considered as a serviceability limit state.
