INVESTIGATIONS INTO SURFACE INTEGRITY IN THE TURNING PROCESS OF DUPLEX STAINLESS STEEL

Summary

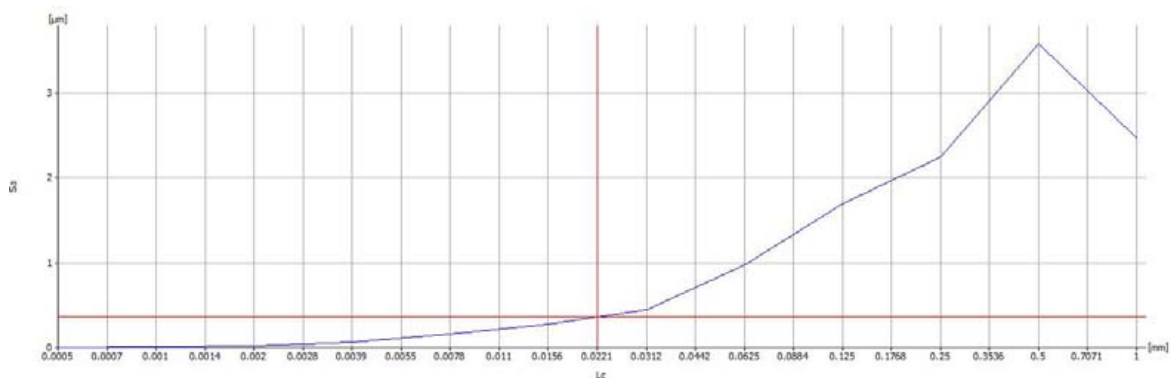
Fig. 10 Spectrum of sample after the turning with the T2 tool point of primary model

Figs 9 and 10 show two views of spectral distributions (Surface Texture Spectrum) of the selected region. The selected parameter was the Sa parameter (average height of selected area). Figs 9 and 10 show the selected parameter Sa in certain wavelength ranges. Due to the same machining parameters, the analysed surfaces have similar wavelength ranges but the sample turned with the T2 wedge is characterized by steep slopes.
