# JT9D Performance Deterioration Results from a Simulated Aerodynamic Load Test

Prepared for the  
Seventeenth Joint Propulsion Conference  
cosponsored by the AIAA, SAE, and ASME  
Colorado Springs, Colorado, July 27-29, 1981

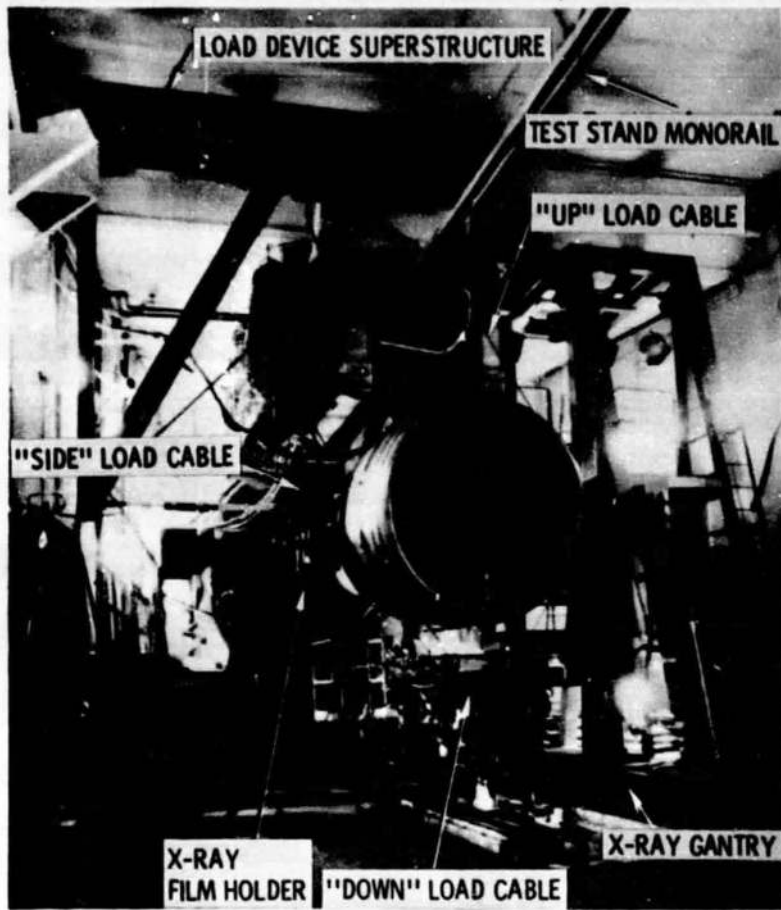
Figure 3. - JT9D-7AH test engine prepared for approach load.

The test was conducted in the P&W production radiographic test stand (Fig. 3). This stand was designed for sea level testing of large high bypass gas turbine engines with airflow rates up to 3000 lb/sec. The stand is equipped with a fully Automatic Production Test Data Acquisition and Control (APTDAC) system, which programs the engine test including the performance of such operations as start-

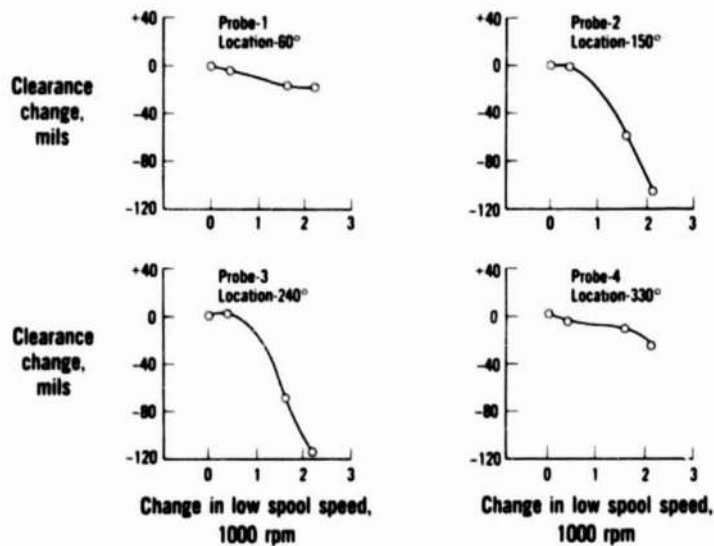
Figure 10. - Fan clearance changes (from ground idle) due to thermal loads - proximity probe data.

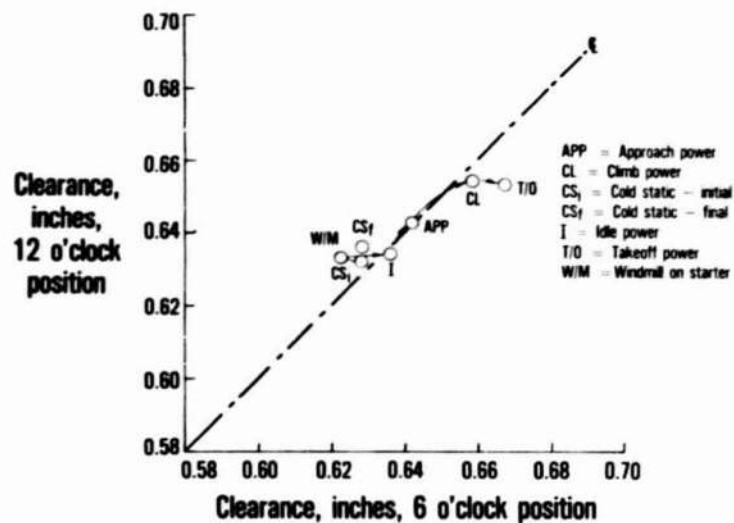
Figure 11. - Third stage low-pressure turbine rear knife edge to case - x-ray results from thermal loads testing.

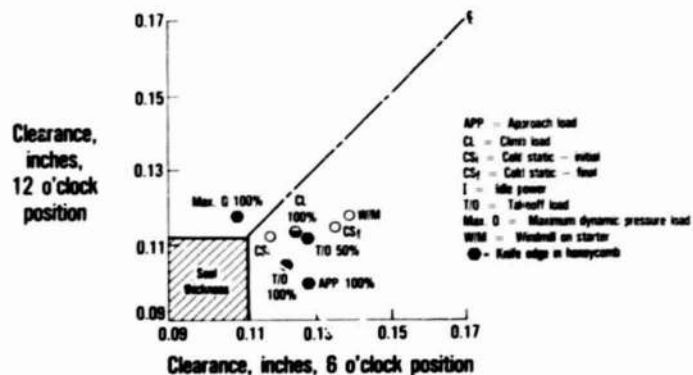
Figure 13. - Fourth stage low-pressure turbine forward knife-edge to outer air seal body - x-ray results from static load test.

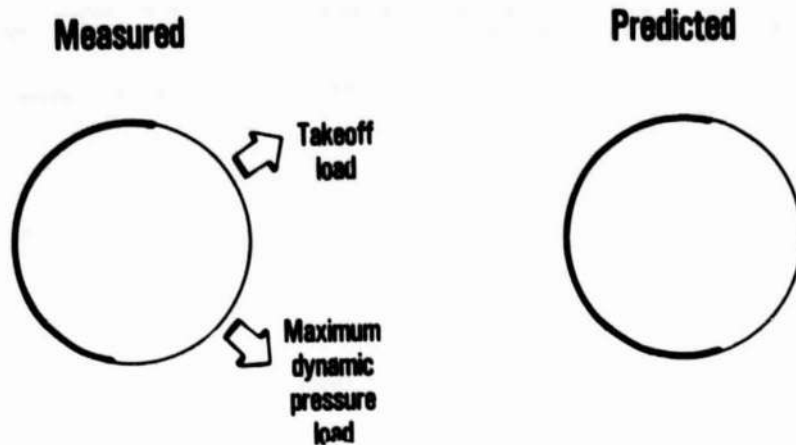
Fan outer airseal (looking forward)

Figure 14. - Predicted versus measured outer seal wear patterns produced by flight loads.

Seal land wear patterns observed during the teardown of the test engine are shown in Fig. 14 for the fan. The locations of wear were as expected. Wear in the upper left quadrant was produced by the maximum dynamic pressure air load which pulled the fan case down and to the right. The take-off air load pulled the fan case up to the right and produced wear in the lower left quadrant of the fan outer air seal.
