Article

Lamb Wave-Based Structural Health Monitoring on Composite Bolted Joints under Tensile Load

Keywords: Lamb wave propagation; composite bolted joints; structural health monitoring; FE simulation

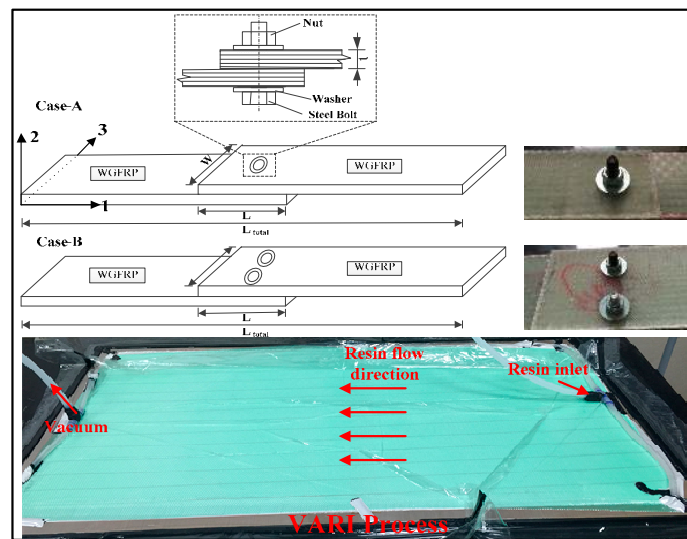
Figure 1. Schematic diagram of the vacuum-assisted resin injection (VARI) manufacturing process and the two studied composite bolted joints with the coordinate system.

The polymer used in the composites as the matrix was vinyl ester resin. The resin can be cured at room temperature in the presence of a hardening agent and an accelerating agent. The hardening agent was methyl ethyl ketone peroxide (MEKP), and the accelerating agent was dimethylaniline. The resin was mixed with hardening agent and accelerating agent at mass ratio of 1:2:0.5. The reinforced material was plain woven glass fabric cloth (WGF). We adopted a vacuum-assisted resin injection (VARI) process to manufacture the WGF/epoxy composites in the bolted joints. Figure 1 shows the schematic diagram of the VARI process. During the manufacturing process, we used a glass plate at the bottom of the VARI system as a holder. After coating the release cloth on the holder, we placed four layers of woven glass fabric. The stacking sequence of the plate was $[90^\circ/0^\circ]_4$. After the system was covered with peel and silk ply, the system was closed by a vacuum bag and sealant tape. We vacuumed the system at 600 mbr at room temperature for 10 h to ensure complete vacuum conditions. To ensure the resin flowing uniformly, a delivery pipe was fixed at the entrance. After resin injection and curing for 24 h, the composites were demolded. The final dimension of the manufactured WGF/epoxy composite laminates was $800 \times 800 \times 2 \text{ mm}^3$, and we cut it into the required dimension by a low speed diamond saw blade cutting machine under water protection.

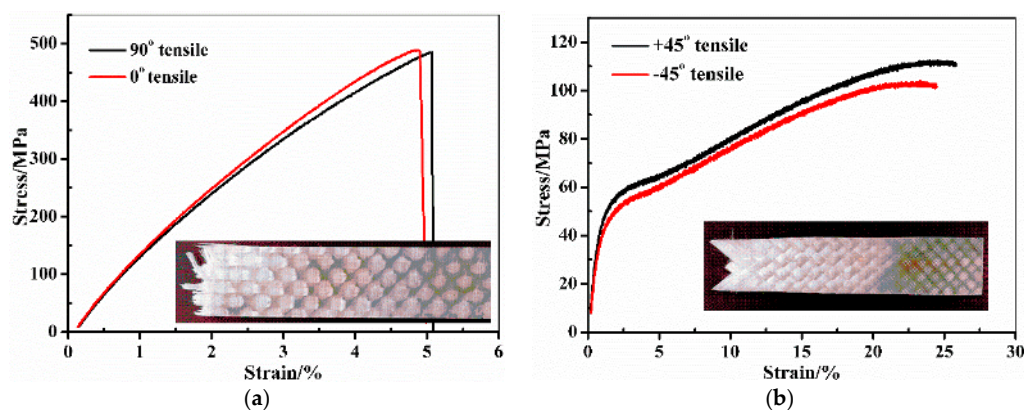
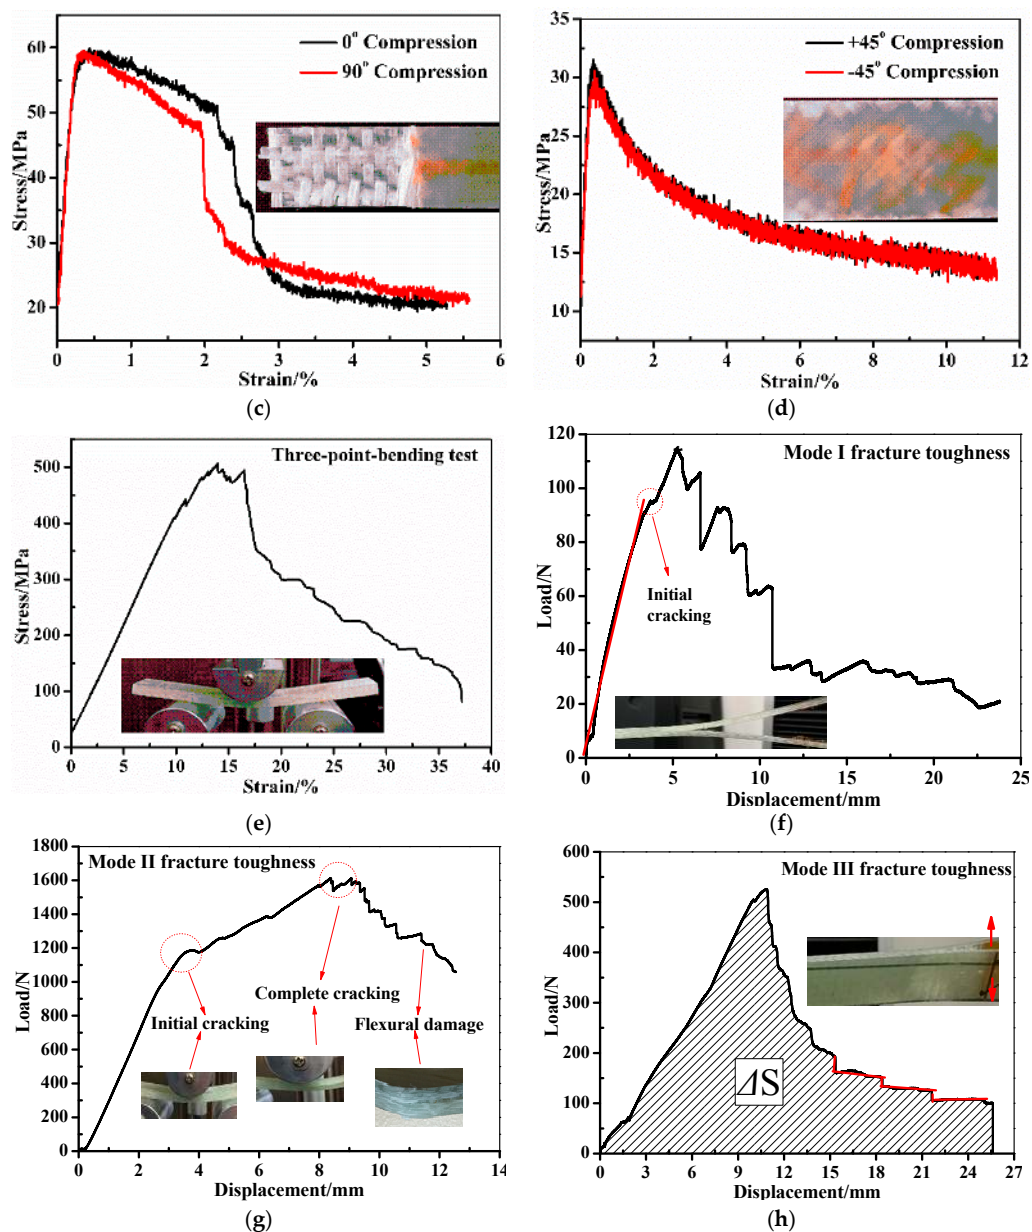
Figure 2. Cont.

Figure 2 demonstrates the average stress-strain and load-displacement curves of the WGF/epoxy composite laminates in different mechanical tests. In detail, Figure 2a–d are the tensile and compression curves along 90° , 0° , and $\pm 45^\circ$ of the fibers, respectively. Figure 2e is the three-point bending test curve, while Figure 2f–h are the load-displacement curves obtained in DCB, 3ENF and the Mode III test, respectively. The elasticity, strength, and fracture toughness parameters together with their standard deviations of the WGF/epoxy composite laminates determined from Figure 2 are listed in Tables 3–5. In these tables, the longitudinal and transverse elastic modulus E_{11}/E_{22} , and the shear modulus G_{12} were calculated using the initial tensile curve slope in Figure 2a–d. The longitudinal/transverse tensile strength (X_t/Y_t), compression strength (X_c/Y_c), and the shear strength S were the peak stresses in Figure 2a–d that were determined by the maximum load divided by the cross-section area of the longitudinal, transverse, and 45° tensile specimens, respectively. The elastic modulus E_{11} , E_{22} and G can be calculated by the following equation:

Figure 2. Mechanical performance of woven glass (WG)/epoxy composite laminates obtained in different experimental tests. (a): 90°/0° tensile; (b): 45° tensile; (c): 90°/0° compression; (d): 45° compression; (e): Three-point-bending test; (f): Mode-I fracture toughness test; (g): Mode-II fracture toughness test; (h): Mode-III fracture toughness test.

where E is the modulus, and S is the support span. m is the slope of the load-displacement curve, while b and h are the width and thickness, respectively. The following three formulas were adopted to calculate the Mode I, Mode II, and Mode III interlaminar fracture toughness (ILFT) of the WGF/epoxy composite laminates according to Figure 2f–h:

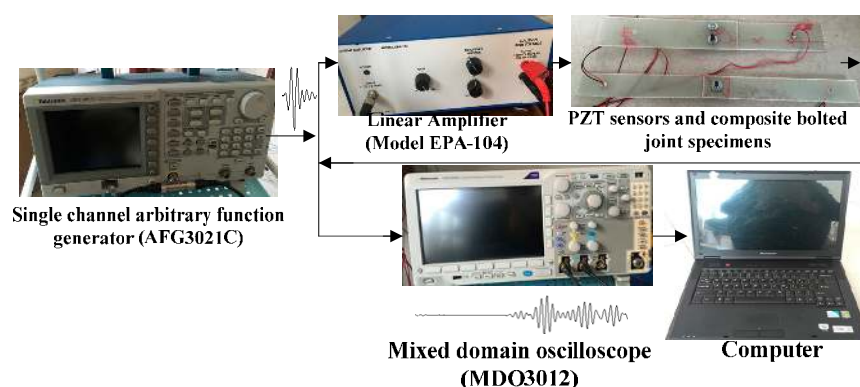
Figure 3 shows the experimental setup for Lamb wave propagation in the composite bolted joints in Case A and Case B. In the setup, a single channel arbitrary function generator (AFG3021C, Tektronix, INC., Beaverton, OR, USA) was adopted to excite the transmitting transducers. The actuating signal consisted of a 3.5-cycle sinusoidal tone burst. The signal had a frequency of 210 kHz and was modulated by a Hanning window. The actuating signal was then divided into two groups: one group was used as the input wave into the composite bolted joints after being amplified 20 times by a linear amplifier (Mode EPA-104, Piezo Systems, INC., Cambridge, MA, USA), while the other group was collected directly by the oscilloscope (MDO3021, Tektronix, INC., Beaverton, OR, USA). The signals were then transferred to a PC for data processing through a general purpose interface bus (GPIB) interface. It should be noted that the transmitting transducers adopted in the experiments were piezoelectric (PZT) wafers, and they had a circular shape with a diameter of 10 mm, and a thickness of 1 mm. All PZT transducers were bonded on the surface of the composite bolted joints using cyanoacrylate adhesive. Two PZT wafers were tied symmetrically on both ends of the joint specimen with an actuator-sensor distance of 215 mm, thus the signals had to travel through the joint region.

**Figure 3.** Experimental setup of the Lamb wave-based Structural health monitoring (SHM) system.

Figure 3. The signals were recorded with a torque incremental interval of 1 N·m. All the obtained data were compared and analyzed in terms of wave amplitude. To evaluate the relationship between the waveform and the applied load on the composite bolted joints, we performed tensile tests on the joint specimens. During the tensile test, the load-displacement curves were collected, and the corresponding Lamb waves were captured. The load speed was also set as 2 mm/min at room temperature.

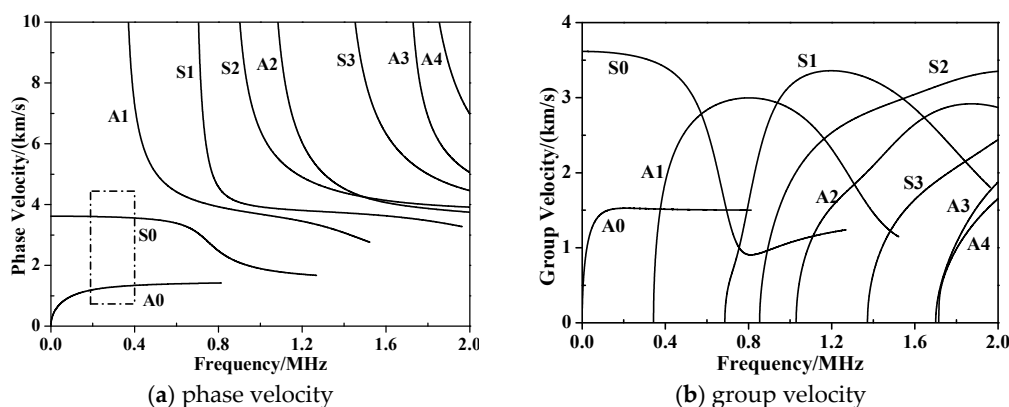
The selection of the appropriate Lamb wave mode and frequency could deeply affect the wave structure analysis processing due to the dispersive nature. This is further complicated during the propagation into anisotropic material due to the complex structural features. To find out the suitable frequency for effectively monitoring the composite bolted joint, we calculated the dispersion characteristics by solving Equation (5) in Disperse software [31]. Figure 4 depicts the phase/group velocity-frequency curves of a boundary-free WGF/epoxy composite laminated with a stacking sequence of $[90^\circ/0^\circ]_4$. The dispersion curves in Figure 4 clearly displayed the symmetric (*S*) and antisymmetric (*A*) Lamb wave modes. As highlighted with a dotted rectangle in Figure 4, a less dispersive region existed in the low frequency range where the *S0* and *A0* modes travelled at almost constant velocities. This frequency is referred to as the non-dispersion region. In detail, there were only *A0* and *S0* wave modes when the excited frequency was less than 400 kHz. In the following work, we selected the incident wave with a frequency of 210 kHz to monitor the health status of the composite bolted joints. This selected frequency could simplify the waveform analysis in post-processing since it could minimize the amplitude of unwanted mode signals.

Figure 4. Dispersion property of WGF/epoxy composite laminates with a stacking sequence of $[90^\circ/0^\circ]_4$.

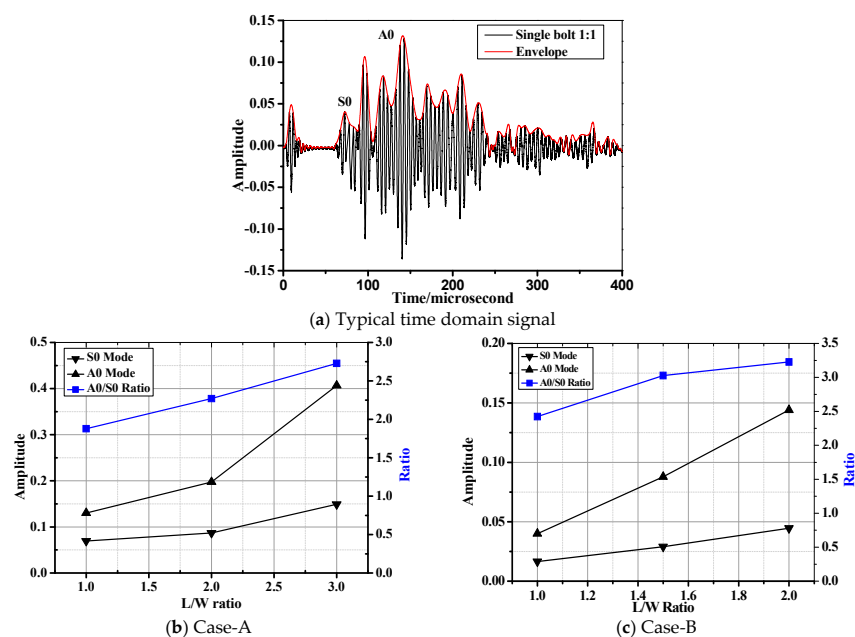
Figure 5a–c depict the typical Lamb wave, $A0/S0$ amplitude and their ratio tendency in the composite bolted joints, respectively. It should be noted that the tested specimens in Figure 5a are in the free boundary condition without tensile load. For easy observation, we gave the incident Lamb wave and the reception signals by the actuator and sensor pairs, simultaneously. The received waves were formed by different sources such as direct wave, the inner scatter, and boundary reflection waves. In Figure 5a, the propagation duration of the direct Lamb wave in different cases matched the $S0$ mode in the dispersion curves in Figure 4. The predicted phase/group velocity was calculated by dividing the actuator-sensor distance (215 mm) by the arriving time; this was 3700 m/s. The first wave package was the $S0$ mode Lamb wave that propagated directly from the actuator to the sensor, and its group/phase velocity was the largest. According to the dispersion curve, the phase/group velocity of the $A0$ Lamb wave was 1500 m/s, thus the wave package with arriving times approximately of 140 μ s was the $A0$ mode Lamb wave package, as marked in Figure 5a. There are normally two wave packages between $A0$ and $S0$ wave modes, which are formed by Lamb wave scattering effect such as reflection, transmission and mode conversion when they meet the discontinuity in the overlapped joint region. As shown in Figure 5b,c, the amplitude of the $S0$ mode was smaller than that of $A0$ mode in both cases. This was mainly the case because that $S0$ and $A0$ mode are excited differently, depending on the tone burst excitation frequency [32–34]. Furthermore, since it is difficult for in-plane particle motion to cross the interface, $S0$ mode is mostly retained in the plate, while partial energy of the out-of-plane $A0$ modes will leak into the interface. Another aspect, we found that the Lamb wave amplitude increased with increasing of L/W ratio. This phenomenon can be explained as following: In the joints, the discontinuity occurs at the ending edge and the bolt region. This leads to a result where the incident Lamb wave will be partially received by the sensor, and partially reflected. Since the overlap area increased, the Lamb wave energy during its propagation in the joints with higher L/W ratio also increased. This mechanism further leads to the larger wave amplitude. Moreover, the amplitude in Case A (Figure 5b) was relatively larger than that of Case B (Figure 5c), which was mainly due to the increased number of fastener holes that could dissipate the wave energy by reflection.

Figure 5. Waveform characteristics and the amplitude tendency in different composite bolted joints without tensile load (the applied torque on the bolts in the joints is 20 N·m).

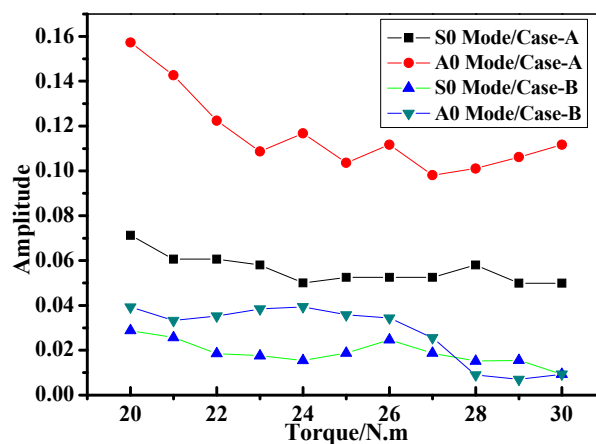
Also, the interface between two jointed composite plates could affect the wave energy and cause the wave amplitude decline by reflecting and scattering during its propagation. As known, in the composite bolted joints, the interface state between the two jointed specimens can be evaluated by the torque on the bolts during the assembling process. In order to evaluate the interface bonding effect on Lamb wave behavior in composite bolted joints, Figure 6 describes the relationship between the amplitude of S_0 and A_0 mode waves and the torque on the bolts in different composite joints cases. As shown in the figure, the amplitude of both the S_0 and A_0 mode waves showed an approximately decreasing tendency with an increase of torque. The wave amplitude in Case A was generally larger than that of Case B. As discussed, this was attributed to the wave reflection phenomenon in Case B being more severe than that of Case A. To make signal analysis processing easier, we applied a torque of 20 N·m on all the bolts, since their S_0 and A_0 wave amplitudes were easier to distinguish among all the complex wave packages in the received signals.

Figure 6. Amplitude of S_0 and A_0 mode as the function of the applied torque on the bolt.

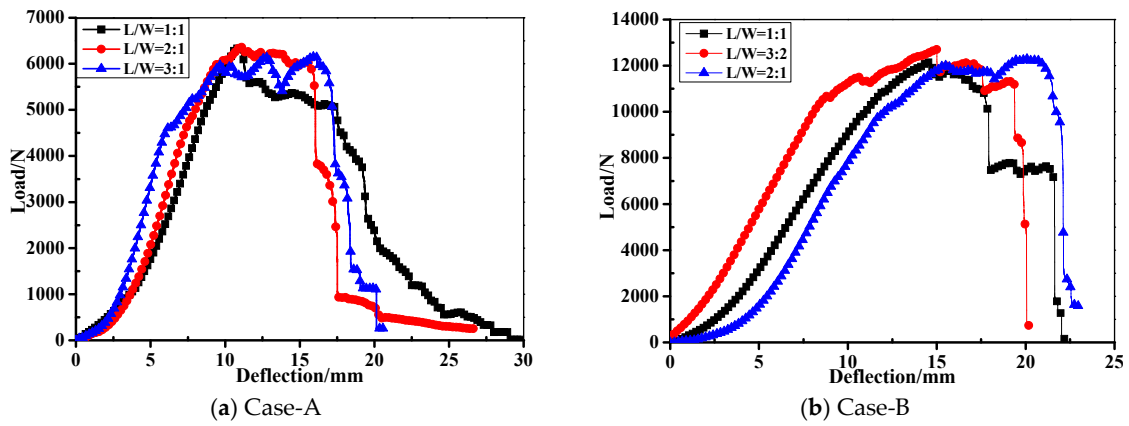
Figure 7 illustrates the representative curves of macroscopic load-deflection ($L-D$) of the composite bolted joints in tensile test. It can be seen from the experimental results that the tensile load appeared initially to be an approximately linear relationship, and with plastic yielding with increased displacement. The failure loads were approximately 6300 N and 12,000 N for Case A and Case B, respectively. In terms of joint configuration, the potential failure modes in bolted composite joints are comprised of cleavage (C), net-tension (N), shear out (S), and bearing (B) [16,18]. Figure 8 shows the final damage pattern after the experiments. Since the strength of the steel bolt is much higher than that of the WGF/epoxy composites, composites damages were the main failure modes. Damages occurred on $L/W=1:1$ bolted joints are the comprehensive failure modes that comprised of $B + S + N$, while the other specimens appeared for the failure mode as $B + N$. It is worth mentioning that during the test, the occurring sequence of failure mode in the composite plate was $B > S > N$. In the tensile test, the tensile stress in the joints was mainly supported by the shear load from the used bolts, which further limited the tensile peak load in Figure 7. This stress firstly caused bearing failure (B) around the bolt hole, and then shear damage appeared. It should be noted that this process was accompanied by other failures such as delamination and fiber/matrix cracking. These failure modes in the composite panel further led to the final failure mode (N) on the specimens. Since fiber breaking in the composite specimens progressively occurred, it resulted in a 'load plateau' in the load-displacement response. Both the failure process and the final damage modes of the composite bolted joints deeply affected the captured Lamb wave feature in the Lamb wave inspection procedure, and discussions on this aspect will be carried out in the following work.

Figure 7. Typical load-deflection curves of the composite bolted joints in tensile test.

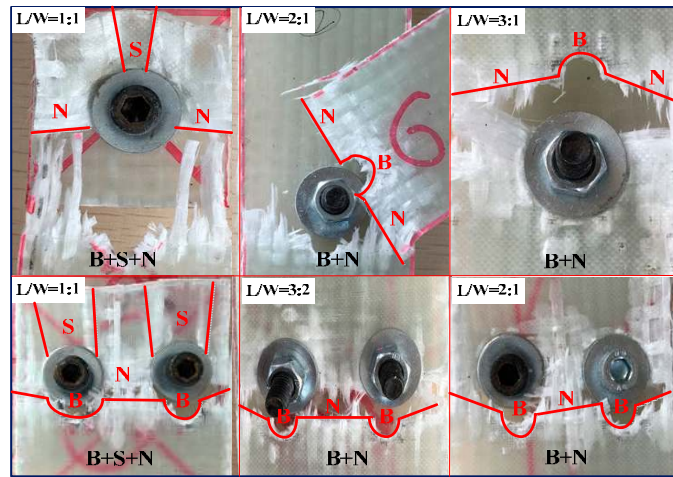
Figure 8. The final damage modes of the composite bolted joints after the tensile tests (In this figure, *N* indicates net-tension, *S* indicates shear out, and *B* means bearing failure mode).

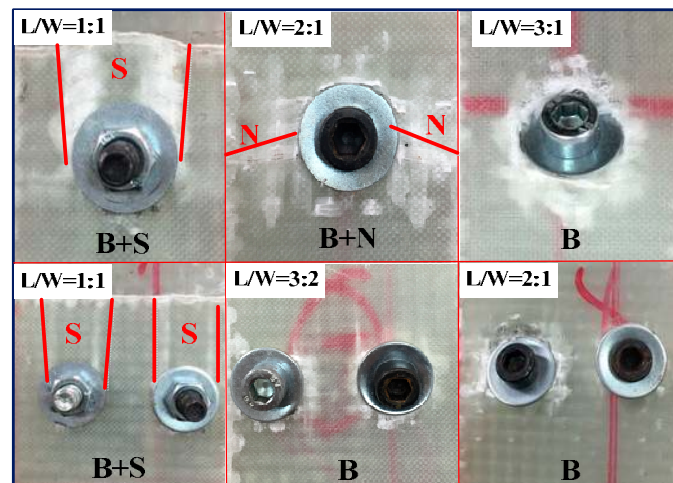
Because the composite bolted joints after the tensile test were completely discontinuous and the Lamb wave could not be captured by PZT sensors the SHM processing, we selected specimens over 5 kN and 10 kN tensile loads as research objects to establish quantitative connections between the extracted signal characteristics and the damage parameters. As concluded from the *L-D* curve in Figure 7, these applied loads were very close to the failure tensile load of the joints. The corresponding damage modes of the specimens after these tensile loads are illustrated in Figure 9. Unlike the final damage modes in Figure 8, the damage modes are mainly comprised of bearing failure mode accompanied with some shear out, and net-tension failure modes. The *A0/S0* wave amplitude and their ratio tendency after the tensile load are presented in Figure 10. It should be noted that the wave was excited and received by the PZT actuator-sensor pairs whose locations were the same as the specimens in Figure 5. In contrast to Figure 5, the amplitude in Figure 10 showed a decline in tendency with an increase in *L/W* ratio.

Figure 9. Damage modes of the composite bolted joints before completely failure after tensile test (In this figure, *N* indicates net-tension, *S* indicates shear out, and *B* means bearing failure mode).

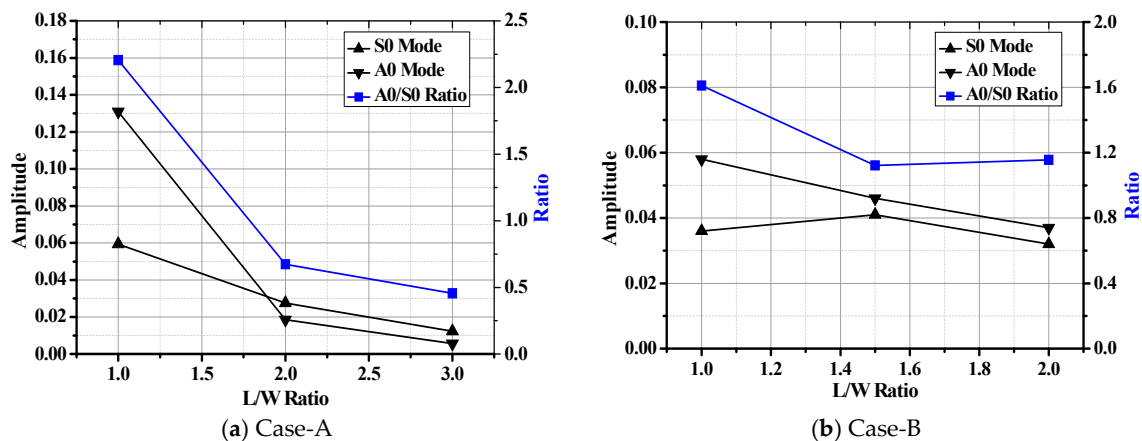
Figure 10. Waveform characteristics and the amplitude tendency in different composite bolted joints after tensile load.

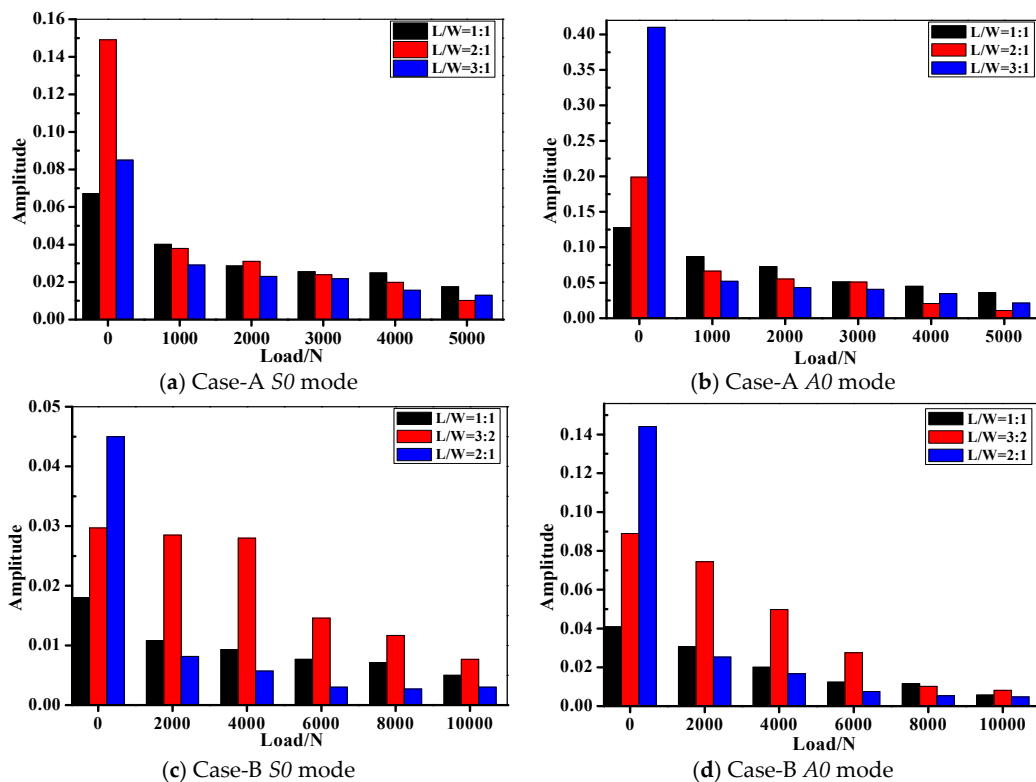
Figure 11 shows the amplitude of *S0* and *A0* mode as the function of applied load in different joints during the tensile test. Clearly in the figure, the amplitude showed a declining tendency with the increase of the applied tensile load. Taking the Lamb wave captured in Case A as the example, the amplitude of *A0* mode was larger than that of *S0* mode when the tensile load was applied at the same level. As discussed above, this phenomenon is associated with the unique wave propagation characteristics of *A0* and *S0* mode in the composite plates. Differences between Lamb wave amplitudes of unloaded joints are very easy to distinguish between different *L/W* specimens, while the *S0/A0* amplitude was nearly the same when the joints were under tensile load. In terms of the joints in Case B, it seemed that the wave amplitude in *L/W* = 3:2 specimens was always larger than the other cases under tensile load. The amplitude decreasing phenomenon could be interpreted as the following: As it is known, the Lamb wave propagation characteristics vary with entry angle, frequency and structural geometry [35,36]. Compared the *L-D* curve in Figure 7 and the damage modes in Figure 9, the damage modes under consideration were mainly comprised of bearing failure, whose severity is proportional to the applied tensile load. With the increasing of tensile load, the waveforms changed with the varying geometries. Moreover, since tensile strength on the composite bolted joints is offset axial tension, the contact between the two plates in the joint region began to weaken. As a result, much less kinetic

Figure 11. Comparison between amplitude of composite bolted joints during the tensile tests.

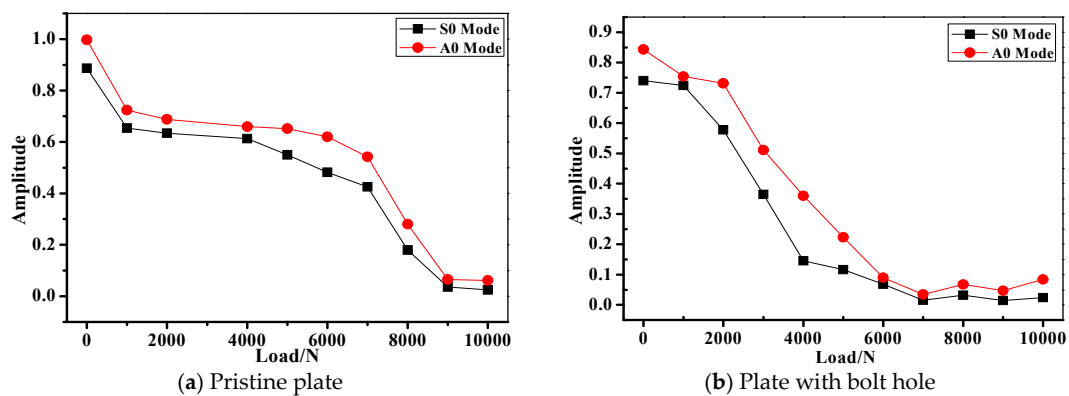
energy of from the wave particles could go through the joints region and received by the PZT sensor. In order to verify this assumption, we performed the axial tensile experiment on a pristine composite plate and a composite plate with a bolt hole (drilled plate). Figure 12 shows the amplitude tendency of the two specimens as the function of the applied load. With the tensile load increasing from 0 to 10,000 N, the $S0/A0$ mode amplitudes declined from 0.887/0.997 to 0.0243/0.0611 for the pristine plate in Figure 12a, while the $S0/A0$ mode amplitudes declined from 0.74/0.843 to 0.024/0.0838 for the drilled plate in Figure 12b. The wave amplitudes show a decreased tendency with the increasing of tensile load, which was due to the increased geometry length of the specimens. Another aspect, the amplitude attenuation level in Figure 11 was sharper than that of Figure 12. By comparison, this was mainly attributed to the weakened contact property of the composite plate in the joint region.

Figure 12. Amplitude of $S0$ and $A0$ mode of a pristine and drilled composite plate during the axial tension test.

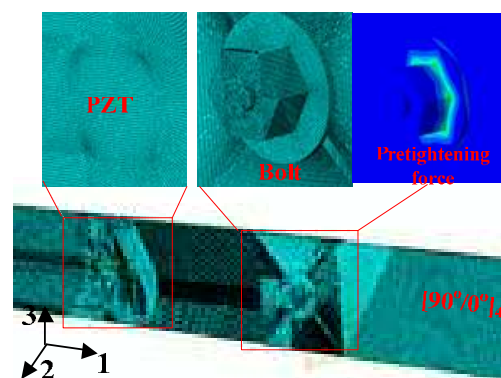
As discussed in the experimental section, the Lamb wave propagation phenomenon in the joint region is very complex, mainly due to structural discontinuity. In order to further interrogate the joint influence on the Lamb wave propagation feature, FE simulations were conducted. For the sake of brevity, the main aim of the performed FE simulation was to study the Lamb wave propagating feature in $L/W = 1:1$ composite bolted joints in Case A. In [37], we carried out the simulation work on woven composite laminates under low-velocity impact load. Also based on the developed three-dimensional FE method in previous work [38], we adopted 3D Hashin criteria and a user material subroutine to perform the Lamb wave inspection on the composite bolted joints. The simulation was carried out on the Abaqus/Explicit (Version: Abaqus 6.12, Simulia, Providence, RI, USA) platform, and the FE model with details is shown in Figure 13. The bolted composite laminates had four layers, each layer having a thickness of 0.55 mm. The fiber stacking sequence was $[90^\circ/0^\circ]_4$, and the final dimension, bolt location in the model was the same as the experiment in Figure 1 and Table 1. The laminates were assigned anisotropic properties according to the parameters listed in Tables 3–5. For the interface property in the overlapped jointed region, ‘hard contact’ was applied between the two parts. In terms of the interlaminar property between each composite layer, the surfaces were tied together in the interaction module in Abaqus. The element type was an eight-node C3D8R with a spatial resolution of 0.1 mm. This is more than ten times smaller than the smallest wave length of the Lamb waves in the considered frequency range [35,39]. For the excitation signal, a 3.5 cycle Hanning-windowed sinusoidal tone burst was excited by a circular fine mesh region with diameter of 10 mm. In order to keep pace with the experiment, two steps were performed in the simulation: a pre-tightening force on the bolt was applied in the first step, and then the Lamb wave propagating behavior in the bolted joints was carried out in the second step.

Figure 13. FE model in the Lamb wave inspection simulation with details (Coordinate system: 1: length, 2: thickness and 3: width direction).

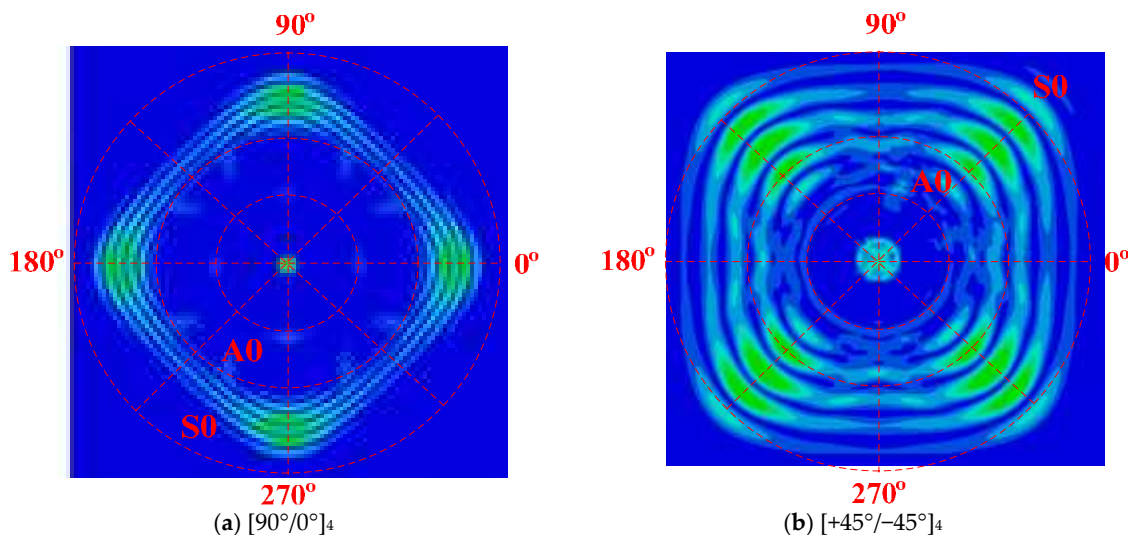
The woven fabrics in the WGF/epoxy composite laminates are along $90^\circ/0^\circ$, and the strength and modulus along the fiber direction was much higher in the composites. The particle elastic motions of Lamb wave in the fiber direction were stronger and this led to a high wave amplitude and velocity in the slowness profiles. It should be noted that the Lamb waves in the joints followed the same slowness profiles in Figure 14a. Since the sensor-actuator path was along the fiber direction (0° in slowness profile), the captured Lamb wave signal had a higher amplitude and velocity in the $[90^\circ/0^\circ]_4$ composite bolted joints.

Figure 14. Slowness profiles of S_0 and A_0 modes in WGF/epoxy composite laminates with different ply modes.

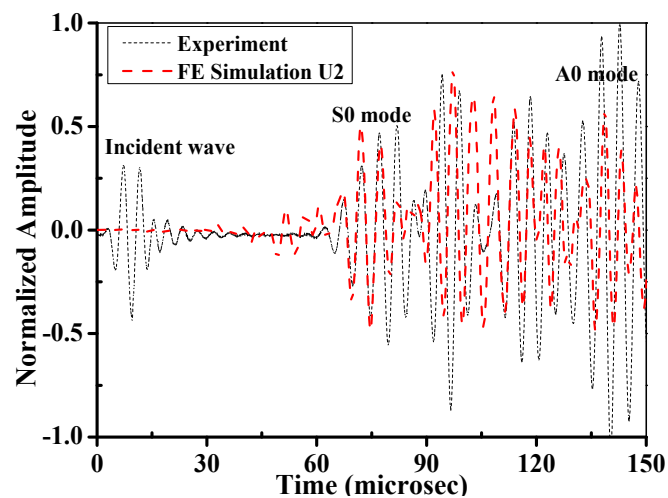
The wave structures of the composite bolted joints in the simulation and experiment are compared in Figure 15. Because the wave is mainly propagated by particle motions along the thickness direction, we used the U2 displacement fields to represent the Lamb wave in the simulation. It was obvious that the S_0 mode was predicted successfully, and the simulation and experimental results matched well. Like the received signal in experiments, two wave packages were found between S_0 and A_0 in the simulation. Minor differences between the simulation and the experimental results of the A_0 amplitude were attributed to the fact that the elastic vibration of A_0 wave at the composite plate edges in the experiment is difficult. Meanwhile, the distortion of the A_0 wave packets due to dispersion could also have led to the differences observed. As calculated by the relationship between propagation duration and the sensor-actuator distance in the FE, the predicted S_0/A_0 wave velocity followed the dispersion curves in Figure 4. Figure 16 shows the Lamb wave propagation feature when it propagates through the joint region. As can be seen, the fundamental S_0 and A_0 modes were captured well, and their propagation duration was consistent with the signal curve in Figure 15. It is worth mentioning that two significant phenomena were found in Figure 16: Expansion of the excited Lamb waves occurred at the incident edge of the jointed plate, and when it was propagating from a large cross-section to a small area at the second edge, reflection and transmission occurred. This phenomenon implies that the wave motion in the composite bolted region was constructed during the propagation.

Figure 15. Comparison of the normalized amplitude between FE simulation and the experiments.

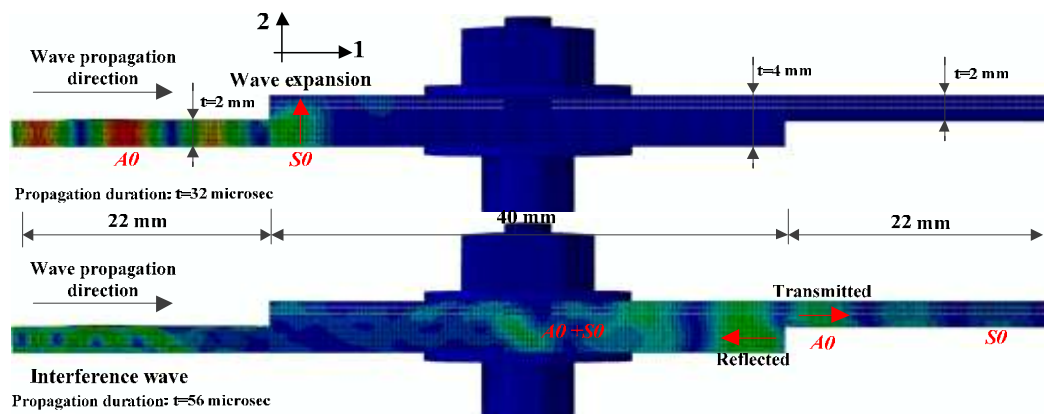
Figure 16. Displacement fields (U_2) of Lamb waves in the composites bolted joints for an excitation frequency of 210 kHz obtained in the FE simulations.
