LANDSLIDE MANAGEMENT IN THE UK, – THE PROBLEM OF MANAGING HAZARDS IN A ‘LOW RISK’ ENVIRONMENT

A D Gibson¹, M G Culshaw², C Foster³, C V L Pennington³

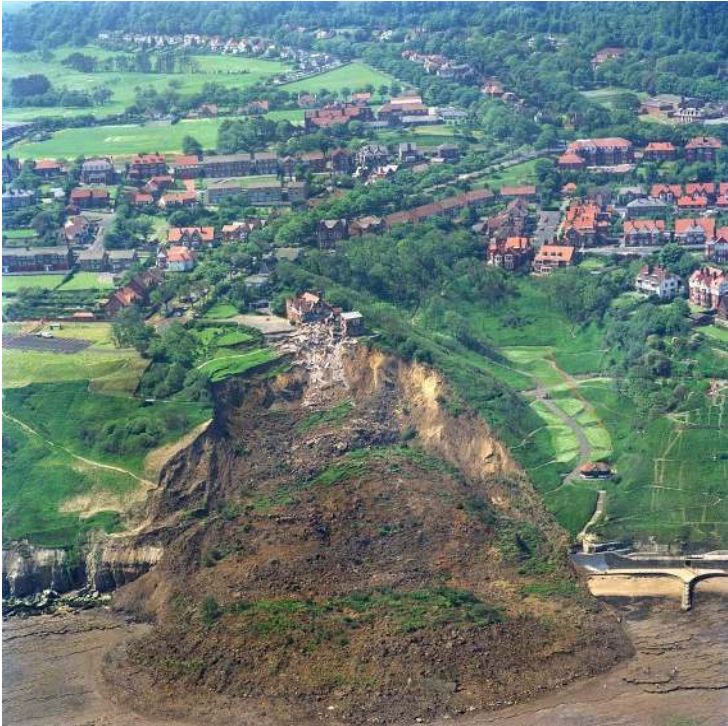
Fig. 3 The Holbeck Hall Hotel landslide, Scarborough, North Yorkshire

The Holbeck Hall Hotel in Scarborough, North Yorkshire, England (Fig. 2), was destroyed as a result of a landslide that took place over a period between the night of the 3rd and 5th of June 1993 (West 1994; Lee *et al.* 1998; Lee 1999; BGS 2008a). The hotel had been built in 1880 close to the coastal cliff top; the coast was known to have been susceptible to movement and slipping (though not recognised as landsliding at that time). Following an unusually wet period in May (West 1994), a pre-existing relict landslide reactivated and began to move downslope, the bulk of the movement taking place overnight. The foundation of the hotel was partially undermined and most of the structure of the hotel subsequently collapsed (Fig. 3). The remains of the hotel were demolished. The subsequent movement of the slide and collapse of the hotel was sufficiently slow to allow repeat visits to the site to monitor progress. The slow movement of the hotel also meant that all residents could be evacuated and that electricity and gas supplies could be switched off before they caused fire.

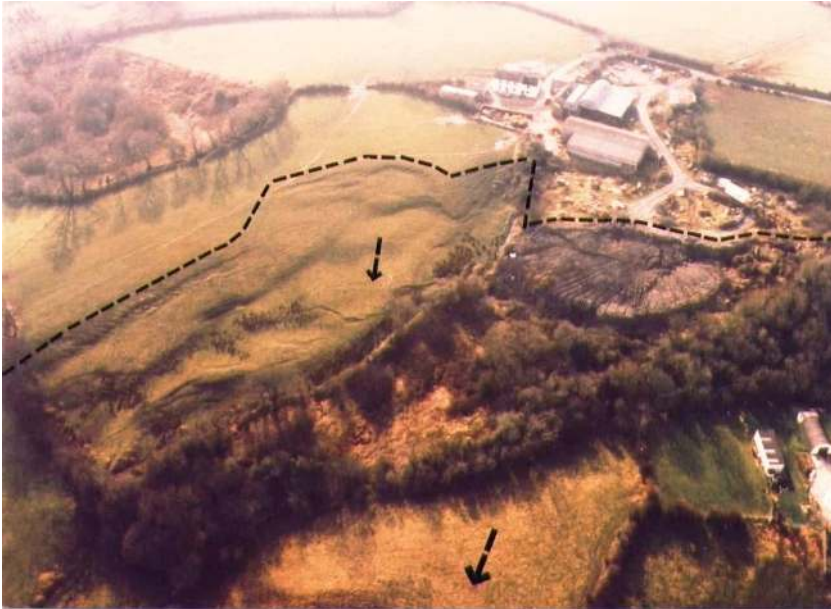
Fig. 5 Landsliding at St Dogmaels. Image courtesy of Dyfed Police

Subsequent investigations showed that the landslide was a reactivation of part of an ancient (12 000 years ago), complex, multiple retrogressive failure. The landslide was a moderately deep-seated non-circular failure and took place in glacio-lacustrine deposits which were up to 60m thick infilling a deeply-incised valley (Fletcher & Siddle 1998). Ground movements of up to 1m began at the head of the landslide and gradually progressed downhill. Movements continued for almost eight months. The ground movement affected the upper part of the ancient landslide, which, itself, extended down to the edge of the main part of the village of St Dogmaels.

The landslide appeared to be caused by the presence of artesian and sub-artesian groundwater levels in the glacio-lacustrine deposits and periods of higher-than-average rainfall in the months and weeks leading up to the failure (Maddison 2000). Other factors, such as the presence of a waste tip at the head of the landslide, poorly-maintained land-drains on the landslide and poorly-controlled drainage of water from springs upslope from the landslide, may have contributed to the failure.

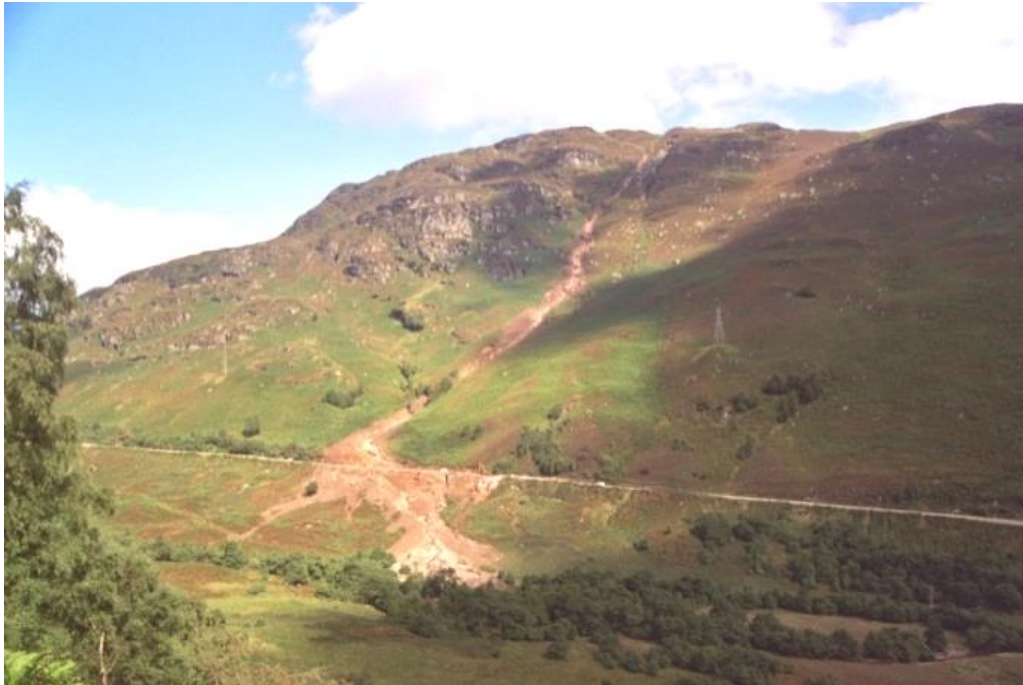
Fig. 7 Debris flow deposit at Glen Ogle.

On 18th August, a debris flow was triggered by an intense rainfall event that displaced a small peat slide into one of the streams that would normally drain through one of the road culverts (Fig. 7). This peat slide set off a cascade within the stream channel, first ripping up weathered bedrock, then mobilising a relict deposit of granular head/landslide material. This dense flow moved rapidly down slope, scouring superficial materials on the way and eventually overwhelming the drainage culvert designed to protect the road. The flows entirely blocked the highway, trapping 57 people in 20 vehicles, with potential for further failures. All 57 people were airlifted to safety by military
