# Landslide stability assessment along Panchkula–Morni road, Nahan salient, NW Himalaya, India

We report the slope stability analysis of three vulnerable sites (S1, S2 and S3) within the lower Siwalik along the Panchkula–Morni road section in the Nahan salient, north-western Himalaya. Kinematic analysis of joint data was conducted to understand the different modes of failure. Rock mass classification techniques like rock mass rating, slope mass rating (SMR) and continuous SMR were used for stability classification and the factor of safety was calculated using stability charts. At site S1, the instability is controlled by the orientation of the discontinuity joint J1 which is parallel to the bedding and at site S2, the slope fails due to the wedge. The Umri landslide site S3 is the product of a damage zone by the normal faults which intersect at joint J3; a wedge is formed which falls in the critical zone. The damage zone in the Umri landslide greatly affects the porosity and permeability of the rockmass and acts as a pathway for the percolation of water during rainfall which reduces effective stress. The slope failures are tectonically controlled results due to the high slope angl

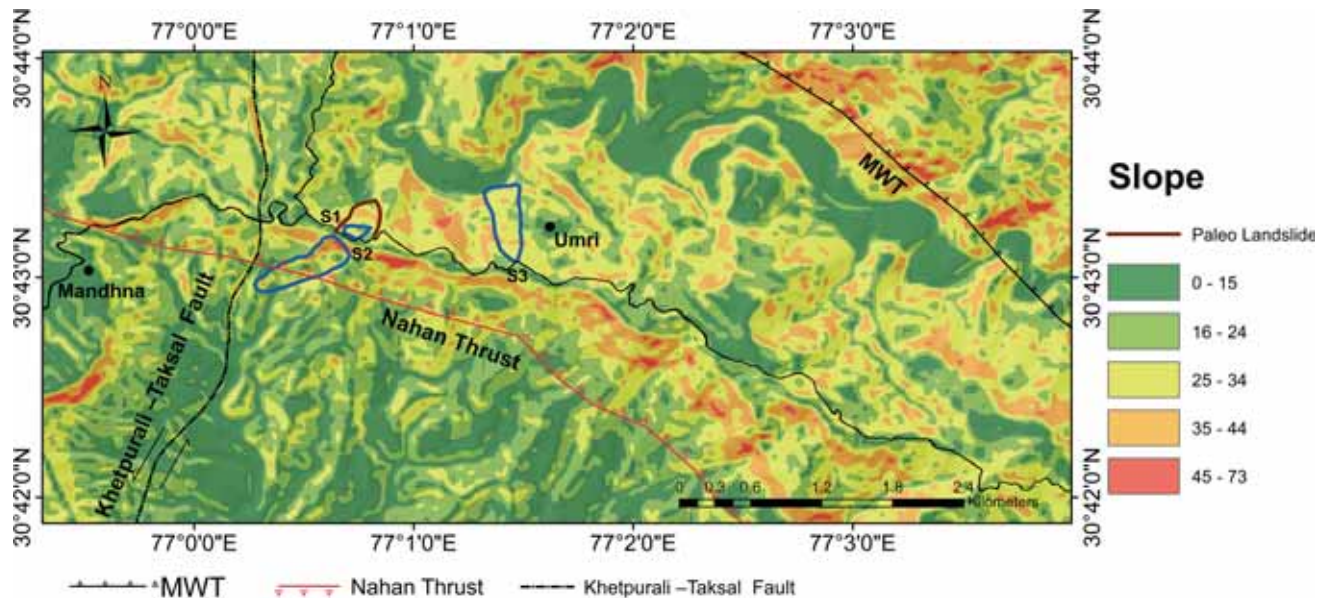
Figure 3. Slope angle of the study area using Bhuvan, Carto DEM. The slope angle varies from 0 to more than 70°.

A high slope angle may cause an instability in the rock mass as it affects the drainage of the area. In many areas due to steeper slopes, the bed's daylight can result in the failure of the slope; therefore, it is important to understand the spatial distribution of the slope angle, which is prepared from the DEM data. The slope angle in the study area varies from 0° to 70° as shown in figure 3. At site S1, the slope angle varies from

25° to 34° and the slope dip towards the north. At site S2, the south dipping slope has a high slope angle of 44–73° along the Nahan thrust which is a contact between the Nahan formation sandstone and the upper Siwalik (figure 3). A high slope angle in the south facing slope along the Nahan thrust is due to the comparatively resistant and indurated sandstones of the lower Siwalik rocks overriding the upper Siwalik sequence of mudstone and clays. This is the prime reason for the high slope angle and is one of the main reasons of the resulting instability of the slope in the region. The slope angle at site S3 (Umri landslide) lies between 25° and 50° and it dips towards the north. The slope angle is low at site S3, but the slope is unstable pointing towards the fact that this may result due to unfavourable structural discontinuities.

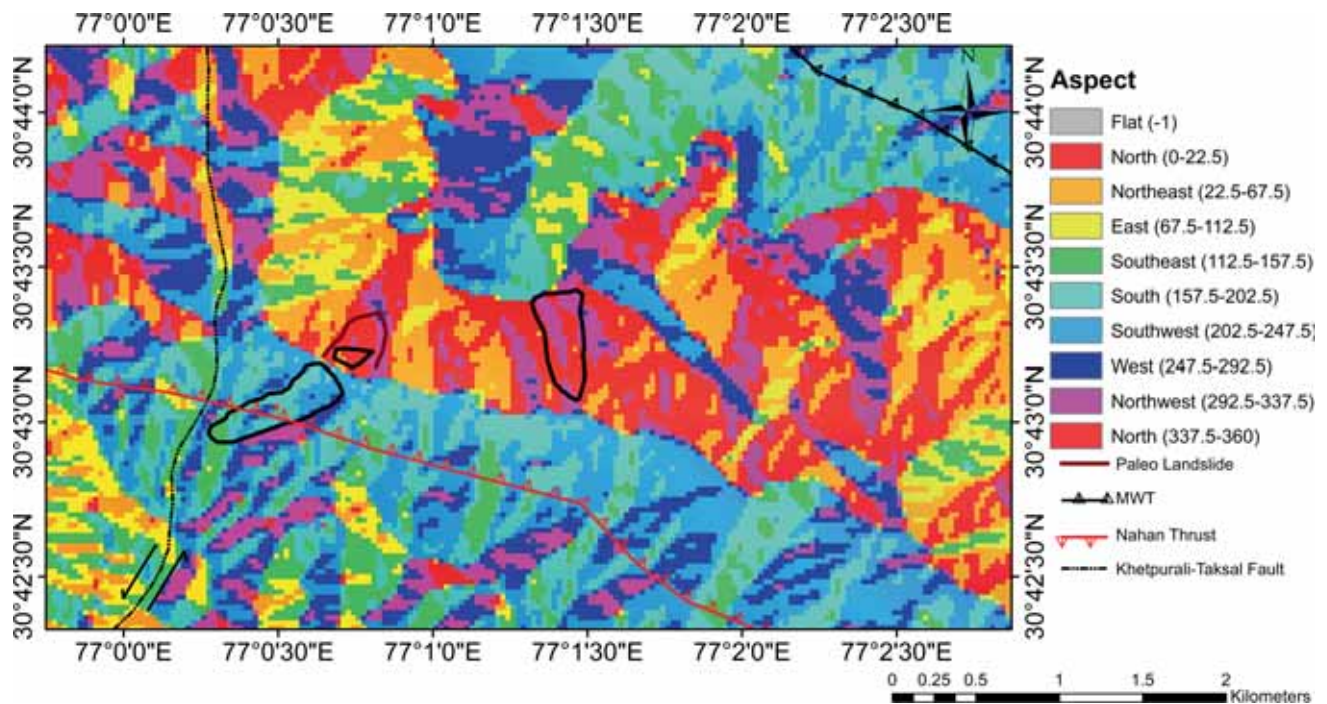
Figure 4. Aspect map of the study area which shows the dip direction of the slopes with respect to the north.

Aspect is another important parameter; it defines the dip direction of the slope. The south-facing slopes are humid and lack vegetation, whereas the north-facing slopes experience more orographic rainfall and are relatively cool and have high moisture content (Chauhana *et al.* 2010). The aspect map is prepared from the DEM data and divided into nine aspect categories (Mathew *et al.* 2005) listed as (a) north, (b) north-east, (c) east, (d) south-east, (e) south, (f) south-west, (g) west, (h) north-west and (i) flat. At sites S1 and S3, the slope is north-facing which may contain more moisture content which further reduces the effective stress due to the increase in pore pressure and may destabilise the slope (figure 4).

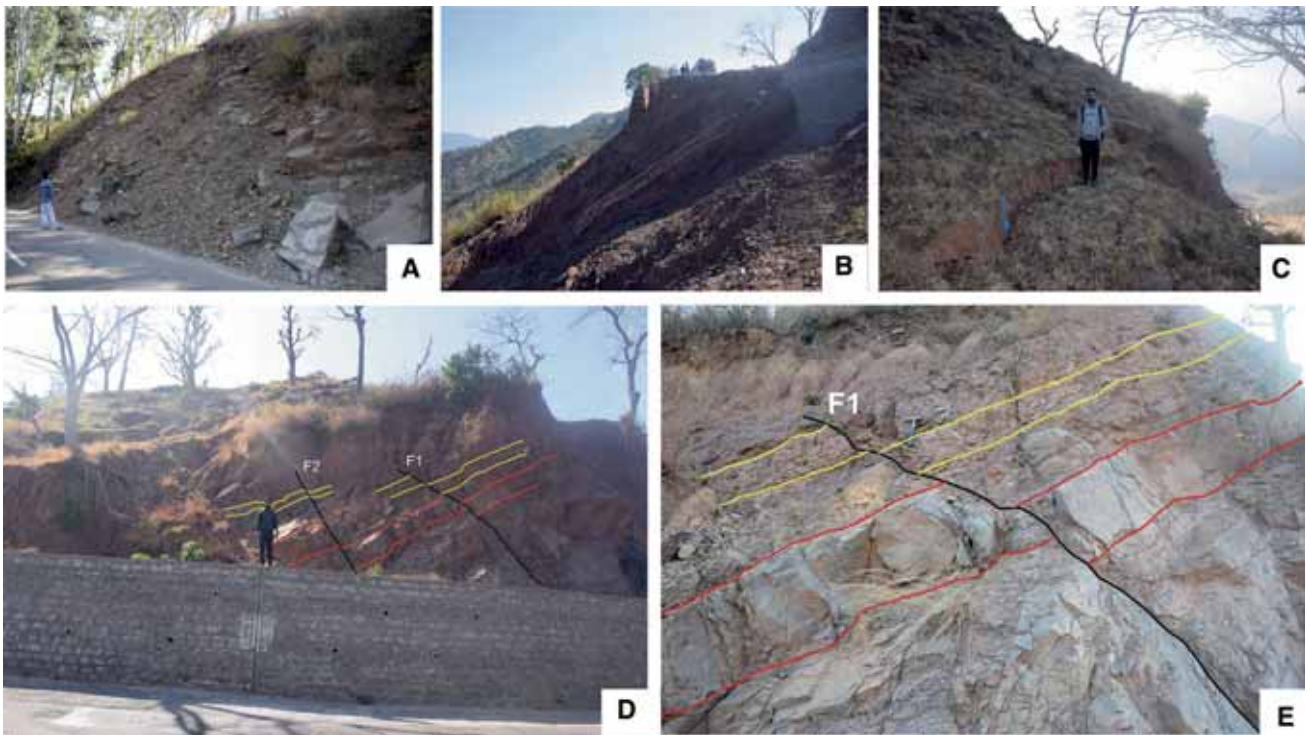
Figure 5. Field photographs: (A) At site S1, unstable road cut slope showing planar failure dominantly composed of sandstone (location figure 1) (B) S3 (Umri landslide) near Umri village, the section is exposed due to landslide showing interbedded sandstone and clay (location figure 1). (C) Tension crack with a thickness of 60 cm due to failure at site S3. (D) Two faults identified in the field on the road cut slope at site S3. (E) Normal faults with hanging wall moving down relative to the footwall at site S3.

Panchkula–Morni road cut slope covering all three unstable slope sites S1, S2 and S3. The slope at site S1 is unstable in the NE direction (figures 5A and 9A), whereas the slope at site S2 is unstable in the SW direction opposite to S1. The lithology at sites S1 and S2 which are located on the opposite side of the slope (water divide) mainly consists of the lower Siwalik sandstone unit. At site S3 (Umri landslide), sandstone beds are interbedded with the

clay and mud rocks as shown in figure 5(B). The houses near the site S3 show cracks in the roof and walls due to the movement of basement rocks near the Umri landslide. Four joint sets are identified in the rock mass at site S3. At the crown of the landslide, a tensional crack of thickness 60 cm is observed due to the circular failure at site S3 as shown in figure 5(C). At the Umri landslide, two normal faults (figure 5D and E) are identified with

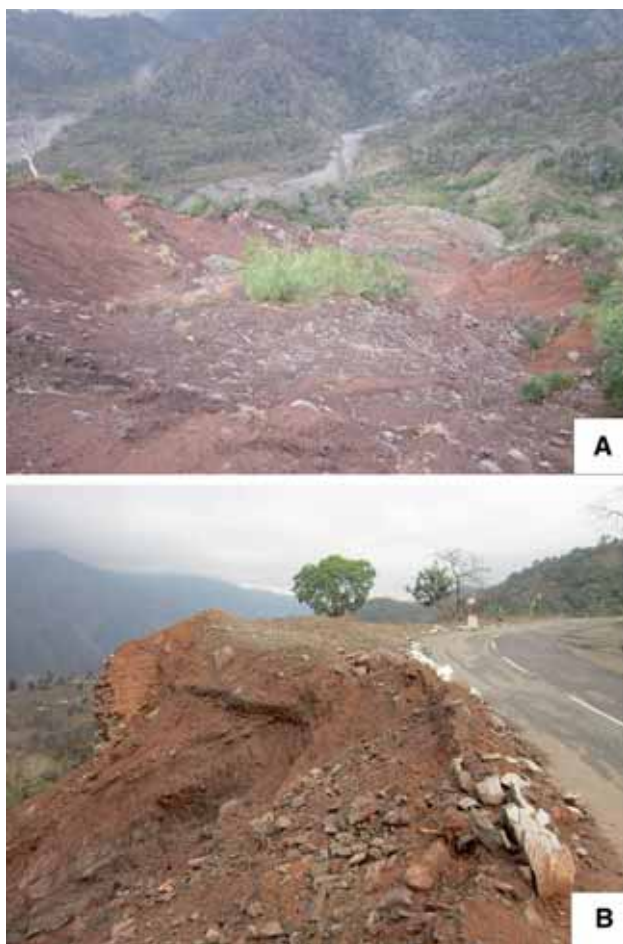
Figure 6. Field photographs of the Umri landslide in Haryana, India. The crown area is still unstable, causing serious damage to road.

a fault plane dipping at an angle of  $55\text{--}330^\circ$ . The main body of the Umri landslide slope is still unstable and damages the road as shown in figure 6(A and B). Deranged forest and traverse ridges are formed due to the piling up of debris down the slope of the landslide (site S3) as shown in the figure 6(B). The dip-strike data collected during the field study plotted on Stereonet indicates that the regional trend of the lower Siwalik sandstone is due  $N40^\circ E$  as shown in table 2 and figure 7. A systematic 3D block model for site S3 (Umri landslide) is constructed which shows different joint sets and the normal fault found in the rock mass and Stereonet depicts the orientation of joint sets and the fault at site S3 (figure 8).

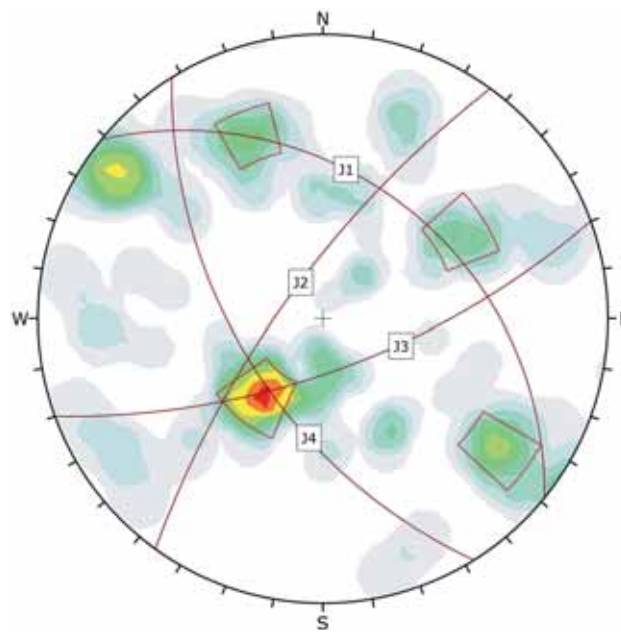
Figure 7. Stereonet with four regional joint sets marked as J1, J2, J3 and J4. J1 is parallel to the bedding plane and its high frequency is represented by poles countoured in red colour.

Table 2. The average regional trend data of all joints calculated using Stereonet (figure 8) along the Panchkula–Morni road.

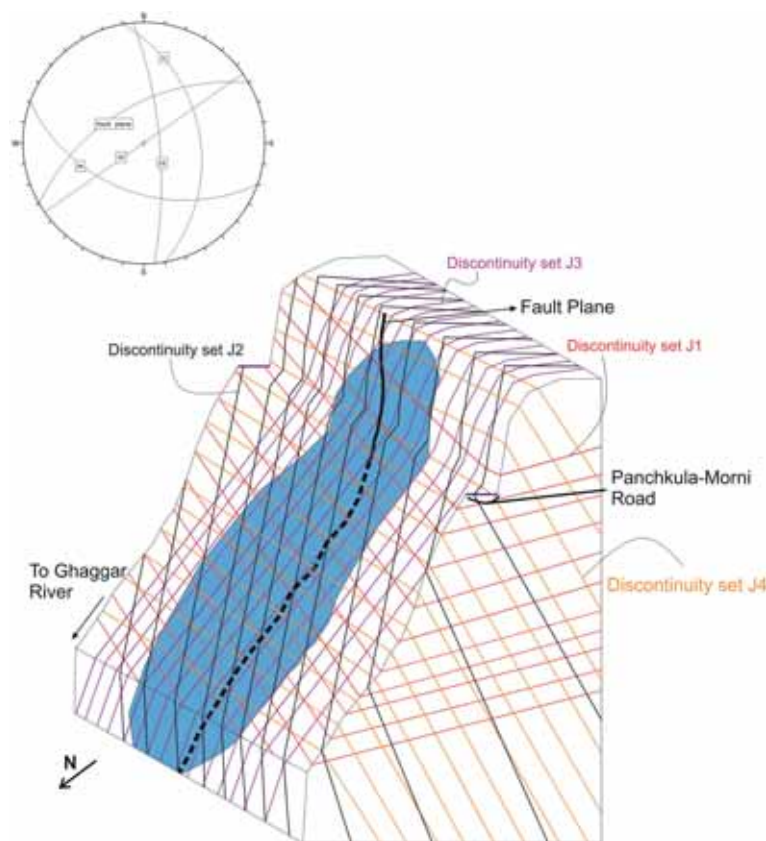
Figure 8. Conceptual three-dimensional-block model of the Umri landslide showing the presence of the discontinuity sets and the tectonic structure that influence the stability of the slope. Stereonet depicts the orientation of the fault and different joint sets at site S3 (not to scale).

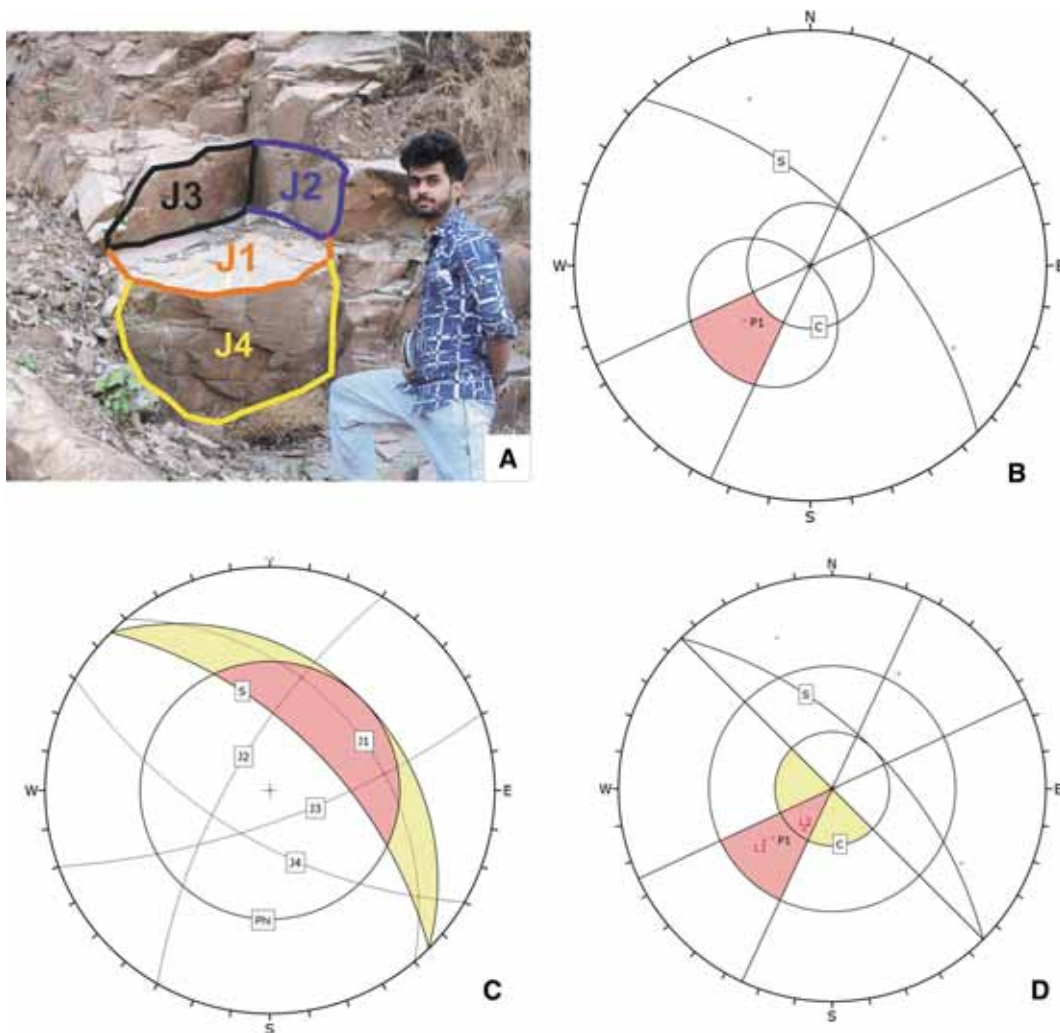
Figure 9. Kinematic analysis of the slope at site S1; *S* = slope face; *c* = cone of friction;  $\phi$  = angle of friction; P1 = pole to joint J1; L1 = line of the intersection of joint J2 and J3; L2 = line of the intersection of joints J3 and J4.

The kinematic analysis of site S1 shows three modes of failure: planar, wedge and direct toppling (figure 9). In figure 9(B), a pole to joint J1 lies in

the shaded region fulfilling the condition of planar failure. The intersection of joint J1 with joints J2 and J3 forms two wedges with the trend of line of intersection being at N15°E and N80°E, respectively, as shown in figure 9(C). Blocks formed due to these wedges will slide along the joint J1 in the NE direction. The line of intersection of joints J2 and J3 is dipping into the slope which forms the edge of block and the joint J1 acts as a surface for direct toppling in the NE direction as shown in figure 9(D). The RMR value at site S1 is 31 (table 5), representing the poor quality of the rock mass. The SMR (planar) value is 7 at site S1 which lies in class V (table 6) and the slope face is classified as completely unstable. Hence, using kinematic analysis and SMR, the slope face at site S1 is unstable. Therefore, the instability along the road cut slope at site S1 is dangerous for road transport.

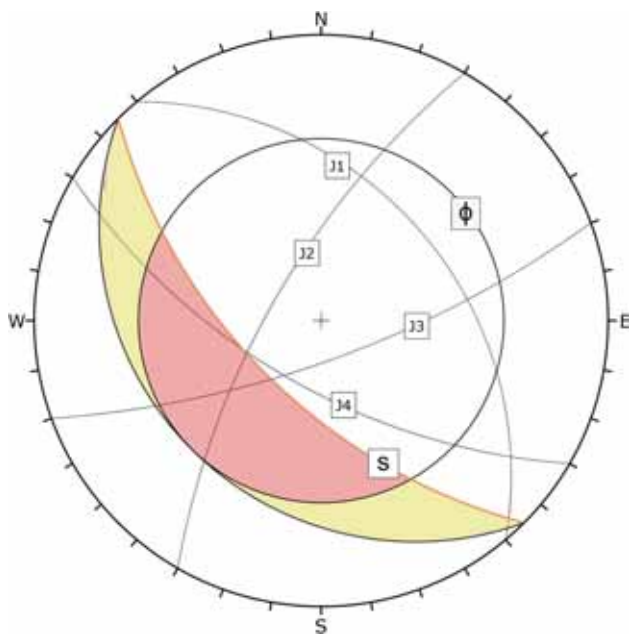
Figure 10. Kinematic analysis of the slope at site S2;  $\phi$  = angle of friction; S = slope face.

Furthermore, the kinematic analysis of site S2 (figure 10) clearly shows the formation of a wedge due to the intersection of the two joints J2 and J3 and the intersection lies in the shaded region. The RMR value is 31 for site S2 (table 5) which represents the poor quality of the rock mass and the SMR (wedge) value is 21 which lies in class IV (table 6). Hence, the slope at site S2 is classified as unstable. The FS calculated using friction-only charts is 1.2 which defines the slope as critically stable. A little increase in the disturbing factors like

earthquake vibrations as this region is highly active and pore water pressure due to rainfall can easily destabilise the slope. Due to the Nahan thrust, the zone is highly fractured and damaged, the rock mass loses its stability because of the daylighting of the structural features and rainfall. Therefore, failure at sites S1 and S2 is mainly controlled by the joint sets and the slope angle.

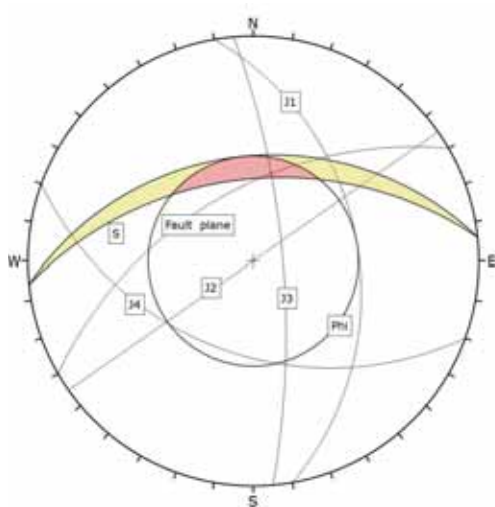
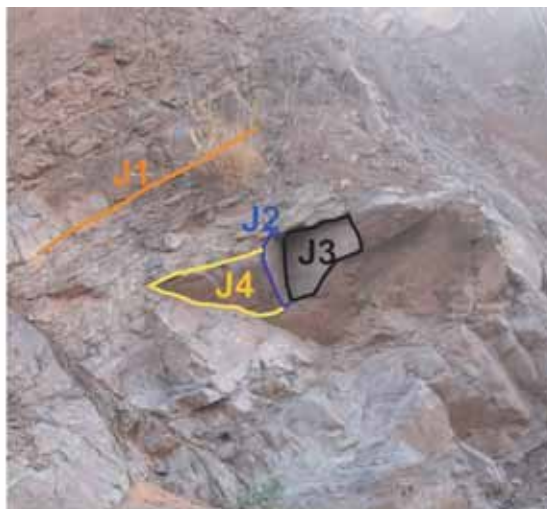
Figure 11. Kinematic analysis of the slope at site S3;  $\phi$  = angle of friction; S = slope face.

The kinematic analysis of site S3 (figure 11) shows the mode of wedge failure, the wedge due to the intersection of the fault plane and joint J3 dipping out of the slope. The wedges formed due to the intersection of the fault plane and J1 (parallel to bedding) and the intersection of joints J1 and J2 also lie near the critical zone. The RMR value is 55 (table 5) for site S3 which represents the fair quality of the rock mass and the SMR (wedge) of joints is 66 for site S3 which lies in class II (table 6). Hence, the slope is classified as a stable slope with failure in some blocks. This points towards the fact that the rock mass instability at site S3 is governed by other factors. First, the wedge formed by the fault plane and the joint J1 as shown in kinematic analysis (figure 11). The normal faulting in the slope decreases the quality of the rock mass and the damage caused favours the instability. In addition, the fault plane also acts as a pathway for the flow of water because of high persistence than joints. The analysis of the soil samples as shown in figure 12 from site S3 (Umri landslide) shows that the soil is dominantly composed of unconsolidated sand. The cohesion of unconsolidated sand material is generally taken as zero, so the only resisting force left is friction. The percolation of the water

into the rock mass and gap-graded soil decreases the effective stress which in turn reduces the effect of friction. Therefore, the Umri landslide at site S3 is mainly controlled by structural discontinuities including joints and faults and interbedded soil layers between the sandstone units.

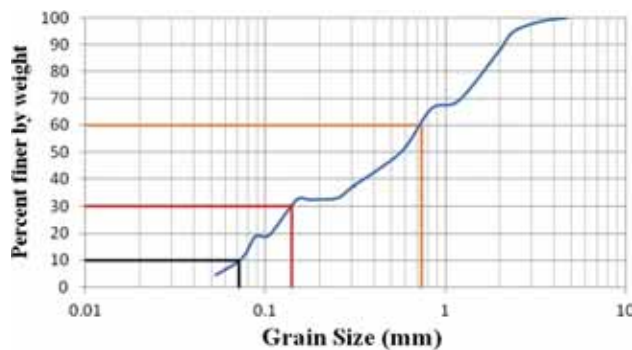
Figure 12. Grain size distribution curve for the soil sample collected from site S3 (Umri landslide).

Sieve analysis is the technique to differentiate the grains on the basis of their size. It was used to separate silt, clay and sand in the soil sample of slope S3 (Umri landslide). First, by weight, 100 g of the dry soil sample was taken for sieve analysis. After sieving, the independent weight of the soil in each sieve was measured to compare the relative amount of silt, clay/silt and sand in the soil. The sieve analysis data were plotted with size *vs.* percent finer by weight to prepare the particle size distribution curve (figure 12). The uniformity coefficient (Cu) and coefficient of gradation (Cc) were calculated. If Cc is between 1 and 3 the soil is well graded, but if  $Cc < 1$  soil is poorly graded. Poorly graded is further classified into gap-graded and uniformly graded depending upon grain sizes. Also, it is clearly depicted from the particle size distribution curve that the soil at site S3 is gap-graded because some intermediate sizes are missing. The gap-graded soils generally have excellent drainage

quality (permeability coefficient,  $K > 10^{-3}$  cm/s) (Pandit *et al.* 2016). The flowing water gives rise to seepage forces and water pressure which in turn reduce the frictional effect and decreases the instability of the soil:

$$\begin{aligned} \text{Uniformity coefficient (Cu)} \\ &= D_{60}/D_{10} = 0.73/0.071 = 10.28, \\ \text{Coefficient of gradation (Cc)} \\ &= D_{30}^2/D_{60} * D_{10} \\ &= 0.14 * 0.14/0.73 * 0.071 = 0.38. \end{aligned}$$
