Large Scale Application of Self-Healing Concrete: Design, Construction, and Testing

This article was submitted to
Structural Materials,
a section of the journal
Frontiers in Materials

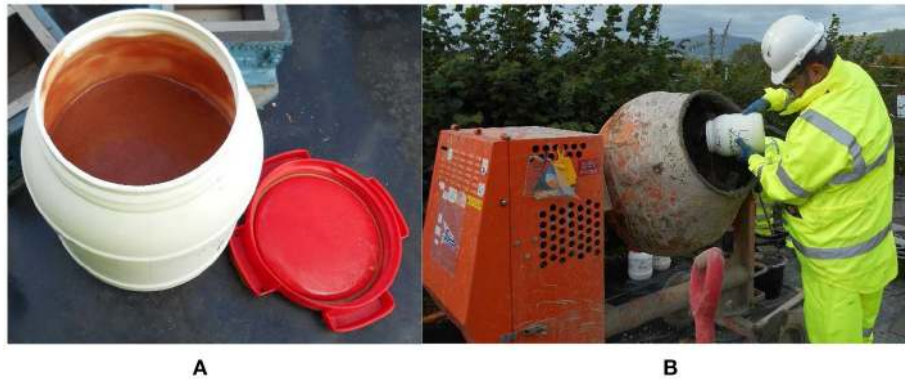
FIGURE 4 | (A) Microcapsules in solution prior to mixing and **(B)** addition of microcapsules into the mix.

A total of 8% by volume of cement of microcapsules were mixed into the concrete using the onsite Belle mixer. As the microcapsules were provided by Lambson in a preserving aqueous solution, this added an additional small quantity of water to the concrete mix, increasing its water-cement ratio from 0.43 to 0.45. This had a minimal effect on the slump increasing it by $< 20 \text{ mm}$. **Figure 4** shows the microcapsules in solution prior to and during their addition to the mix.

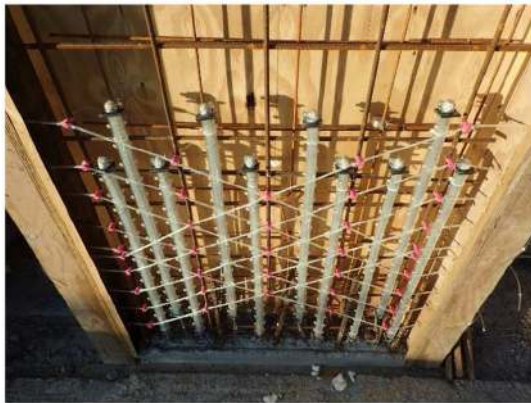
FIGURE 8 | Layout of SMP tendons and flow networks in Panel B.

Flow networks were included in Panel B to allow the introduction of healing agents into the concrete. A 2D network of 4 mm diameter channels was created using polyurethane tubes, which were removed from the concrete after the formwork had been struck. The channels were connected using 3D printed joints made from polylactic acid (PLA), which were tied to the outermost reinforcement, allowing the networks to pass in front of the SMP tendons. At either side of the panel, the flow networks were terminated with lockable steel injection packers, which allowed each channel to be sealed individually to aid the loading and pressurizing of the network. The final layout of the tendons and flow networks within the panel prior to casting is shown in **Figure 8**.

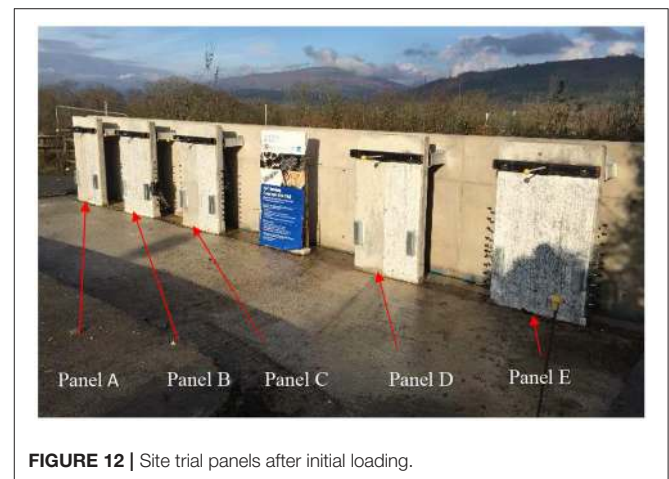
**FIGURE 12** | Site trial panels after initial loading.

be employed in large-scale applications and this was successfully achieved as evidenced in **Figure 12**. Although it was originally intended to cast six panels, the central panel wasn't used, being kept as a reserve in case of unforeseen problems during construction. The following sections describe some of the many valuable lessons learnt from the construction of these panels.

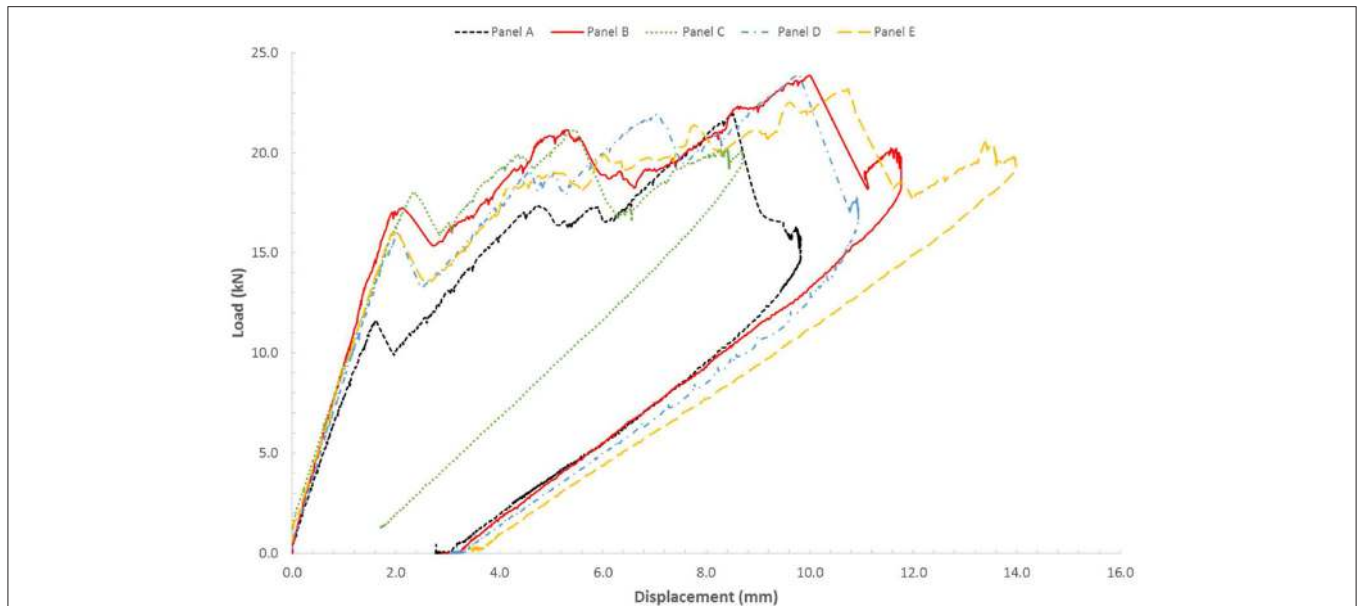
FIGURE 13 | Load-displacement curves for all panels during the initial loading stage.

The load/displacement curves for all panels during the initial loading stage are presented in **Figure 13**. This comparison explores the differences in the stiffness and flexural strength of the panels. The displacement values were obtained from LVDTs 2 and 4 positioned at the level of the loading bar (**Figure 10**) and measured the displacement of the panel relative to the mounting column. For the purposes of comparing overall displacement, the average value of the two transducers was used, taking account of any twisting in the panels.

The load-displacement profiles are similar for all panels, but with some key discrepancies. For Panels B, C, D, and E, initial small reductions in load can be observed between 16 and 18 kN and this corresponds to the first cracks at the base of the wall. Fluctuations in load are observed beyond 18 kN with a second significant reduction in load at around 21–22 kN corresponding to a second crack about 200–300 mm above the base. Panel A, containing microcapsules, experienced initial cracking at about 250 ± 20 mm above the base at the much lower load of 11.6 kN, however, this panel did crack at the base of the panel at around 17 kN which is consistent with the other panels. Further load was then applied until a crack formed at the CoS location. Panel C, containing the bacterial concrete layer, experienced cracking at the CoS location with the least amount of deflection and Panel E had the largest deflection at 14.35 mm.

It can also be seen that the gradient of the initial loading curve for Panel B is slightly greater than that of all of the other panels. This indicates that this panel has a greater stiffness, probably due to the contribution of the PET tendons. The loading curve of Panel A has the smallest gradient, indicating that this panel has the lowest stiffness. This could be a result of the inclusion of the polymeric capsules into the mix or the slightly higher water-cement ratio of this concrete compared to the control, and it is consistent with the cube strength results presented in section Concrete Strength.

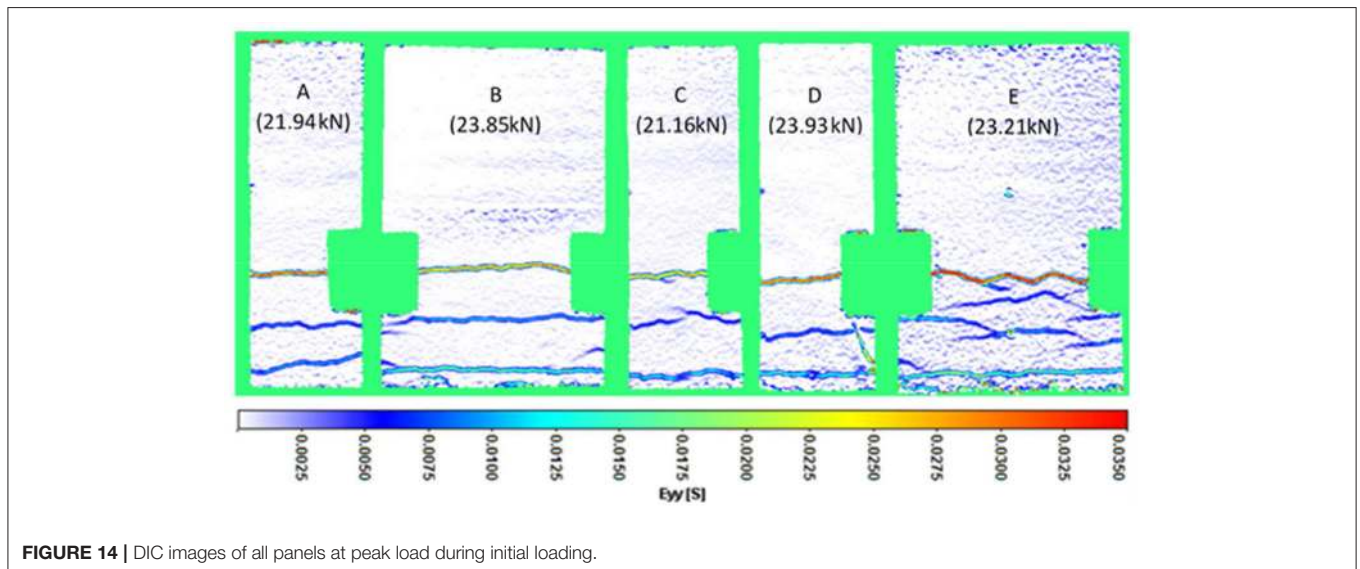
FIGURE 14 | DIC images of all panels at peak load during initial loading.

Figure 14 shows DIC images of all five panels immediately following cracking at the CoS. The loads displayed are indicative

of the peak load immediately before the formation of these cracks. As indicated when discussing the experimental set-up, Panels A, C and D are shown as half-panels, to enable permeability measurements to be taken across the non-painted side of the panels.

The DIC images show some branching of the cracks. This is particularly evident on Panel E, which has flow networks in addition to the control concrete. The presence of these multiple cracks and a larger displacement of the panel at higher loads suggests that there is a loss of strength but an increase in ductility due to the inclusion of the flow networks.
