Laser Repair and Clean of Extreme Ultraviolet Lithography Photomasks

Tod Robinson^{*a}, Jeff LeClaire^a, Iacopo Mochi^b, Ricarda Maria Nebling^b, Yasin Ekinci^b,
Dimitrios Kazazis^b

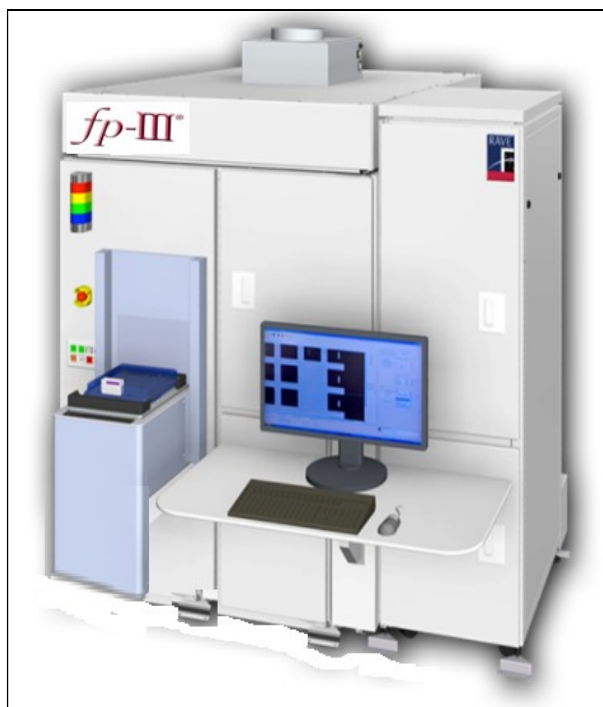
Figure 2, fp-III advanced laser photomask repair system

The fp-III photomask repair tool employs a deep ultraviolet (DUV) 258 nm wavelength, femtosecond pulsed laser with high numerical aperture (NA) objectives. Compared to prior toolsets, the fp-III has increased stability, reliability, and a smaller cleanroom footprint. Repairs are performed with one of two different objective lenses. The 50X objective is most often used for through-pellicle repairs and dry cleaning (due to its longer working distance) and typically shows thin film removal beam burn diameter around 300 nm in diameter. The 150X, or highest magnification objective, is used when there is no pellicle mounted on the mask (this is automatically detected at mask load, and if a pellicle is present, this objective is locked out or disabled from being selected). The nominal beam burn diameter for the 150X on most photomask absorbers is approximately 200 nm. Another unique feature of the fp-III is that it has integrated features to support particle and surface clean processes that allow for EUV photomask defect selective repair and clean with potentially no detectable mask damage.

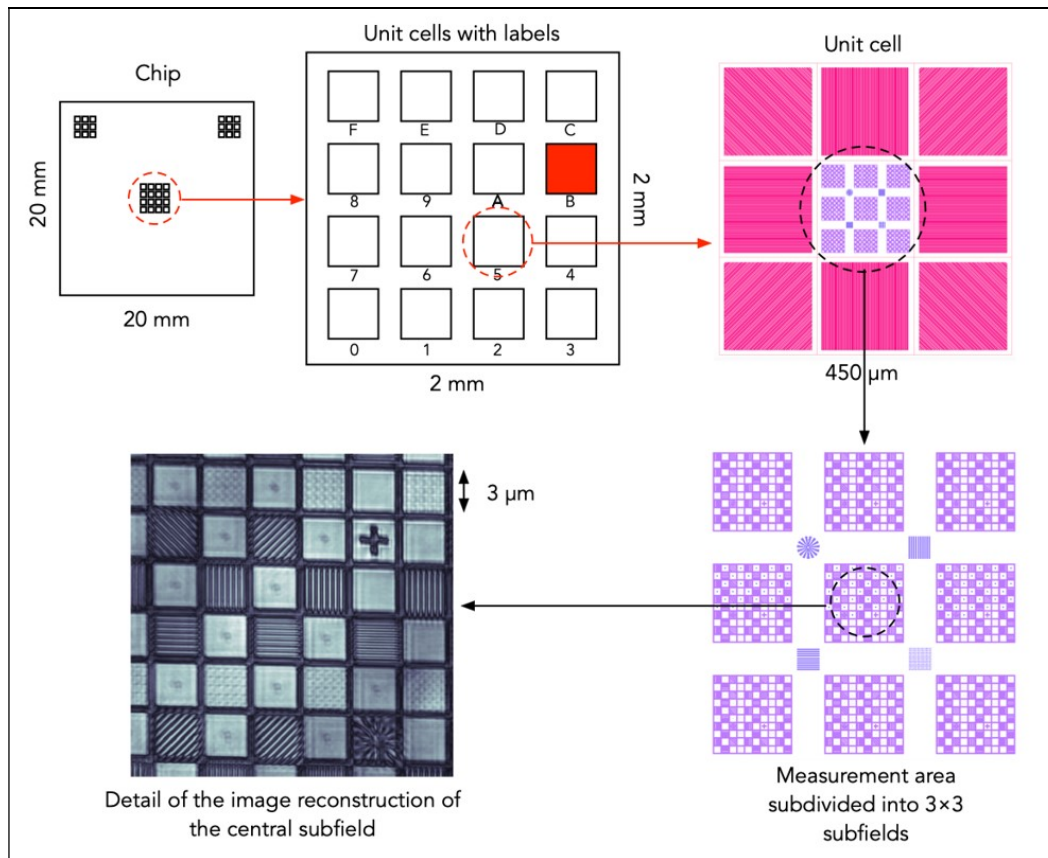
Figure 3, sample pattern layout for RESCAN EUV metrology

Figure 3 shows a summary of the test defect matrix pattern for the sample specifically made for the RESCAN apparatus. The sample's substrate was a silicon wafer cut to 2 x 2 cm with a testing pattern in the center and two reference patterns in the upper corners. All repairs and AFM scans were performed on the center test pattern only which included a 4 x 4 array of die with identical patterns and defects. Each die (labelled 0-9 then A-F as shown in Figure 3) was then comprised of a 3 x 3 array of sub die (referred to by row and column number, for example row1 column 2, or R1C2). Each sub die was even further comprised of 3x3 um square cells, each of which could contain up to 50 defects. With this very large number of defect sites, most of the repairs were focused on one die (die B as seen in Figure 3), additional test repairs were performed in R1C3 sub die of die F as well as some pre repair referencing metrology performed in dies A and C.

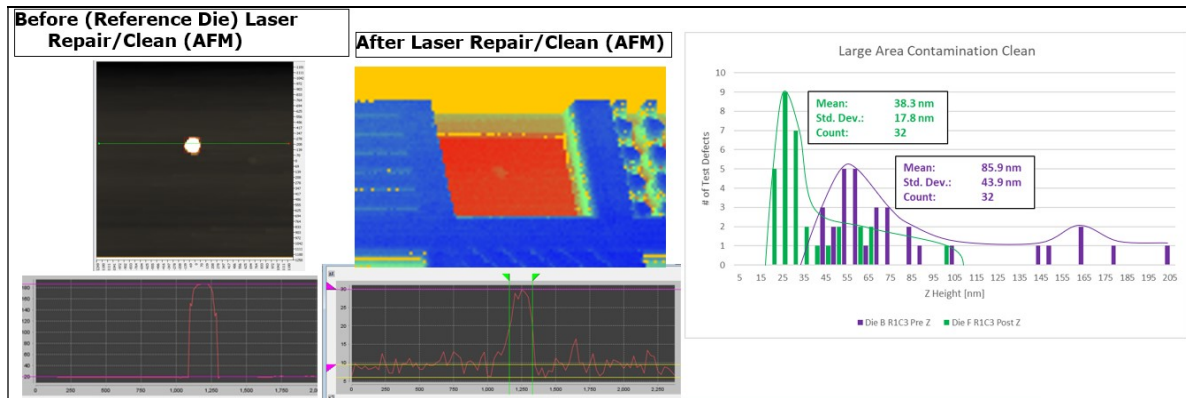
Figure 11. New Area, Low-Aspect Laser Clean Process. HAR C-Pin dots are significantly reduced, but not as much as with thinner, more spread out contaminates (Low AR or LAR).

An example of one of these high aspect carbon pin dot defects after repair (in die F) with area process 2 in the middle panel of Figure 11 next to an AFM of a comparable reference from die A in the far left panel. In the far-right panel of this figure are the two histograms to compare the overall z height distributions between the repaired (in green) and unrepaired (violet) sub die. One may see in the comparison of these histograms that the mean, maximum, and minimum of the distribution were reduced by the area repair as well as the variance of the distribution. The difference is significant and clearly discerned. However, the reduction is qualitatively less than what was observed with the lower aspect contamination removed in the demonstration repairs in Figure 9.
