## Lessons Learned from the 2011 Great East Japan Tsunami: Performance of Tsunami Countermeasures, Coastal Buildings, and Tsunami Evacuation in Japan

**Key words:** The 2011 East Japan earthquake and tsunami, tsunami countermeasures, Sanriku coast, Sendai plain.

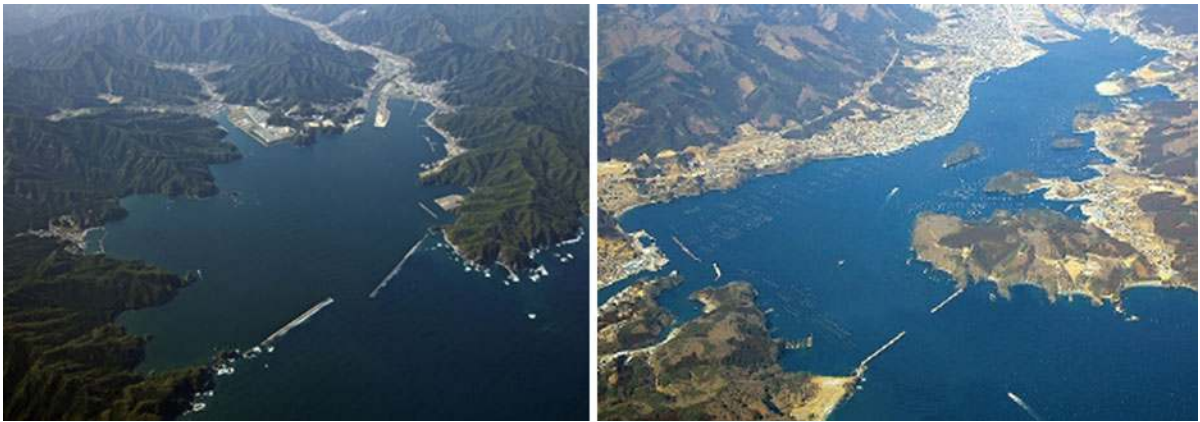
Figure 3  
Tsunami breakwaters in Kamaishi city and in Ofunato city (before the 2011 tsunami)

Large-scale tsunami breakwaters are present along the Sanriku coast. They were constructed to protect cities from future tsunamis, because of the region's long history of devastating tsunamis. The tsunami breakwaters were designed to resist tsunamis that are similar in strength to the 1896 Meiji Sanriku tsunami. Two well-known tsunami breakwaters are located in Kamaishi city and Ofunato city. In Kamaishi, the tsunami breakwaters were constructed at the entrance to the bay; they are 63 m deep and hold the Guinness world record for the deepest breakwaters (Fig. 3, left). Construction of the breakwaters was completed in 2009; they have a 300 m opening and are 670 and 990 m long (KAMAISHI PORT OFFICE, 2011). The two tsunami breakwaters in Ofunato city were constructed after the city was struck by a large tsunami with long-period waves caused by resonance with the tsunami generated by the 1960 Chilean earthquake (Fig. 3, right). The two breakwaters are located at the bay entrance where the water is 38 m deep; they have a 200 m wide opening and are 290 and 250 m long (KAMAISHI PORT OFFICE, 2011). Construction of the breakwaters was completed in 1967 and successfully protected the city from the Tokachi-oki tsunami in 1968.

the impact of the tsunami (both tsunami height and arrival time) on the cities, especially Kamaishi, where many houses still remain (Fig. 4). Figures 5 and 6 show the performance of the Kamaishi breakwaters

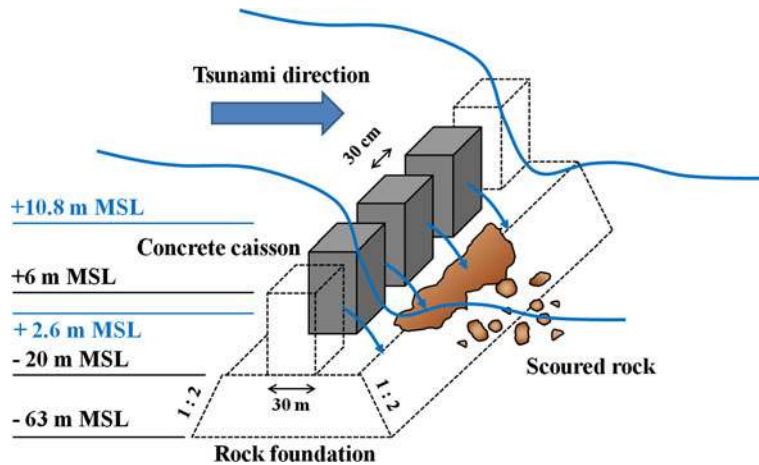
Figure 5  
Mechanisms of damage to the Kamaishi breakwaters

runup height from 20.2 to 10.0 m (PARI, 2011). Because of the strong current in the 30 cm spaces between the blocks, the rock foundation was damaged. Eventually,  $\sim 70\%$  of the blocks were destroyed. This process occurred slowly; as a result, the arrival time of the tsunami inundation was delayed by 8 min (from 28 to 36 min) (PARI, 2011). However, the tsunami breakwaters at Ofunato were more seriously damaged and are currently submerged in the sea. Possible reasons are that the Ofunato breakwaters were constructed using earthquake resistance design of nearly 40–50 years ago and the wave period of the strong tsunami current

- From the perspective of structural damage, breakwaters and seawalls should have stronger foundations, and there should be more secure connections between neighboring blocks. New designs for stronger and more stable coastal structures should be developed. Tsunami gates and gates in seawalls should be remotely controlled. However, these structures may reduce the tsunami awareness of residents by leading them to believe that the structure fully protects them rather than simply reducing damage; an example of this thinking occurred in Taro town. The scenery should also be considered after the construction of high seawalls; Matsushima town, for example, has one of the best views in the Tohoku area.
- Control forests are not only unable to stop or reduce huge tsunamis such as the 2011 event but may also cause more damage when the trees

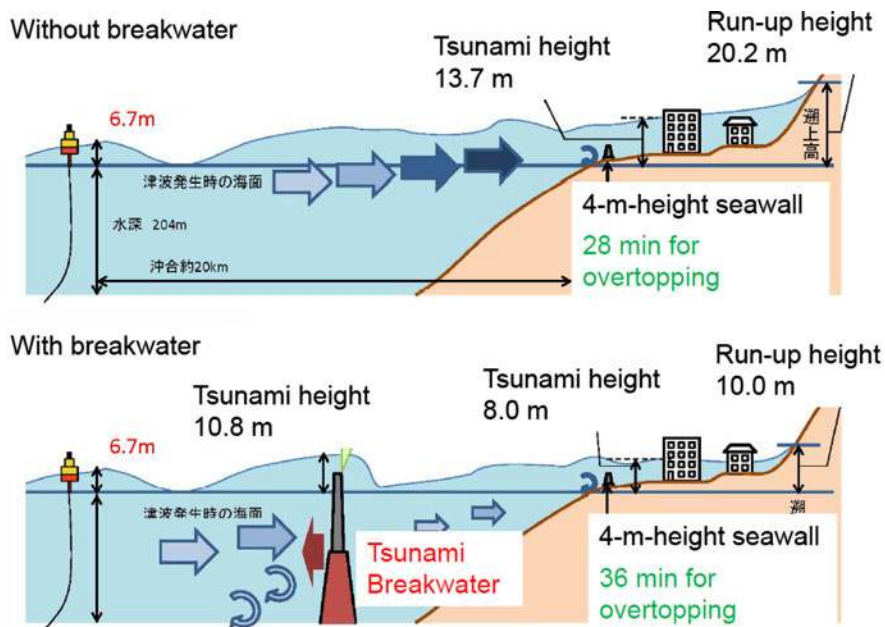
Figure 6  
Tsunami impact reduction performance of the Kamaishi breakwaters (PARI, 2011)

direction of the axis of the breakwaters. The blocks rose 6 m above sea level and were designed to protect the city from a 5.6 m high tsunami. A tsunami height of 6.7 m was measured at a GPS station in Kamaishi Sea. On the basis of these data, two simulations were performed for cases with and without breakwaters (PARI, 2011). From the results, the height (mean sea level, MSL) of the tsunami was 10.8 m in front of the blocks and 2.6 m behind the blocks; therefore, the blocks helped to reduce the tsunami height by 8.2 m (Figs. 5, 6). With regard to inundation by the tsunami, the breakwaters reduced the tsunami height (at the shoreline) from 13.7 to 8.0 m and reduced the

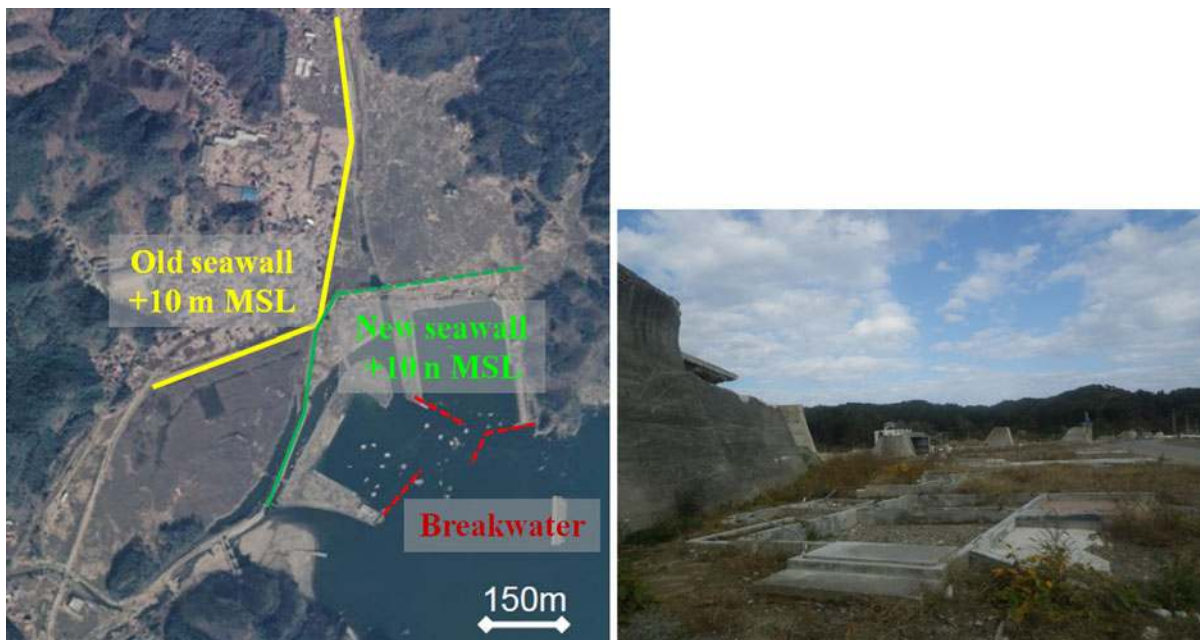
Figure 7

Seawalls in Taro town. Damage occurred to the eastern parts of the new seawalls (9/11/2011)

There are three main reasons why the seawalls were damaged.

- The two seawalls crossed in an X shape, which caused the tsunami to accumulate and increase in size at the center of the seawalls.
- The foundations of the seawalls were weakened by the river on the eastern side of the town. Soil properties near rivers may have disrupted the stability of foundations.
- The seawalls were not maintained properly and had not been adequately connected to each other. The tsunami flowed over the seawalls and became a high-speed water jet. The strong current at high speed caused scouring around the foundations.

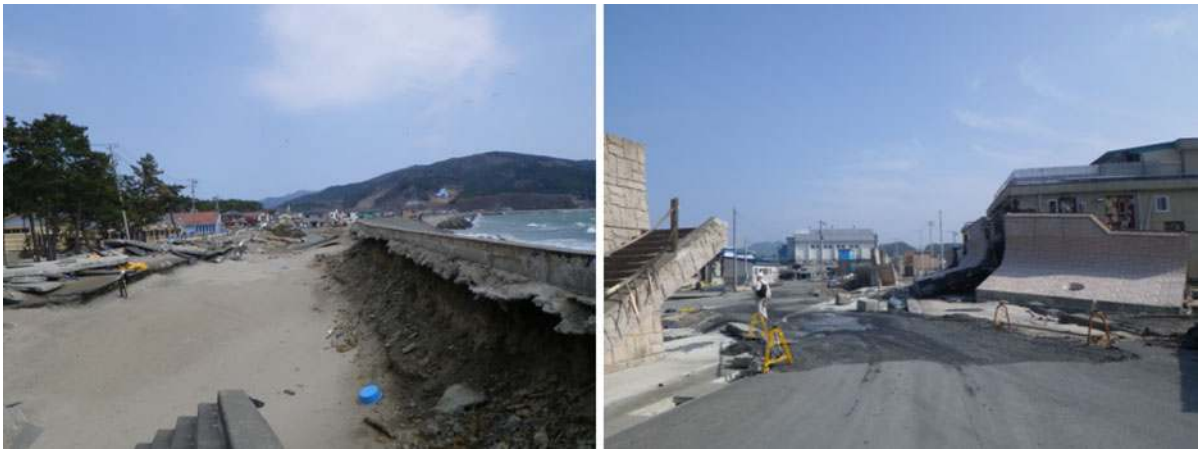
Figure 8

Examples of damage to typical seawalls can be found in Ishinomaki city (Fig. 8, left) and in Higashi-Matsushima city. The tsunami height near the control forests of both cities was 7–8 m. On the sea side, the surfaces of the seawalls survived, but on the land side, severe scouring occurred at the foundations. Another example of damaged seawalls is shown in Fig. 8, right. In Yamada town, five blocks of seawalls of total length

Seawalls damaged by scouring in Ishinomaki city (*left*, 26/4/2011) and by sliding in Yamada town (*right*, 31/5/2011)

of 50 m were moved by the tsunami. The block structure survived but failed because of poor connection with the foundations and with neighboring blocks. Figure 9 shows typical mechanisms of damage to seawalls including sliding because of the pressure difference, overturning because of collision of the wavefront, and scouring by strong currents (PARI, 2011).

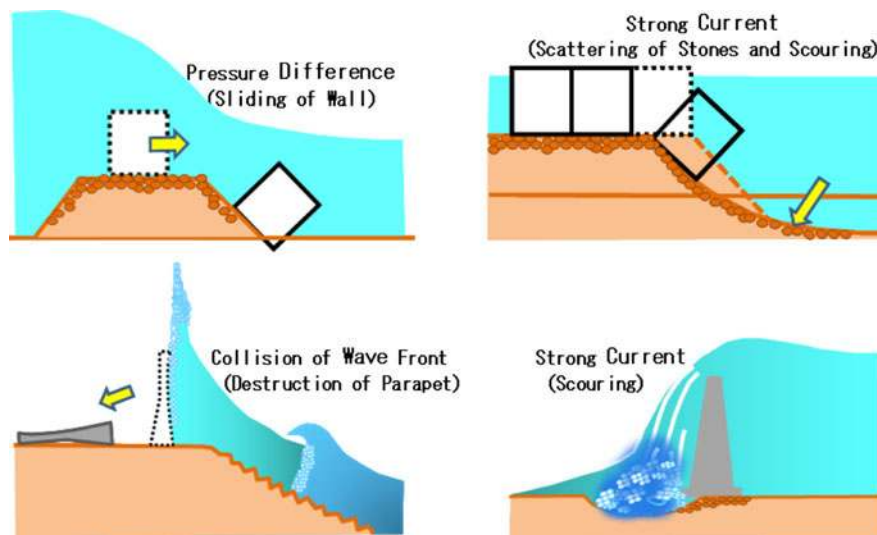
Figure 9

Typical mechanisms of damage to seawalls (PARI, 2011)

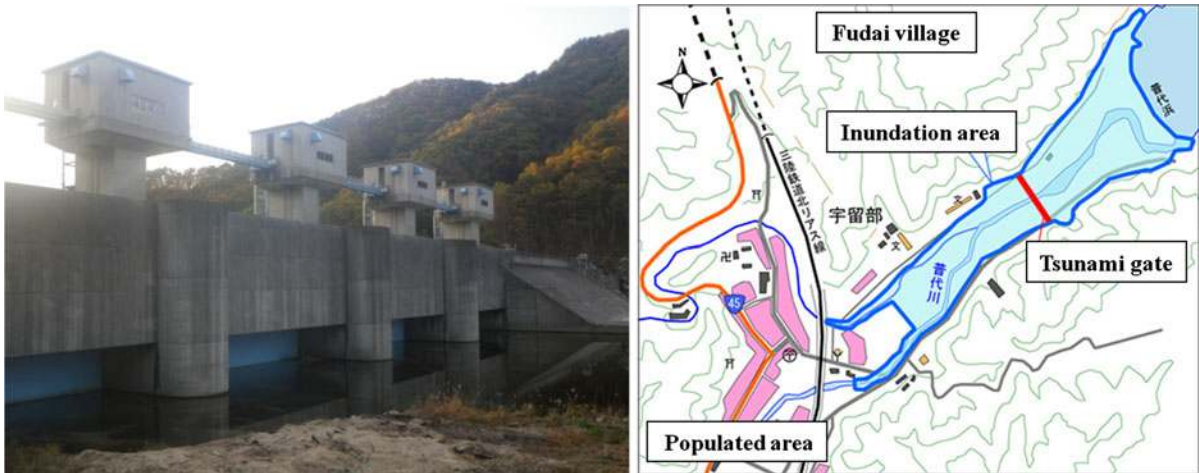
propagated along the river. In 1984, 15.5 m high tsunami gates were constructed to close the river mouth in case of tsunamis. Fudai was the location of a successful countermeasure structure that protected the village from the 2011 tsunami. The 17 m high tsunami flowed over the gate but inundated only a few hundred meters past the gate (NIKKEI NEWSPAPER, 2011), as shown in Fig. 10, left. Most of Fudai village, including the evacuation shelters (primary and secondary schools), was protected, as shown in Fig. 10, right, and no loss of human life was reported (TOKEN, 2011). If there had not been a tsunami gate,

Figure 10  
The tsunami gate that protected Fudai village and led to no reported casualties (9/11/2011)

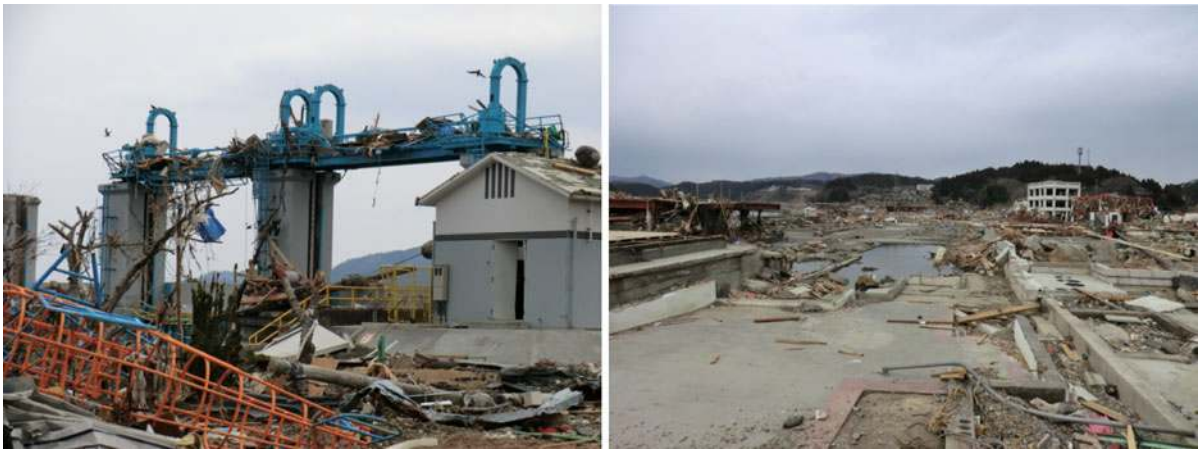
Figure 11  
The damaged tsunami gate in Minami-Sanriku town and the town's condition after the tsunami (25/3/2011)

overwhelmed and did not stop the 2011 tsunami, which was higher than 15 m (Fig. 11, left). As a result, 95 % of the town, including the disaster prevention building, was destroyed (Fig. 11, right), and approximately half of the population was missing immediately after the tsunami. Approximately 1,000 people died or are missing as a result of the tsunami.

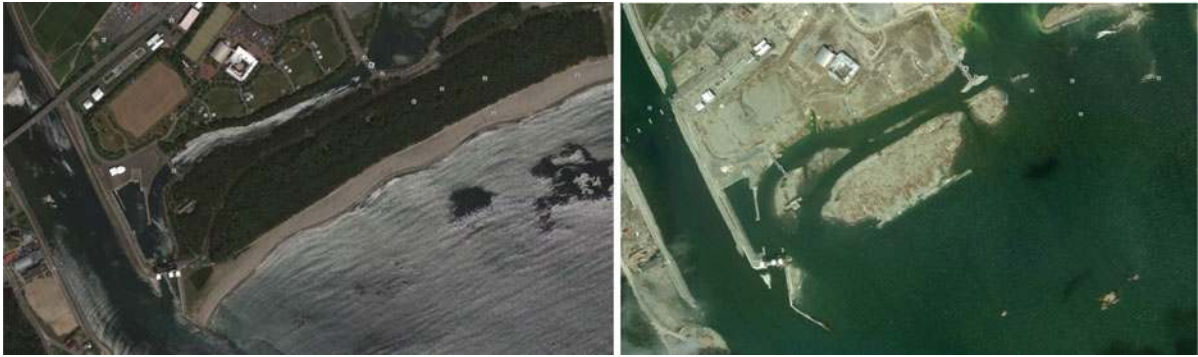
Figure 12  
Control forest in Rikuzen-Takata city. Approximately 70,000 pine trees were completely swept away

become floating debris, as observed in Ofunato and Rikuzen-Takata. Because they can only withstand tsunamis with heights up to 5 m, control forests should be planted as a second barrier behind seawalls or at elevations that are higher than the level of the seawalls. Another option is to plant the control forest more deeply in the ground so that their roots can be more connected with the land and increase their strength.

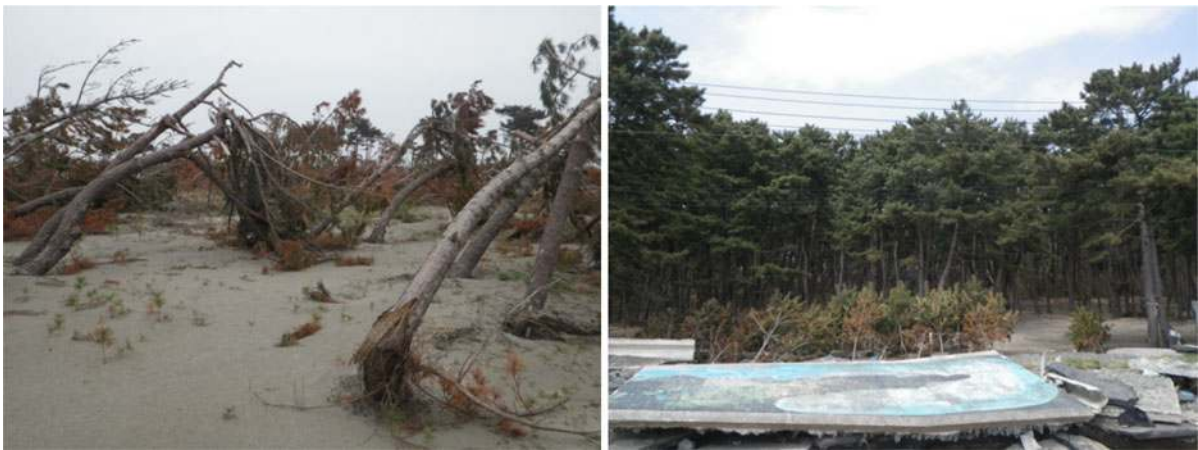
Figure 13  
Damage to a control forest in Natori city (11/5/2011), and a control forest that survived in Ishinomaki city (26/4/2011)

Unlike the first two examples, almost all of the pine trees in the control forest in Ishinomaki survived (Fig. 13, right). The forest reduced the destructive

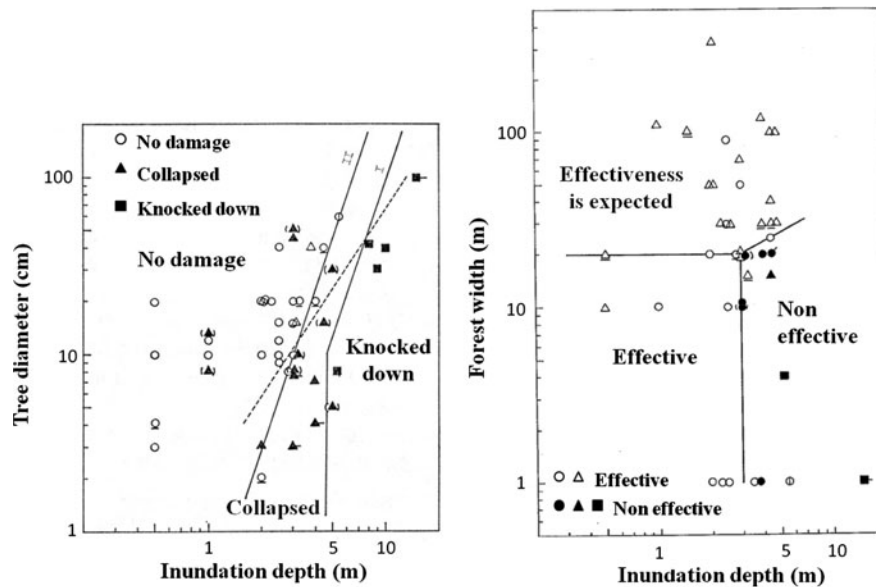
Figure 14

Tree damage as a function of inundation depth and tree diameter, and the effectiveness of control forests as a function of inundation depth and forest width (SHUTO, 1985)

inundation depth is greater than 4 and 5 m, respectively. Figure 14, right, shows the effectiveness of the control forest in trapping debris and reducing the wave current. The effectiveness of the control forest was limited at an inundation depth of 3 m for a forest width of  $<20$  m. Historical data show that a forest width  $>100$  m is expected to be effective up to an inundation depth of 5 m. The maximum 2011 tsunami heights in both Rikuzen-Takata (150 m forest width) and Natori (500 m forest width) were  $>10$  m (out of the data range), and caused devastating damage. On the other hand, a 6 m tsunami attacked the control forest in Ishinomaki (150 m forest width); the damage that was caused is shown in Fig. 14, left.

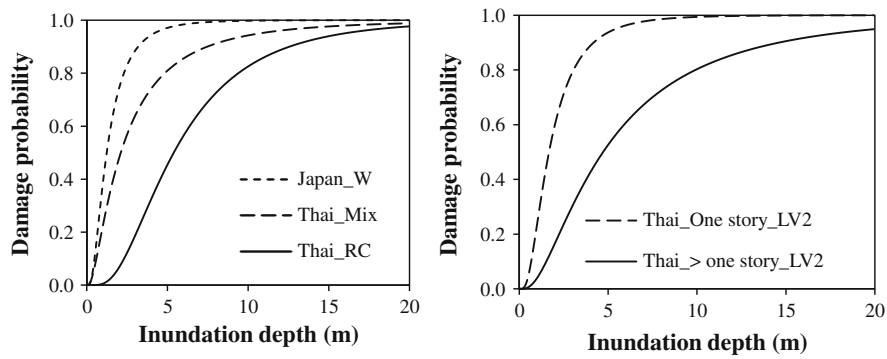
Figure 16

damage (destroyed or washed away) from a tsunami with an inundation depth of  $4\text{ m}$  is  $0.3$ ,  $0.7$ , and  $0.9$  for a reinforced concrete (RC) house, a mixed-type house in Thailand (SUPPASRI *et al.*, 2011), and a wooden house, respectively (Fig. 16, left). For the same tsunami, the probability of damage is  $0.9$  for a one-story house and  $0.5$  for a house that has more than one story (Fig. 16, right). Figure 17, top, shows examples of three damaged houses. Although all three houses experienced an inundation depth of  $4\text{ m}$ , the level of damage is different, depending on building typology. In Fig. 17, bottom, the first building on the left side (green rectangle) is a two-story RC office that sustained broken windows but no structural damage. The two-story wooden house in the center (yellow rectangle) sustained damage to some of its walls and columns. The one-story wooden house on the right (red rectangle) completely collapsed. However, the impact from floating debris is complex and difficult to ascertain at this time. In fact, the velocity of the tsunami wave current was also important in the structural destruction, because of the hydrodynamic force. Nevertheless, the current velocity is quite difficult to measure using only tsunami traces found during field surveys, especially along the Sanriku ria coast, where the tsunami wave easily accumulated such hydrostatic and hydrodynamic force that the tsunami height and velocity became

Tsunami fragility curves for different types of structural material and for different numbers of stories (KOSHIMURA *et al.*, 2009; SUPPASRI *et al.*, 2011)

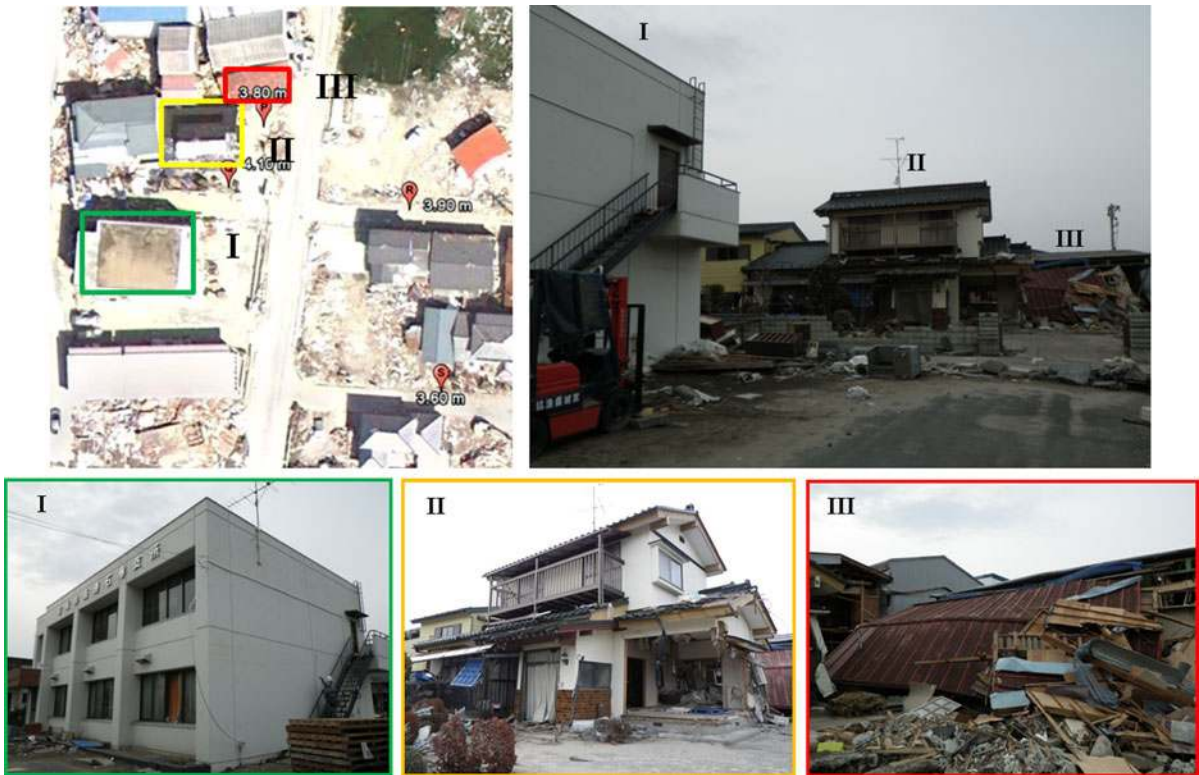
Figure 17

Examples of different damage levels for the same tsunami inundation depth (26/4/2011)

larger than in the Sendai coastal plain. Comparison of the housing damage ratio between the plain and ria coast of Ishinomaki city shows that the damage ratio for houses washed away at 3 m of inundation depth

was 0.1 along the plain coast but as high as 0.6 along the ria coast (SUPPASRI *et al.*, 2012b). This result confirms the effect of current velocity on different damage levels at the same inundation depth.

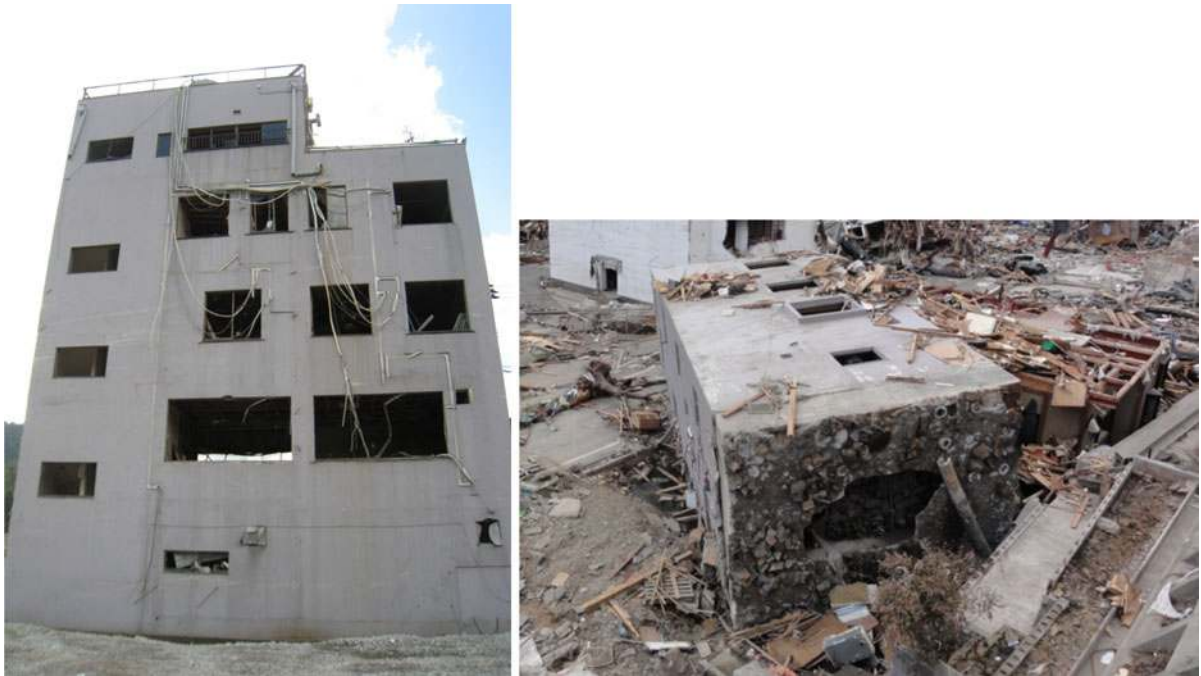
Figure 19

Building X (sea front), which survived (29/9/2011), and building B, which was overturned (29/3/2011)

at the foundations. Table 3 summarizes detailed information on the overturned and non-overturned RC buildings in Onagawa town, as measured during field surveys. Most of the buildings in Onagawa town (including buildings C and E) were overwhelmed by the tsunami, except building X.

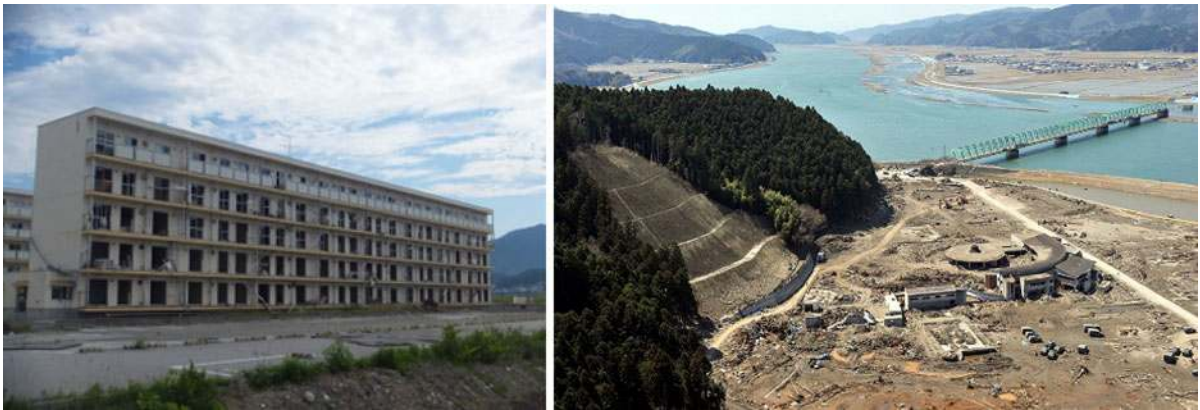
Figure 21

A five-story apartment building in Rikuzen-Takata city, and Okawa primary school

The tsunami overwhelmed the gym, and only three people survived out of more than 80 evacuees. Another example in Rikuzen-Takata is a five-story residential building (Fig. 21, left). The tsunami reached only the fourth floor; however, the building had no stairway that would enable people to evacuate to the roof in the case of a larger tsunami. Another example of an unfortunate result of the unexpected tsunami was at Okawa primary school (Fig. 21, right), located near the mouth of a river. The tsunami claimed 74 out of a total of 108 children and 10 staff. Most of the children that survived climbed the mountain behind the school; the others went to the bridge where they were struck by the tsunami. The school had not conducted evacuation drills and had no tsunami plans before the 2011 event.

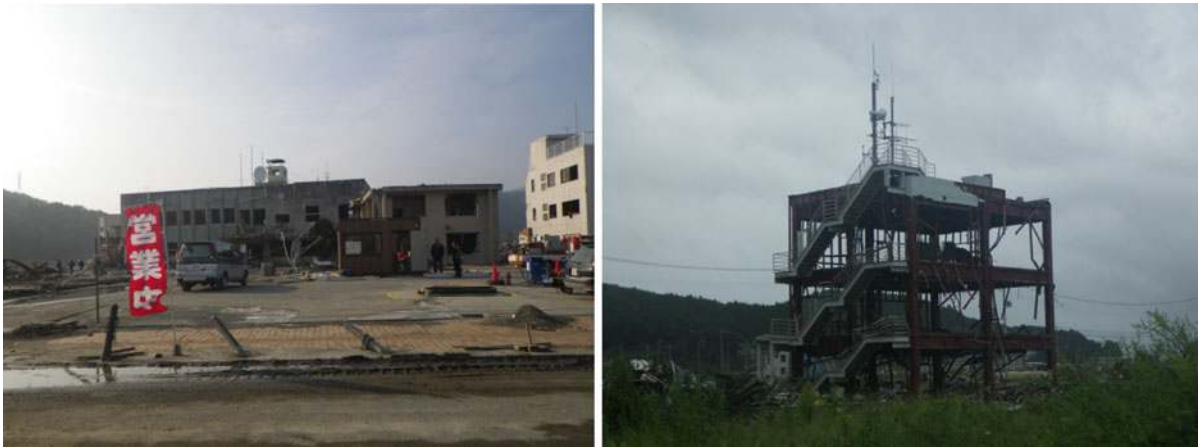
Figure 22

Officers and staff members that were stationed at the Otsuchi town office (Fig. 22, left) and the disaster prevention building (Fig. 22, right) in Minami-Sanriku also lost their lives. In Otsuchi town, the town leader and his staff lost their lives; this loss has caused the reconstruction process in Otsuchi town to be slower than at other locations. A staff member in Minami-Sanriku town lost her life while announcing the evacuation; other staff members inside the building also lost their lives.

The Otsuchi town office (31/5/2011) and the disaster prevention building in Minami-Sanriku town (3/9/2011)

- Evacuation shelters in plains (e.g., the community gym in Rikuzen-Takata city), low-rise buildings (e.g., the disaster prevention building in Minami-Sanriku town), and primary schools near the sea or river mouths (e.g., Okawa School in Ishinomaki city) are all examples of failed evacuation shelters. The design and location of tsunami evacuation buildings should be reconsidered. Escape hills can be constructed in plain areas using debris from this tsunami. Evacuation signs should include information not only about tsunami height but also about the height above sea level of each evacuation shelter, evacuation building, and escape hill.

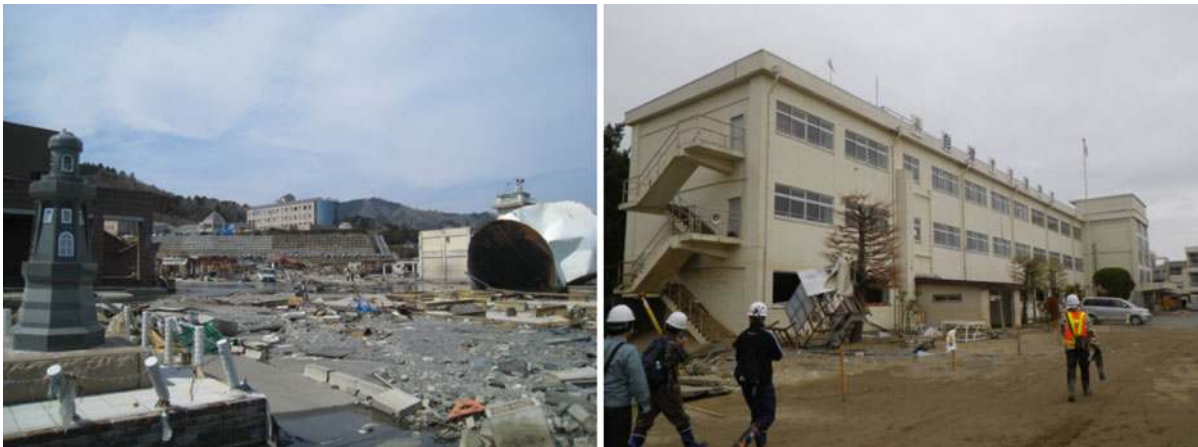
Some other successful cases are reported here. Onagawa town hospital is located ~15 m above the sea level, and the tsunami reached the first floor (Fig. 23, left). A school in Ishinomaki city that was located behind the control forest was inundated to the second floor (Fig. 23, right). The tsunami reached the first floor at the sightseeing ferry terminal in Shio-gama city; the evacuation sign suggests evacuating to the second or third floor (Fig. 24, left). Last, a school in Arahama town was the only building in the area that was located on high ground; it survived because the tsunami reached the second floor only (Fig. 24, right).

Figure 23  
Evacuation buildings in Onagawa town (29/3/2011) and Ishinomaki city (12/5/2011)

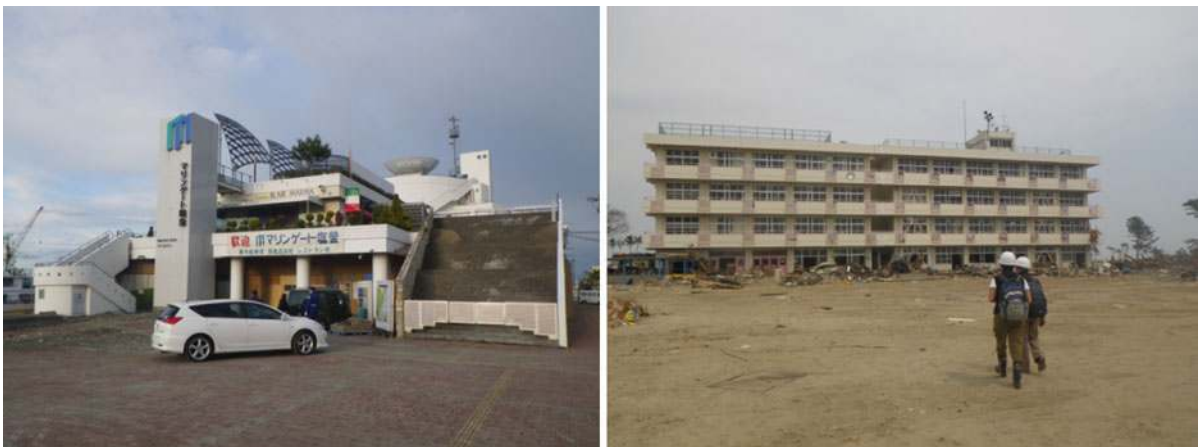
Figure 24  
Evacuation buildings in Shiogama city (29/4/2011) and Arahama town (16/4/2011)

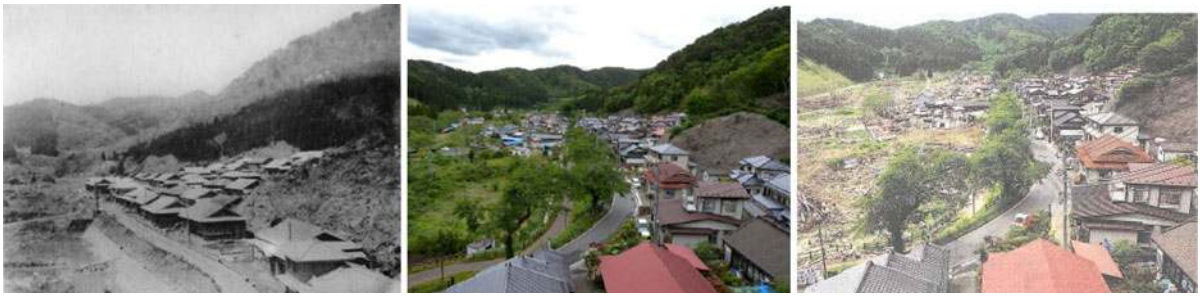
Figure 29

Toni-Hongo village after the 1933 Showa Sanriku tsunami, before the 2011 Tohoku tsunami, and after the 2011 Tohoku tsunami

The Toni-Hongo village was struck by the 1896 tsunami (with a tsunami height of 14.5 m and 224 houses destroyed) and the 1933 tsunami (with a tsunami height of 9.3 m and 101 houses destroyed) (MEIJI UNIVERSITY, 2011). After the 1933 tsunami, the village was rebuilt on high land at an elevation of 20 m (MSL), as shown in Fig. 29, left. The village survived the 1960 Chilean tsunami, which was ~5 m high. After this event, many houses were built in the lowland areas to accommodate the increasing population, as shown in a picture from 2009 (Fig. 29, center) and a satellite image from 2010 (Fig. 30, left). The 2011 tsunami destroyed the lowland houses but not the highland houses (Figs. 29, right, 30, right).

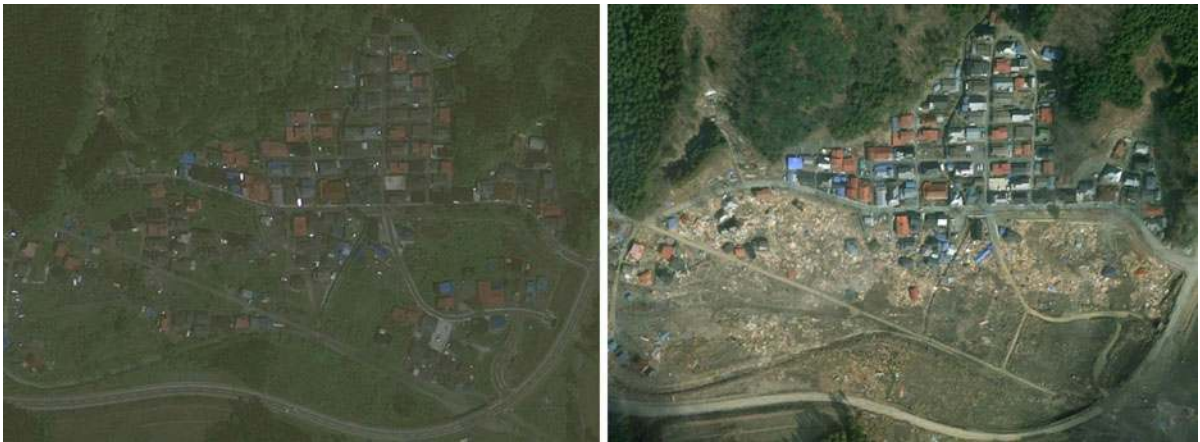
Figure 30

Satellite images of the Toni-Hongo village in May 2010 and in April 2011

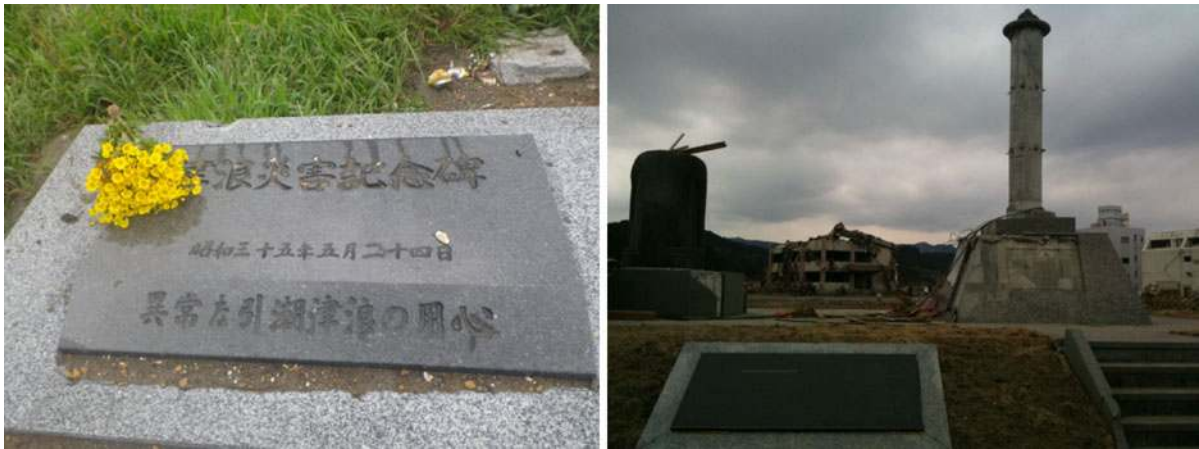
Figure 31

The stone monuments for the 1933 Showa Sanriku tsunami and the 1960 Chile tsunami in Minami-Sanriku town (25/3/2011)

Tsunami memorials, for example stone monuments, can be found in many areas along the Sanriku coast. These memorials can be found in Minami-Sanriku town, where there are monuments for the 1896 Meiji, 1933 Showa, and 1960 Chile tsunamis. The message on the stone monument for the 1933 Showa tsunami (Fig. 31, left) reads “to be cautious of an abnormal receding wave”. However, these monuments, including a 2.6 m high monument for the 1960 Chile tsunami (Fig. 31, right), were destroyed

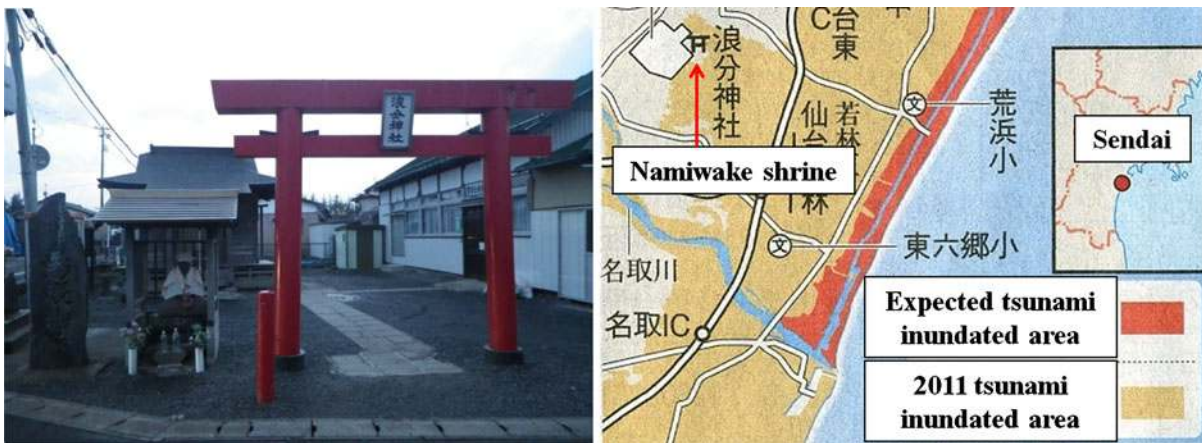
Figure 32

Namiwake Shrine and the inundation area of the 2011 tsunami

by the 2011 Tohoku tsunami. The Namiwake shrine (Fig. 32, left) is a monument in the Sendai area that is located  $\sim 5.5$  km from the sea (Fig. 32, right). The shrine is located in a low-lying area in the Wakabayashi ward of Sendai city, and was originally built in 1703. Many flood and tsunami disasters have occurred in this area in the past. In the 1611 Keicho event, the tsunami inundated the shrine's original site, and  $\sim 1,700$  people were killed. At one site, the tsunami wave, which approached from the East, was split in the north–south direction; at the time, people believed that the tsunami was created by the god of the sea. In 1835, the shrine was moved to that site to protect it from the next tsunami; it was given the name “Namiwake” (“Nami” means wave and “Wake” means separate) and is viewed as a symbol of tsunami prevention. In fact, deposits from the 869 Jogan tsunami were found 200–300 m from the front of the shrine. Although the 2011 tsunami was larger

than expected, the shrine survived the 2011 Great East Japan earthquake and tsunami (Fig. 32). Additionally, many shrines along the Pacific coast of the Iwate, Miyagi and Fukushima prefectures survived this tsunami. They were built at locations that were regarded as safe on the basis of historical tsunamis, for example the 1611 Keicho tsunami, and left as a warning message to future generations.
