NASA/TM-2009-215794

# Lightning Pin Injection Testing on MOSFETS

September 2009

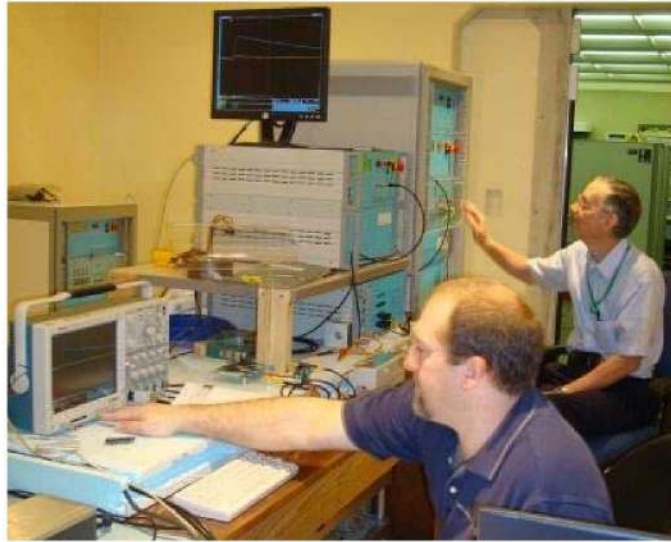
**Figure 3:** EMC Partner lightning-generating equipment was used for pin-injection tests.

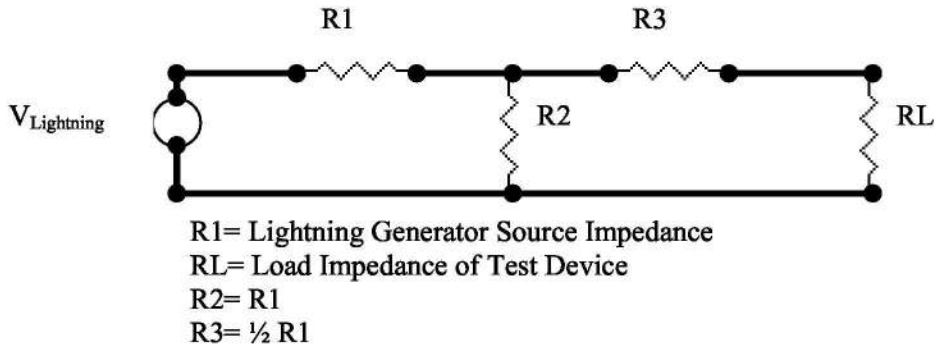
**Figure 5:** Circuit Schematic to enable Waveform 3 testing down to 40V Peak with MIG-OS-MG Transient Generator. Actual values were  $R1=25 \text{ Ohm}$ ,  $R2=25 \text{ Ohm}$ ,  $R3=12.5 \text{ Ohm}$ .

Some testing required pin-injection levels below DO-160E Level 1. The EMC Partner MIG-OS-MB Lightning Waveform generator does not allow testing below 80V peak. To accommodate test voltages below 80V, a resistor network was used to reduce Open-Circuit voltage of Waveform 3 by half, while still maintaining the correct source impedance. A schematic of the resistor network is shown in Figure 5, and a photograph of its implementation is shown in Figure 6.

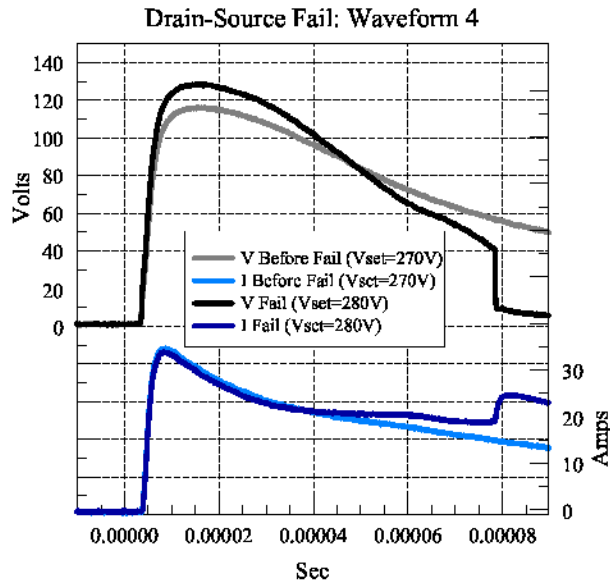
**Figure 9:** Ⓜ D-S fail plot for Waveform 4 shows V and I before failure (file 0238,  $V_{set}=270V$ ) and after failure (file 0239,  $V_{set}=280V$ ). The Ⓜ S-D fail plot is of special interest, and is discussed separately in Section 4.3.

Voltage and Current versus Time plots are shown in Figures 7 through 10, for the Waveform 3 & 4 failures noted in Table 8. Waveform 5 S-D failure plots are provided separately in Section 4.3. In every case, the current *increased* after failure, which is an interesting result.

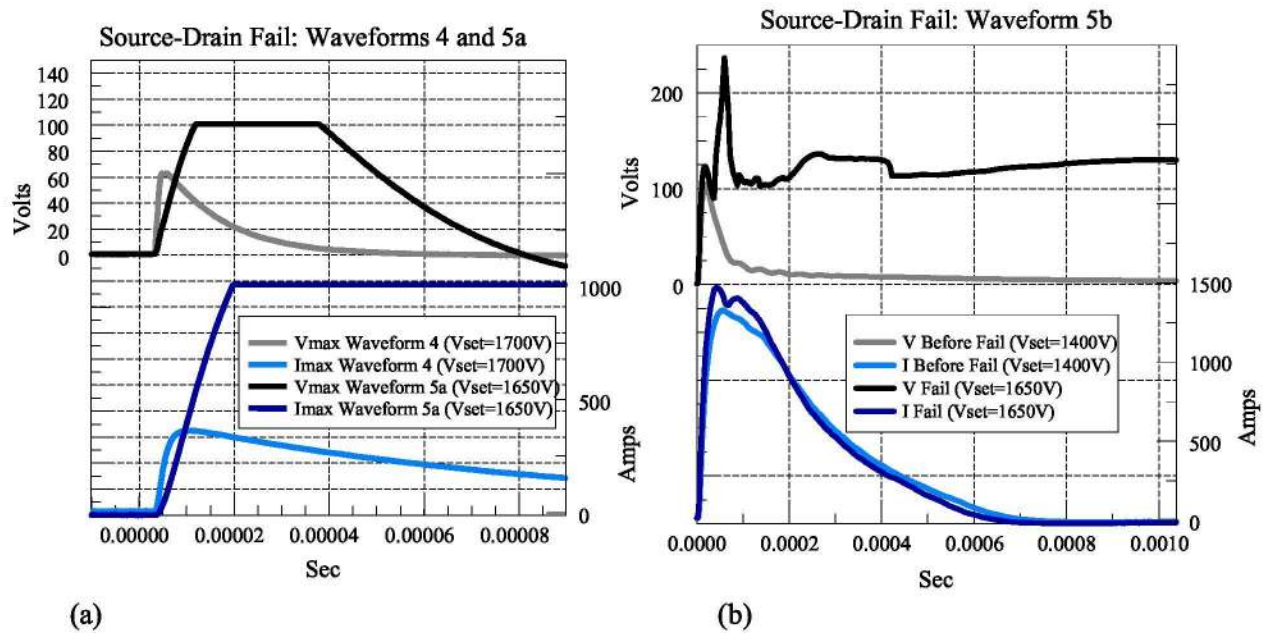
**Figure 11:** (a) S-D plot for Waveforms 4 (file 0103, Vset=1700V) and 5a (file 0104, Vset=1650V). It is unlikely that the MOSFET was damaged by either stroke, rather it is likely that the discontinuous oscilloscope display was because of the measurement being out-of-range instead. The plot shows V and I before failure (file 0847, Vset=50V) and after failure (file 0848, Vset=55V). (b) S-D fail plot for Waveform 5b shows V and I before failure (file 0508, Vset=1400V) and after failure (file 0509, Vset=1650V). After failure, the current remained similar to before, however, the voltage remained over 100V, indicating significant additional deposit of energy into the device.

From Tables 8, 9 and 10, it can be seen that the S-D pin configuration was highly resistant to damage by injecting lightning waveforms. Using Waveform 4, the  $V_{Peak}$  setting of 1700V resulted in an MOSFET terminal voltage of 62.2V and a current of 365 Amps, with no apparent functional damage. Comparing Waveforms 4 and 5 in Figure 2 shows that Waveform 5A contains more energy than Waveform 4 (i.e. level decreases to 50% in 120  $\mu$ sec versus 69  $\mu$ sec), and Waveform 5B contains more energy than Waveform 5a (i.e. level decreases to 50% in 500  $\mu$ sec versus 120  $\mu$ sec). As part of the Pre-Test, Waveform 4, 1700V (maximum setting) was applied to MOSFET F8, without apparent damage. Then, Waveform 5A was applied with 1650V (maximum setting). The resulting plot is shown in Figure11a. At the time, it was thought that the MOSFET was damaged; however, subsequent data review indicated a likelihood that the discontinuous oscilloscope display was caused by the measurement being out-of-range instead. To evaluate the damage scenario further, the team decided to try again with Waveform 5B. The  $V_{Peak}$  set level was increased in steps, and repeatedly applied to the same MOSFET (V6). Surprisingly the MOSFET withstood a  $V_{Peak}$  Set ( $V_{oc}$ ) of 1400V, with voltage and current values of 105V and 1326A developed over the MOSFET S-D terminals, respectively. When  $V_{Peak}$  Set ( $V_{oc}$ )= 1650 V was reached, the MOSFET exploded with a sound comparable to a firecracker. The final MOSFET terminal voltage and current values were  $V_{Peak}$ = 237V and  $I_{Peak}$ = 1469A. The resulting plot is shown in Figure11b. A photograph of the exploded MOSFET is shown in Figure 12. This test demonstrated that lightning-induced transients from an IRF 520 MOSFET Source-to-Drain are significantly less likely to be damaged than other pin configurations. As shown in Figure 1, the IRF520NPBF includes an integral reverse p-n junction source-to-drain diode, which is likely responsible for the high source-to-drain current characteristic.

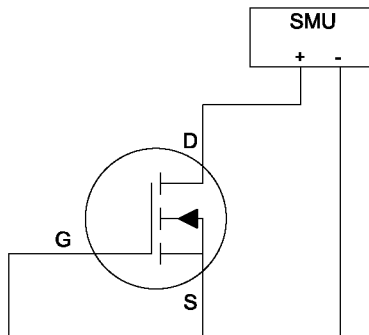
**Figure 13:** Configuration of Leakage Current and Breakdown Voltage tests for an n-type power MOSFET.

The Breakdown Voltage ( $V_{(BR)DSS}$ ) indicates the voltage at which the drain-to-source path of the device starts conducting drain current ( $I_D$ ) given that the gate is not biased ( $V_{GS}=0V$ ). When the gate is not biased, the drain-source path should behave like an open circuit and very little current (in the  $\mu A$  range) should flow through the device. As the voltage applied to the drain and source terminal ( $V_{DS}$ ) increases it reaches a point when the device starts conducting current, this is known as the Breakdown Voltage. A source measurement unit (SMU, also identified as the Keithley 2410 SourceMeter in Section 3.2) is required to assess the value of this parameter. The SMU is able to source large voltages while measuring the supplied current with high precision (usually at the pA level). Figure 13 shows the configuration of the Breakdown Voltage test. The SMU equipment is controlled via a LabView virtual instrument in order to automate the drain-source voltage sweep to identify the Breakdown Voltage.

The drain-to-source Leakage Current ( $I_{DSS}$ ) is the current flowing from drain-to-source as the gate is shorted with the source (no gate bias  $V_{GS}=0V$ ). Gate and source are connected to the negative connector of the SMU which is the ground and the drain is connected to the positive connector (see Figure 13). The Leakage Current is a parameter indicated in the specifications of the device. For the IRF520Npbf MOSFET the drain-to-source Leakage Current ( $I_{DSS}$ ) specifications are: a) max  $I_{DSS}=25\mu A$  for  $V_{DS}=100V$  and  $V_{GS}=0V$  at room temperature; and b) max  $I_{DSS}=250\mu A$  for  $V_{DS}=88V$ ,  $V_{GS}=0V$ , and  $T_J=150^{\circ}C^{11}$ .

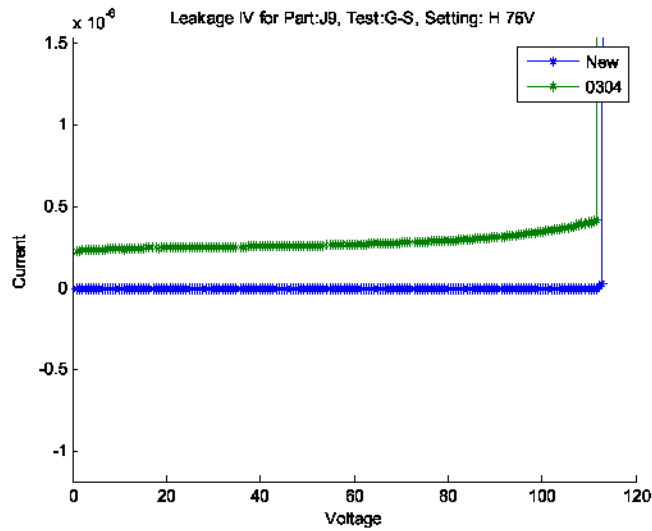
**Figure 15:** Drain-to-source Leakage Current plot for Device J9, G-S injection at high voltage setting (76V). New device is compared to same device after pin-injecting 20 consecutive strokes (Test File Number 0304).

Figure 15 shows the results of the test performed on Device J9. It can be observed that there is an increase in the Leakage Current due the lightning injection. Even though the device still conforms to the datasheet rating, it is evident that there is damage resulting from the repeated lightning strokes.

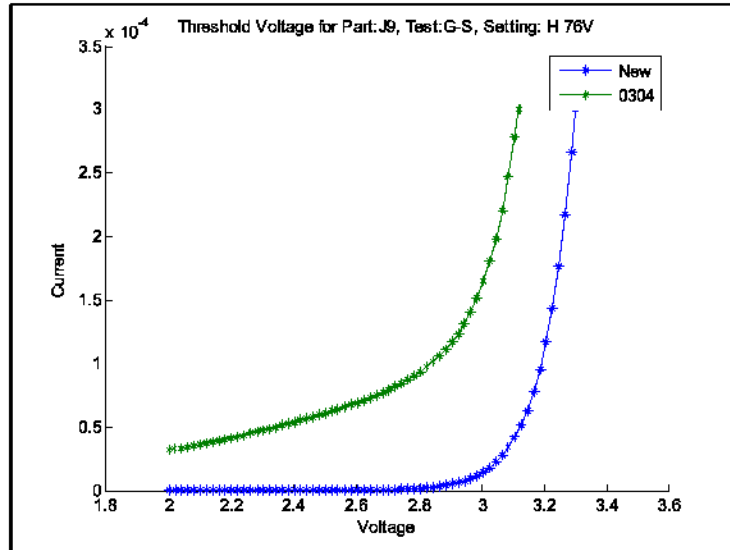
**Figure 17:** Threshold Voltage plot for Device J9, G-S injection at high voltage setting (76V). New device is compared to same device after pin-injecting 20 consecutive strokes (Test File Number 0304).

The threshold voltage rating for IRF520NPbF indicates a minimum Threshold Voltage  $V_{GS(th)} = 2V$  and a maximum of  $V_{GS(th)} = 4V$  with  $V_{GS} = V_{DS}$  and  $I_D = 250\mu A$ . Figure 17 shows Threshold Voltage results for Device J9. It can be observed that the lightning pin-injection resulted in a shift on the Threshold Voltage by a few hundred mV, which means that the device requires a lower bias voltage to switch ON. This change is an indication of damage on the gate, though the device still complies with the rating specified in the datasheet.
