Lime-crusted rammed earth: materials study

Abstract. This study analyses the durability of rammed-earth wall construction techniques. The analysis focuses on three medieval masonry types from the Castle of Villavieja (Castellón, Spain) using two variations of lime-reinforced rammed earth in its walls: lime-crusted rammed earth and brick-reinforced rammed earth. Materials analysis reveals the good properties of the materials used in the outer wall facing despite its age. It also clearly shows how deterioration depends more on the construction technique (construction of the wall with a base, cornice, facings, core; on-site installation, bonds, etc.) than on the material itself. These two types of lime-reinforced rammed earth (lime-crusted rammed earth and brick-reinforced rammed earth) are the most common kinds of fortified architecture in the Iberian Peninsula as well as in northern Africa and the Middle East. The case presented herein is therefore highly relevant as it advances our knowledge of the behaviour of the materials comprising these walls and lays the foundations for suitable future conservation works of a vast array of architectural heritage.

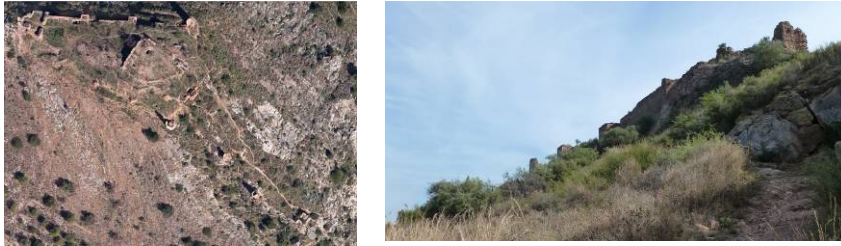
Fig. 1. Top view of the castle and general view of the northern wall of the upper enclosure.

The Castle of Villavieja is currently an imposing ruin on a hilltop with a commanding view inland and of the plain as far as the sea (fig. 1). The castle still preserves part of its walled enclosure, extending some 250 m long and 130 m wide at its maximum, following the hill's topography. Throughout the walled enclosure there is a series of towers of different types, shapes, and construction techniques that reflect the variety of constructive periods in which the complex was built.

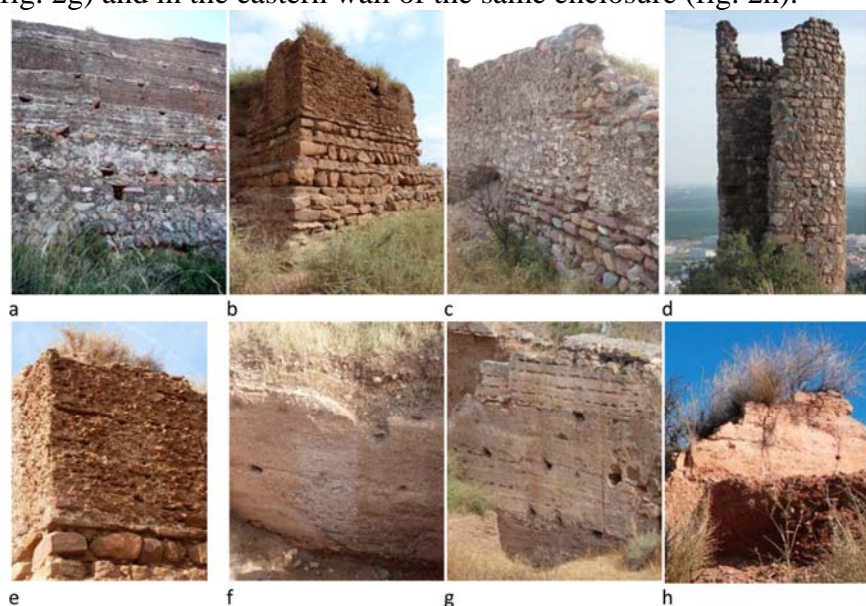
Fig. 2. Construction techniques at the Castle of Villavieja: masonry base and rammed-earth wall (a and b), masonry wall (c and d), lime-crusted rammed-earth wall (e and f), and brick-reinforced rammed-earth wall (g and h). Photographs: C. Mileto

The castle walls mainly consist of masonry and rammed earth. But each of these techniques appears in a wide range of variations as to materials used and the type of execution (fig. 2). The types of masonry include: formwork masonry in a herringbone pattern with river rocks at the base of the north wall section in the upper enclosure (fig. 2a); masonry with courses of rough-hewn stone at the base of the central tower in the eastern wall of the upper enclosure (fig. 2b); formwork masonry in the palace zone walls (fig. 2c); masonry with rubble and river rocks in ten of the visible towers, six in the upper enclosure and four in the lower enclosure (fig. 2d). In addition, the rammed-earth technique has several variants in the castle: the lime-crusted rammed earth wall with more (fig. 2e) or less (fig. 2f) erosion of the outer lime layer in the eastern and southern wall sections of the upper enclosure and four towers therein; brick-reinforced rammed earth at the western end of the northern wall in the upper enclosure (fig. 2g) and in the eastern wall of the same enclosure (fig. 2h).
