1 Limited vegetation development on a created salt marsh associated with over-
2 consolidated sediments and lack of topographic heterogeneity.

4 Katherine L. Brooks, Hannah L. Mossman[†], Joanna L. Chitty and Alastair Grant^{*}

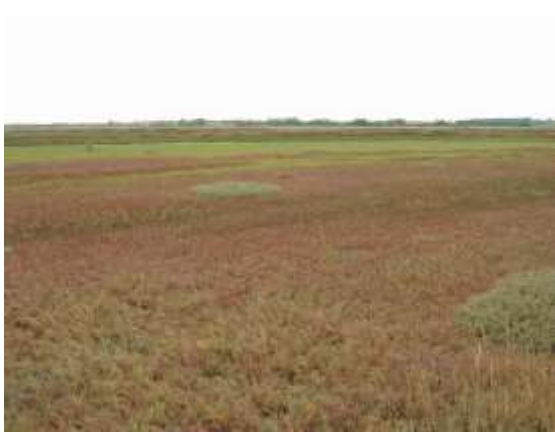
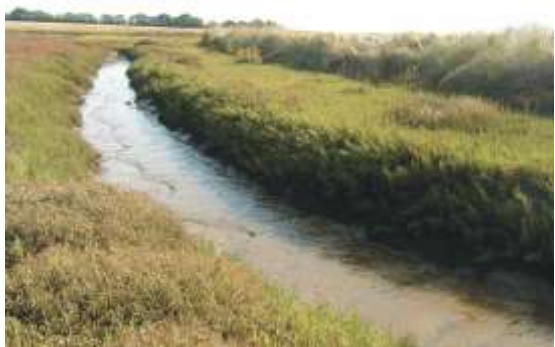
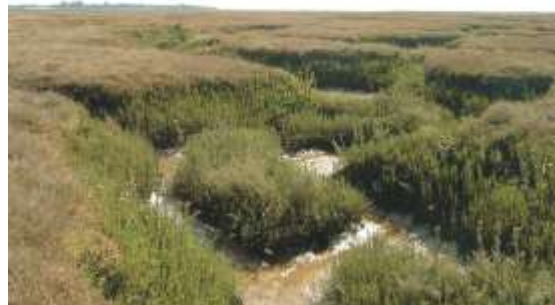
565
566 Fig. 2. Photographs showing characteristics of each site. Taken 22/08/09. A) non-engineered
567 part of the restored salt marsh; b) engineered part of the restored salt marsh, with
568 embankment of spoil from excavating creek to right; c) reference site
569

129 part of the marsh consists of a relatively well vegetated and rather flat surface. This is visible
130 as darker areas on Fig. 1 and these can also be seen in Fig. 2a and b. It is located at
131 approximately 2.25 to 2.5m ODN (see also Fig. 6), an elevation at which species-rich
132 marshes dominated by *Puccinellia maritima* and *Atriplex portulacoides* normally occur in
133 this region (Mossman 2007). Seawards of this is an area of mudflat with pioneer vegetation,
134 visible as the lighter coloured parts of the site in Fig. 1. As we wanted to focus on factors
135 influencing the vegetation on the upper parts of restored marshes, the areas sampled were
136 located approximately mid-way between the landward sea wall and the areas of mudflat
137 and pioneer communities. To allow comparison with the restored sites, the reference site
138 was located in an area where the main marsh surface was at an elevation of around 2.25m

142 Many restored marshes appear to be topographically more uniform than reference marshes
143 and this could be a cause of ecological differences (Grant and Mossman, *pers. obs.*, and
144 compare figure 2c with figures 2a and b). To allow us to quantify spatial heterogeneity of
145 elevation on small and intermediate scales, at each of the sites we used systematic sampling
146 of a grid rather than using random or transect sampling. A square 6 by 6 grid at 10 m
147 spacing was laid out in a 50 x 50m section of each area, with 36 sampling points at the
148 intersections of the grid lines. Eight of these points were randomly selected and additional
149 sampling points were located at 1 m and 2 m N, S, E and W from the focal point; giving an
150 additional 64 sampling points. The same eight positions were used in each site to give
151 consistency in sampling spatial patterns. This sampling design resulted in a total of 100

289 The data on elevation heterogeneity confirmed the visual impression given by the
290 photographs in Fig. 2. On the reference marsh, locations that are 1 m apart horizontally
291 typically differed by 15 cm in elevation, rising to about 30 cm for locations 8 m apart (Fig. 8),
292 reflecting the dissection of the site by an extensive system of creeks (Fig. 2c). By contrast,
293 locations up to 10 m apart on both parts of the realignment site were likely to differ in
294 elevation by only 10 cm, reflecting the flat surface topography visible in Figs. 2a and b. The
295 three sites only showed similar patterns of heterogeneity in elevation at horizontal scales
296 greater than 40 m.
