# Local plastic strain evolution in a high strength dual phase steel

H. Ghadbeigi<sup>a\*</sup>, C. Pinna<sup>a</sup>, S. Celotto<sup>b</sup> and J. R. Yates<sup>a</sup>

## Abstract

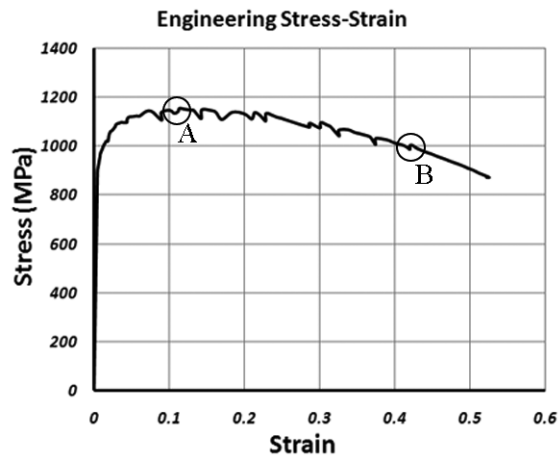
Fig. 2 shows the engineering stress–strain curve obtained from the test. Average engineering strain values within the gauge section were determined using the displacement measured using a LVDT and the initial gauge length. Point A corresponds to the onset of softening and Point B corresponds to the last micrograph taken before fracture of the specimen that took place at a strain value of 52%. The small stress variations along this curve correspond to the interruption of the test needed to take the micrographs for DIC analysis.

Fig. 2. Engineering stress-strain curve of material tested in-situ. Note that the large amount of post-uniform elongation is due to the tensile geometry
