TECHNICAL REPORT D-86-2

THE DUWAMISH WATERWAY CAPPING  
DEMONSTRATION PROJECT: ENGINEERING  
ANALYSIS AND RESULTS OF  
PHYSICAL MONITORING

by  
Clifford L. Truitt

March 1986

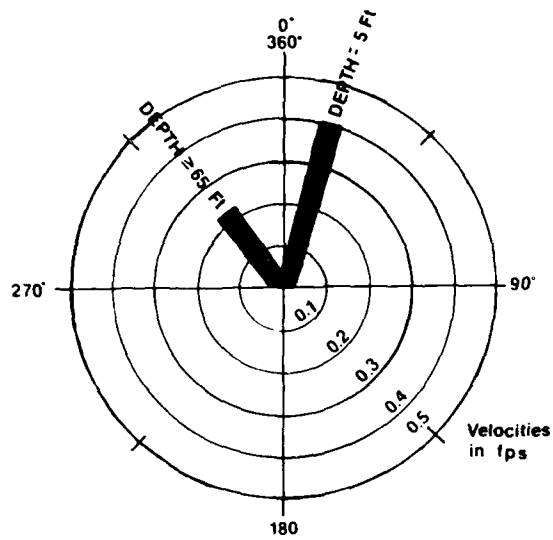
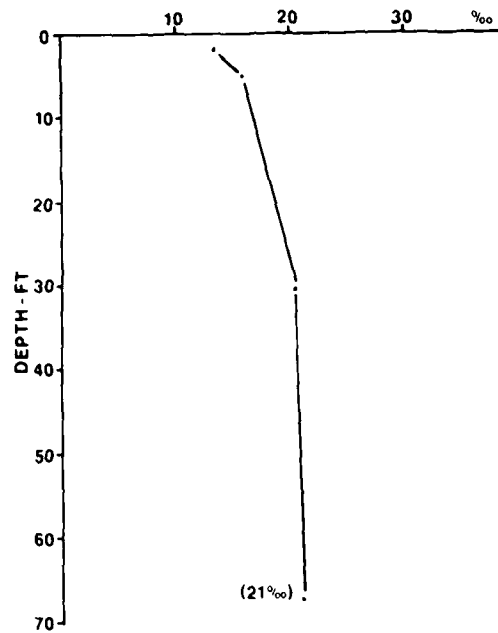
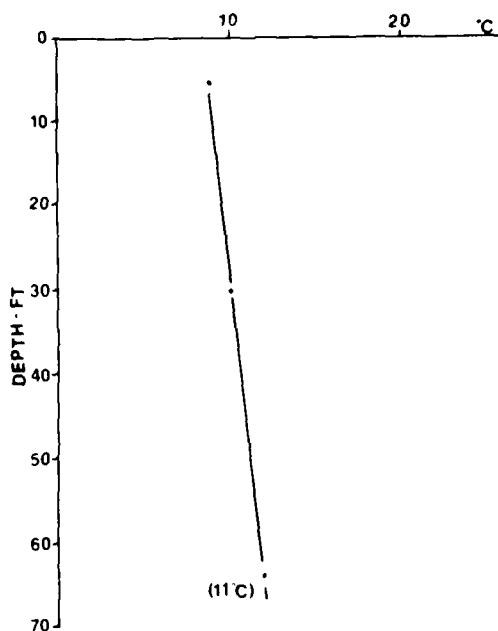
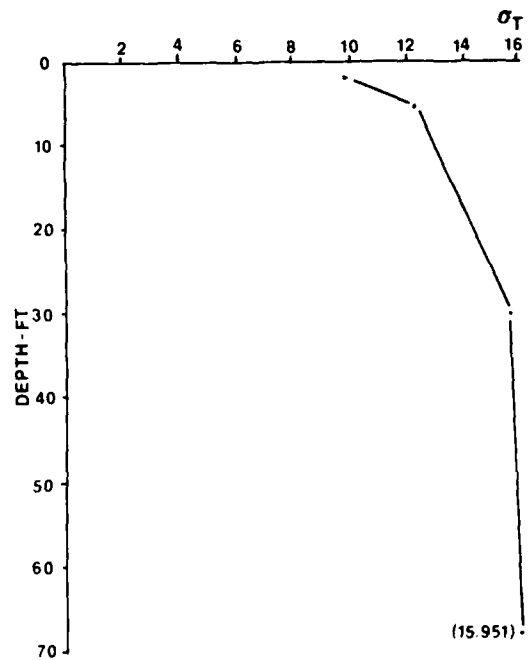
Figure 4. Physical parameters measured at disposal site

NOTE: Channel axis runs approximately north-south. 0°/360° is north.

10. The highest current velocity measured during the fieldwork was a single value of 1.4 fps just beneath the water surface. Sustained maximum values in the upper third of the water column were more typically 0.4 to 0.8 fps. Sustained maximum values near the bottom were approximately 0.2 fps. The recording current meters showed frequent periods during which current velocities were less than the instrument threshold value of approximately 0.05 fps. Figure 4 presents a current rose representative of site conditions at the actual time of the disposal.

11. Ambient salinity, temperature, and density data are also presented on Figure 4. Bulk samples of the water at both the dredge site and the disposal site were obtained two days prior to the start of dredging for analysis of background chemical constituents and for use in elutriate tests. Results of these chemical analyses are shown in Table 1 as background values.

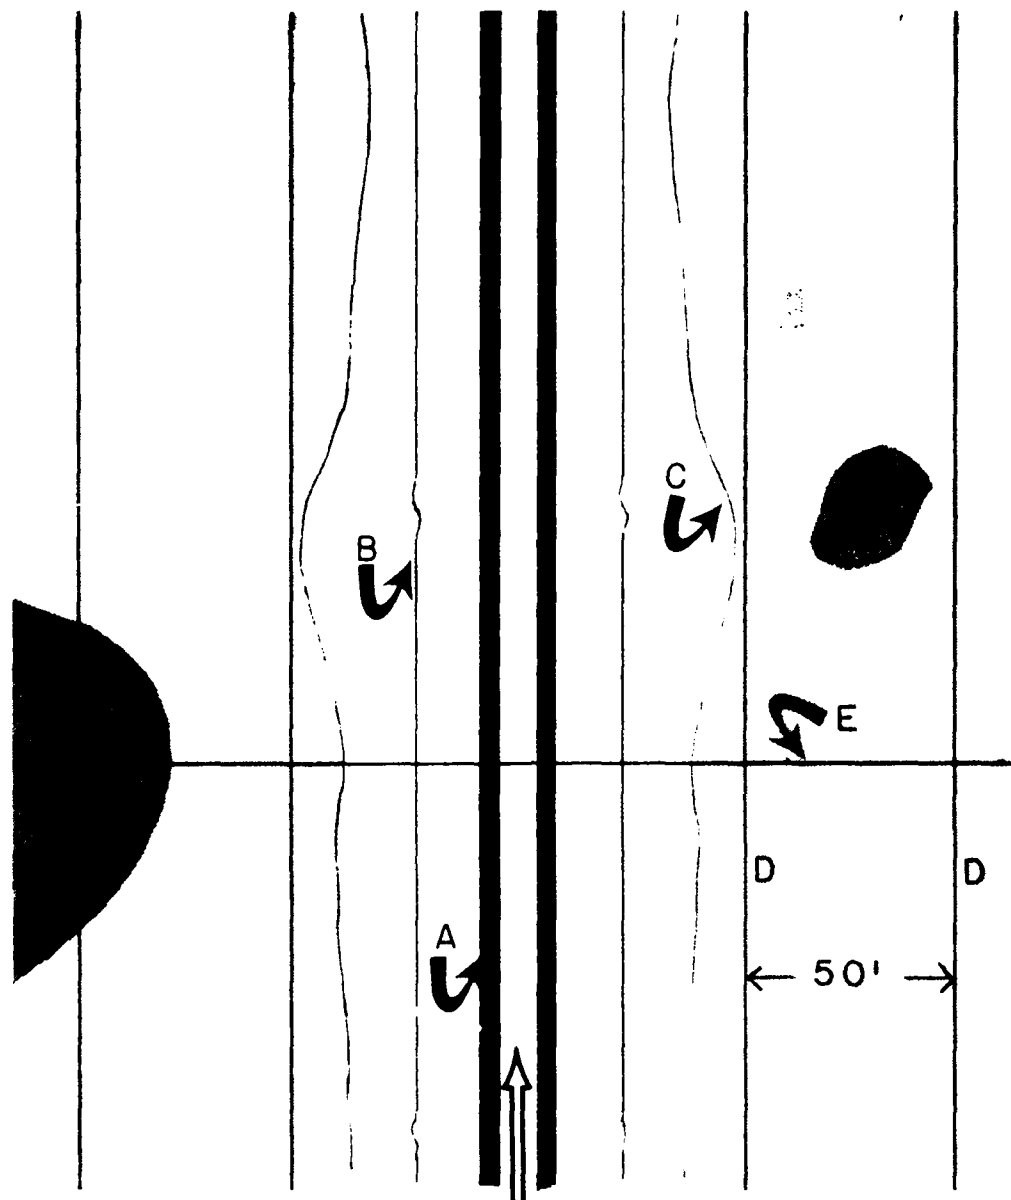
Figure B1. Example SSS record

### DIRECTION OF FISH MOVEMENT

6. The following discussion applies to Figure B1. The dark parallel lines (A) running down the center of the sonograph are the starting points of
