LONG TERM PERFORMANCE OF A SUBMERGED COASTAL CONTROL STRUCTURE: A CASE STUDY OF THE NARROWNECK MULTI-FUNCTIONAL ARTIFICIAL REEF

Angus Jackson¹, Rodger Tomlinson², Bobbie Corbett¹ and Darrell Strauss²

Keywords: multi-functional artificial reef; geotextile containers; monitoring; salient

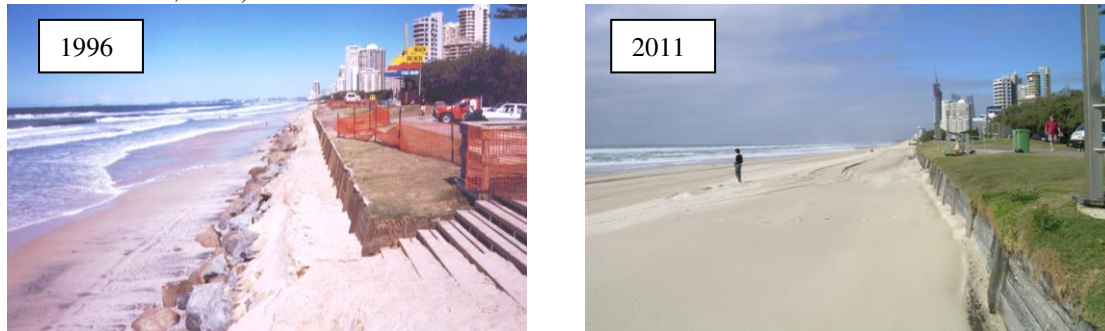
Figure 1 shows the exposed boulder wall at Narrowneck following storms in 1996. This section of the boulder wall is some 20m seaward of the general seawall alignment resulting in minimal beach widths and potentially hazardous conditions. Widening of the beach by 30-50m was proposed to provide a storm buffer for 1:50 year events.

Figure 1. Narrowneck Beach, looking south to Surfers Paradise. 1996 photo pre-nourishment. (ICM)

The exposed boulder wall (Figure 1) that was visible prior to the nourishment and reef construction has remained completely covered despite the occurrence of several large storms and a significantly wider beach has been evident since 1996. Wave conditions experienced in 2009 were considered to be the stormiest for more than 20 years. Seven storms with significant wave height exceeding 3m impacted the coast between February and May 2009 causing significant erosion (Figure 12). The last and largest was caused by an "East Coast Low" which persisted from 19-25 May. The storm recorded a peak significant wave height of 6.2m and a maximum wave height of 10.6m. Peak periods reached 14s and wave direction was predominantly easterly (shore-normal to the coast) (Figure 11). The combined storm surge and high energy waves, which persisted above 2m from May 19th to May 25th (Figure 13), resulted in widespread erosion of beaches. The maximum significant wave height of 6.1m corresponds to a 1:10 year event according to the extreme wave analysis of Allen and Callaghan (2000) (T

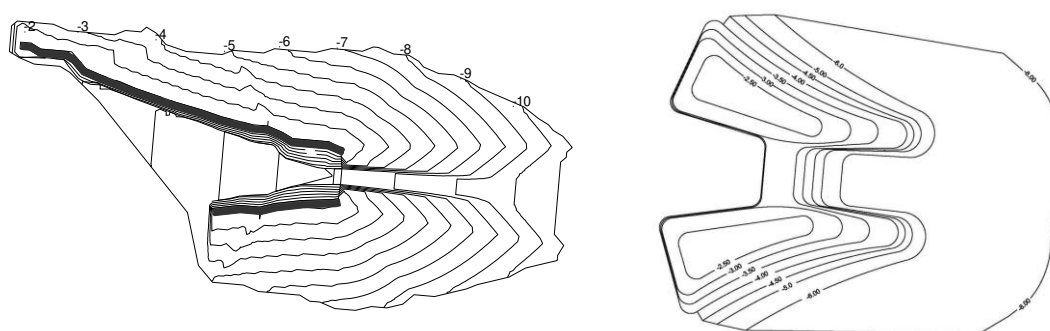
To achieve these objectives there has been a progressive evolution of the reef shape since the major construction phase was completed in 2000. The final revised design (2004) is shown in Figure 2.

Figure 2. Reef Levels – Original and Revised Design (ICM)

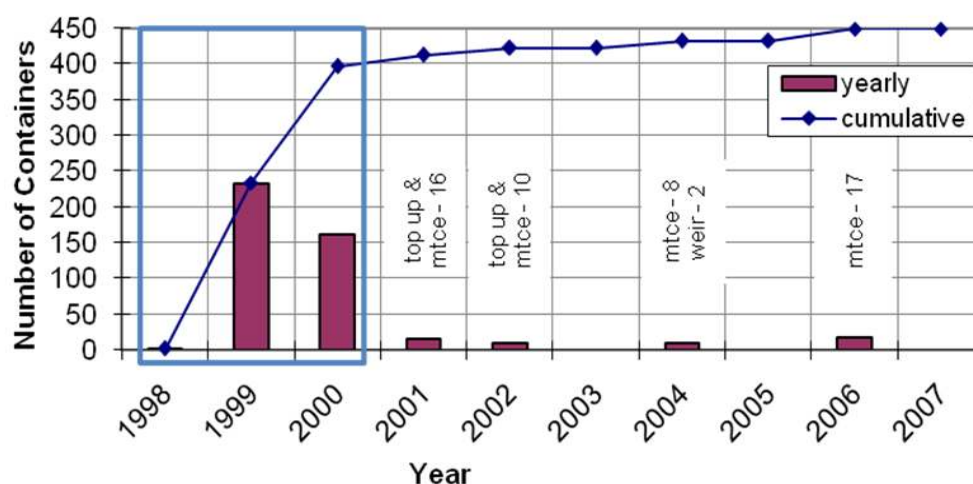
Overall, some 450 mega sand filled containers, ranging in size, have been placed to form the reef since 1999 (Figure 3). Of those, 42 have been placed in three maintenance campaigns (Figure 4).

Figure 3. Container placement schedule

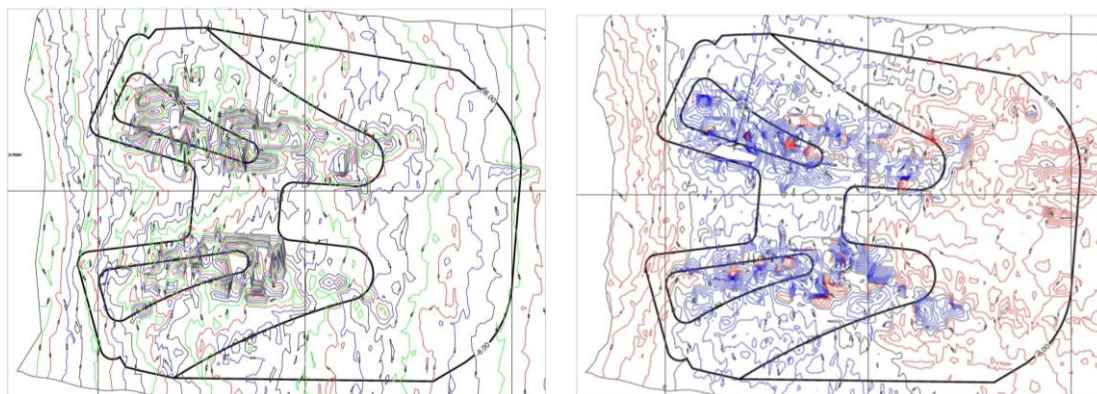
As part of the recent update of the performance of the reef, a survey of the Narrowneck reef was undertaken by the Gold Coast city Council on 9th June 2011 (Figure 5) and an isopach comparing this survey with another survey undertaken in 2008. It is noted that survey of this type of structure is very useful but needs interpretation and verification since individual containers are unusual in shape and not always well represented by the survey interpolation.

Figure 5.a) Reef Bathymetry (9/6/11), b) Isopach showing changes to surveyed levels between 2008 & 2011

An interpretation of the survey of critical crest areas showed that there are particular areas where there would be sufficient height to place a mega-container and areas where the isopach indicates a container has been lost since 2008. This has been overlaid with as-constructed survey of containers placed as part of previous maintenance campaigns. This indicates that:

- Maintenance of the structure is required as there are critical areas below design levels
- Since 2008 (3 years), the isopach indicates some 10 containers have been compromised
- Raising of seabed levels on outer reef since 2008 appears to have resulted in burial of seaward containers

Four containers showed significantly lowered levels on the isopach survey (Figure 5) although visual inspection indicates that the crest containers are in good condition and it appears likely that the slumping is the result of failure of lower containers (Figure 9).

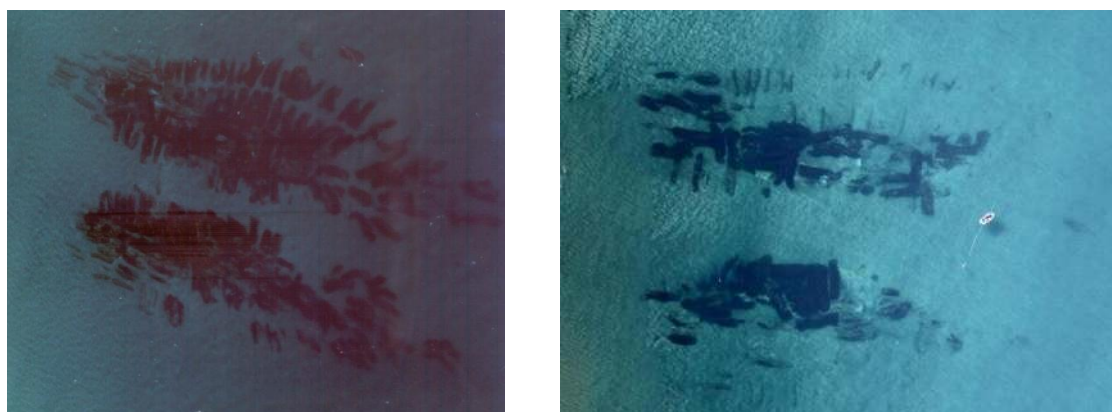
Aerial images of Narrowneck reef during calm conditions are occasionally clear enough to clearly distinguish individual bags (Figure 6) and can be very useful for reviewing the condition of the reef prior to direction inspection. Overlay of the most recent (July 2011) aerial photo with as-constructed survey of containers placed as part of previous maintenance campaigns (Figure 7) indicates that:

Figure 6. Aerial photographs taken in 2004 and 2011

In 2004 two containers were placed on the existing sandy seabed to create the weir across the central channel between the northern and southern reefs. As such, there was no attempt to provide a foundation to support the containers during periods where the seabed is eroded and this results in lowering the container to scour level. This was expected and as dredging to possible scour level was not as cost effective as the strategy of allowing settlement and topping up, initial placement heights were approx 0.5m above design levels to provide some initial compensation. Since placement, these containers have experienced lowering of up to 2m, resulting in present levels some 1.5m below design. Containers are predominantly buried at present (Figure 6).

Two containers were also placed to provide a widened, more flared crest. These containers have also experienced settlement, although this is limited to 1 – 1.5m [and as a result present levels are within 1m of design levels]. Again, containers are predominantly buried during seabed conditions at present (Figure 6).

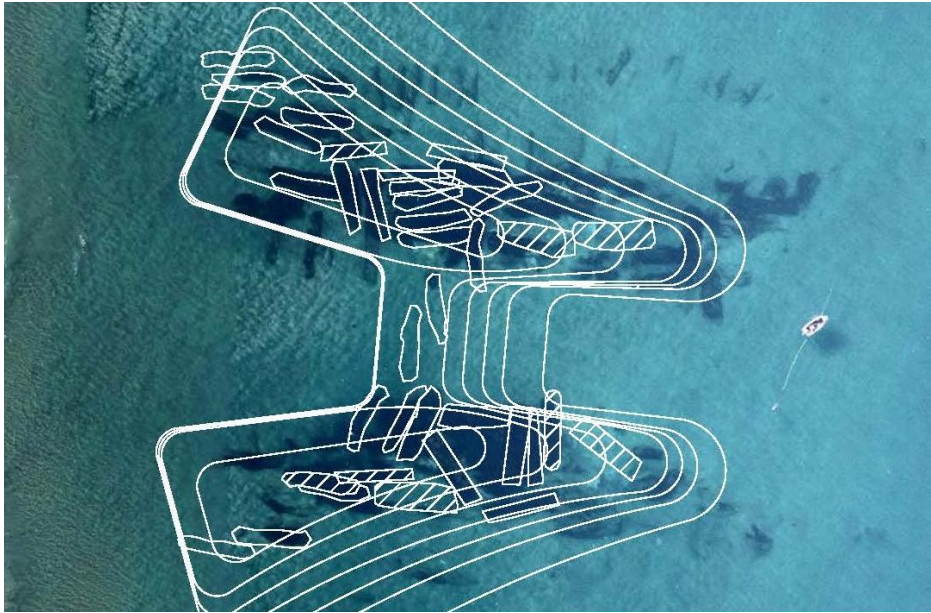
- Raising of the seabed levels on the outer reef has resulted in extensive burial of seaward containers. It does not appear that these containers are missing, although their condition is unknown and it is expected that there would be some damage in these outer areas.
- Partial burial of containers used for design modification indicates that changes to crest levels likely reflects long-term settlement of foundation containers rather than damage or loss of the containers themselves.

Figure 7. Overlay of July 2011 Aerial Photo with containers placed during maintenance campaigns (ICM)

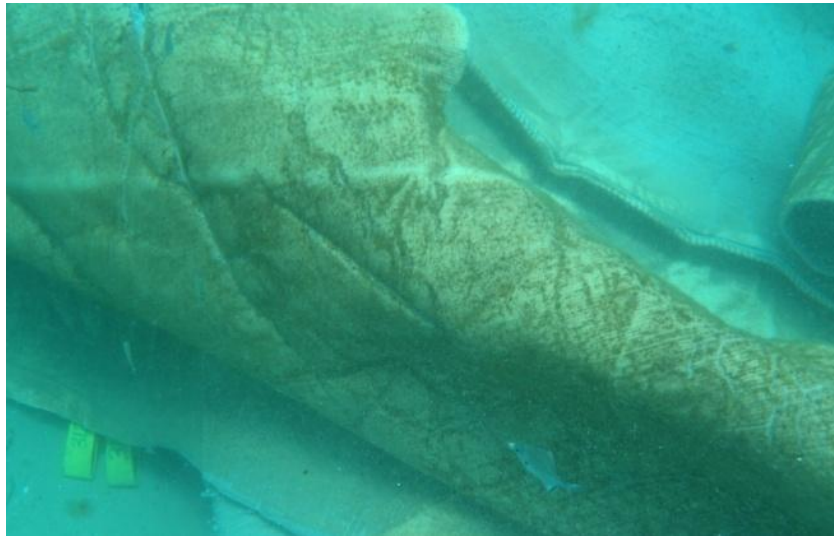
- No evidence of a general deterioration or wearing of the standard (ELCOMax 1200R) or composite (ELCOMax 1209RP) geotextile on intact containers
- At least one container with the unsuccessful trial polyurethane coating is still present and in good condition, although several of these have failed (Figure 8). This coated geotextile was discontinued usage during initial construction as it made the containers more rigid and stress cracking was observed relatively quickly after placement. Progressive failure of these trial containers was expected.

Figure 8. Failed container with polyurethane coating

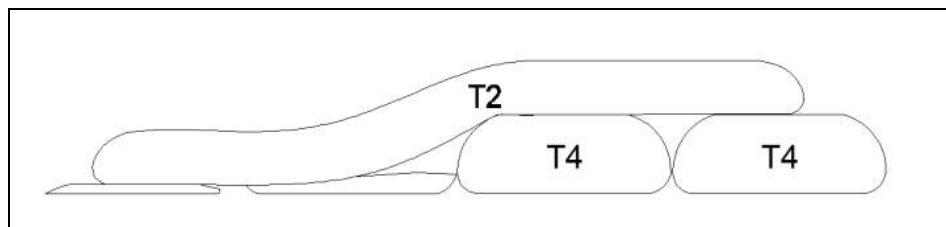
Figure 9. Conceptual sketch showing slumping

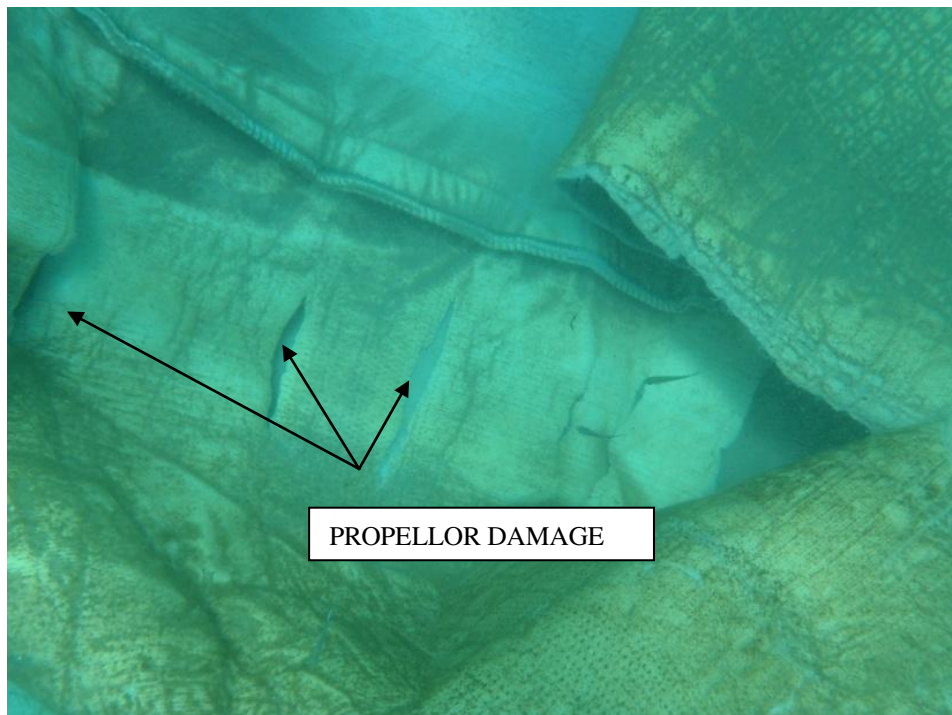
During the 2011 inspection, one container was almost fully deflated and showed clear evidence of propeller damage (Figure 10). The slumping on the north reef due to damage of base containers would indicate potential damage due to anchors. As a result, it seems clear that damage to the structure as a result of vessels is ongoing.

Figure 10. Container with evidence of propeller damage

The fact that the majority of the damaged containers were of the standard 1200R geotextile would indicate that the reinforced 1209RP geotextile (developed specifically for this project) is in fact proving to be more robust and anchor resistant. Continued usage would be expected to reduce ongoing maintenance requirements.

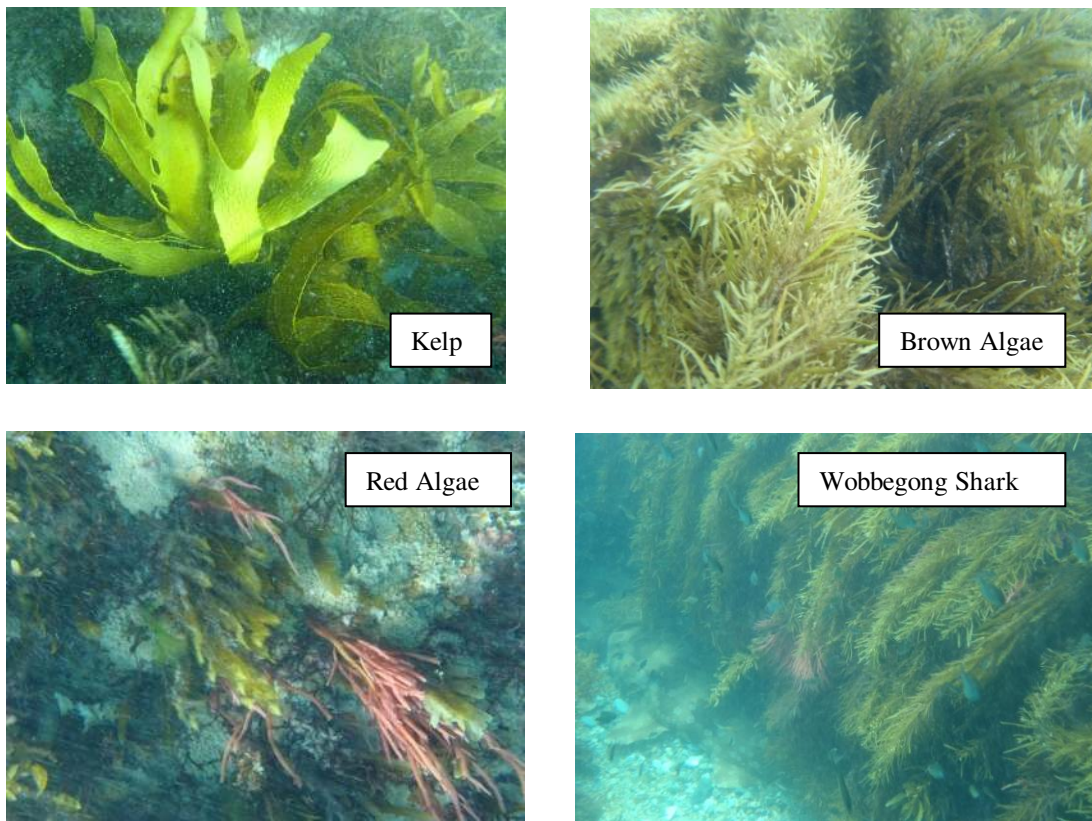
Figure 11. Marine Species Present on the Reef (Table 2).

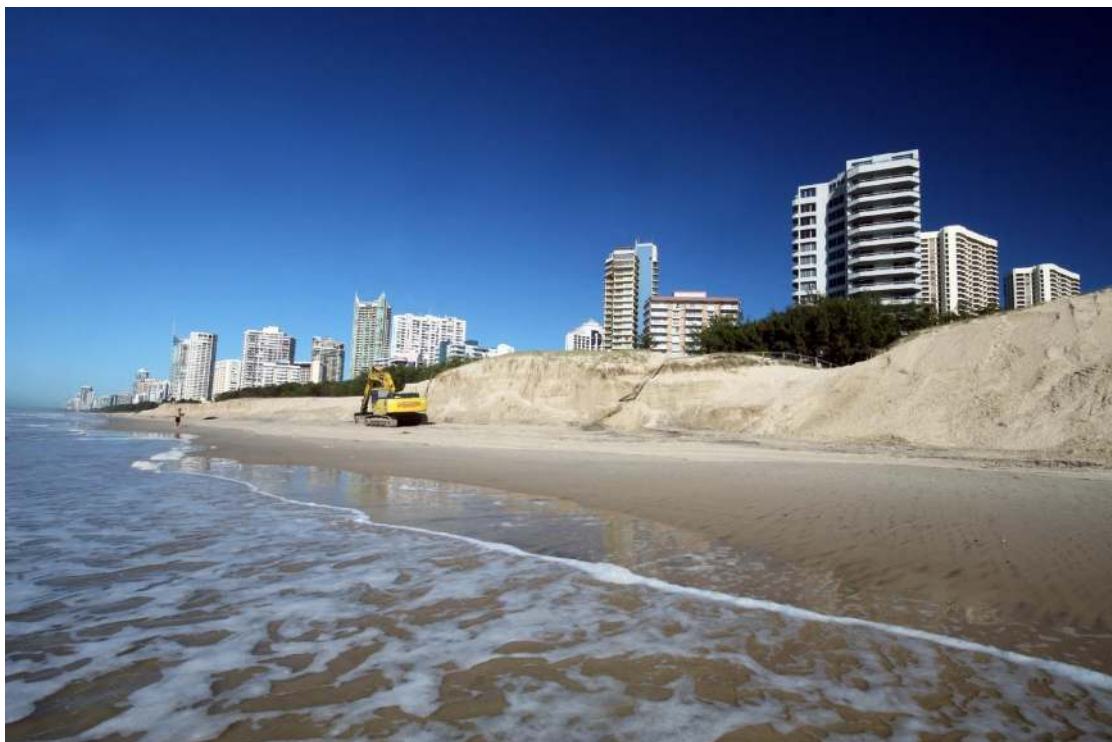
Figure 12. Narrowneck beach looking south – June 2, 2009. Large volume of sand seaward of boulder wall is evident.

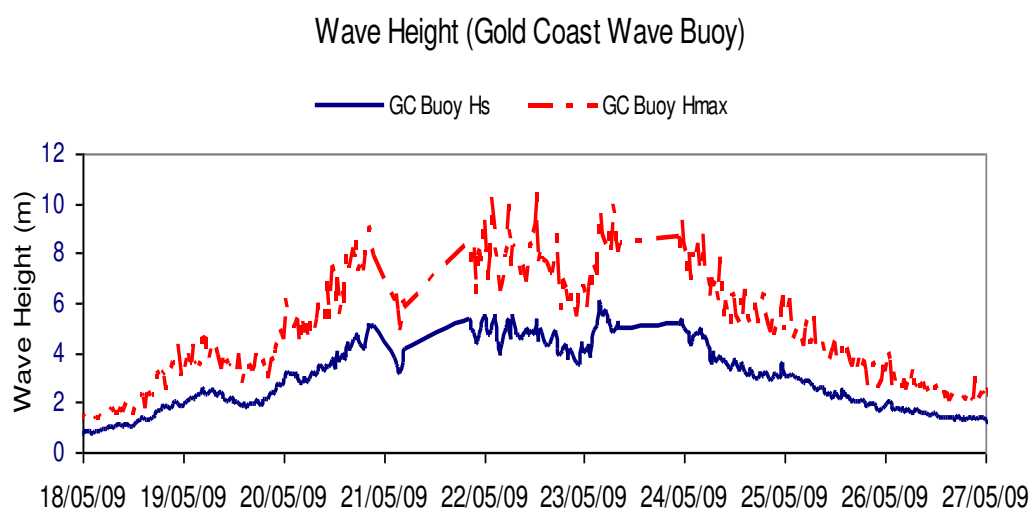
Figure 13. Wave height measured at the Gold Coast Seaway wave rider buoy (DERM).

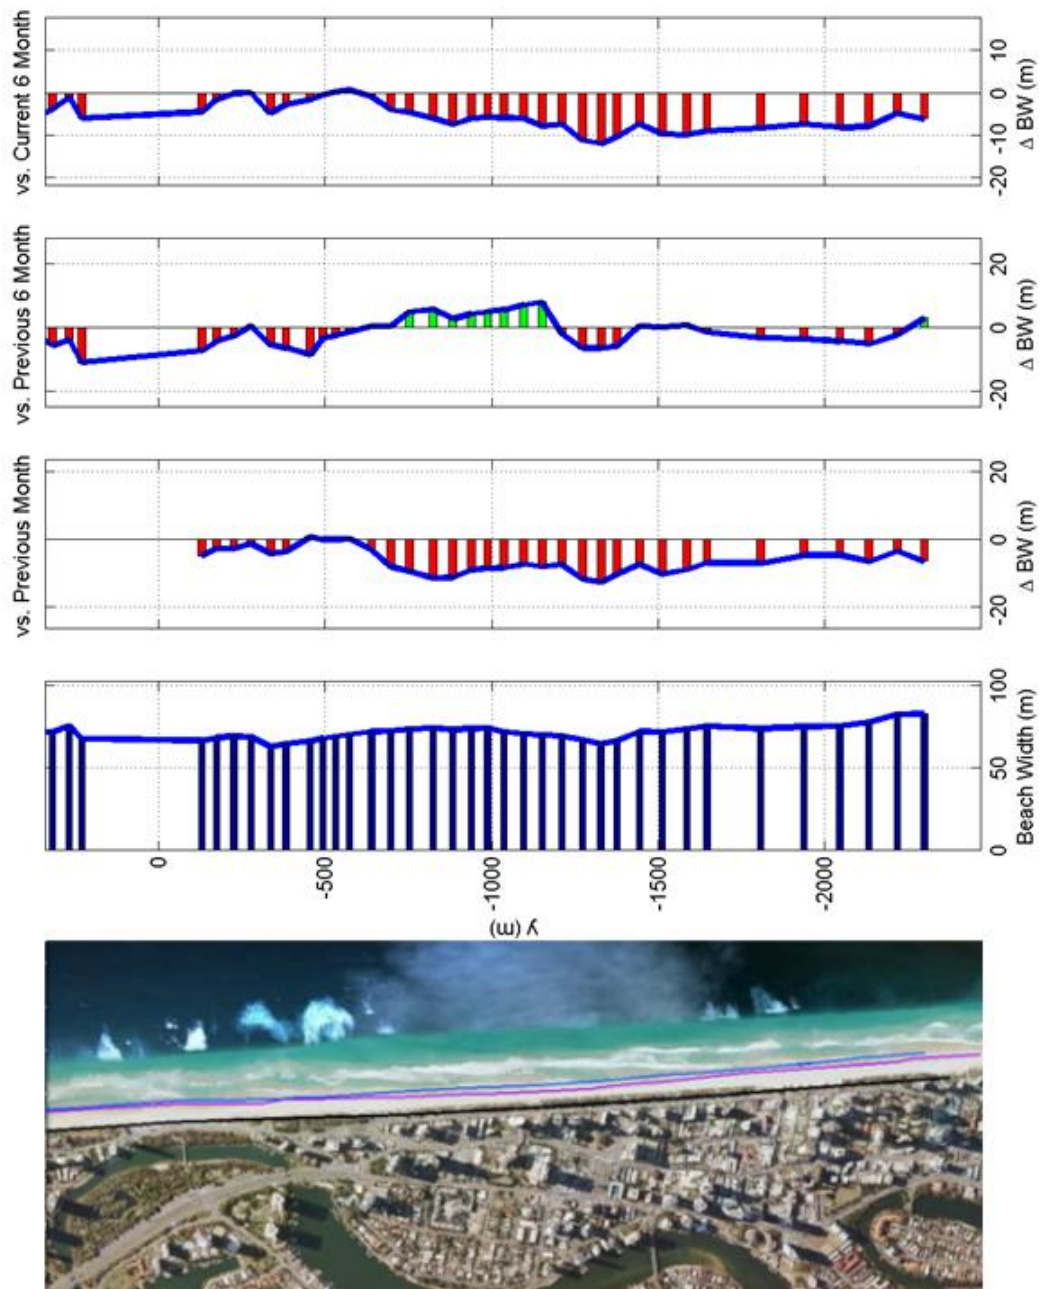
The latest analysis of beach width at Narrowneck derived from the CoastalCOMS monitoring system reveals a monthly average beach width varying from 50 to 100m along the section of coastline covered by the analysis shown in Figure 15. Much of this increase may be due to onshore movement of nourishment sand placed offshore. This sand was dredged from the Gold Coast Seaway and has provided nourishment to the active profile depths of around 6-9m offshore of Surfers Paradise. The nourishment volume was approximately 170,000 m³.

Figure 15. Northern Gold Coast beach width (400 to -2200m), October 2011 (from top to bottom): (a) Beach width relative to current 6 month mean, (b) Beach width relative to previous 6 month mean (c) Change in beach width from previous month, (d) Mean beach width, (e) Monthly average shoreline position (CoastalCOMS).

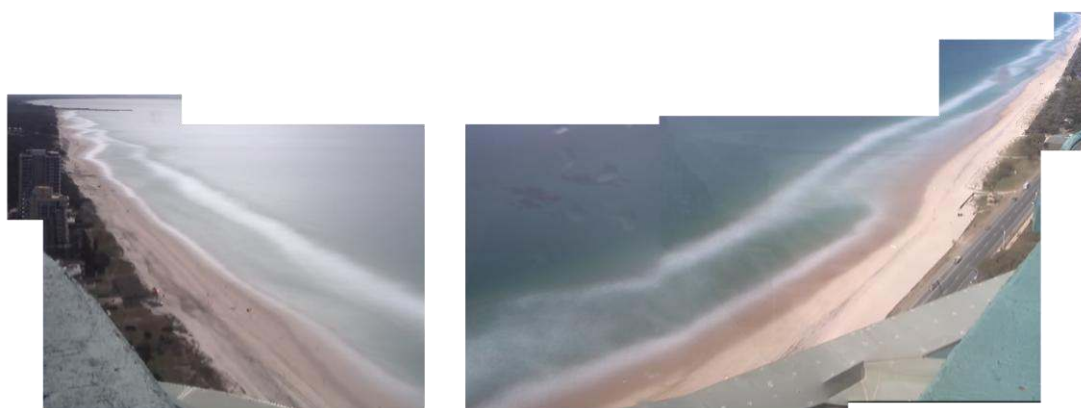
A distinct salient in the lee of the reef is not continuously present but is a recurring feature which can be clearly identified in time exposure images such as in Figure 16.

Figure 16. Salient in lee of Narrowneck Reef on May 20th, 2010

The reef structure has generally produced a salient as predicted by physical and numerical modelling, however the location of the salient is offset by 100m from the centreline of the reef. The continuing evolution of a marine habitat on the reef has resulted in it becoming a very popular fishing and, to a lesser extent, dive location.
