# Managing Cold Temperature and Brittle Fracture Hazards in Pressure Vessels

Daniel J. Benac · Nicholas Cherolis · David Wood

Submitted: 25 November 2015 / Published online: 4 January 2016  
© ASM International 2016

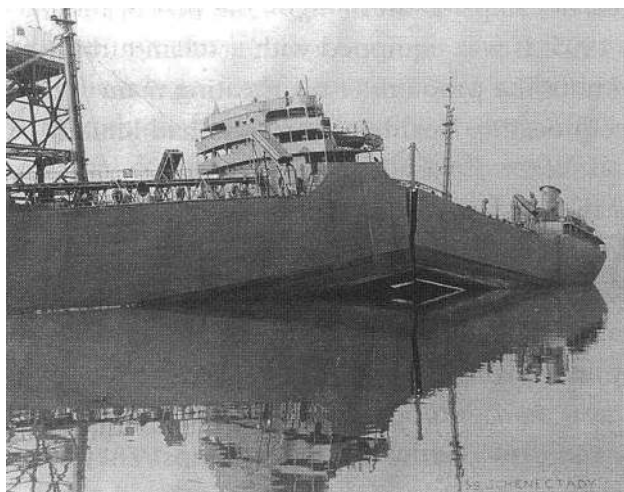
**Fig. 1** Liberty ship Schenectady in the Portland shipyard split in two while still under construction in 1943

Historic brittle fractures include the brittle fracture of 160 World War II liberty ships, which caused them to break in half during the winter months between 1943 and 1944, Fig. 1. Catastrophic failures of molasses storage tanks also occurred on two separate occasions, in 1919 and 1978. In 1919, on a cold day, just 4 years after it was built, a giant storage tank ripped open, releasing a flood of molasses in the city of Boston, Fig. 2. Poor fabrication practices, low material toughness, and design practices contributed to the failures [1, 2].

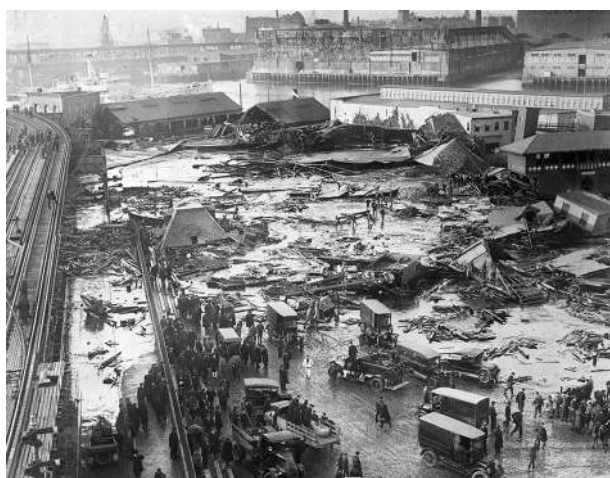
**Fig. 2** Boston Molasses tank failure wrecked an entire neighborhood in January 1919

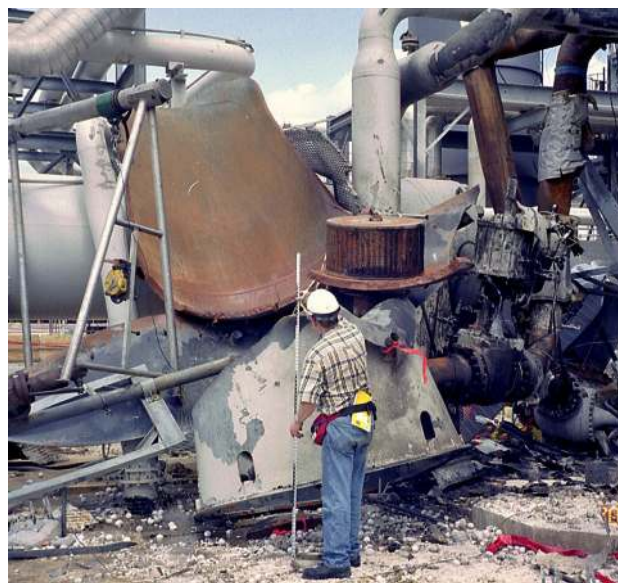
**Fig. 3** Brittle fracture of a pressure vessel is sudden and catastrophic, resulting in loss of containment of product and energetic fragmentation

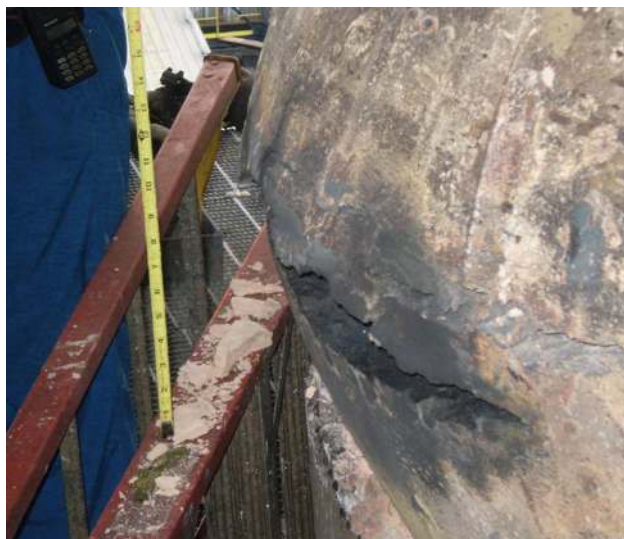
**Fig. 5** Ductile fracture in a 112-mm (4.4-inch)-thick steel pressure vessel shell indicated by extensive bulging and deformation that preceded the fracture

First it helps to recognize the gross macroscopic differences between ductile and brittle fractured components. Figure 5 shows gross bulging that resulted in a steel pressure vessel shell that was 112 mm (4.4-inches) thick, after the shell was over-heated on the inside due to high heat condition on the inside surface [10]. Such gross deformation often accompanied by shear lips on the fracture itself is a good indication that the failure was not brittle, but was ductile.

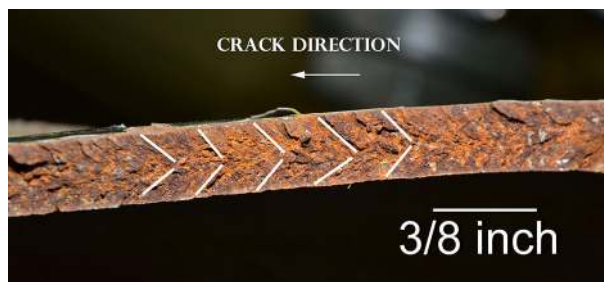
**Fig. 6** V-shaped chevron marks found on a pressure vessel brittle fracture surface indicating the direction of crack propagation

Figure 6 shows the directional V-shaped chevron markings that point back to the origin of the fracture. Also notice the flat fracture and the absence of a shear-lip and no elongation or stretching, indicating a brittle fracture. Often there is a crack-like flaw or defect or feature at the origin of a brittle fracture that would be of little or no consequence,

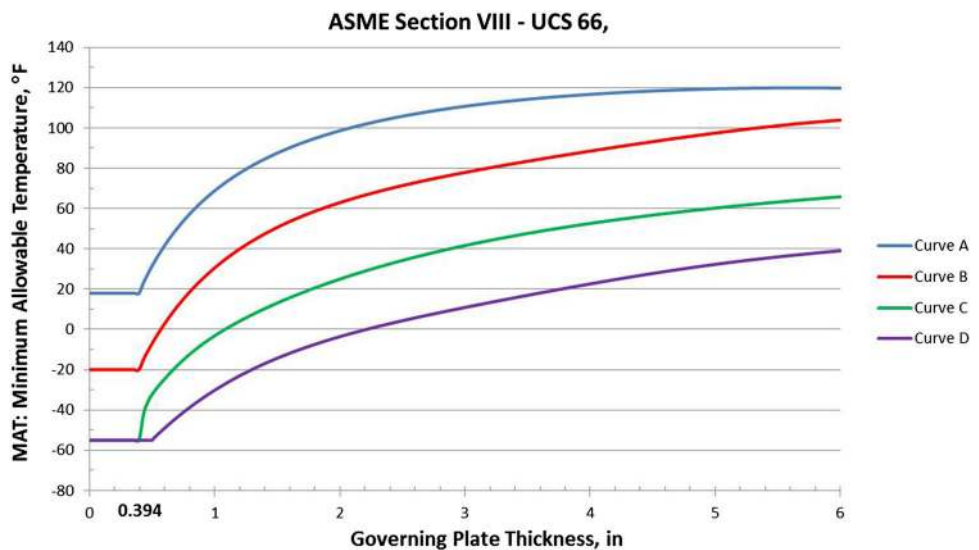
**Fig. 10** Minimal allowable temperature (MAT) based on the material thickness and grade of material [15, 16]

However, as the material thickness of the vessel increases, the allowable temperature to avoid brittle fracture also must increase, as shown in Fig. 10 [13, 14]. Curve A represents a material that has potentially poor toughness properties; while Curve D represents a material that has improved toughness. If the operating temperatures are held below that minimum allowable temperature, then there is a risk of brittle fracture. To avoid this, process controls have to be established in order to regulate the temperature, or a material upgrade may be necessary, or the vessel pressure may have to be reduced to reduce the wall stresses.

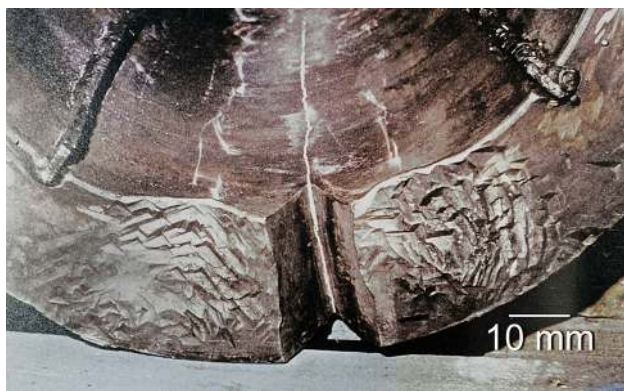
**Fig. 11** Arc-gouged notch and a hard region causing a long crack on as-forged nozzle

Repairs or improper welds can introduce stress points that lead to brittle failure or brittle material behavior if proper procedures are not followed. For example, a 46-cm (18-inch)-long crack was found in a carbon steel as-forged nozzle on a vessel that was arc-gouged. Failure occurred after 5 years in service during a cold-start-up procedure. The crack initiated at the arc gouge notch due to a very hard zone (HRC 54) that was not removed after arc gouging. An initial flaw and poor toughness during the cold start condition resulted in cracking (Fig. 11) [18].

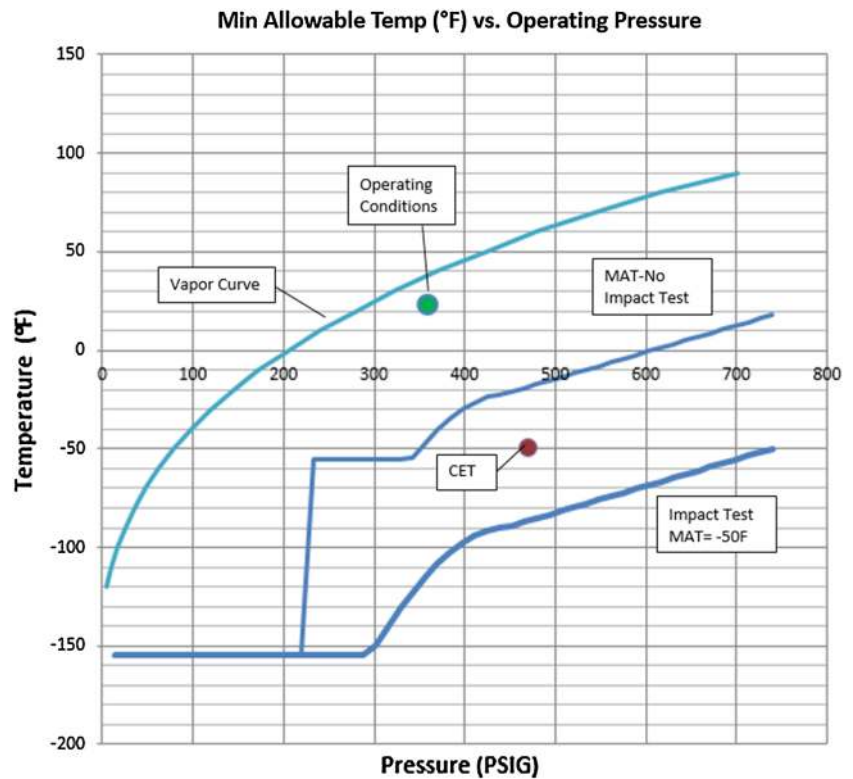
**Fig. 12** BakerRisk Software input screen showing the parameters considered for brittle fracture assessment

**Fig. 13** Plot of the MAT curve as a function of decreasing pressure compared to the CET

A cold temperature brittle fracture engineering assessment as outlined in the API 579-1/ASME FFS-1 Part 3 evaluates the safeguards in place to control pressures and temperatures required in order to avoid low temperature conditions and assess the material behavior of the equipment. Figure 12 shows a spreadsheet of parameters considered in a review.

Figure 13 shows a plot of the equipment minimum allowable temperature (MAT) as a function of pressure and stress. The assessment identifies potential scenarios for low temperature excursions and then reviews the process and equipment condition input from the plant to determine the critical exposure temperature (CET). The CET is the lowest metal temperature that the material is exposed to in the coldest scenario. The CET is derived from either the operating or atmospheric conditions at the maximum assumed combination of pressure and primary supplemental loads. The shell, head, and nozzles are assessed as shown in Fig. 14.

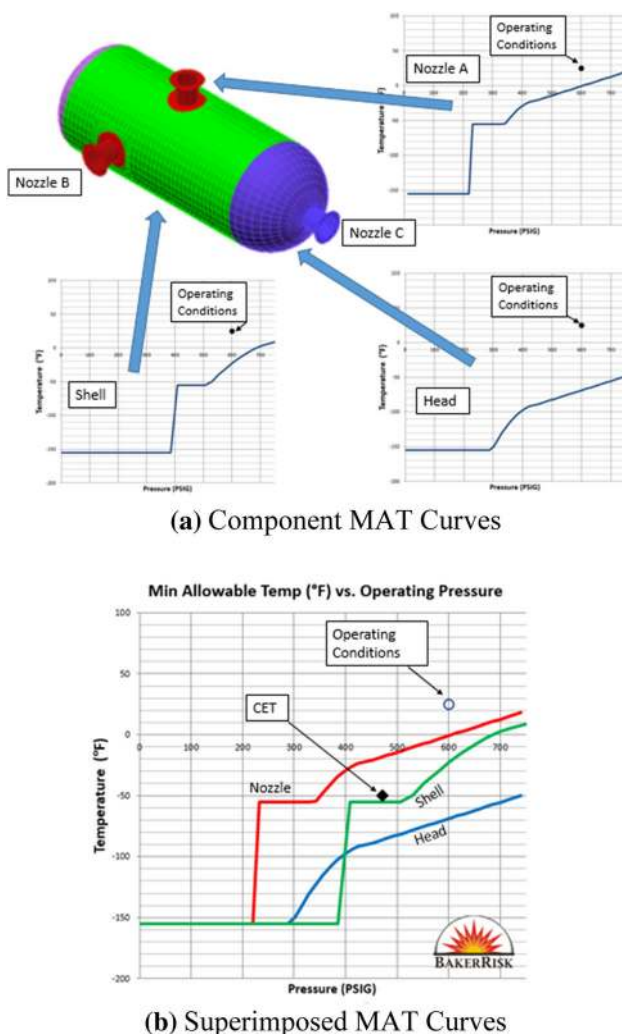
**Fig. 14** Brittle fracture review for a vessel assesses nozzles, shells, and heads made of different materials and different thicknesses. **(a)** Depicts MAT of equipment components in relation to operating conditions and **(b)** illustrates how risk for cold temperature embrittlement may develop if the temperature drops to the CET

only one of the three nozzles, Nozzle A, is represented. In this particular illustration, the shell, head, and nozzle are acceptable at the operating conditions, assuming operating conditions are above the MAT curve.
