Material and Manufacturing Properties of Bracket Mural Paintings of Daeungjeon Hall in Gaeamsa Temple, Buan

Journal of Conservation Science
2022;38(1):45-54

ABSTRACT This study examined the production technique of bracket murals in Daeungjeon Hall, Gaeamsa Temple by conducting a analysis of their wall structure, material characteristics, and painting layers. Wall was a single-branch structure with support layer, middle layer, finishing layer, and painting layer. The support layer, middle layer and finishing layer, were produced by mixing sand (quartz, feldspars etc.), and loess. The ratio of above medium sand to below fine sand was approximately 0.7 : 9.3 in the support layer, 4 : 6 in the middle layer and 6 : 4 in the finishing layer, which had a more percentage of above medium sand than the support layer. The analysis of the painting layer showed that natural soil pigment was used to establish a relatively ground layer of up to 50 μm , and pigments such as Lead sulfate, atacamite and mercury sulfide were painted on top of the layer. This study's results confirmed that the bracket mural paintings in Gaeamsa Temple are within the category of the production style of murals during

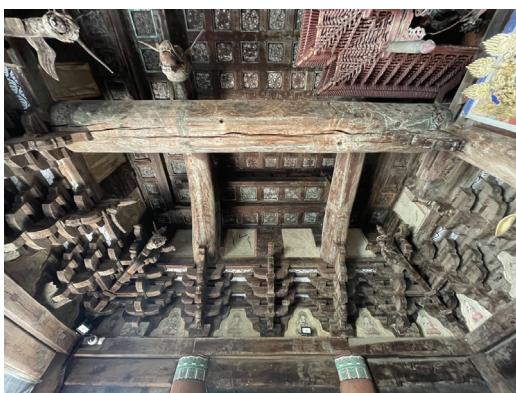
Figure 1. Inside the Daeungjeon hall of Gaeamsa Temple, Buan.

Daeungjeon Hall, Gaeamsa Temple, Buan is currently designated as Treasure No. 292 and has 52 murals, including bracket murals painted on interior and exterior walls and murals at the top of Nemok-dori (Figure 1). While there are 32 interior bracket murals with 6 each on the east and west and 10 each on the south and north, 4 on the north have no painted image and 5 have been repainted relatively lately. The latest scientific investigation on bracket murals in Daeungjeon Hall, Gaeamsa Temple found that damage in the wall and damage due to the deteriorated painting layer had gotten worsen, which would require conservation treatment (Figure 2). Accordingly, a study identifying manufacturing conditions based on structures and materials, which constitute murals, would need to be conducted first to prepare stable

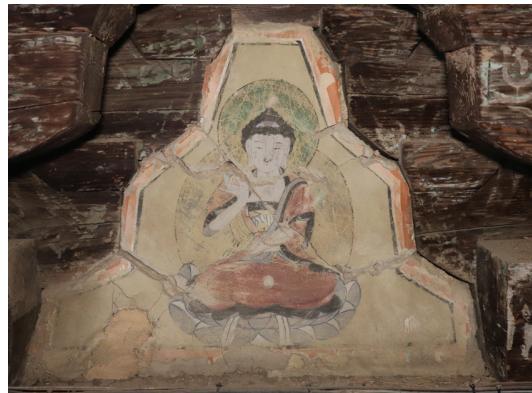
Figure 2. Example of conservation status of murals in Gaeamsa Temple, Buan.

(Lee *et al.*, 2018b). As it can be seen that the pattern of damage confirmed in the current murals of Gaeamsa Temple reflects some of these structural and material characteristics, attention is required for the conservation of the murals.

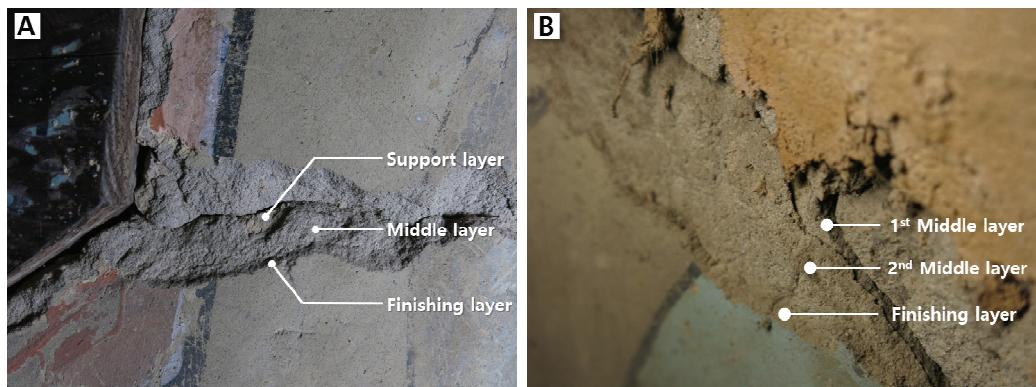
The walls of the bracket murals in Gaeamsa Temple were made with soil around the branches were tied with straw rope. On the top of the branches that serve as the frame of the wall, a support layer in the form of plastering a mixture of fine loess and sand is confirmed, and a layer of sand with large particles and various sizes is observed above it, and the corresponding layer has two layers. Separated from above. Bracket murals in Daeungjeon Hall, Gaeamsa Temple, Buan consisted of three layers: the support layer, middle layer, and finishing layer (Figure 3A). In some parts, traces confirmed that the middle layer was made more than once (Figure 3B).

Figure 3. Types of wall layers (A: 3 Layers, ‘support layer - middle layer - finishing layer’, B: 4 Layers, ‘support layer - 1st middle layer - 2nd middle layer - finishing layer’).

It is found that the support layer has a thickness of about 50 mm from the branch, and traces of roughly and quickly plastering appear through the area where the mural has been exfoliated, and a mixed of wooden material and leaves is observed on some walls. The middle layer and finishing layer were applied relatively evenly with a high level of smoothness, the thickness of the middle layer was estimated to be about 7 mm, and the finishing layer to be 3 mm.

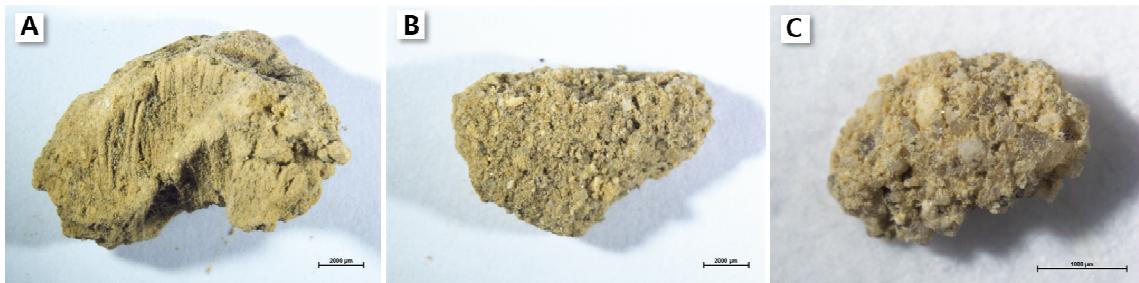
Results of microscopic observation of wall samples of the braket mural painting of Daeungjeon Hall in Gaeamsa Temple (Figure 4), while samples from the support layer consisted of below silt particles rather than larger ones like gravel, samples from the middle layer and the finishing layer had a mixture of larger particles like sand grains and silt or like clay. In addition, fibers presumed to have been mixed during the wall manufacturing process were confirmed in all

Figure 4. Microscopic image of samples (A: Support layer, B: Middle layer, C: Finishing layer).

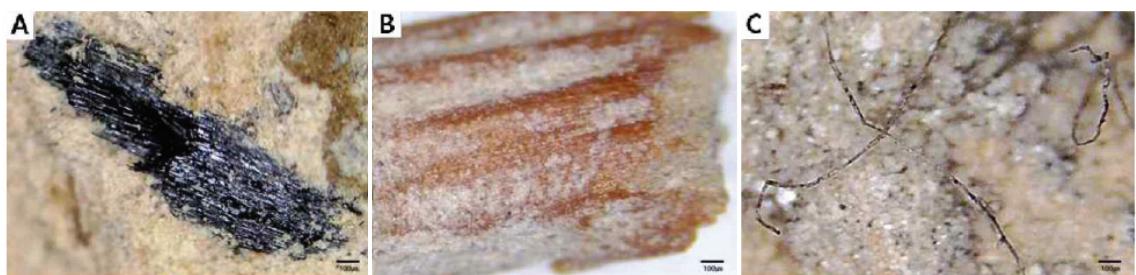
Figure 5. Digital microscope image of wood and fiber mixed in the wall (A: Wood piece in support layer, B: Wood piece in middle layer, C: Fiber in finishing layer).

In the case of the support layer, fibers presumed to be wood or bark were mixed in the wall (Figure 5), and it was confirmed that the fibers of fine thickness were evenly mixed in the middle layer and the finishing layer. The microstructure analysis by the scanning electron microscope confirmed that soil particles such as sand and clay minerals formed aggregates in the support layer, and multiple materials suspected to be fibers were observed. Large and small soil particles were found to have a plate-like microstructure, which was believed to be an aggregate of clay minerals.

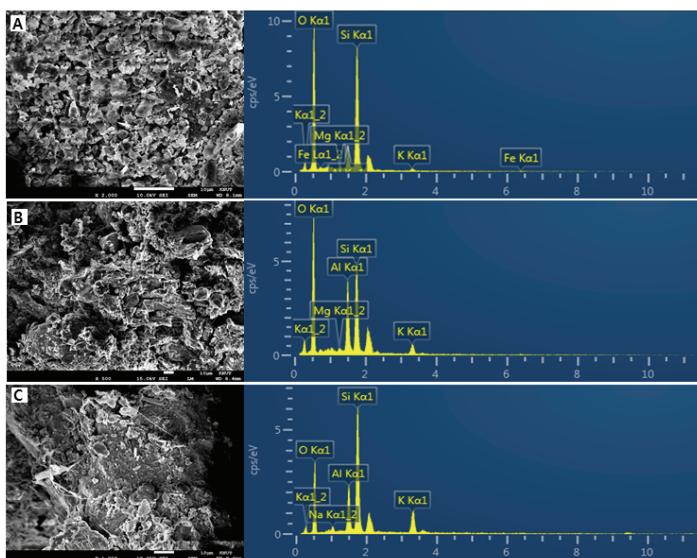
In the middle layer and the finishing layer, aggregates of soil particles resembling silt or clay minerals as large and small ones or in the form of plates were observed on the surface of large particles suspected to be quartz. The chemical composition analysis detected silicon (Si), aluminum oxide (Al), iron (Fe), potassium (K), magnesium (Mg), and sodium (Na) in the support layer, and in the middle layer and the finishing layer, atoms usually found in the soil such as iron (Fe), potassium (K), magnesium (Mg), and sodium (Na) were detected, including silicon (Si) and aluminum oxide (Al) like the support layer (Figure 6).

Figure 6. Results of SEM-EDS (A: Support layer, B: Middle layer, C: Finishing layer).

An analysis of the microstructure and chemical composition of particles consisting of each layer of bracket murals detected soil particles of various sizes or crystal aggregates in plates and chemical components usually found from soil materials such as silicon (Si) and aluminum oxide (Al). Furthermore, the mineral crystal habit such as quartz and feldspars was identified, demonstrating that the main materials of the wall layer and the finish layer were weathered soil and sand originating from rocks, which is consistent with the results of a previous study on the wall material characteristics of temple murals (Lee, 2016).

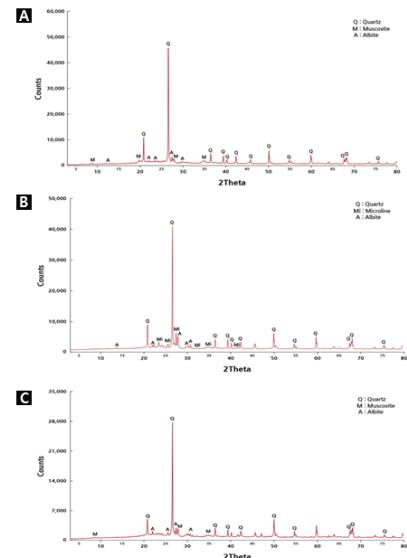
quartz in the support layer. In the middle layer, feldspars such as quartz, microcline, and albite were identified, while the same minerals from the initial layer such as quartz, muscovite, and albite were found in the finishing layer. It is estimated that feldspars including quartz and minerals in the mica group were used in bracket murals (Figure 7).

Figure 7. Results of XRD (A: Support layer, B: Middle layer, C: Finishing layer).

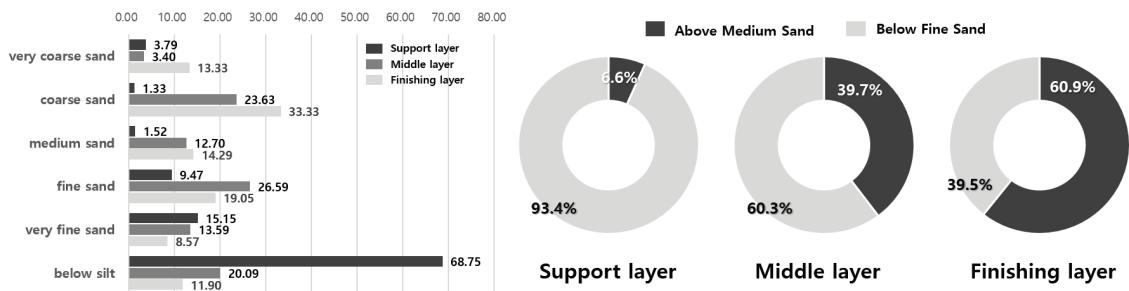
The particle size analysis by the wet sieve (Table 3, Figure 8) found that in terms of distribution in the size of mineral particles used in the support layer of bracket murals, very coarse sand accounted for 3.79%, coarse sand 1.33%, medium sand 1.52%, fine sand 9.47%, very fine sand 15.15%, and below silt 68.75%. For the support layer of bracket murals in Gaeamsa Temple, below fine sand accounted for more than 93%, which led this author to believe that it was mixed with the soil of very fine particles. In terms of distribution in the size of mineral particles used in the middle layer, very coarse sand accounted for 3.40%, coarse sand 23.63%, medium sand 12.70%, fine sand 26.59%, very fine sand 13.59%, and below silt 20.09%. Below fine sand accounted for more than a half of the middle layer, and it had a higher percentage of sand than the support layer. Finally, in terms of distribution in the size of mineral particles used in the finishing layer, very coarse sand accounted for 13.33%, coarse sand 33.33%, medium sand 14.29%, fine sand 19.05%, very fine sand 8.57%, and below

**Figure 8.** Results of particle size analysis.

silt 11.90%. Above medium sand accounted for more than a half of the finishing layer of bracket murals, and it had a higher percentage of sand than other layers. When the particle size distribution was divided into above medium sand and below fine sand, the finishing layer had an opposite trend to the middle layer in terms of the particle size distribution.

A particle size analysis found that the support layer had a high content of loess, while the middle layer and the finishing layer had a fairly high content of sand. In the support layer, above medium sand accounted for 7% and below fine sand 93%. And since the proportion of soil less than silt is 53.6% even in the soil of fine sand or less, it is estimated that the support layer is made by mixing soil of relatively even and fine soil materials to produce the murals. In the middle layer, above medium sand accounted for 40% and below fine sand 60%, showing that it had a higher fine sand content than the support layer. In the finishing layer, above medium sand accounted for 60% and below fine sand 40%, compared to other layers, the proportion of very coarse sand and coarse sand size soil is high, indicating that the content of large sand is high. The difference in the particle size distribution of the soil at each layer indicates the difference in the voids according to the arrangement of the soil particles, and the attractive force according to the particle gap affects the cracks or strength of the wall, which is directly related to the conservation of the mural. In particular if moisture were absorbed and released repeatedly in the wall, this condition would lead to changes in the volume fraction between wall layers, create a difference in stress over the long term, and cause physical damage such as cracks and separations between the layers

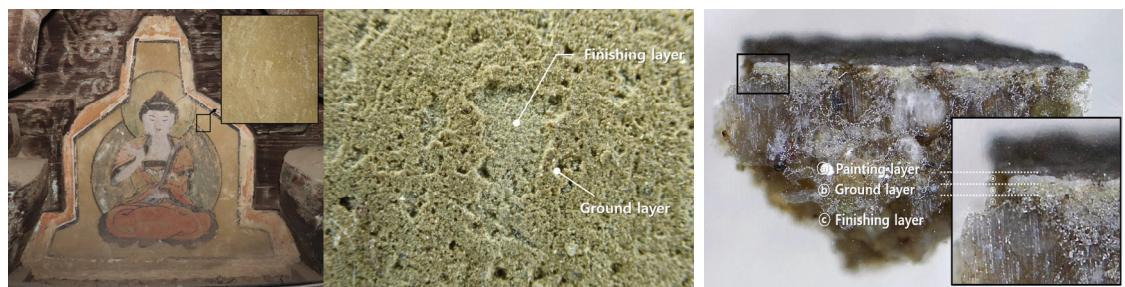
Murals in Daeungjeon Hall, Gaeamsa Temple, Buan were painted in seven colors: white, black, grey, dark green, pale green, red, and flesh color. By examining the surface of the murals, this study identified the ground layer (Figure 9). The

**Figure 9.** Coloring condition of mural painting.

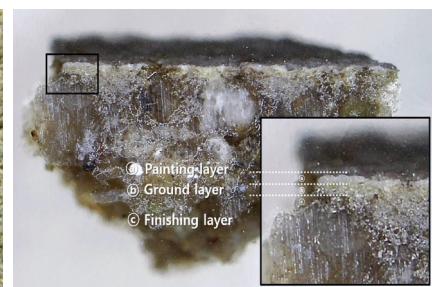
retrieved samples were used to investigate the cross-section and showed some traces, confirming that the ground layer was made and painted on top of the finishing layer (Figure 10). The ground layer was pale ochre (off white) and had the thickness of 35 to 50 μm . The painting layer painted on the ground layer had the thickness of 22 to 80 μm . The painting layer in the white sample (P1) had thickness with 21.53 μm in thin parts and 38.3 μm in thick parts, while the painting layer in the green sample (P2) ranged from 45.77 μm to 79.38 μm in thickness. In addition, another green sample of P3 other than P2 ranged from 36.33 μm to 48.46 μm in thickness, which showed a difference of 2.69 μm to 43.05 μm from P3, albeit in the same color category. Lastly,

**Figure 10.** Structure of painting layer.

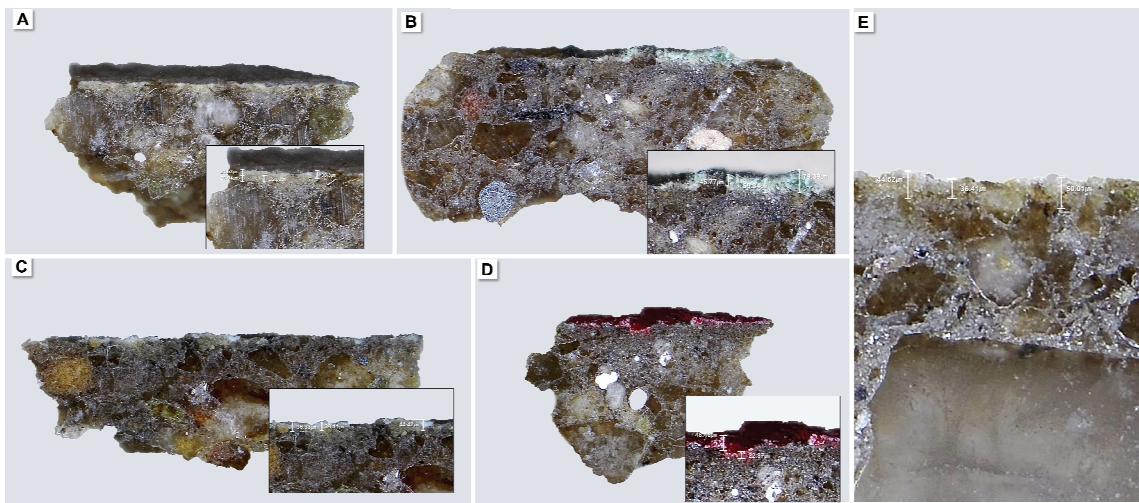
Figure 11. Thickness measurement results for painting layer through cross-section (A: Cross section of P1, B: Cross section of P2, C: Cross section of P4, D: Cross section of P3, E: Cross section of G1).

the red sample (P4) from $26.91 \mu\text{m}$ to $48.46 \mu\text{m}$ in thickness (Figure 11).

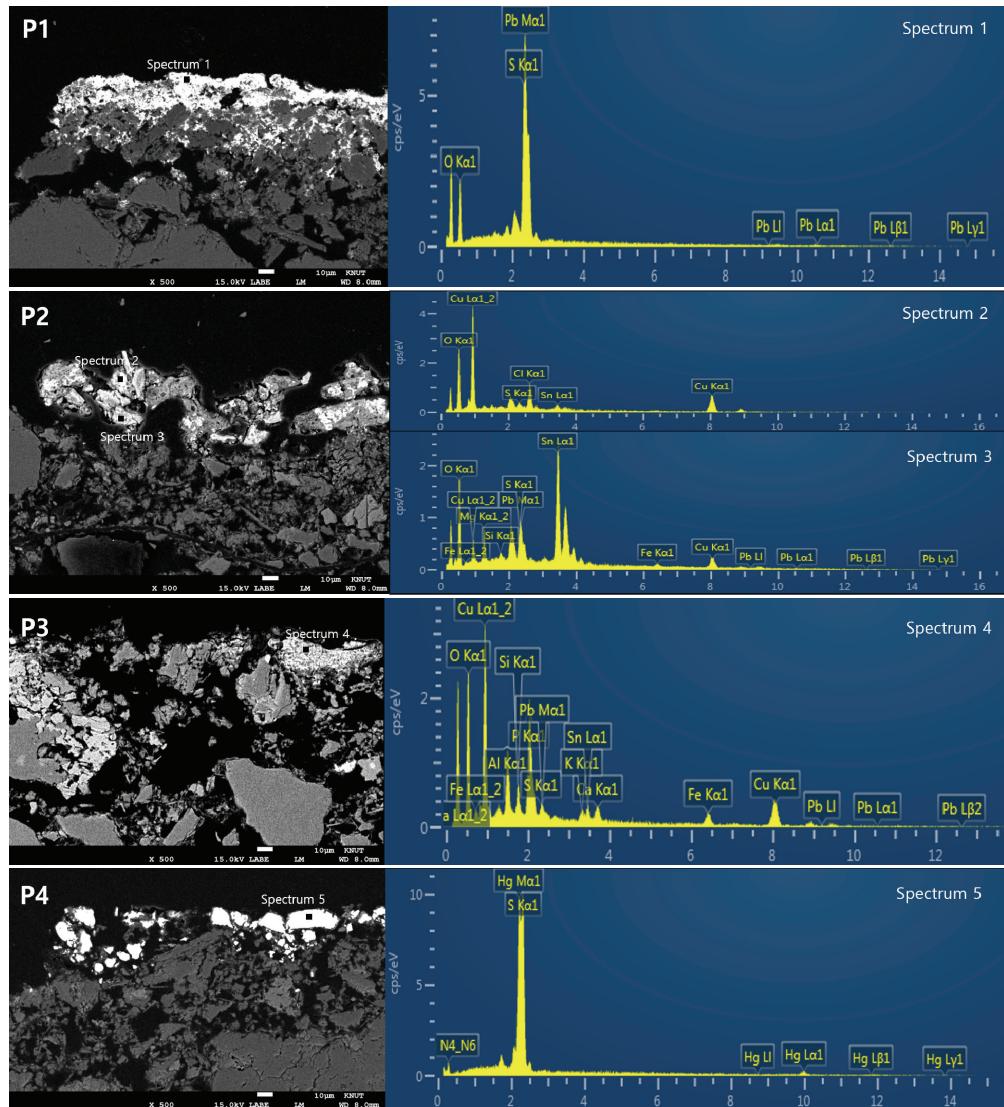
Based on the results of the cross-section investigation into the structure of painting layer, the results of chemical components analyzed from 4 samples from the ground layer and the painting layer are provided in Table 4 and Figure 12. G1 found in the ground layer mainly consisted of silicon (Si) and aluminum oxide (Al), along with calcium (Ca) and iron (Fe). To confirm whether there was the ground layer below the painting layer, samples from the painting layer were analyzed for parts suspected to be the ground layer through the microstructure, which showed the layer below the painting layer in P1 to P4 had the same chemical composition as G1. The white P1 was confirmed to contain lead (Pb) and sulfur (S), and the green mainly consisted of P2 copper (Cu) and chlorine (Cl), along with tin (Sn), lead (Pb), and sulfur (S). P3 had copper (Cu), tin (Sn), lead (Pb), and sulfur (S).

The red P4 mainly consisted of mercury (Hg) and sulfur (S).

Figure 12. Results of SEM-EDS.

An analysis of samples by the digital microscope found five colors: white, dark green, pale green, red as well as ochre in the ground layer. From the ochre ground layer, silicon (Si), aluminum oxide (Al), calcium (Ca), and iron (Fe) were detected as the main components, which suggest soil pigments such as loess or kaolinite may have been used. In the white color layer, lead (Pb) and sulfur (S) were the main components, and lead (II) sulfate seems to have been used. For green, copper (Cu) and chlorine (Cl) were observed as the main components, and atacamite may have been used. For red, mercury (Hg) and sulfur (S) were detected, showing that mercury sulfide pigments may have been used. The existence of the ground layer and the pigments used in the painting layers identified in the bracket mural paintings of Gaeamsa Temple belong to the category of the types of pigments applied to the buddhist murals of the Joseon Dynasty investigated so far, and their production methods are similar. It has been reported that the conservation condition of the painting layer is relatively good compared to the wall, and, judging from the pigment used or the composition of the painting layer, no factors directly affecting the damage have been identified so far. The structure and materials of the bracket mural paintings of Daeungjeon Hall in Gaeamsa Temple, Buan have a similar manufacturing style in terms of the earthen wall layer, pigments, and techniques, compared to the Buddhist mural paintings in the Joseon Dynasty studied so far. Such information can provide useful data for diagnosing the conservation status of the bracket mural painting in Gaeamsa Temple and is expected to provide effective information on materials and technologies for conservation treatment planning.
