# Measured Performance and Stability Analysis of Large-Scale Reinforced Model Embankments at Different Moisture Contents

**Abstract** This paper describes construction and instrumentation of two 1.65-m high reinforced embankment models that were tested at two different gravitational water contents (GWC) on the dry and wet sides of the optimum moisture content (OMC); i.e. OMC−2 % and OMC+2 %. The embankment models were constructed using a clayey sand that was reinforced with four layers of instrumented geotextile with a uniform vertical spacing of 300 mm. Each model embankment was subjected to a line surcharge load (strip footing) near its crest until failure. The magnitudes of GWC, earth pressure, geotextile strains, footing settlement and embankment deformations were measured using EC-5 sensors, earth pressure cells, wire potentiometers, linear variable differential transformers and reference plates, respectively during the construction and loading phases of each test. The GWC values in each model embankment were measured using EC-5 sensors and the oven drying method to ensure that they were close to the target values. Slope stability analysis was carried out to study the equilib

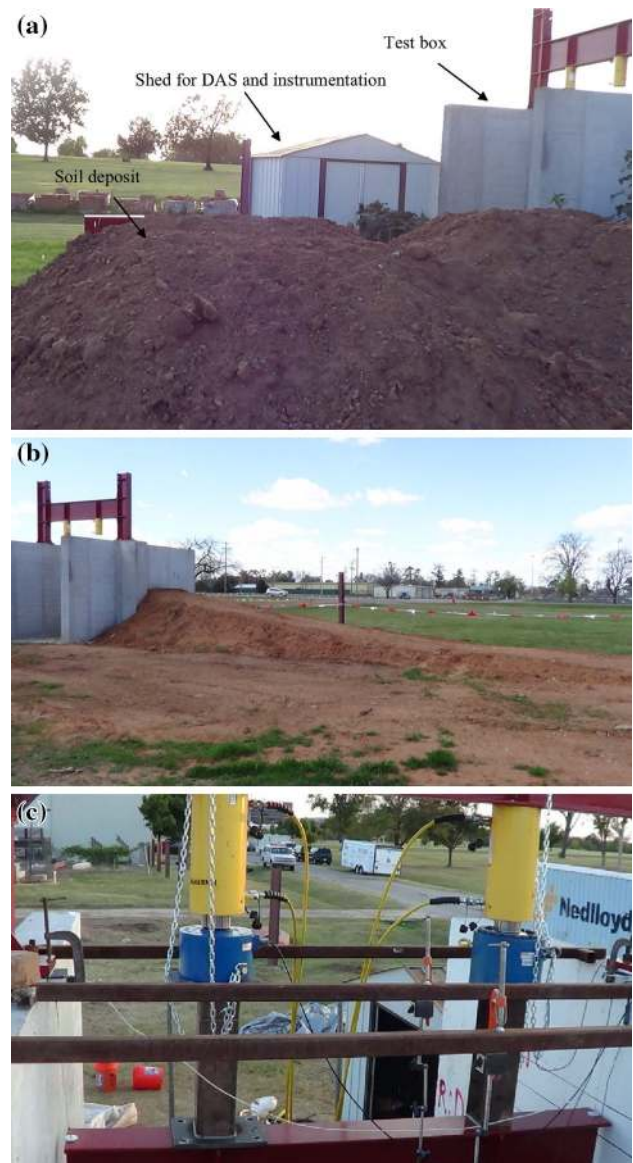
Figure 1 shows the large-scale outdoor test facility that was used to carry out the embankment tests reported in this paper. The external dimensions of the reinforced concrete test box are 5 m (L) × 3 m (W) × 2.8 m (H). The walls of the test facility are 0.3 m thick on all three sides and the test box is flanked by two buttress columns that support the steel loading frame and two 180-ton-capacity hydraulic cylinders. The reinforced concrete floor of the box provides a rigid foundation for the model walls and embankments that are constructed and tested in the facility. An earthen access ramp was built on the east side of the test box to facilitate the transportation and placement of the soil inside the box during construction. The sidewalls of the test box were coated with polyurethane to reduce the friction with the embankment soil during the tests.

**Fig. 1** **a** Large-scale outdoor test facility for reinforced soil walls and embankments at OU; **b** ramp for transporting soil to the test box using a front loader; **c** loading assembly

The blended soil was subsequently transported to the test box through an access ramp using a front loader machine (Fig. 1b) and was compacted in 11 150-mm lifts to 95 % of its maximum dry unit weight ( $\gamma_{dmax} = 20.6 \text{ kN/m}^3$ ) using a pneumatic rammer. Regular soil samples were taken throughout the construction process to ensure that the soil density and GWC values remained consistently near their target values within the embankment.

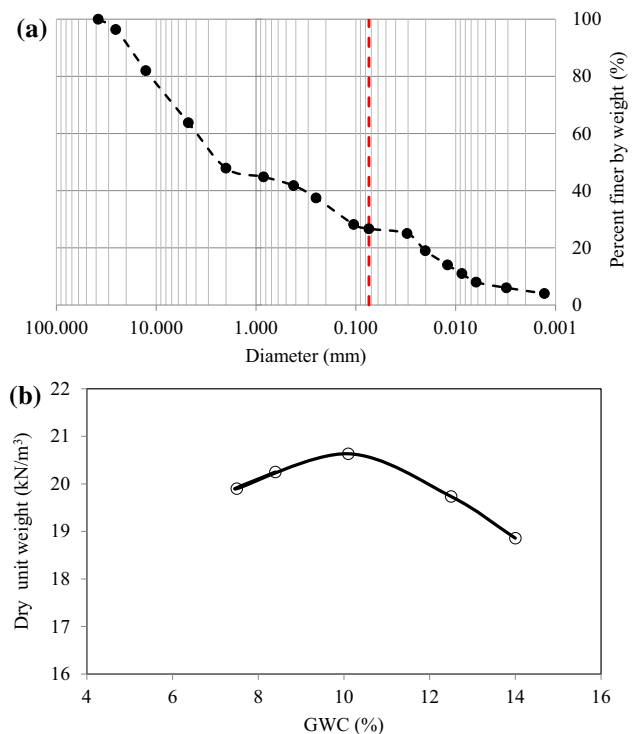
**Fig. 2** a Gradation curve from sieve analysis and hydrometer tests on the embankment soil; b compaction curve from modified Proctor tests. Dashed line indicates the location of 0.075 mm

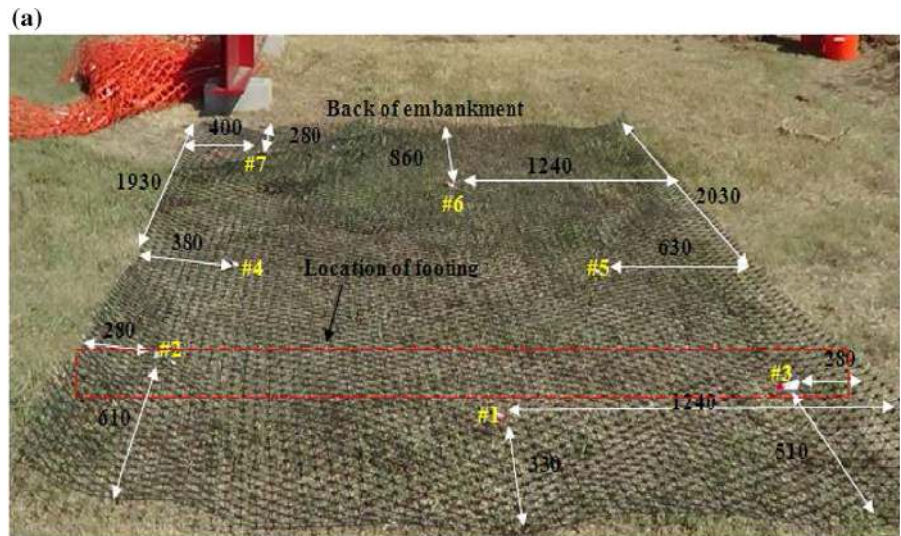
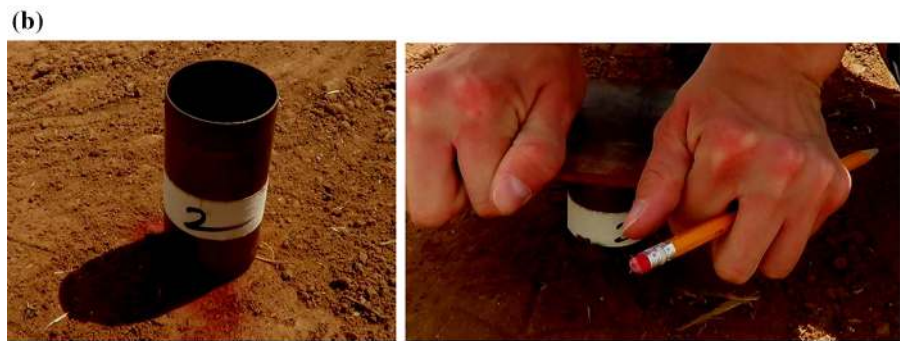
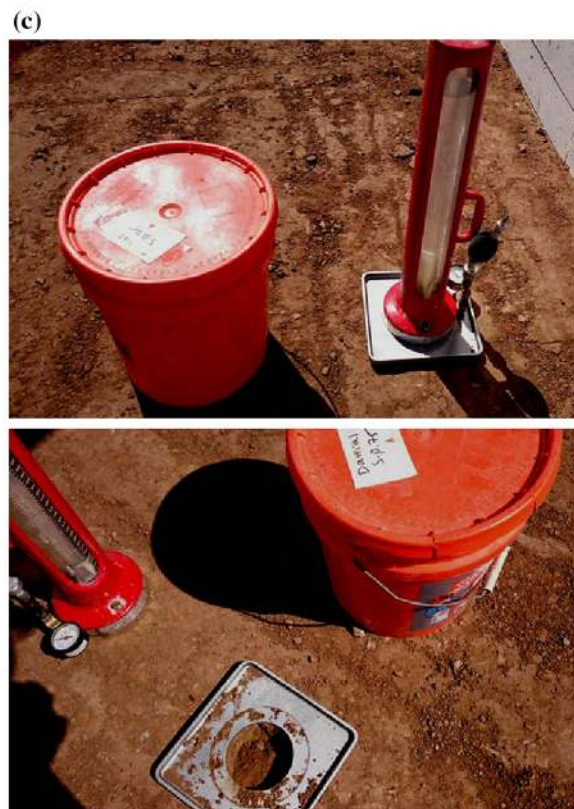
**Fig. 3** **a** Marked-up geogrid template indicating sampling locations for moisture content and density in each compacted lift (dimensions in mm); **b** brass tube samples to measure soil density; **c** rubber balloon measurement of soil density

The embankment was reinforced with four 1500 mm-long instrumented geotextile layers at a uniform spacing of 300 mm. Compaction of each soil lift took approximately 45 min. Then, several brass tube samples at seven different locations throughout each lift were taken to determine the as-compacted GWC and dry unit weight (i.e. degree of compaction) for each lift using the oven-drying [22] and rubber balloon [23] test methods (Fig. 3). The soil density and GWC values for each lift were measured twice; i.e. immediately after compaction and immediately before the placement of the following lift. Figure 3a shows the marked-up geogrid template that was used to take

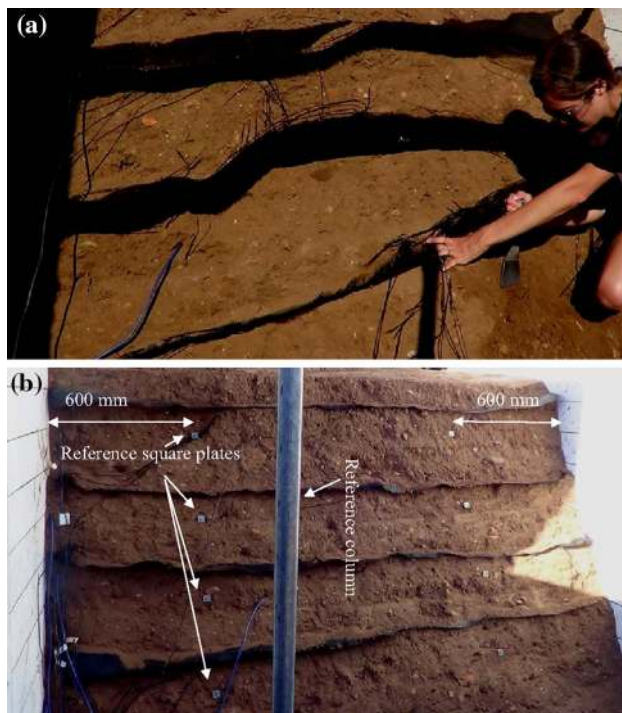
**Fig. 4** **a** Trimming of model embankments facing to the target slope angle; **b** locations of reference plates on the facing to measure its deformations

from two observation (reference) poles that had been installed in front of the facing (Fig. 4). Additionally, 16 wire potentiometers (WP) were collectively attached to the four reinforcement layers to determine their global strains (Fig. 5).

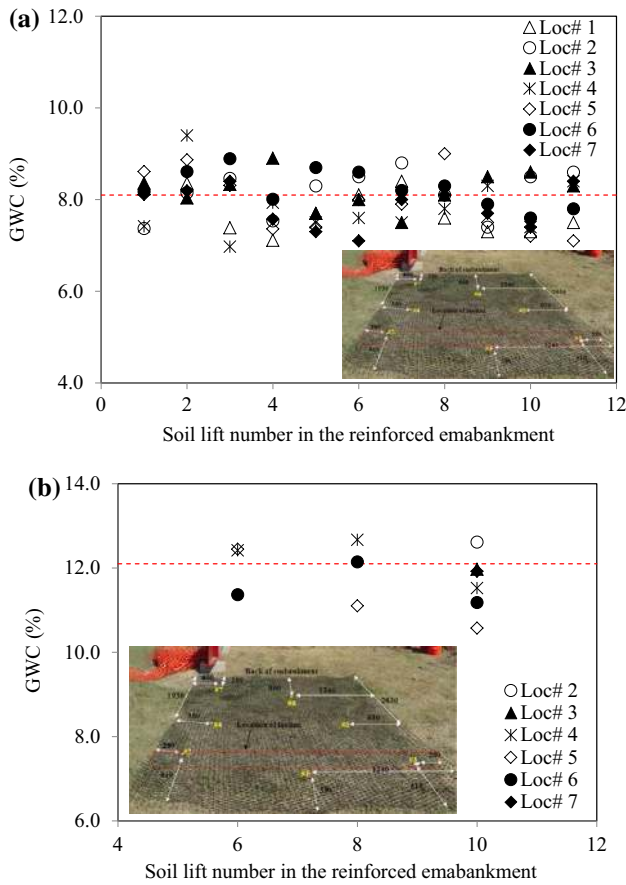
Figures 6 and 7 show example distributions of the soil gravimetric water content (GWC) in each lift within the

**Fig. 6** Distribution of GWC within the embankment models: **a** Immediately before placement of the next lift (test case at OMC-2 %); **b** after loading and failure of the embankment for the test case at OMC+2 %. Horizontal dashed line indicates target GWC value

model embankments as measured using oven-drying method and EC-5 sensors at locations 1 through 7 (Fig. 3a) during construction and after the completion of the loading phase. Results in Figs. 6 and 7 indicate that the GWC values throughout the model embankments deviated from the target values by as much as approximately 1.5 % on either side of the OMC. However, given that processing of the soil and setting up and carrying out the tests were all carried out outdoors and the length of time that was needed to complete the entire operation, it can be concluded that by and large, the GWC values throughout the model embankments were stable and uniform during both the construction and loading phases as practically as possible for outdoor embankment models.

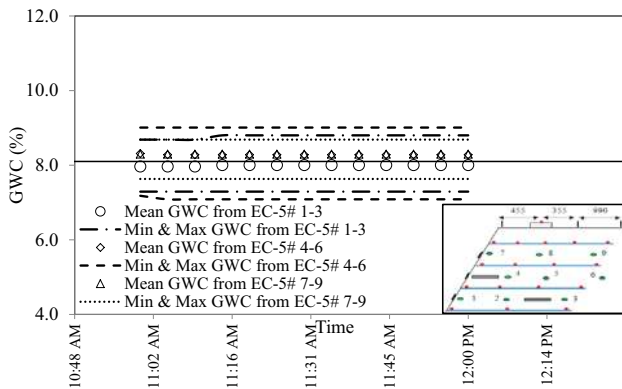
**Fig. 7** Average GWC data from EC-5 sensors during the loading stage in the model embankment constructed at OMC-2 %. Horizontal dashed line indicates target GWC value

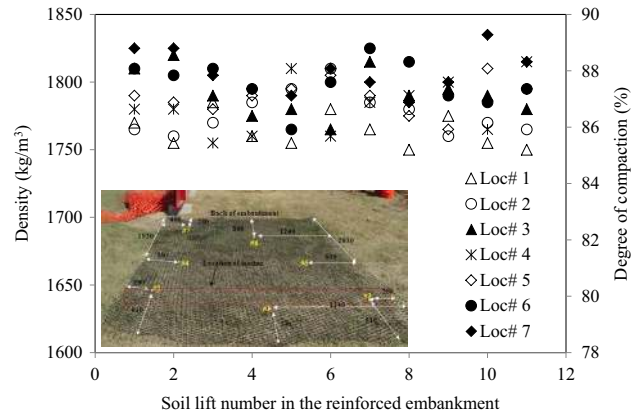
Figure 8 shows the variations in the soil dry density and degree of compaction throughout the embankment at OMC−2 % measured using oven-dried samples and rubber balloon methods at locations 1 through 7. Care was taken to compact each lift with equal amount of energy (i.e. equal passes of compactor equipment). However, measured values for the degree of compaction in Fig. 8 indicate that the degree of compaction over the entire embankment varied between 85 and 89 % (equivalent densities between 1750 and 1835 kg/m<sup>3</sup>, respectively). Apart from the natural spatial variation of density throughout the embankment, the observed difference could partly be attributed to possible disturbance of the local soil during sampling. Nevertheless,

**Fig. 8** Density data in the model embankment constructed at OMC-2 % after compaction of each lift

results shown in Fig. 8 show an overall mean density value of 1790 kg/m<sup>3</sup> (equivalent to 87 % degree of compaction) with a  $\pm 2.5$  % variation around the mean value, which could be regarded as acceptable for field construction.

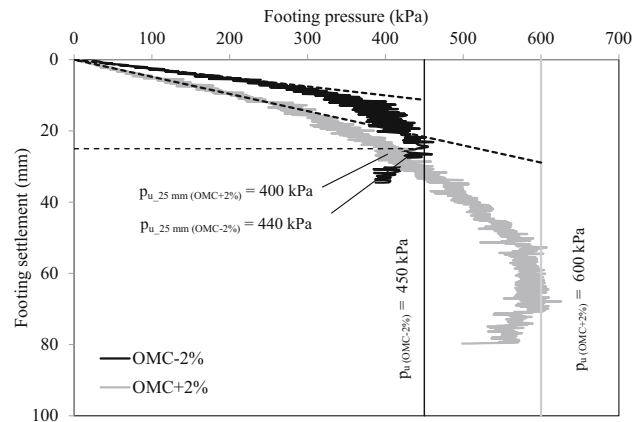
Figure 9 shows the load-settlement data for the model embankments constructed at OMC−2 % and OMC+2 %. The settlement results are the mean values of two wire potentiometers that were mounted near the two opposite ends of the loading beam as shown in Fig. 1c. The vertical wire potentiometers recorded comparable settlements throughout the loading phase with the maximum differential settlement equal to 3 mm. The serviceability failure loads of the two embankments based on a 25-mm settlement criterion and the ultimate failure loads based on precipitous increase in settlements are also shown in Fig. 9.

**Fig. 9** Footing pressure-settlement response and failure loads of reinforced model embankments

Results in Fig. 9 indicate that the serviceability failure pressure of the drier embankment based on a 25-mm settlement criterion is 440 kPa which is 10 % greater than the failure pressure for the wetter embankment. However, the wetter embankment eventually failed at an ultimate pressure of 600 kPa which is 33 % greater than the ultimate pressure measured for the drier embankment. The authors believe that the as-placed moisture content, density and sodium bentonite concentration are among the most important factors that could have influenced the embankment soil properties and performance. In both test embankments, the moisture content and density of the soil were continuously measured for each lift using different methods. The corresponding data which are shown in Figs. 6, 7 and 8 are judged to be consistent and well within the target values for an outdoor test embankment. Therefore, since the type and quantity of the reinforcement and the construction method were also the same between the two test embankments, one plausible explanation for an ultimately larger failure load for the wetter embankment could be a slightly larger amount of sodium bentonite that might have inadvertently been blended with the soil during the soil processing phase of the construction operation near the test facility. Results of several previous studies (e.g. [25]) have also shown that the performance and stability of reinforced soil embankments and retaining walls can be highly sensitive to the amount of cohesion in the embankment soil, which would be consistent with these test results. This observation indicates that cohesion has a significant contribution in the stability of embankments and reinforced soil slopes. As a result, a series of slope stability analyses was carried out to predict the failure load for the model embankment that was constructed at OMC+2 % with an identical amount of bentonite blended with the

On the other hand, comparison of the load-settlement results for the two embankments in Fig. 9 indicate that the wetter embankment (built at  $w = 12.1\%$ ) exhibited a 48 % softer initial response as compared to the

embankment that was built at  $w = 8.1\%$ . In other words, the larger failure load in the case of the model at OMC+2 % was obtained at the expense of larger deformations in the embankment. Therefore, another possible explanation for larger ultimate load that was measured for the wetter embankment is that the dipping slip plane behind

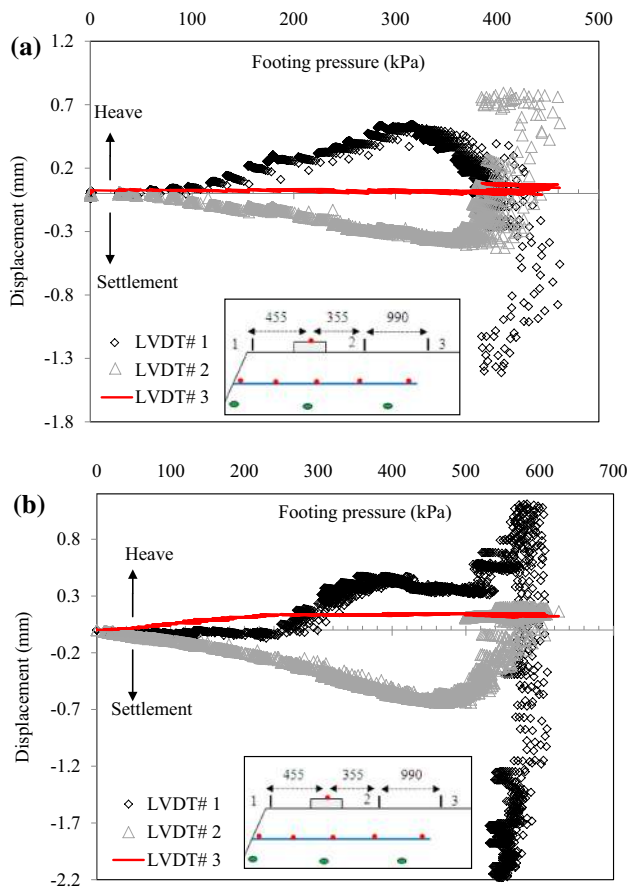
Deformations of model embankments near the loading beam were measured using LVDTs at three different locations along the centerline of the model embankment. Figure 11 shows measured settlements of the embankment top surface during surcharge loading. Results indicate that the embankment surface behind the loading beam (LVDT 2) settled consistently throughout the loading stage but started to dilate at load levels approaching the failure load. In contrast, LVDT 1 results in Fig. 11 indicate that the embankment crest started to heave once the embankment was subjected to the strip footing load. The heaving continued throughout the test but started to reverse into settlement when the embankment approached failure. The LVDT 3 data indicate that the vertical displacement of embankment surface just outside the reinforced mass (i.e. 1345 mm behind the loading beam) was negligible (less than 0.1 mm at failure load). The LVDT results on the

**Fig. 11** Measured settlements of the embankment top surface near the footing during surcharge loading: **a** OMC−2 %, and **b** OMC+2 %

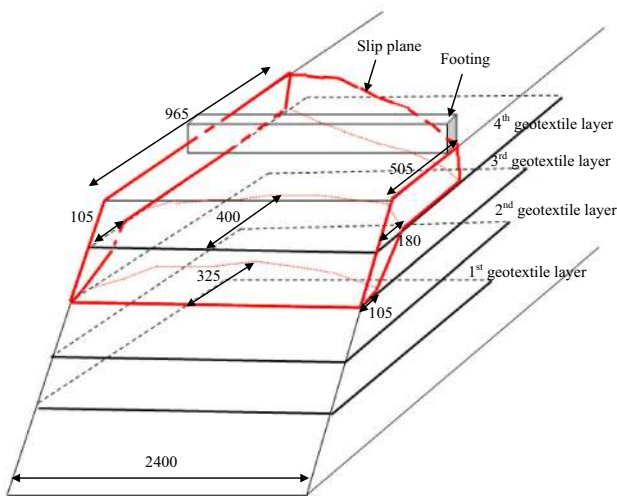
At the end of each loading test, the loading assembly was removed and excavation was started by carefully removing the soil within the failure wedge. Figure 13 shows a traced geometry of the slip plane during embankment excavation after the end of the surcharge loading phase. The failure wedge in the reinforced mass originated behind the loading beam on the surface of the embankment leading to a dipping slip plane which was intercepted by the top two (i.e. 3rd and 4th) geotextile layers as shown in Figs. 13 and 14. These figures indicate that the failure geometry was complex and involved a combination of soil shearing, pullout interaction and interface shearing along the top geotextile reinforcement in addition to interface shearing between the soil and the third geotextile layer. The traced geometry of the slip plane in Fig. 13 also indicates that the scarp of the failure plane behind the loading beam was not parallel to the slope face, which could partly be due to the influence of friction between the embankment and the sidewalls of the test box. It is worth noting that the test embankments were designed using numerical simulations with test data on component materials such that the failure plane originating from the loading beam and extending toward the

**Fig. 13** Failure plane geometry as traced after careful excavation of the failed block at the end of the test constructed at OMC−2 %. All dimensions are in “mm”

embankment slope would not bypass the reinforced mass altogether and would be intercepted by one or more reinforcement layers. Results and observations in Figs. 13 and 14 confirm that this objective has been achieved. Moreover, these results clearly show that the failure mechanism in the model embankments was indeed influenced by the slope, in contrast to the case of footings on level reinforced foundations.

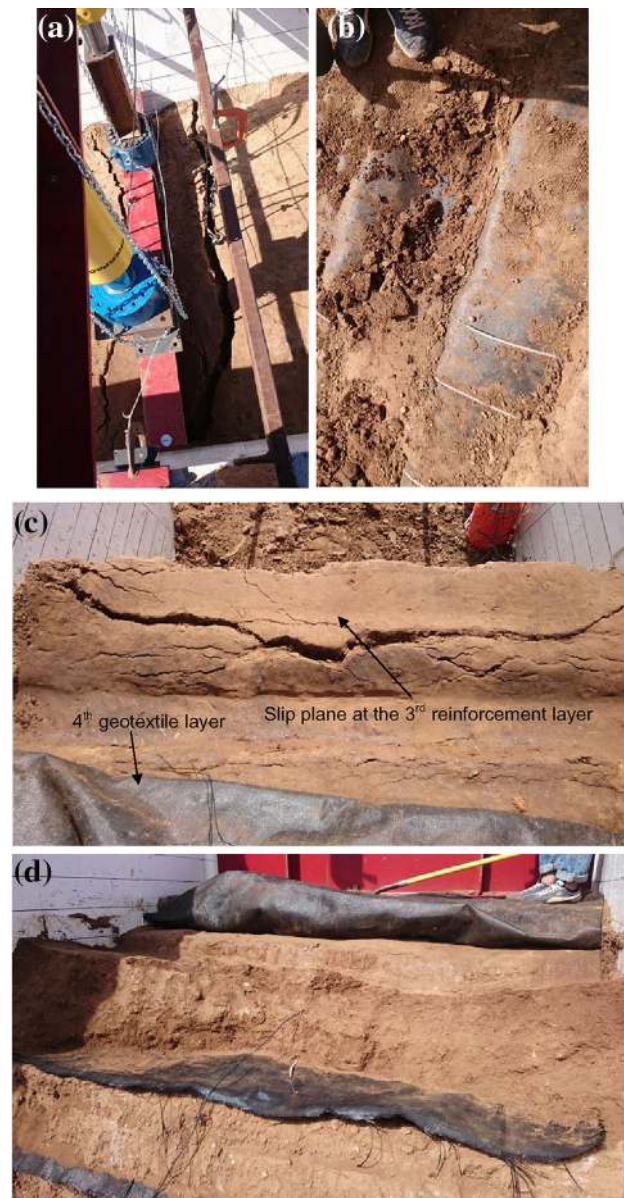
**Fig. 14** Failure wedge in the embankment model tested at OMC−2 % (see the diagram in Fig. 13): **a** Initiation of slip plane on embankment surface; **b** (view from the top) excavated part of failure wedge above the 4th (top) geotextile layer; **c** (view from the top) extension of slip plane underneath the 4th geotextile layer; and **d** excavated part of slip plane shown in “c” which slid over the 3rd geotextile layer

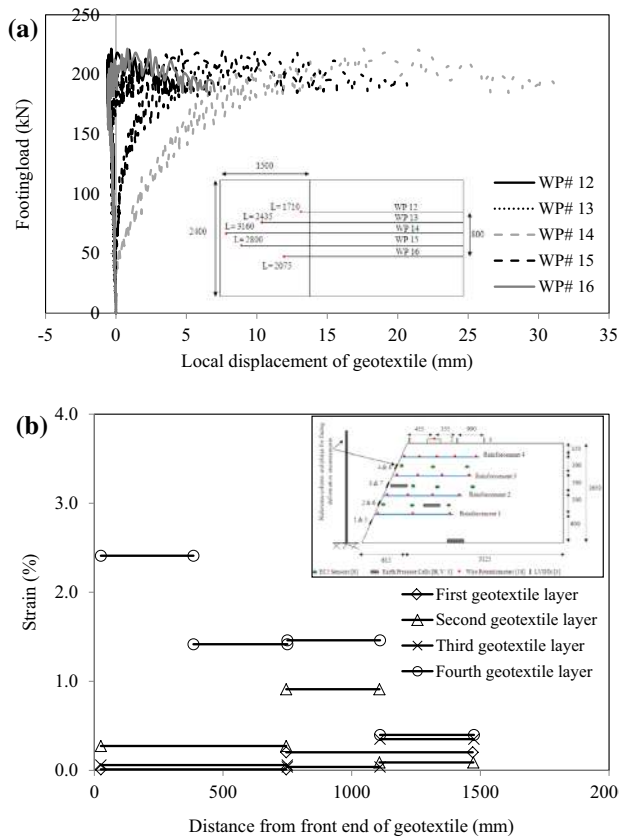
Figure 15a shows local displacements of the top (4th) geotextile layer and Fig. 15b shows the corresponding strain distributions at failure load (i.e. 450 kPa) over the length of all reinforcement layers for the test on the embankment at OMC−2 %. Results in Fig. 15b show that the top geotextile reinforcement experienced a maximum strain of 2.4 % at the front end which decreased to 0.4 % toward its tail end. The strain distributions in the top reinforcement layer which experienced pullout are consistent with those from authors’ earlier study on large-scale pullout tests [5, 6].

**Fig. 15** **a** Local displacements of the top (4th) geotextile layer as measured using five wire potentiometers in the embankment at OMC–2 %; and **b** strains along the length of geotextile layers for the embankment at OMC–2 %

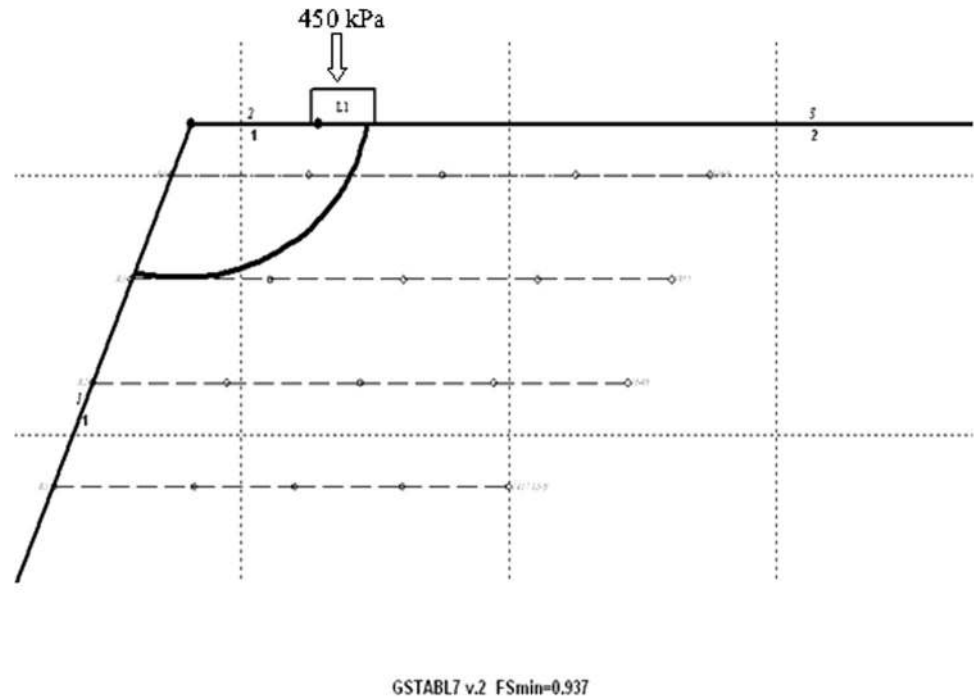
Figure 17 shows the predicted slip surface and factor of safety for the model embankment at OMC+2 % subjected to the laboratory failure pressure of 450 kPa. Results in

**Fig. 17** Predicted slip plane and factor of safety (FS = 0.937) for the reinforced model embankment constructed at OMC+2 % and subjected to observed failure pressure from GSTABL analysis

Fig. 17 indicate that the measured strength properties of the embankment soil and the corresponding MRF values for the soil-geotextile interface for the case of OMC+2 % (as given in Tables 1, 3) would have resulted in a reduction in the factor of safety of the reinforced embankment slope from 1.086 for the case of OMC−2 % to 0.937. This indicates that the embankment constructed at OMC+2 % but with the exact amount of bentonite in the soil blend (2 %) should have become unstable before the failure load would reach 450 kPa that was measured for the OMC−2 % model.

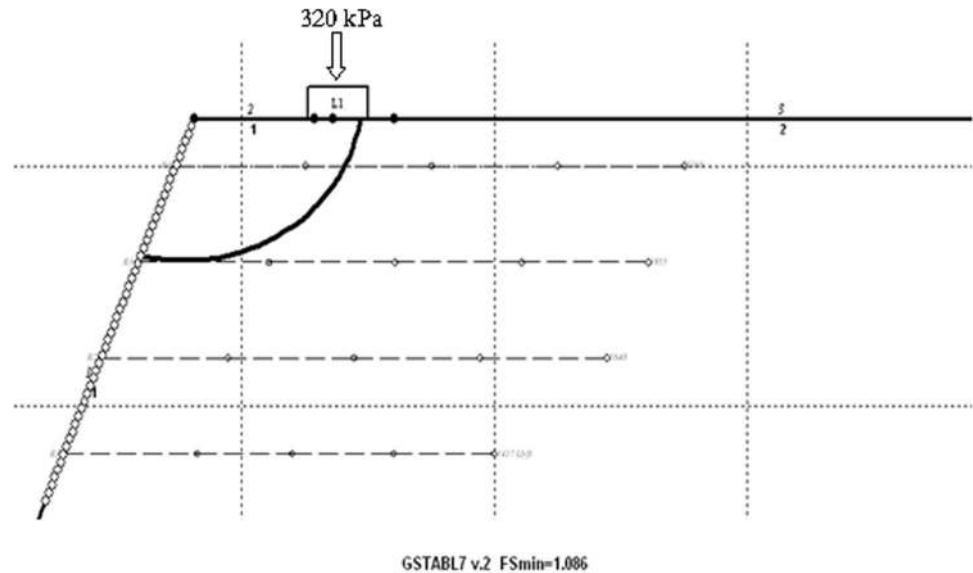
Figure 18 shows that the surcharge load needed to reach the same factor of safety obtained for the OMC−2 % model (FS = 1.086) for the case of embankment constructed at OMC+2 % is 320 kPa. This indicates that a 22 % reduction in the soil-geotextile interface strength (MRF = 0.78) together with reduced shear strength properties of the soil as a result of wetting could result in a 14 % reduction in the factor of safety of the reinforced embankment at OMC+2 % as compared to the model constructed at OMC−2 %.

**Fig. 18** Predicted slip plane and failure load for the model embankment at OMC+2 % from GSTABL analysis to reach the factor of safety equal to 1.086. White circles on the facing slope indicate the initiation points of other possible slip planes
